**ARCHAEOLOGICAL EVALUATION:
LAND AT WILBURY FARM
ARLESEY
BEDFORDSHIRE**

NGR: TL 1903 3318

on behalf of Richard Whitman

ASC: 1116 AWF/2

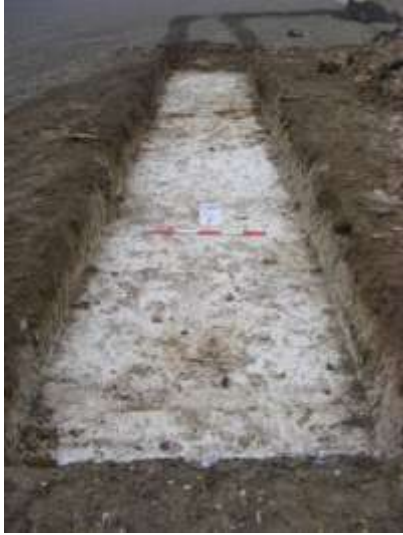
Trench 1

Max Dimensions (m)					
	Length	13	Width	1.8	Depth	0.48
	Levels					
	Trench base northwest		50.02m OD			
	Trench top northwest		50.52m OD			
	Trench base southeast		49.58m OD			
	Trench top southeast		50.03m OD			
	NGR Co-ordinates					
	Orientation		NNW-SSE			
	Reason for Trench		Evaluation			
Context	Type	Description and Interpretation	Width (max: m)	Length (max: m)	Depth (BGL: m)	
101	Layer	Topsoil	>1.8	>13	0.30	
102	Layer	Subsoil	>1.8	>13	0.15	
103	Layer	Colluvial	>1.8	>13	0.03	
104	Layer	Chalk Natural	>1.8	>13	-

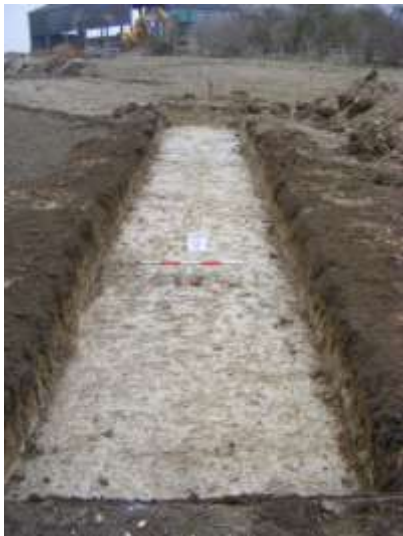
Trench 2

Max Dimensions (m)					
	Length	13	Width	1.8	Depth	0.48
	Levels					
	Trench base northeast		51.13m OD			
	Trench top northeast		51.59m OD			
	Trench base southwest		50.64m OD			
	Trench top southwest		51.09m OD			
	NGR Co-ordinates					
	Orientation		NE-SW			
	Reason for Trench		Evaluation			
Context	Type	Description and Interpretation	Width (max: m)	Length (max: m)	Depth (BGL: m)	
201	Layer	Topsoil	>1.8	>13	0.20	
202	Layer	Subsoil	>1.8	>13	0.18	
203	Layer	Colluvium	>1.8	>13	0.10	
204	Layer	Chalk Natural	>1.8	>13	-

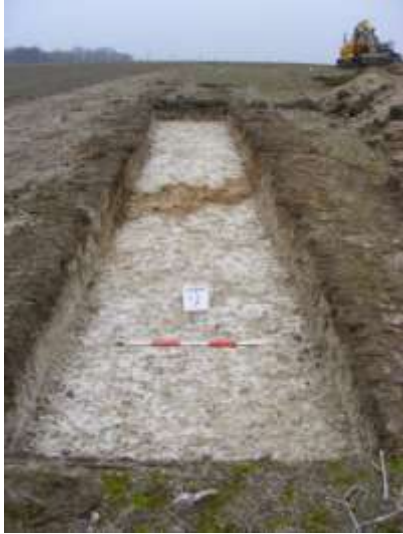
Trench 3

Max Dimensions (m)					
	Length	13	Width	1.8	Depth	0.45
	Levels					
	Trench base northwest		52.14m OD			
	Trench top northwest		52.54m OD			
	Trench base southeast		51.69m OD			
	Trench top southeast		52.18m OD			
	NGR Co-ordinates					
	Orientation		NW-SE			
Reason for Trench		Evaluation				
Context	Type	Description and Interpretation	Width (max: m)	Length (max: m)	Depth (BGL: m)	
301	Layer	Topsoil	>1.8	>13	0.2	
302	Layer	Colluvium	>1.8	>13	0.1	
303	Layer	Chalk & Clay Natural	>1.8	>13	-

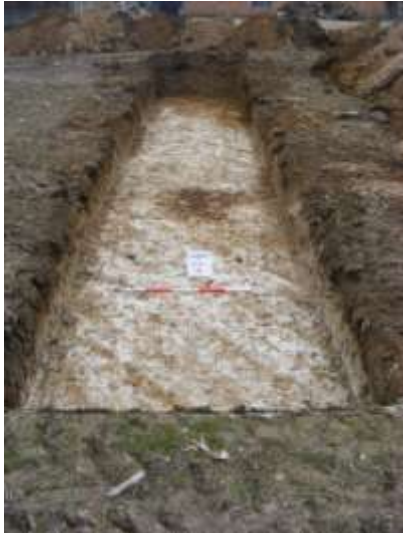
Trench 4

Max Dimensions (m)					
	Length	13	Width	1.8	Depth	0.48
	Levels					
	Trench base northeast		53.01m OD			
	Trench top northeast		53.63m OD			
	Trench base southwest		52.65m OD			
	Trench top southwest		53.13m OD			
	NGR Co-ordinates					
	Orientation		ENE-WSW			
Reason for Trench		Evaluation				
Context	Type	Description and Interpretation	Width (max: m)	Length (max: m)	Depth (BGL: m)	
401	Layer	Topsoil	>1.8	>13	0.20	
402	Layer	Subsoil	>1.8	>13	0.14	
403	Layer	Chalk & Clay Natural	>1.8	>13	-

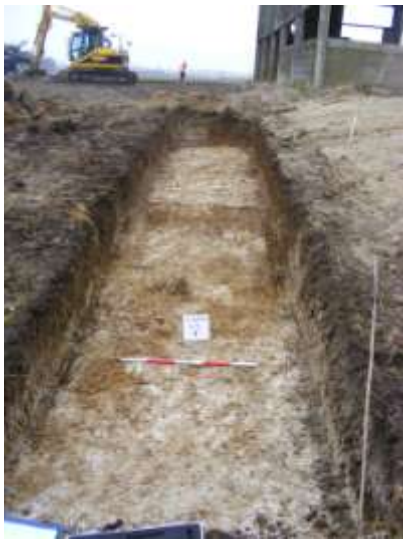
Trench 5

Max Dimensions (m)					
	Length	13	Width	1.8	Depth	0.75
	Levels					
	Trench base northwest		53.37m OD			
	Trench top northwest		54.12m OD			
	Trench base southeast		53.02m OD			
	Trench top southeast		53.56			
	NGR Co-ordinates					
	Orientation			NNW-SSE		
Reason for Trench			Evaluation			
Context	Type	Description and Interpretation	Width (max: m)	Length (max: m)	Depth (BGL: m)	
501	Layer	Topsoil	>1.8	>13	0.25	
502	Layer	Subsoil	>1.8	>13	0.40	
503	Layer	Chalk & Clay Natural	>1.8	>13	-

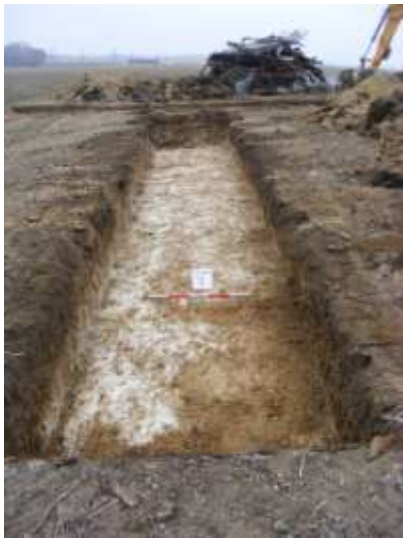
Trench 6

Max Dimensions (m)					
	Length	13	Width	1.8	Depth	0.68
	Levels					
	Trench base northwest		53.19m OD			
	Trench top northwest		53.81m OD			
	Trench base southeast		53.06m OD			
	Trench top southeast		53.81m OD			
	NGR Co-ordinates					
	Orientation			NNW-SSE		
Reason for Trench			Evaluation			
Context	Type	Description and Interpretation	Width (max: m)	Length (max: m)	Depth (BGL: m)	
601	Layer	Topsoil	>1.8	>13	0.25	
602	Layer	Subsoil	>1.8	>13	0.25	
603	Layer	Colluvium	>1.8	>7.0	0 - 0.18	
604	Layer	Chalk & Clay Natural	>1.8	>13	-
