**WATCHING BRIEF:
THE MOAT HOUSE
BRADWELL VILLAGE
MILTON KEYNES**

National Monument No. 19079

April 2009

ASC: 1118/BVM/2

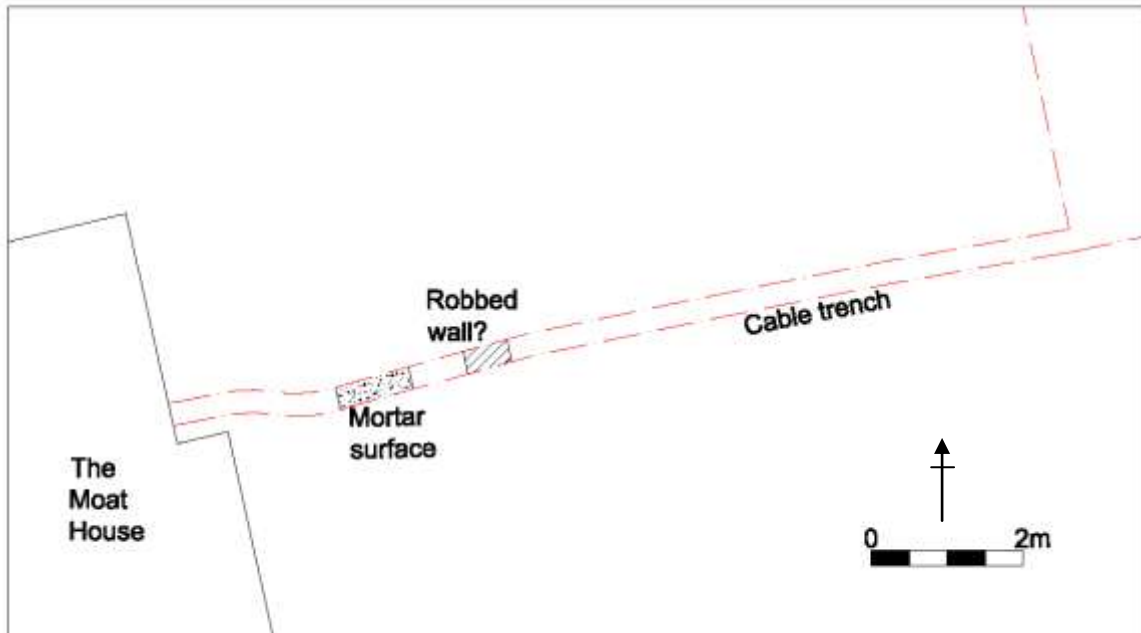
Figure 5: Archaeological remains (scale 1:100)

4.3 The service trench ran east-west from the garage footprint to the Moat House. It was 0.3m wide, 0.2-0.3m deep and *c.* 11.2m long (Fig 4 & 5, Plates 3-6). Excavation revealed possible structural remains (Plates 4 & 5) as well as a mortar surface (Plate6).

The structural remains comprised a possible north-south wall, aligned with the east wall of the Moat House. Only one worked and faced limestone fragment was discovered (not retained) but the cut of a possible robber trench could still be seen in section. The robber trench was *c.*0.6m in width and filled with a mid brown clay deposit containing frequent mortar inclusions. To the west of the wall was a possible mortar surface or what could have been a dump of lathing wall plaster, at least 1m in width.

Between the mortar surface and the robbed wall trench and also to the east of the possible wall the ground makeup consists of 0.15m of made ground overlying a dark brown soil which both the wall and mortar surface cut.

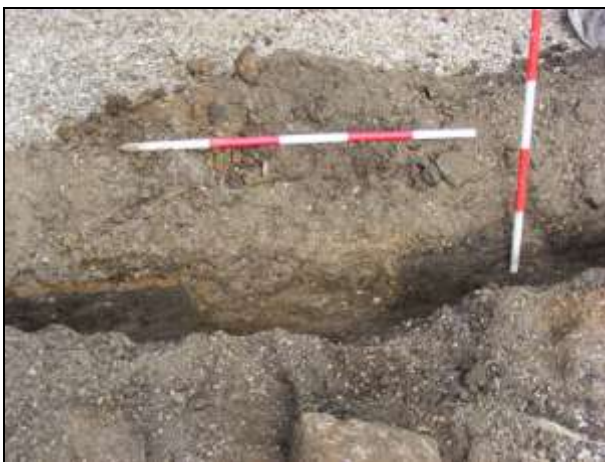
Plate 5: Robbed wall, looking north

A. Poss robbed out wall discovered 3.95m from house.
1 faced stone discovered.
robber trench is 600mm wide and 200mm deep
Back filled with mid brown clay deposit with frequent mortar + tile inclusions.

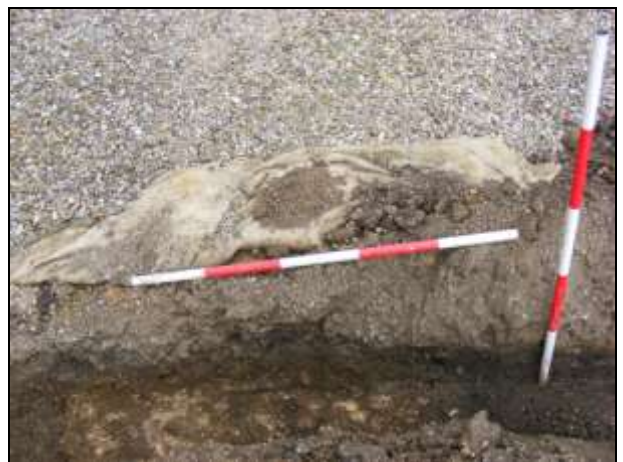
Plate 6: Mortar surface western end of cable trench, looking north

B. finished lime mortar surface at dump of wall plaster - lathing plaster found with occ tile inclusions, one being a peg roof tile.
finishes 3.2m from house begins 2.2m from house - discovered at a depth of 300mm above this is modern made ground.
