**ARCHAEOLOGICAL EVALUATION:
LAND TO THE WEST OF
THE CHURCH OF ST MARY THE VIRGIN
KENSWORTH
BEDFORDSHIRE**

NGR: TL 0306 1905

December 2008

ASC: 1120/KMV/3

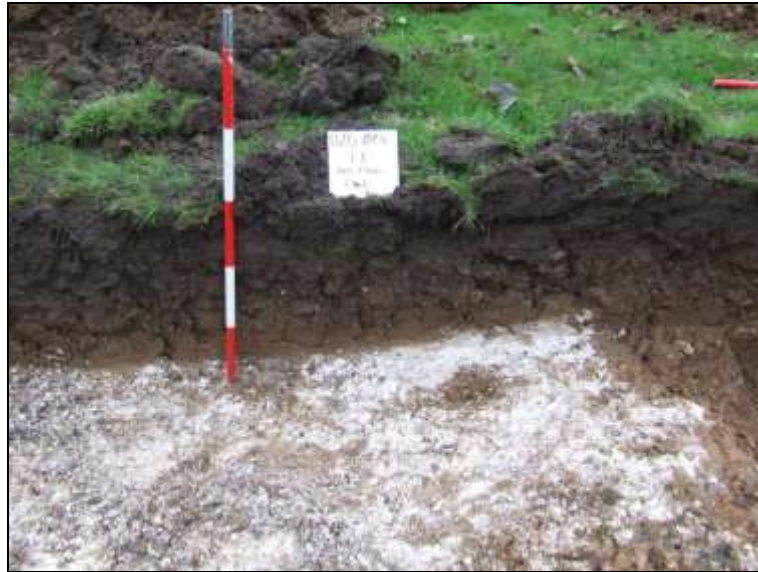
Plate 1: Section of Trench 1

Two trenches were excavated within the area of the proposed graveyard extension. Dark brownish-black clayey-silt topsoil (14) overlay mid orangey-brown silty-clay subsoil (15), which contained inclusions of tile, particularly in Trench 2, and flint, as well as small chalk inclusions. Below this the natural strata comprised mid orange clay with occasional flint inclusions over white chalk.

This trench contained three possible postholes, or truncated pits, on a north-south alignment (Figs 3-5). No finds were recovered from these features (contexts [1], [3] and [5]), which were sub-circular in plan and were sealed by the subsoil.

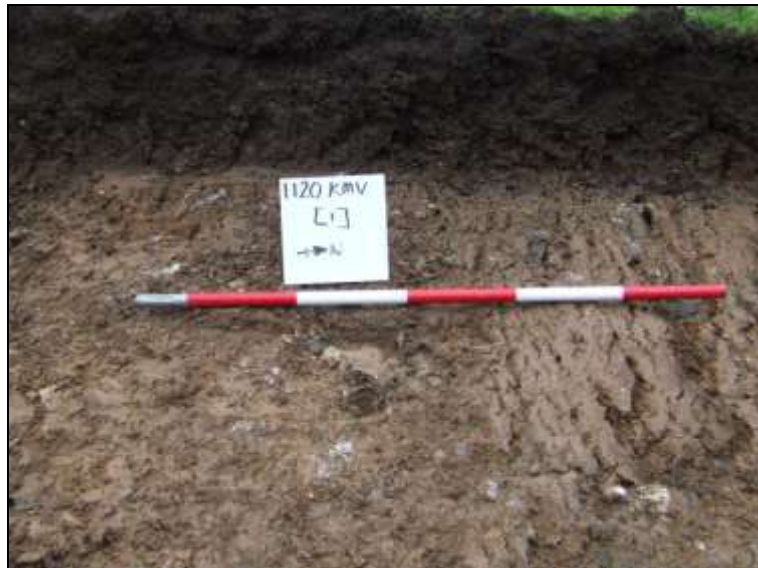
Plate 2: Section of Posthole [1]

Feature [1] cut the natural clay and was 0.92m in length (east-west), 0.62m in width and 0.06m deep. It had gently sloping, irregular sides and a concave base, and was filled with a light greyish brown silty clay with occasional flint inclusions (2).

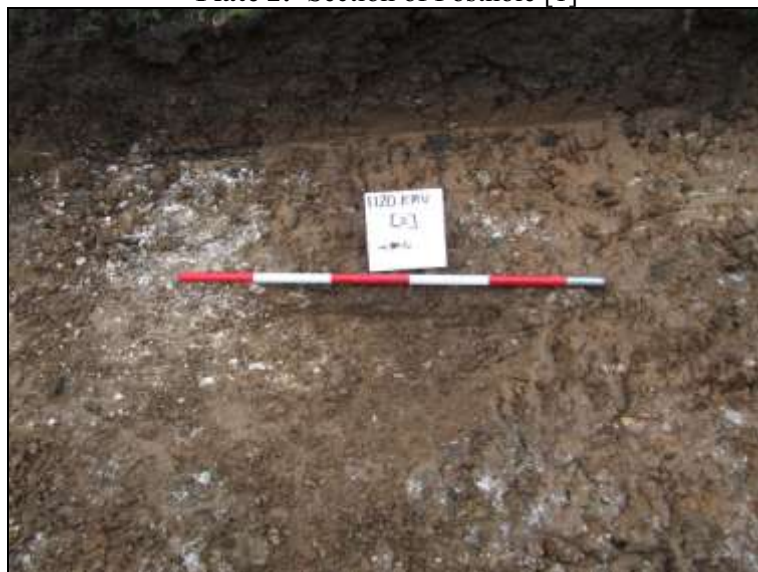
Plate 3: Section of Posthole [3]

Feature [3] was partly cut into the natural clay and chalk. It was 0.91m in length (east-west), 0.72m in width and 0.05m deep, it had sloping, irregular sides and a concave base and was filled with a light greyish brown silty clay with frequent flint inclusions (4).

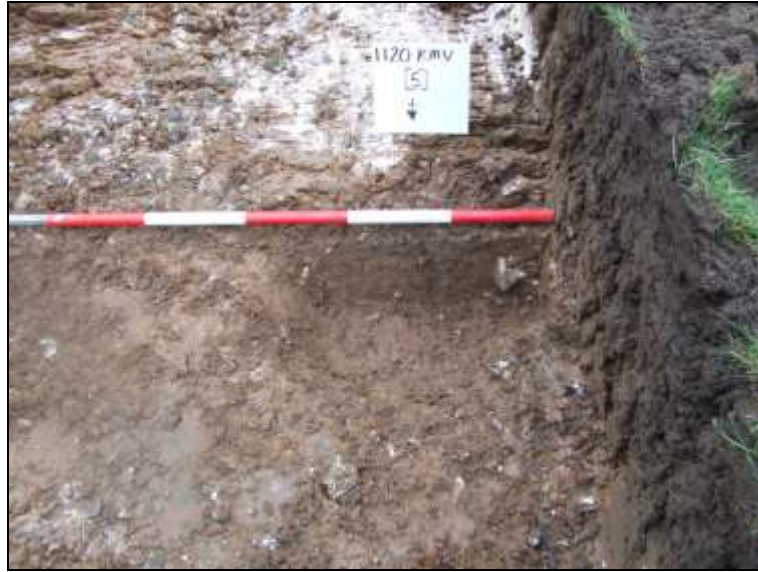
Plate 4: Section of Posthole [5]

Feature [5] was cut into the natural chalk, and was 0.96m in length (north-south), 0.72m in width and 0.13m deep, it had steeply sloping sides and an irregular concave base and was filled with a light greyish brown silty clay with occasional flint inclusions (6).

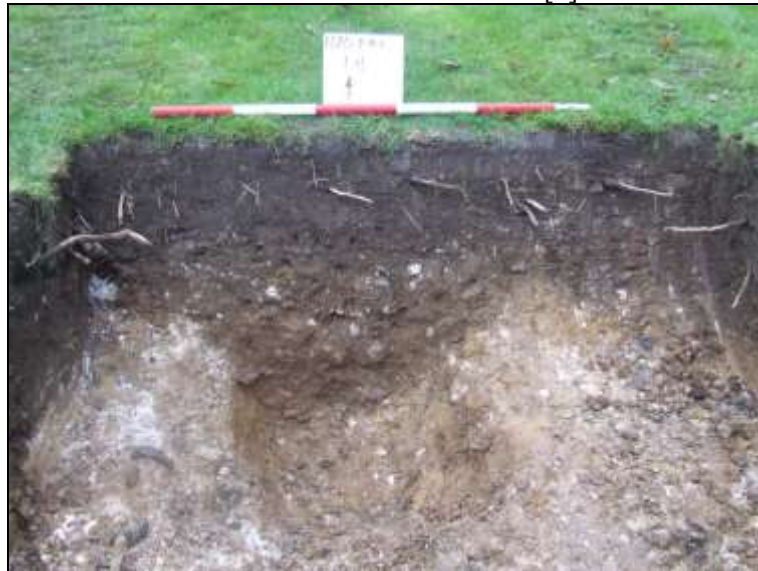
Plate 5: Section of Gully [7]

Gully [7] was 0.70m wide and 0.20m deep. It was filled by dark brownish orange silty clay with occasional flint inclusions (8). A single fragment of peg tile was recovered from this feature, which extended north beyond the trench and was cut by the east-west aligned wall foundation. The fill of this feature was almost indistinguishable from the subsoil, but contained no chalk inclusions.

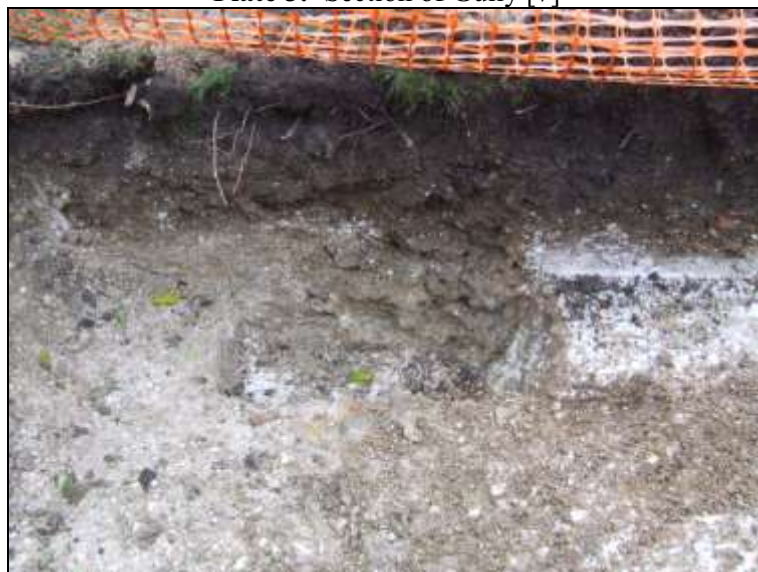
Plate 6: Section of Wall [9]

Wall foundation [10] extended east and west beyond the trench edges. It was 0.71m wide and 0.28m deep. It was constructed with large flint nodules forming four courses, bonded with light brownish yellow clayey sand. The construction cut [9] had vertical sides and a flat base, and was cut into the natural clay to the north.

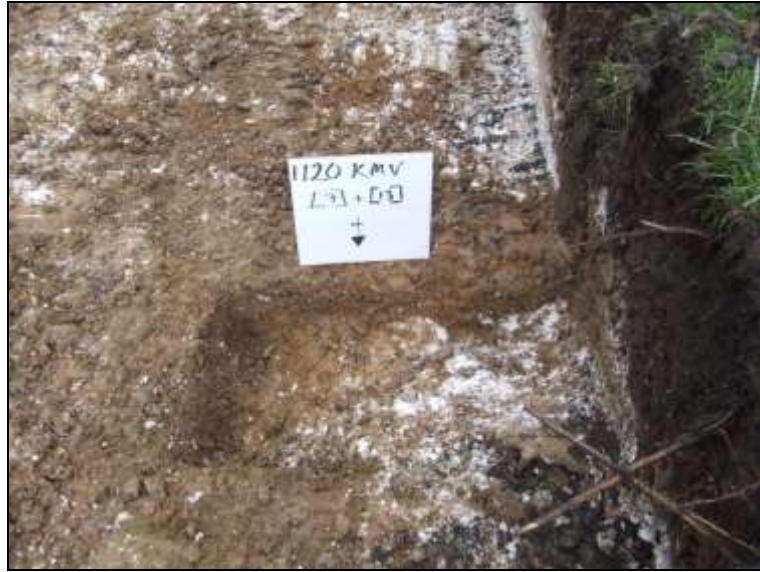
Plate 7: Section of Posthole [13] and Gully [7]

This gully cut Posthole [13], which measured 0.32m north-south, and was filled by orange clay (12), identical to the natural. Posthole [13] had almost vertical sides and a flat base. It was cut into the chalk and was 0.12m deep.

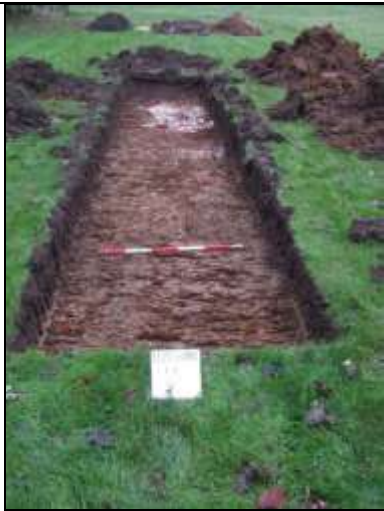
Trench 1

Max Dimensions (m)					
	Length	9m	Width	1.60m	Depth	0.60m
	Levels					
	Trench base north			186.88m OD		
	Trench top north			187.25m OD		
	Trench base south			185.09m OD		
	Trench top south			185.98m OD		
	NGR Co-ordinates					
	N	5030070 219080		S	503068 219070	
	Orientation			N-S		
Reason for Trench			Planning condition			
Context	Type	Description and Interpretation	Width (max: mm)	Thickness (max: mm)	Depth (BGL: mm)	
14	Layer	Dark brownish-black clayey silty (topsoil)	-	200	-	
15	Layer	Mid orangey brown silty clay, flint and chalk inclusions, occasional tile, 1 fragment of white glazed china (subsoil)	-	200	200	
2 1	Fill Cut	Light greyish-brown silty-clay Sub-circular, gently sloping sides, concave base	920	60	400	
4 3	Fill Cut	Light greyish-brown silty-clay, flint inclusions Sub-circular, steeply sloping sides, concave base	910	50	400	
6 5	Fill Cut	Light greyish-brown silty-clay Sub-circular, steeply sloping sides, concave base	960	130	400

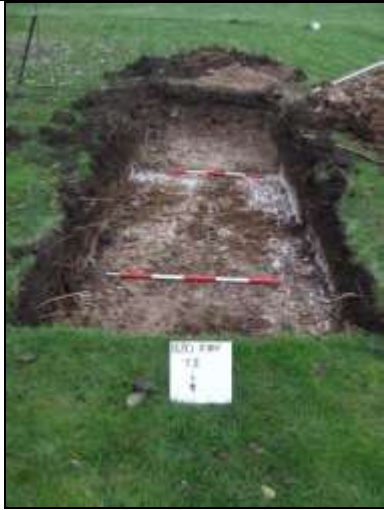
Trench 2

Max Dimensions (m)					
	Length	5m	Width	1.60m	Depth	0.80m
	Levels					
	Trench base north			184.52m OD		
	Trench top north			185.09m OD		
	Trench base south			183.51m OD		
	Trench top south			184.66m OD		
	NGR Co-ordinates					
	N	503065 219054		S	503064 219048	
	Orientation			N-S		
Reason for Trench			Planning condition			
Context	Type	Description and Interpretation	Width (max: mm)	Thickness (max: mm)	Depth (BGL: mm)	
14	Layer	Dark brownish-black clayey silty (topsoil)	-	200	-	
15	Layer	Mid orangey brown silty clay, flint and chalk inclusions, occasional tile, 1 fragment of white glazed china (subsoil)	-	200	200	
8	Fill	Mid orangey brown silty clay, flint inclusions, single fragment of peg tile.	720	200	400	
7	Cut	Linear, steep sided, concave base; cuts (12); cut by [9].				
10	Fill	Large flint nodules in light brownish yellow clayey sand	710	280	400	
9	Cut	Linear, vertical sides, flat base

11	Layer	Mixed light brownish yellow clayey-sand with mid orange sand and light brown clayey silt	-	190	400	
12	Fill	Dark orange clay, no inclusions	375	150	400	
13	Cut	Circular, steep sided, concave base; cut by [7]

This trench contained a possible posthole (context [13]), a north-south aligned gully (context [7]), an east-west aligned wall foundation (context [10]) and a levelling layer (context (11)) (Fig. 5). Several tree roots were observed within the topsoil (14) in this trench, but the root disturbance did not extend into the subsoil (15).
