**ARCHAEOLOGICAL EVALUATION:
CHURCH FARM HOUSE
CHURCH LANE
SAUNDERTON
BUCKINGHAMSHIRE**

NGR: SP 7948 0182

November 2008

ASC: 1122/SCF/2

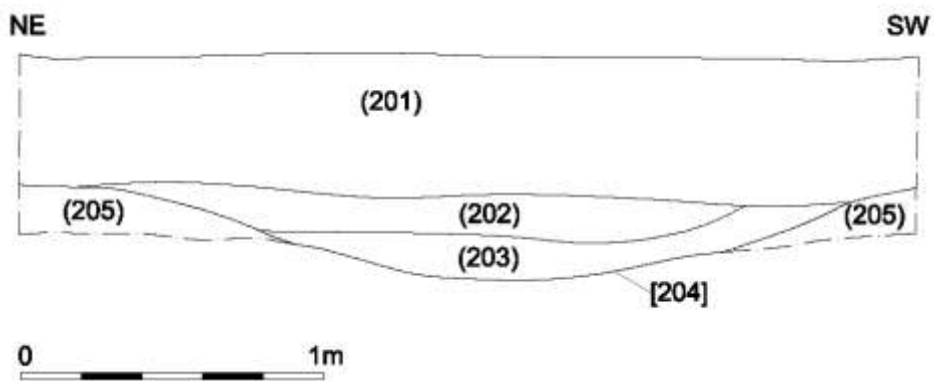
Figure 5: Section of Trench Two (Scale 1:25)

4.3.2 A single feature [204] was present in Trench Two. It comprised a linear construction cut, aligned northwest–southeast and was 1.5m wide and 260mm deep. It is probably a modern ditch or drainage channel.

4.3.3 A deposit of light grey clay (203) was present at the base of the ditch, which contained a quantity of modern brick fragments. In turn this was overlain by a deposit of mixed clay silt and natural chalk fragments (202).

Ditch [204] is a modern feature and is not archaeologically significant.

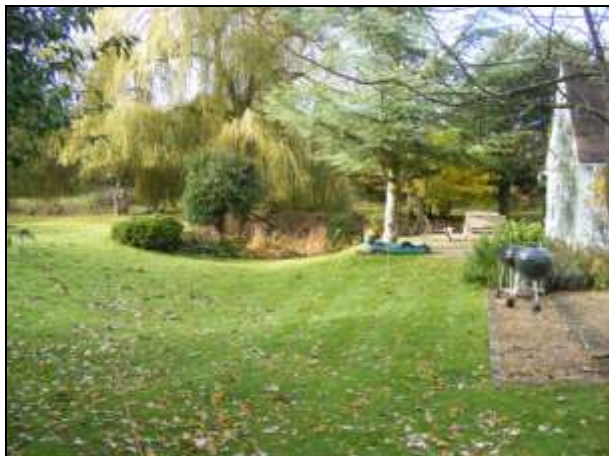
Plate 1: Position of Trench One, pre excavation, looking west. (Note depression in ground surface)

5.1.2 A small stream flows along the west side of the house, and a distinct depression on the south side of the house, may mark the position of a backfilled moat (Plate 1).

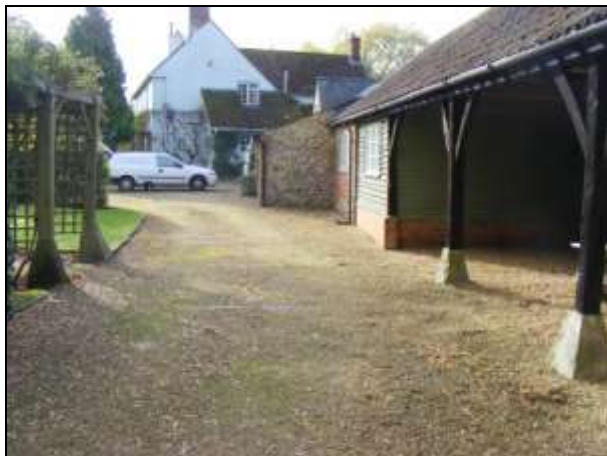
Plate 2: Position of Trench Two, pre excavation, looking southwest

4.3 Trench Two (Fig. 3 & 4: Plates 2 and 6)

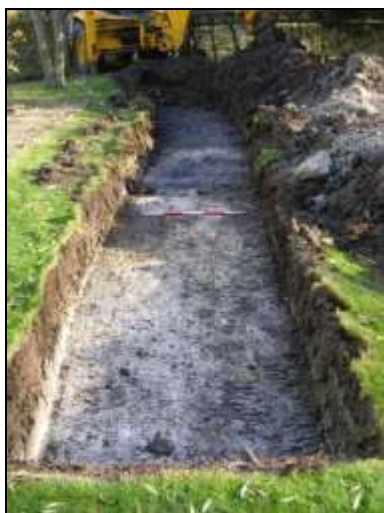
Plate 3: Trench One, looking east south-east

4.2 Trench One (Fig. 3 & 4: Plates 1, and 3-5)

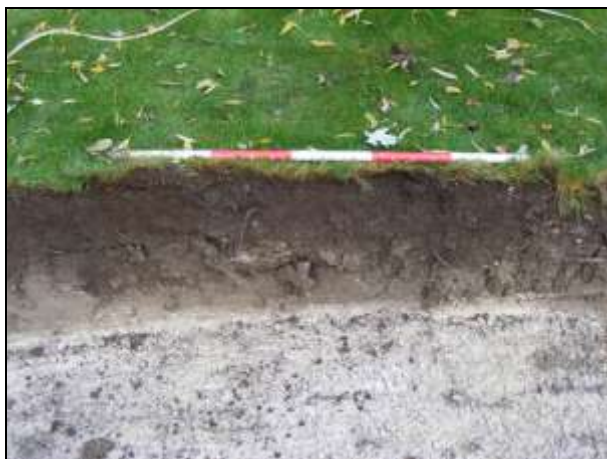
4.2.1 The stratigraphy of Trench One comprised topsoil and turf comprising dark brown silty loam (101), to a depth of 200mm. This overlay the subsoil (102) which comprised grey brown chalky silt c. 200mm deep. In turn this covered the natural strata (103) which was light grey chalk (Plate 4).

Plate 4: Section of Trench One, looking north

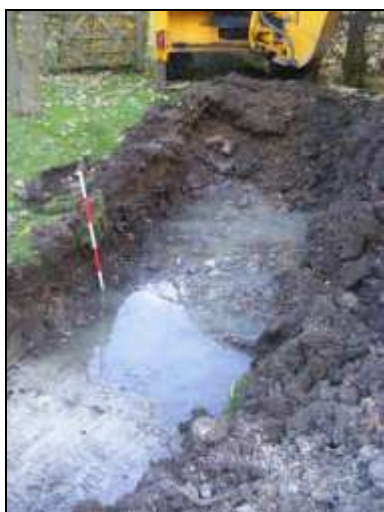
4.2.2 A 19th or 20th century soakaway (Plate 5) was present at the east end of the trench, containing large quantities of tile and brick. This is modern and is not archaeologically significant. No other archaeological remains were observed in this trench.

Plate 5: Soak away at Eastern end of Trench One, looking northeast

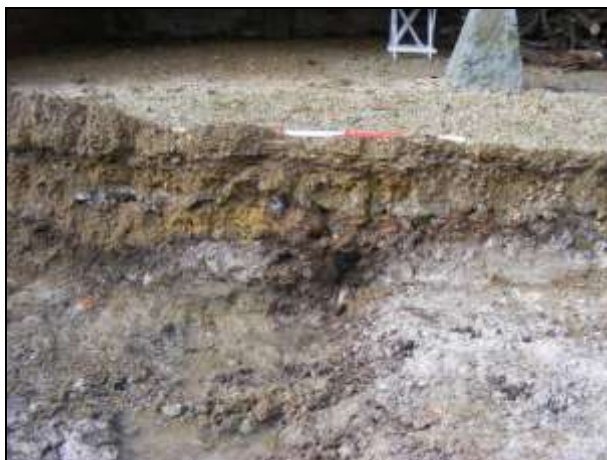
4.3.1 The stratigraphy of Trench Two comprised a layer of modern made up ground (201) which consisted of bricks sand and gravel, to a depth of 480mm. This overlay the natural strata (205) which was light grey chalk (Plate 6).

Plate 6: Section of Trench Two, showing ditch [204], looking northwest

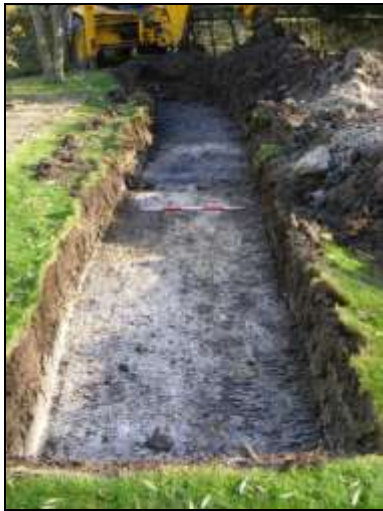
| Trench 1 | | | | | | |

| Trench 1 | | | | | | |
|---|--|--|---|---|---|---|
| | Length | 11m | Width | 1.8m | Depth | c. 0.5m |

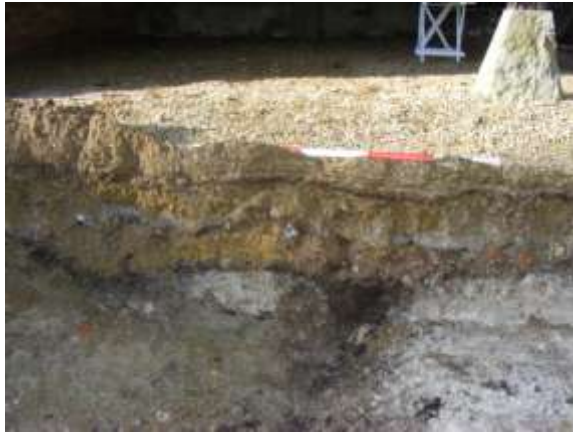
| Trench 2 | | | | | | |

| Trench 2 | | | | | | |
|---|---|--|---|---|---|---|
| | Length | 3.5m | Width | 1.8m | Depth | 0.74m |
