**WATCHING BRIEF:
CLARENDON ARMS
CHANDLERS CROSS
HERTFORDSHIRE**

April 2008

ASC: 997/CCC/2

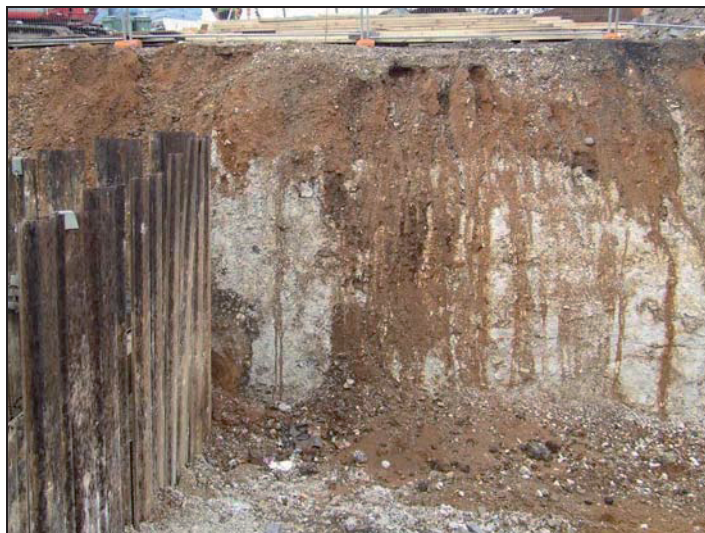
- 4.2 The natural strata was a mid orange sandy clay with frequent inclusions of gravel, which overlay chalk bedrock (Plate 1). The only archaeological features observed were three wells (Fig. 4). Two were located to the north of the site, one 4m east of The Bothy, the other 4m west of it. Both of these were visible in plan within the surface of the car park (Plate 2), they were lined with similar unfrogged, red bricks to those used in the walls of the public house. The third well was located within the existing public house building.

Plate 1: View of stratigraphy within cut for lower ground floor level

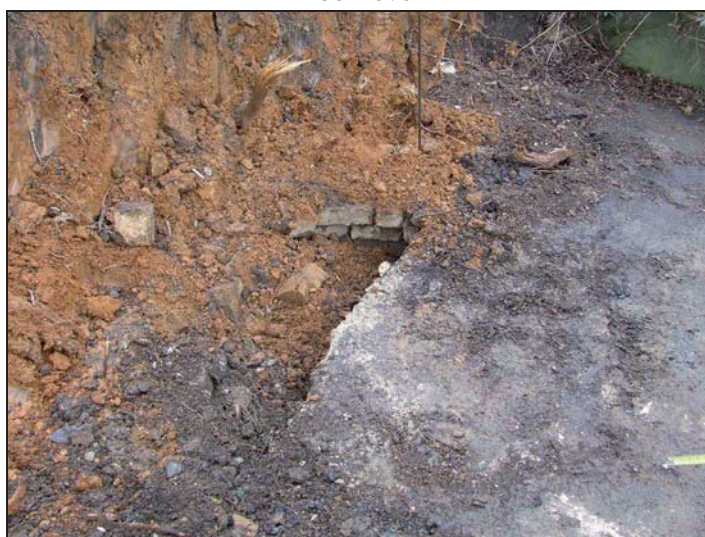
Plate 2: Brick lined well to west of The Bothy

- 5.1 The only archaeological features observed were three wells, two in the northern part of the site close to The Bothy, the third inside the existing public house building. All three were lined with unfrosted red bricks similar to those in the walls of the pub building. These wells are likely to be contemporary with the original construction of the public house in the 19th century.

- 5.2 The northern part of the site was occupied by houses, known as Church Cottages until the pub car park was extended in 1978. The Bothy formed an out building to one of these cottages, indicating that the two wells also belonged to either one or more of these cottages.

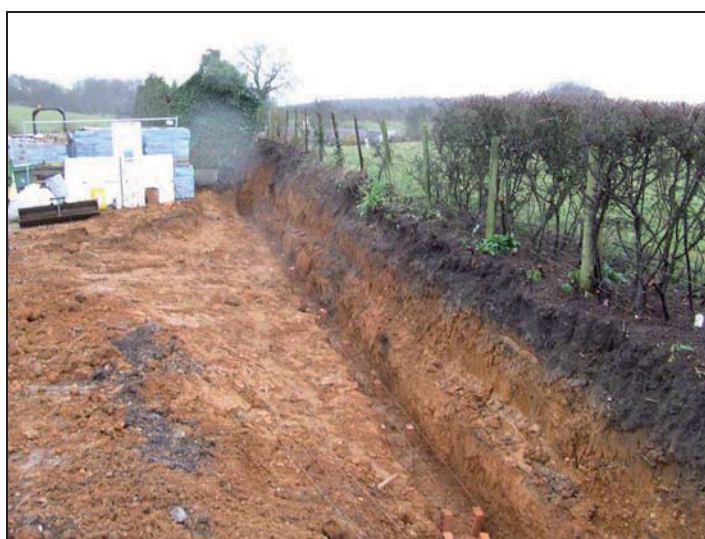
- 4.3 After the removal of the hedge forming the northern boundary of the site, it was clear that the existing carpark level was at least 0.10m below the subsoil horizon, increasing to 0.30m at the eastern edge of the site. It appears that a great deal of ground disturbance had already taken place prior to the current scheme of refurbishment and ground reduction (Plate 3).

Plate 3: Reduced ground level to north of site
