**HISTORIC BUILDING RECORDING & WATCHING BRIEF:
12 WALTON ROAD
MIDDLETON
MILTON KEYNES**

SP 8894 3896

on behalf of Midsummer Housing Association

ASC: 976/MKV/2

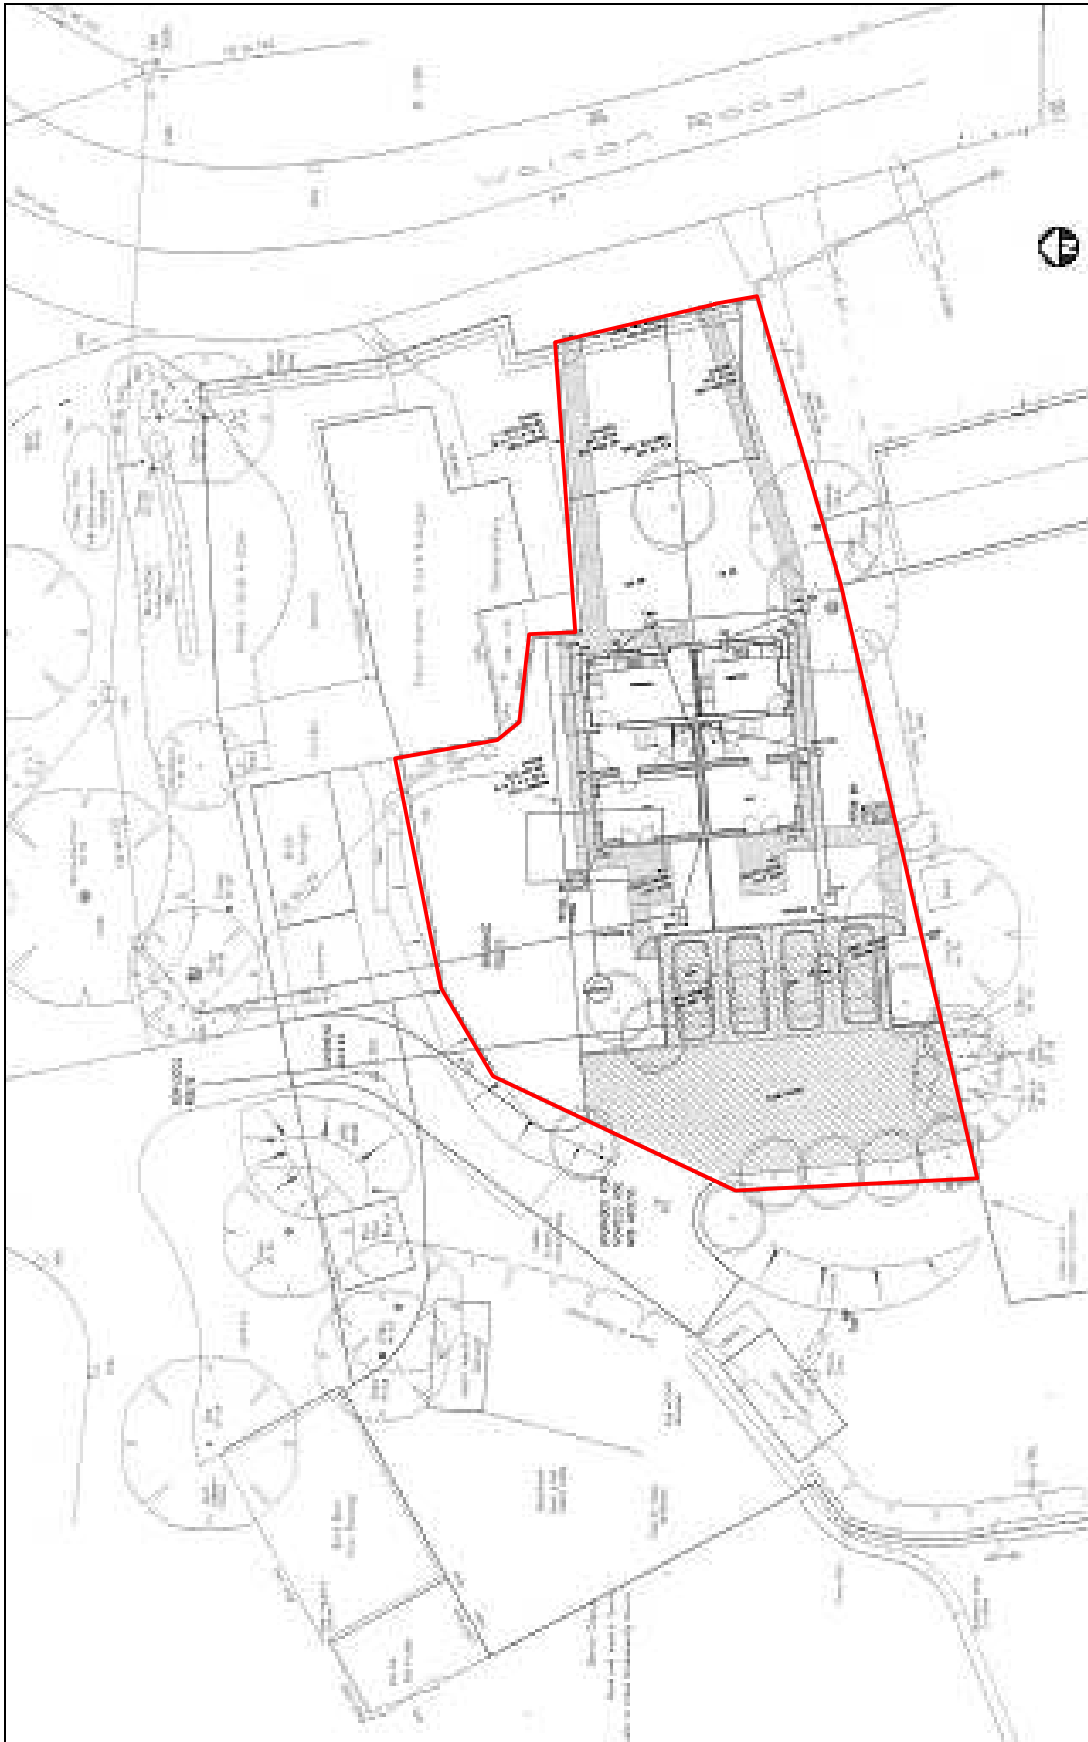
Figure 3: Proposed development plan (*not to scale*)

These archaeological works have been required under the terms of *Planning Policy Guidance Notes 15 and 16* (PPG15, PPG16), in response to proposals for the demolition of the existing cottage and the erection of two semi-detached dwellings (Fig. 3).

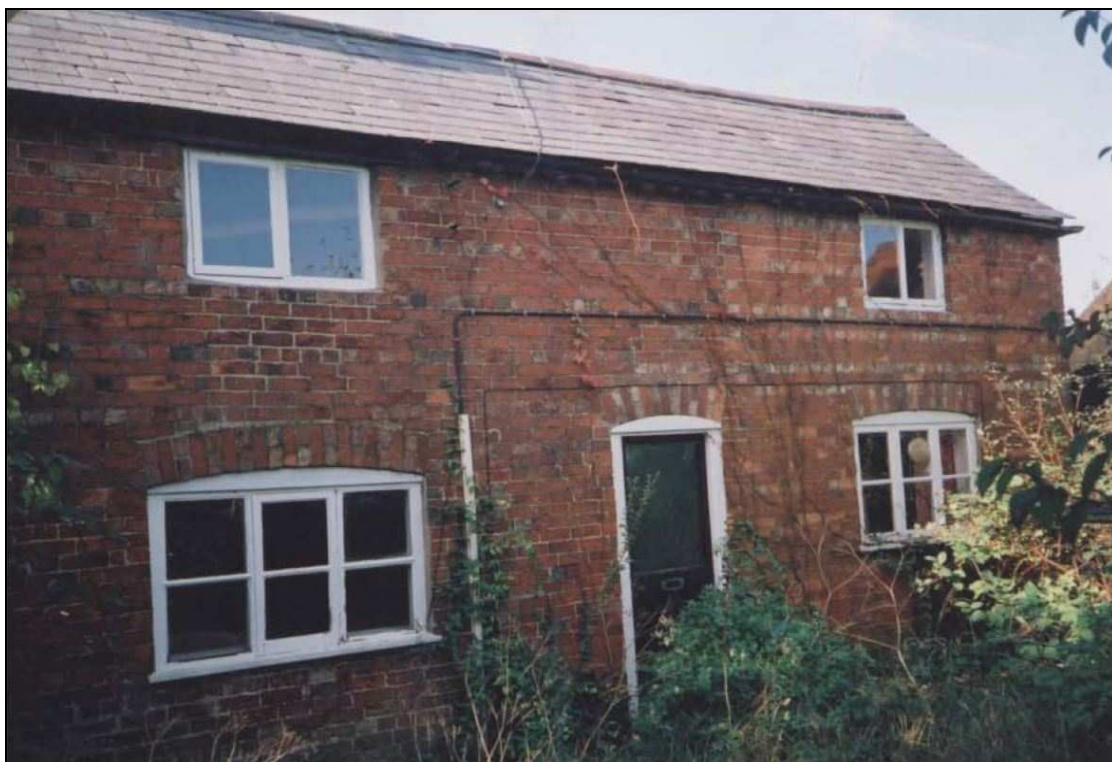
Plate 1: East elevation

The front of the cottage, this elevation had a central door flanked at ground level by wide 3/2 casement windows with wooden sills, all under brick arched lintels. Above the windows at first floor level were smaller 1/1 casements, with timber lintels and no sills.

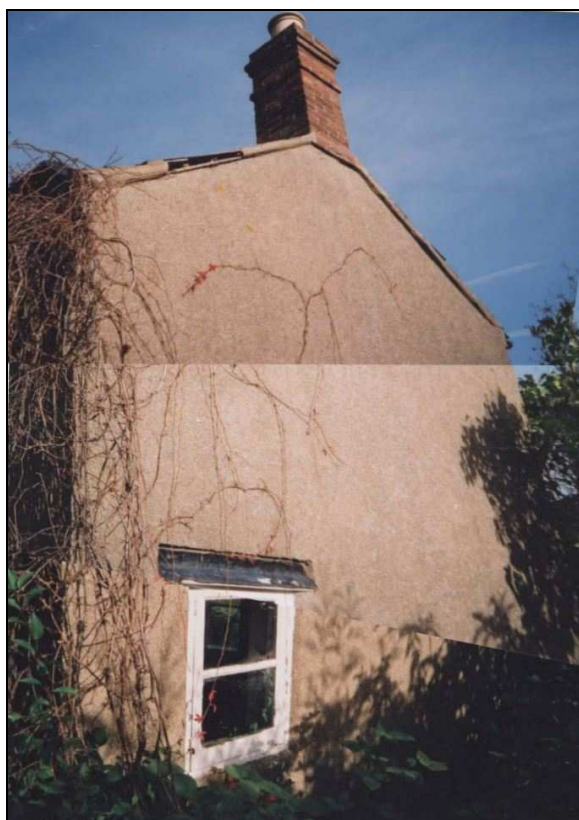
Plate 2: Main south elevation

This elevation comprised the rendered gable wall of the cottage, and the south wall of the west extension. The gable wall was pierced by a single 1/1 casement window at ground level, and was dominated by a brick chimney stack rising above the ridge. Because of the rendering, no other structural details were visible. The south wall of

the west extension was pierced by a modern 1/1 hopper window with a tile sill, lighting the bathroom.

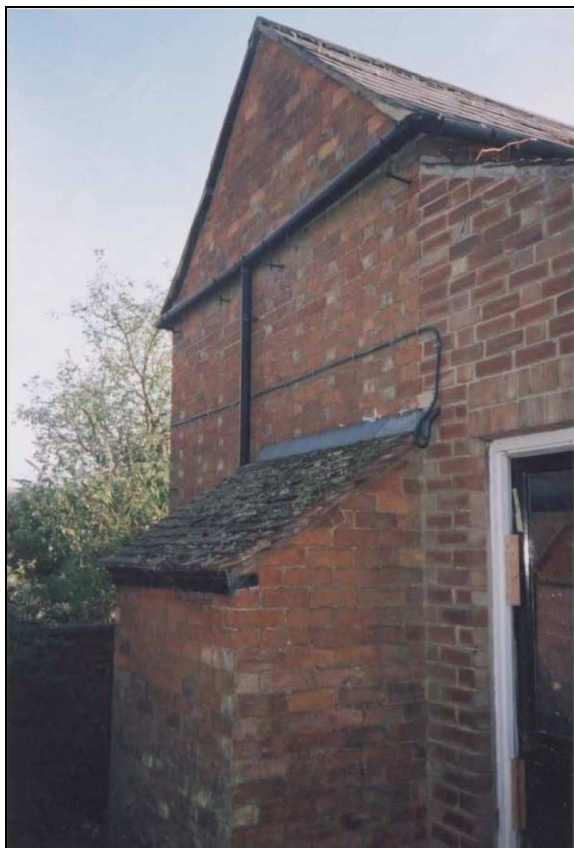
Plate 4: North elevation

The north elevation of the cottage was devoid of openings, except a modern door in the north wall of the west extension. The only other features of note were the small north extension, also windowless, and the gutter and downpipe carrying runoff from the eaves gutters on the east and west elevations. The butt joint between the original cottage wall and the west extension is clearly visible in Plate 4.

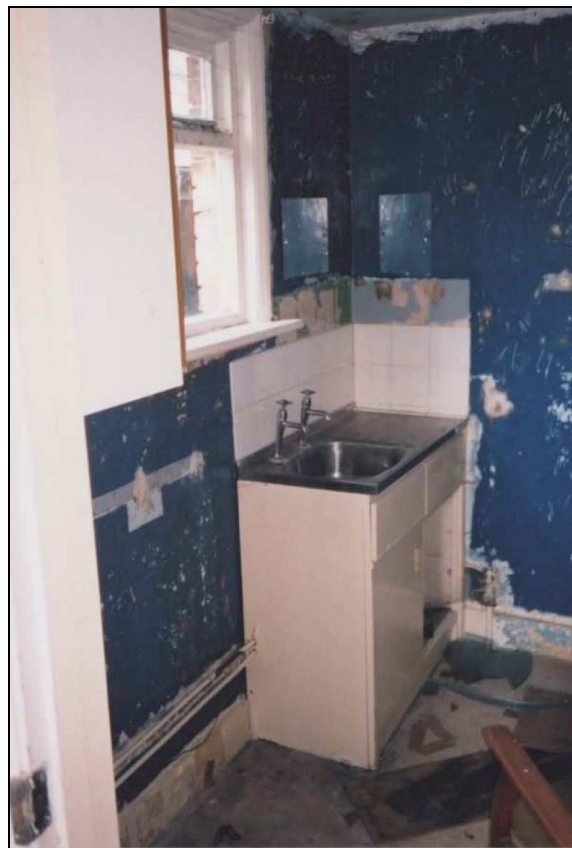
Plate 5: Kitchen, looking north-west

Description: This room was entered by a doorway from the living room to the east. To the south, a door led to the bathroom, and there was an external door to the north. The room was lit by a single window to the west. The south-east corner of the room was occupied by the former external chimney stack. In the north-west corner of the room was a modern sink unit.

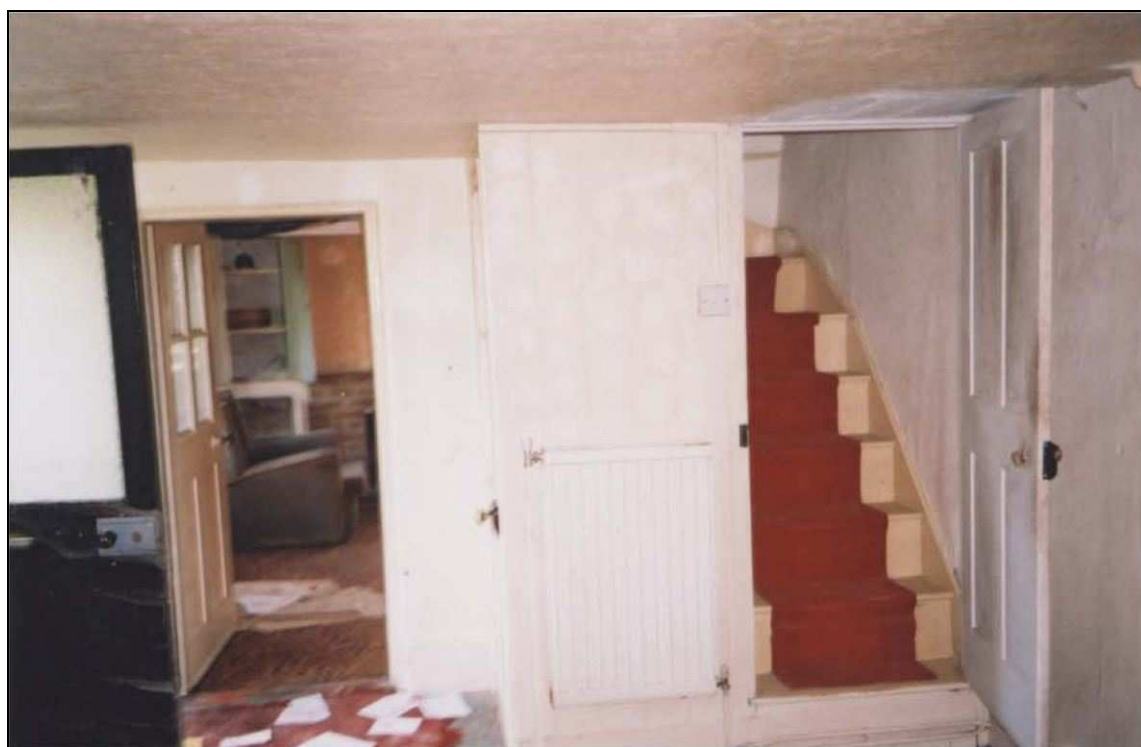
Plate 6: Living room, looking south

Description: Entered in the south-east corner by the front door of the cottage, this was probably originally the cottage kitchen. To the south, a door led to the lounge. In the south-west corner, an enclosed stairway of nine steps led to the first floor, turning anticlockwise through 90 degrees. Between the lounge door and the stairs was a built-in cupboard. In the centre of the west wall was a large fireplace: to the north of this was the door leading to the west extension. In the north wall was a doorway giving access to the north extension, which measured 1.5 × 0.8m and 1.9m high, and was used as a larder. In the centre of the east wall was the only window in the room.

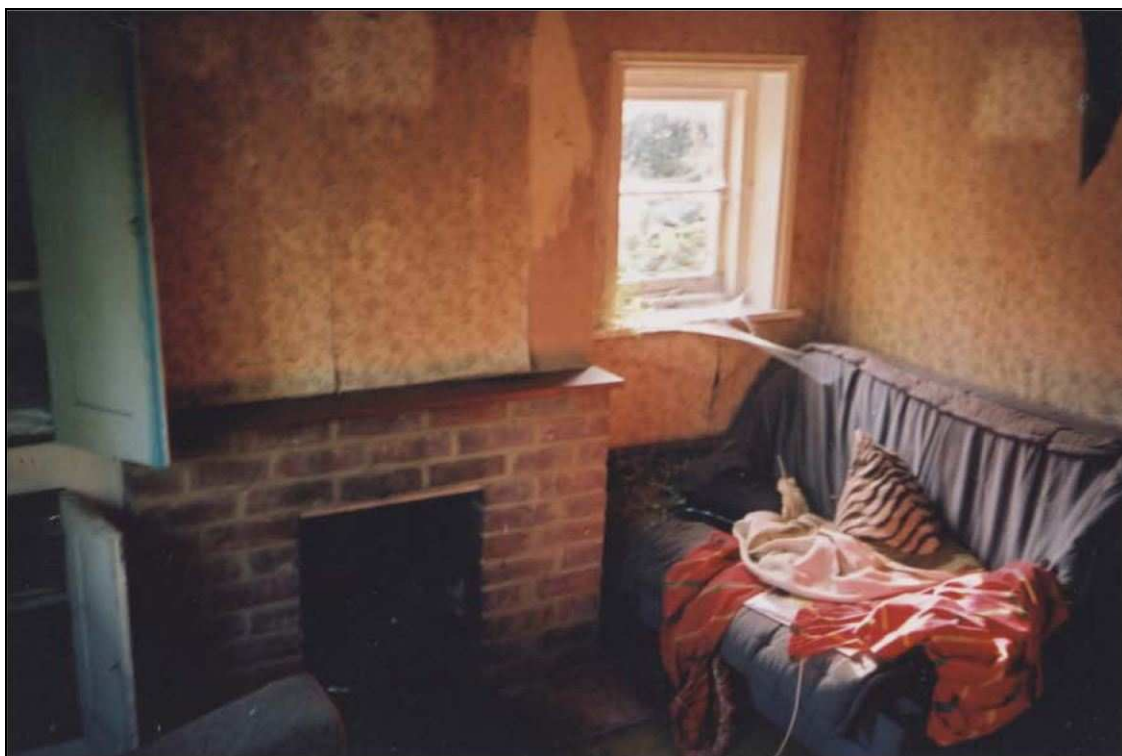
Plate 7: Lounge, looking south-west

Description: This room was entered by a doorway from the living room. It had two windows: a large one to the east, and a smaller one to the south. A wide chimney breast was centrally located on the south wall, with a modern brick and tile fireplace, and built-in cupboards to the east.

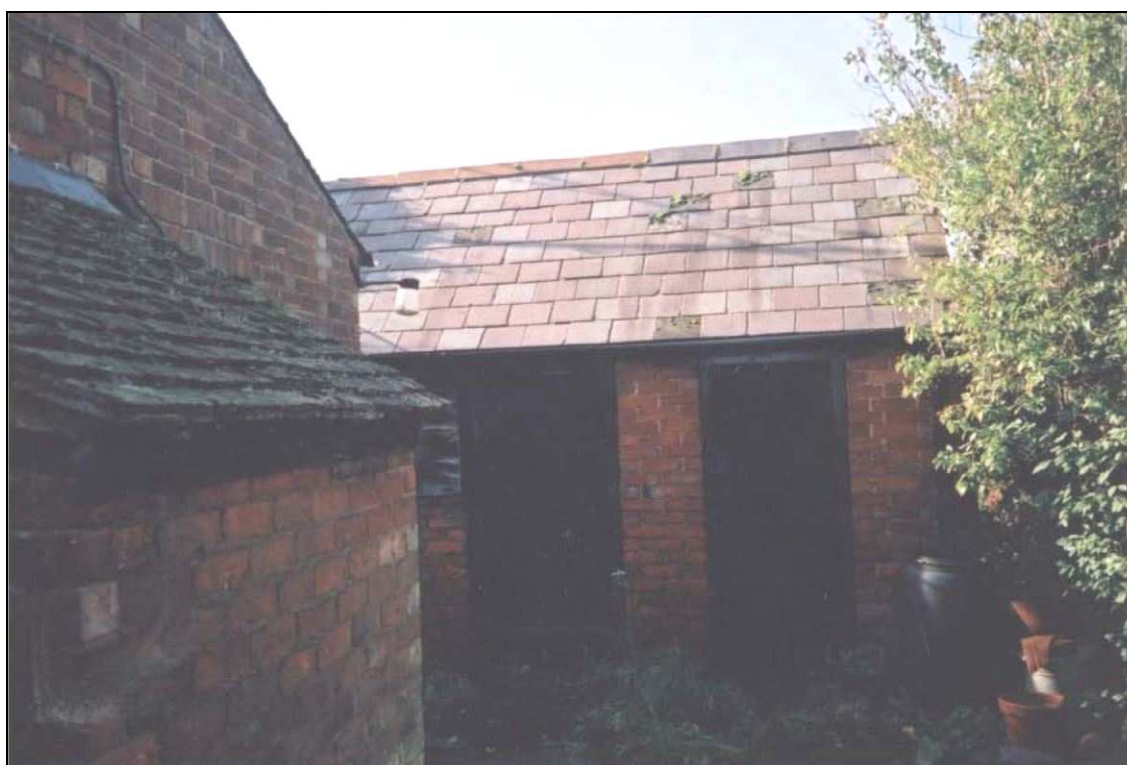
Plate 8: Barn, east elevation

Description: This was divided internally into two rooms: the smaller, c.1.8m square, occupied the north-east corner of the building, and was entered by an external door from the yard to the east. The remainder of the barn was entered by two east-facing doors. There were no windows.

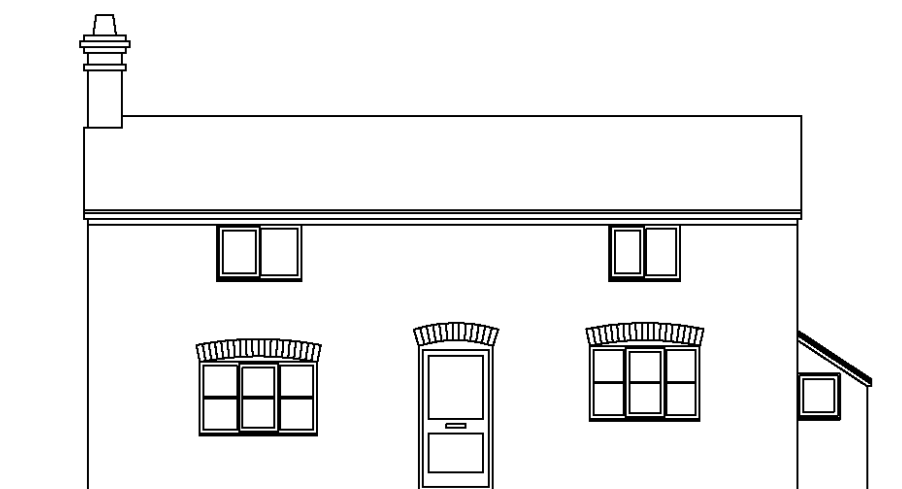
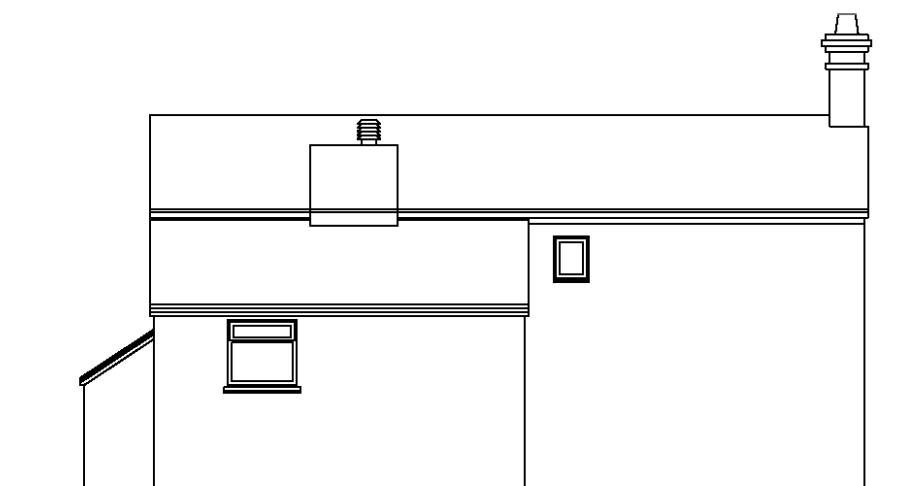
Figure 8: East and west elevations (*scale 1:100*)

No photographs were available of this elevation, which was dominated by the west extension containing the kitchen and bathroom. The original rear wall of the cottage appears to have had only two openings: an entrance at its northern end, which latterly provided access to the extension, and a small first-floor window lighting the stairs. The west extension had a single modern 1/1 hopper window, lighting the kitchen. At the junction of the extension and the original rear wall, a wide brick chimney with a single louvred pot reached almost to ridge height. This rose up from what appears to have been originally an external chimney stack, serving a fireplace in what is now the living room.

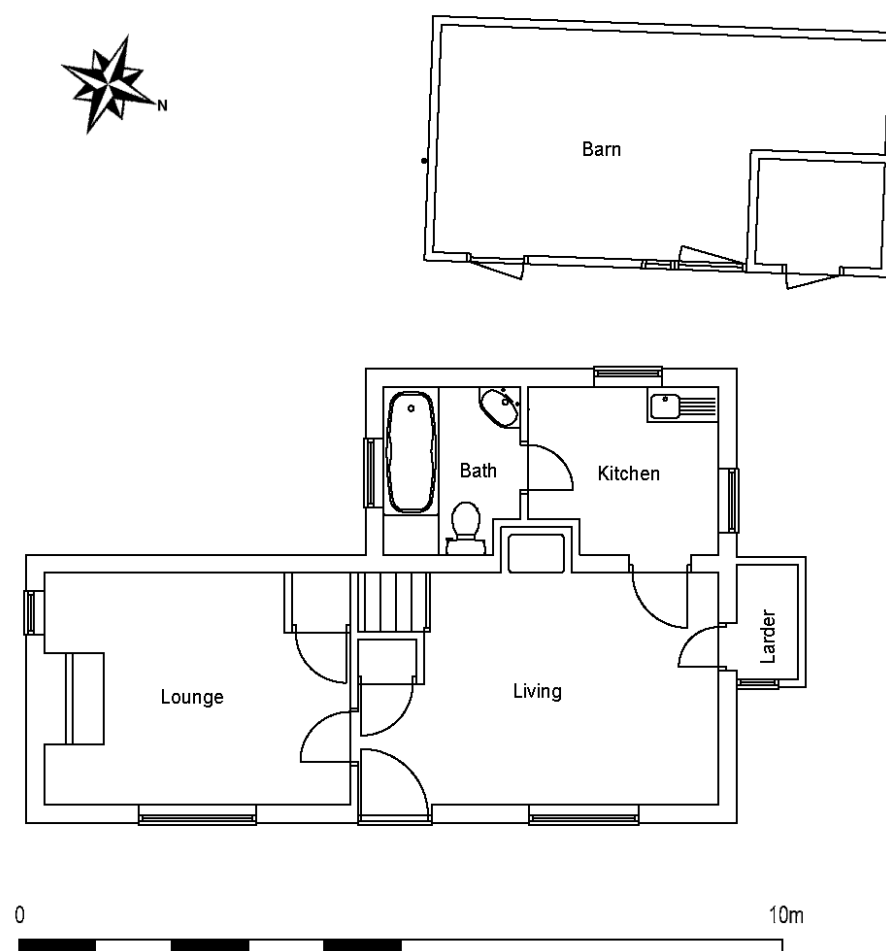
Figure 10: Ground floor plan (*scale 1:100*)

Internally the cottage comprised two rooms on each floor, with a central stairs. The smaller north extension housed a larder, while the larger west extension comprised a kitchen and bathroom.

Description: This room was entered by a doorway from the kitchen to the north. The room was lit by a single window to the south. The north-east corner of the room was occupied by the former external chimney stack. Across the south end of the room was a modern bath, with a WC to the east and a hand basin in the north-west corner of the room.

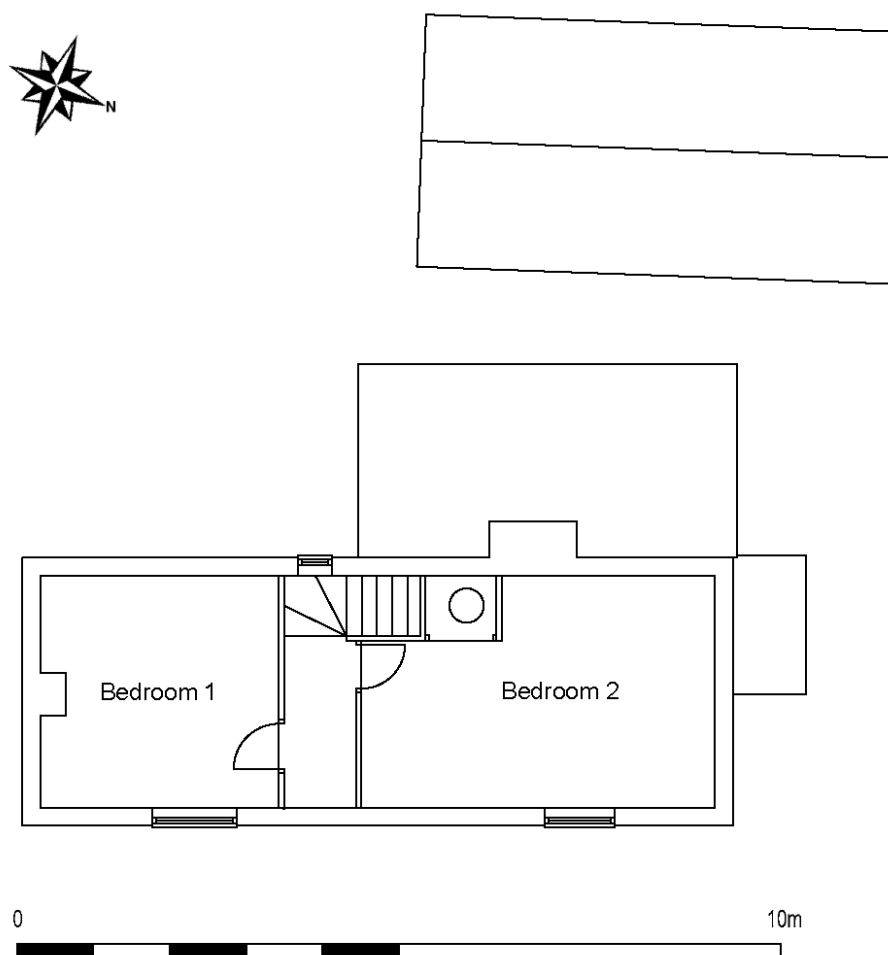
Figure 11: First floor plan (*scale 1:100*)

Description: From the top of the stairs, this room ran west-east across the cottage. It was lit by a small window above the stairs at its west end. Doors to the north and south led to the two bedrooms.

Description: This room was lit by a window to the east. A narrow flue from the fireplace in the lounge below rose up the south wall. There does not appear to have been a fireplace in this room.

Description: This room was lit by a window to the east. The south-west corner was occupied by the stairwell, and a built-in cupboard containing the hot water cylinder.

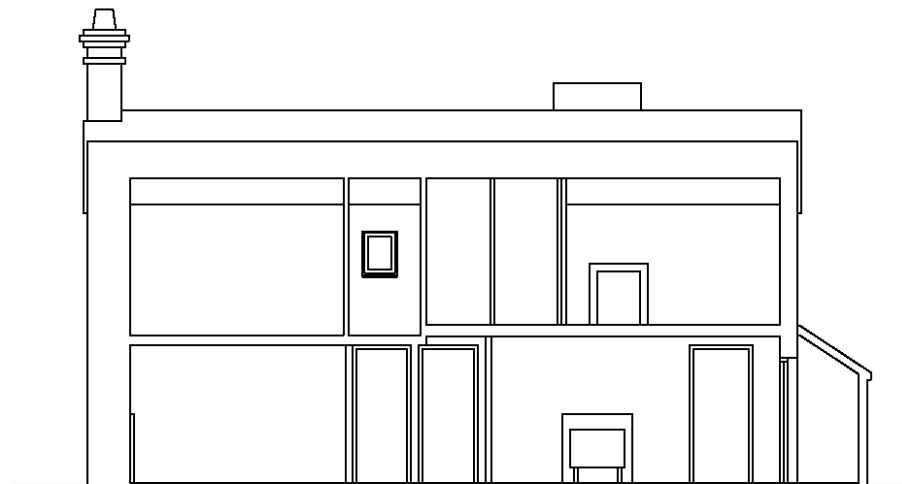
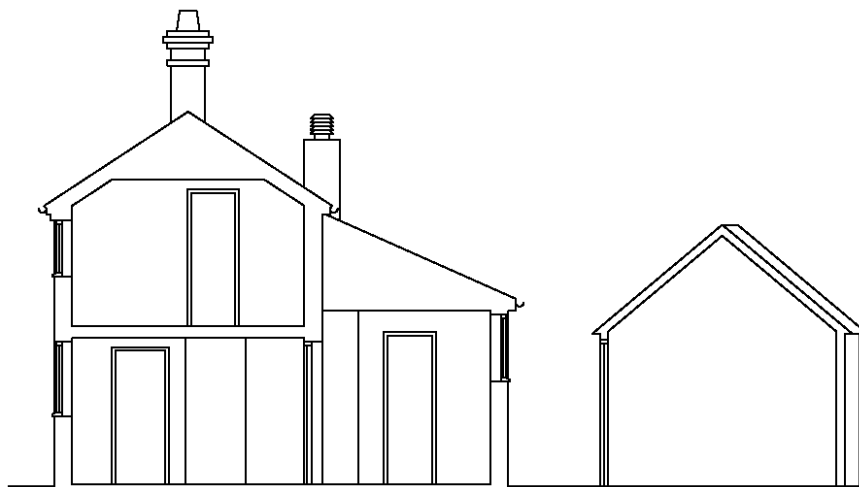
Figure 12: Sections through buildings (*scale 1:100*)

12 Walton Road was a two-storey brick-built cottage under a slate roof, aligned nearly north-south. On its west side was a single-storey brick-built extension, also under a slate roof. A second smaller extension was located on the north end of the building. The cottage measured $9.3 \times 3.6\text{m}$ overall, and stood to a height of 3.7m at the eaves and 4.9m at the roof ridge.

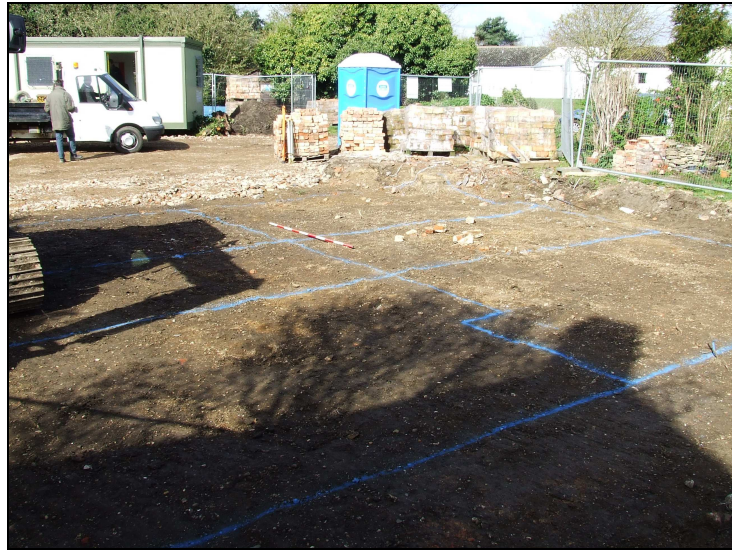
- 5.2 Topsoil across the site was 0.45m deep. Removal of the 19th-century cottage confirmed that the footings of the building, initially observed several years previously during an earlier abortive watching brief (pers. comm. D Fell), were very shallow, and did not extend below this layer. The topsoil strip was not carried out particularly cleanly, and observation of the presence/absence of archaeological features once it had been completed was not possible.

Plate 9: General view of site after topsoil strip, looking south-west

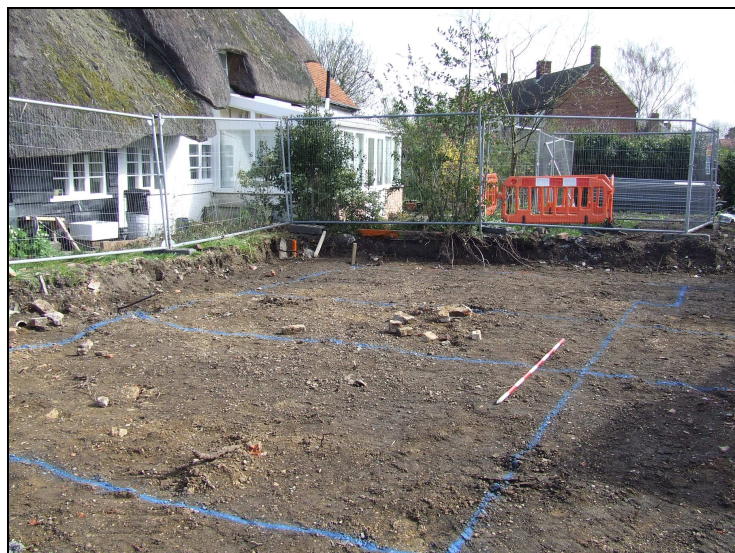
- 5.3 Excavations for the strip footings of the new houses commenced on the south side of the site (Fig. 13). The footing trench, which was *c.* 1m wide and 1.5m deep, cut into the natural gravel. Almost immediately it encountered a possible ditch running north-south. This feature measured 1.0m across and 0.6m deep, with a 'V' section profile (Fig. 14). Its fill was loose dark organic soil: no finds were noted in the section or in the excavated spoil. A second smaller feature adjacent to this could have been a parallel ditch or a pit. Its fill was similar, and no finds were recovered from it.

Plate 10: Location of new houses, looking east
