**WATCHING BRIEF:
ST MICHAEL'S CHURCH
STEEPLE CLAYDON
BUCKINGHAMSHIRE**

NGR: SP 7053 2674

on behalf of Steeple Claydon Parochial Church Council

ASC: 975/SMC/2

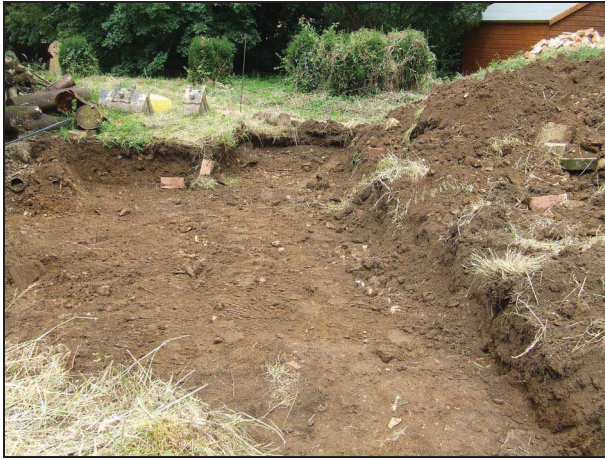
Plate 1: Overview of site during ground reduction

- 4.5 *Raft Foundations*
Ground reduction within the footprint of the new building was carried out using a mini-digger with a toothless bucket. The formation level for the new building was 525mm below the interior floor level of the church. Trenches for the beams supporting the raft foundation were excavated using a 600mm wide toothed bucket to a depth of 650mm below the interior floor level of the church.

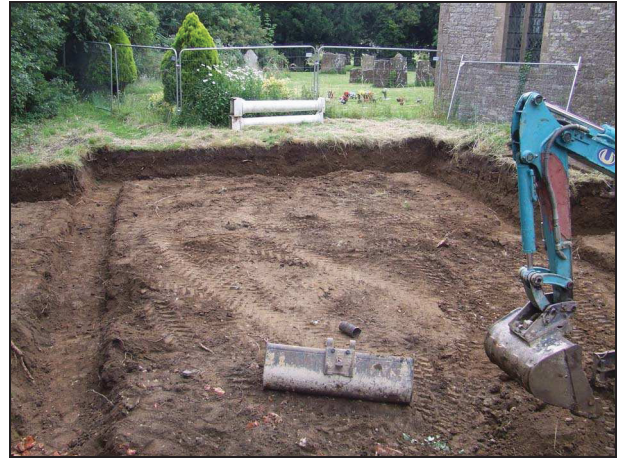
Plate 2: Overview of site after digging foundations

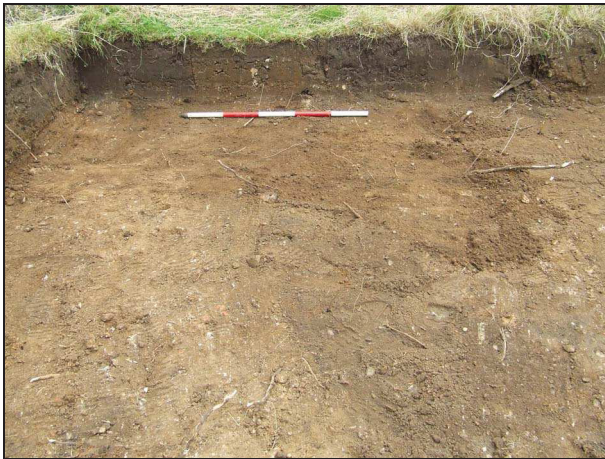
Plate 3: Section showing cut for service trench from disused septic tank (Scale 1m)

Manhole covers for a septic tank and associated drains were observed within the footprint for the new building (Figure 4). The manholes were 0.50m in diameter and lined in plastic, and the cut for the drain or soakaway, leading away from the septic tank to the northeast, was 0.60m wide. The septic tank was drained and then filled with concrete but not removed.

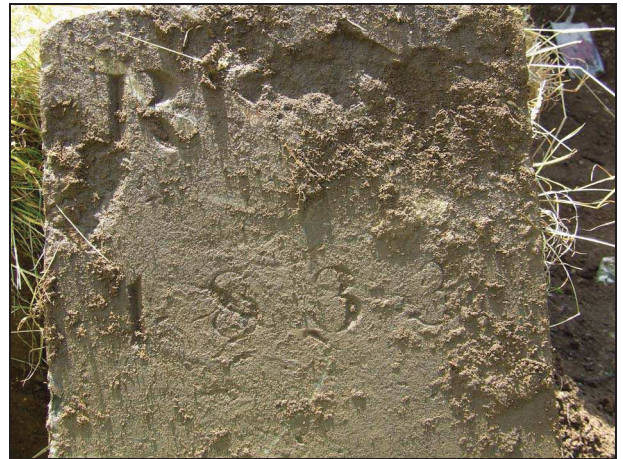
Plate 4: Example of gravestone which had been reused as a footpath outside the vestry

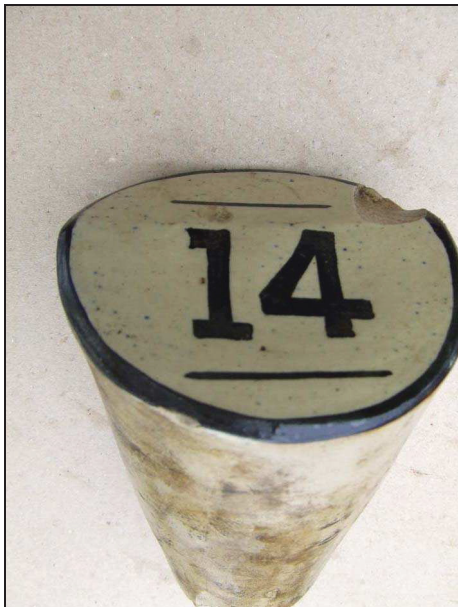
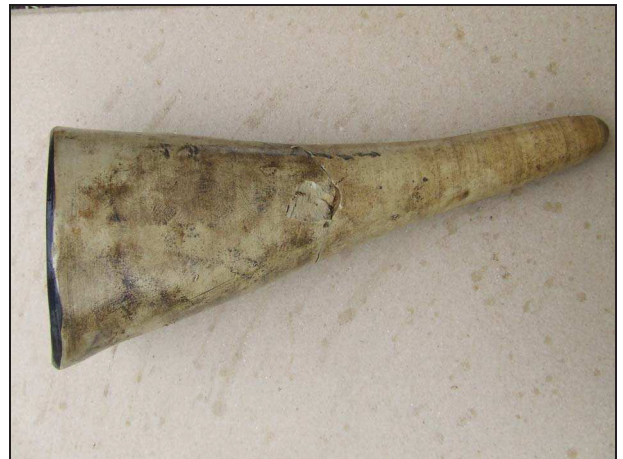
Plate 5: Stoneware "plot marker"

Plate 6: View of "plot marker" from side

Frequent inclusions of disarticulated human bone fragments and occasional fragments of 20th century pottery and glass vessels were observed within the graveyard soil. Also found were two stoneware objects with glazed upper surfaces and unglazed bodies (Plates 5 and 6). These were numbered 4 and 14 and would have marked the location of grave plots prior to the erection of a headstone.

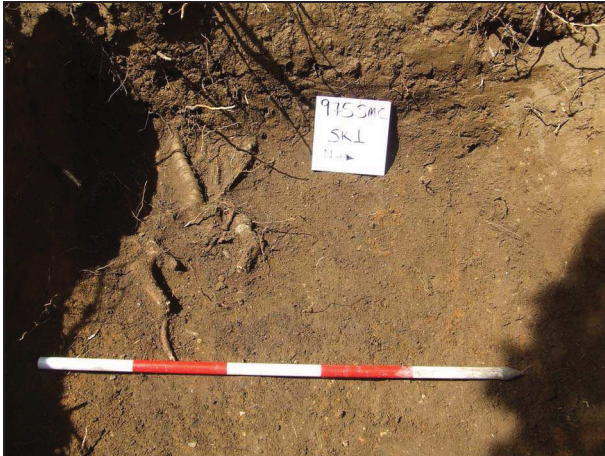
Plate 7: Skeleton 1 from west (Scale 1m)

Both skeletons were adults, as the long bones present had fully fused. Skeleton 1 is tentatively suggested as female on the basis of the size of the long bones. Only the upper part of Skeleton 2 (the skull, neck vertebrae and scapulae and collar bones) was within the trench, and the machine bucket had removed part of the skull, making sex identification difficult. Skeleton 2 displayed signs of decay (cavities) to the teeth of the lower jaw (Plate 9), but no other obvious signs of pathology were observed.

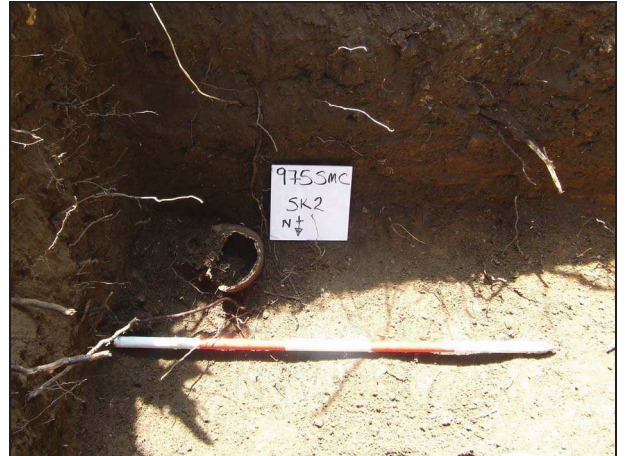
Plate 8: Skeleton 2 from north (Scale 1m)

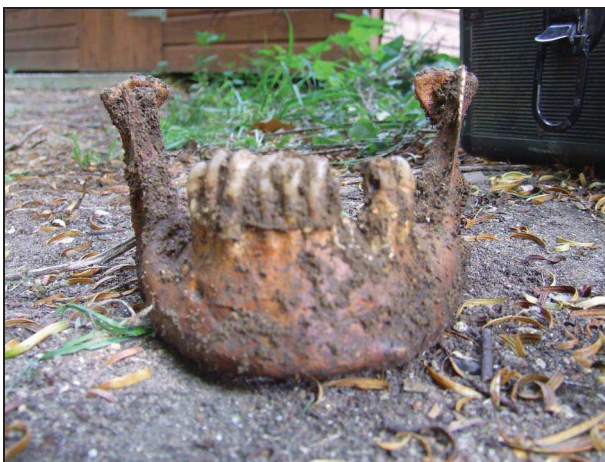
Plate 9: Lower jaw of Skeleton 2, showing tooth decay

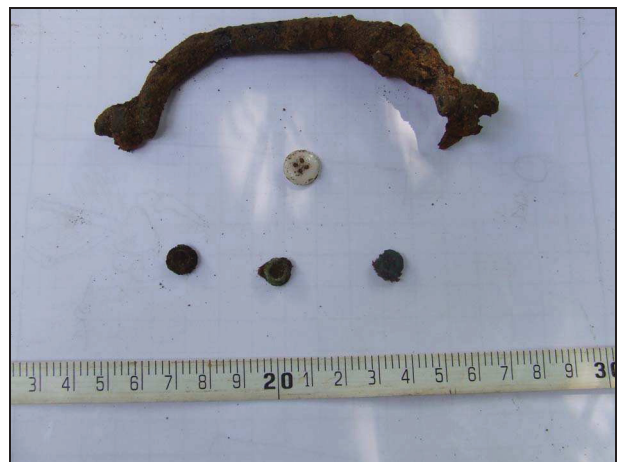
Plate 10: Coffin handle, button and copper rings (Scale 20cm)

Two iron coffin handles were observed within the fill of Grave 1 as well as several iron coffin nails. Three small copper rings were also observed (Plate 10), these were found close to the coffin handles and may relate to the handles' attachment to the coffin.

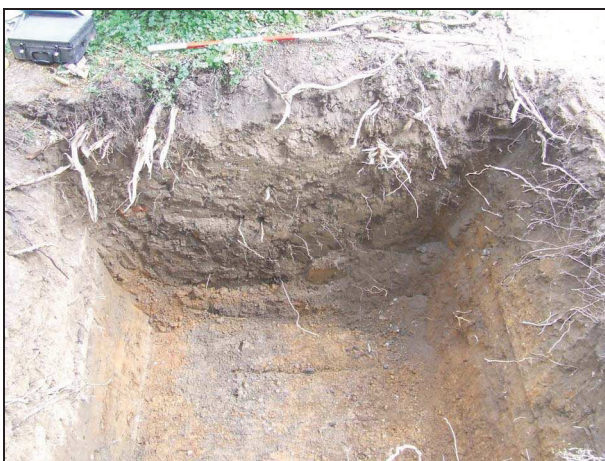
Plate 11: Section of septic tank pit

These burials were at a depth of 1.50m below existing ground level and were located within separate, intercutting, graves with dark brown clayey-silt fills. They both cut the natural strata, mid orange clay with rare inclusions of limestone flecks.

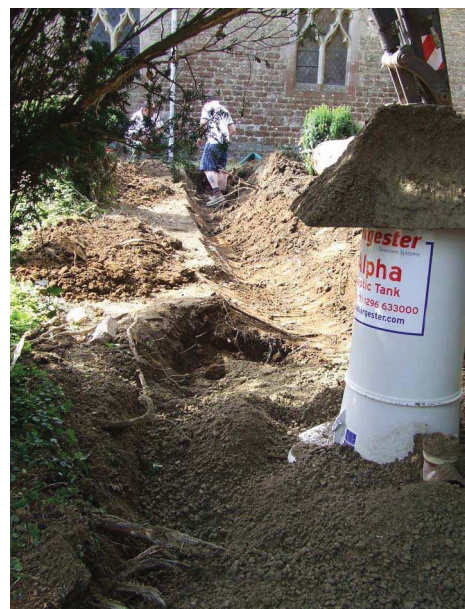
Plate 12: Excavating drain to new septic tank
