WATCHING BRIEF: WESTGATE PETERBOROUGH

*for
BSP Associates Ltd
on behalf of
Anglian Water Services Ltd*

December 2007

ASC: 969/PWG/01

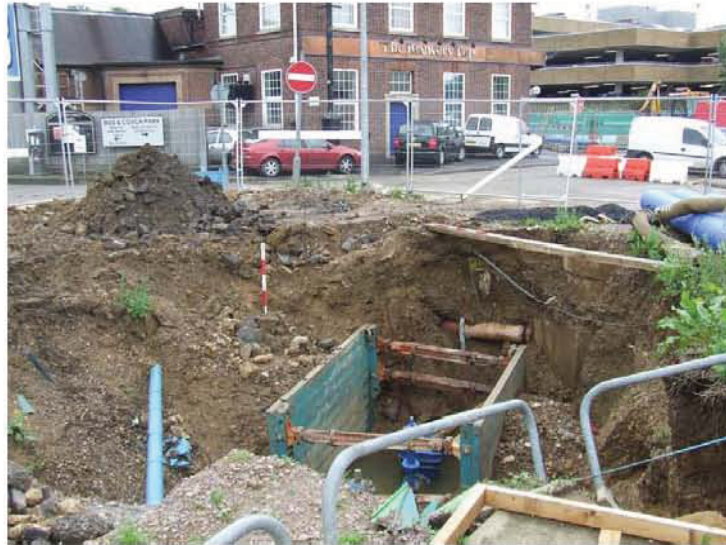
Plate 1: Area 1 in bus and coach park.

- 4.3** Area 1 was a large, deep valve/connector pit dug in the bus and coach park located north of Acland Street. Unfortunately, the sides of the pit had slumped into it by the time of the initial monitoring visit (Plate 1), and the condition of the pit meant that it was impossible to determine the presence or absence of archaeological features. The southern side of the pit was immediately adjacent to a concrete inspection chamber for a service pipe and the groundwork to insert the chamber will have removed any archaeology that may be present in this area.

- 5.2 Valve and connector pits dug at the western end of the replacement water main had either slumped and obscured the faces of the pit (Area 1) or had been cut into the backfill of earlier pipe trenches (Area 2). The presence or absence of archaeological finds or features associated with the 11th century St Leonards Hospital could not be determined.

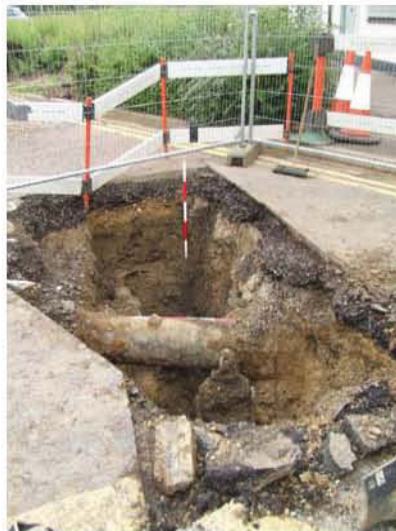
Plate 2: Area 2 at western end of Westgate.

- 4.4** Area 2 was a small connector pit excavated at the western end of Westgate. The pit contained two earlier service pipes and an associated valve and it had been dug entirely within the backfill of the trenches of the earlier services (Plate 2). No archaeological finds or features were observed in this area.

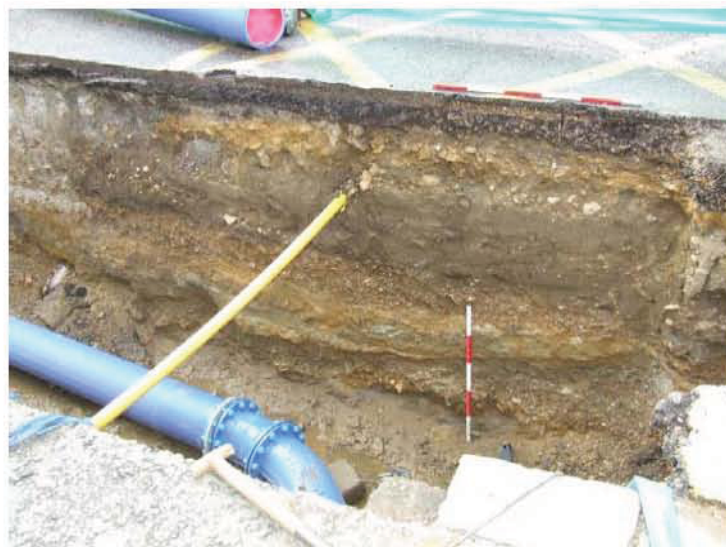
Plate 3: 19th century deposit/feature in Area 3.

- 4.5** Area 3 was located at the junction of Acland Street and Westgate immediately outside the Brewery Tap pub. The eastern end of the trench had been cut into deep deposits of sand and gravel which appeared to be relatively modern make up and/or the backfill of earlier service trenches. The western end of the trench had exposed a *c.*7m wide and *c.*0.4m deep deposit of mid brown sandy silt, which lay *c.*0.4m below the modern asphalt road surface (Plate 3) and overlay apparently natural deposits of gravel and clay. The sandy silt was visible in both the northern and southern sides of the trench. Rapid investigation of this deposit showed that it contained fragments of glass and black/brown glazed earthenware of probable 19th century date.

- 5.3 Evidence of late post medieval activity, probably dating to the 19th century, was observed at the junction of Acland Street and Westgate. An extensive deposit of mid brown sandy silt contained shards of glass and small sherds of black/brown glazed earthenware.

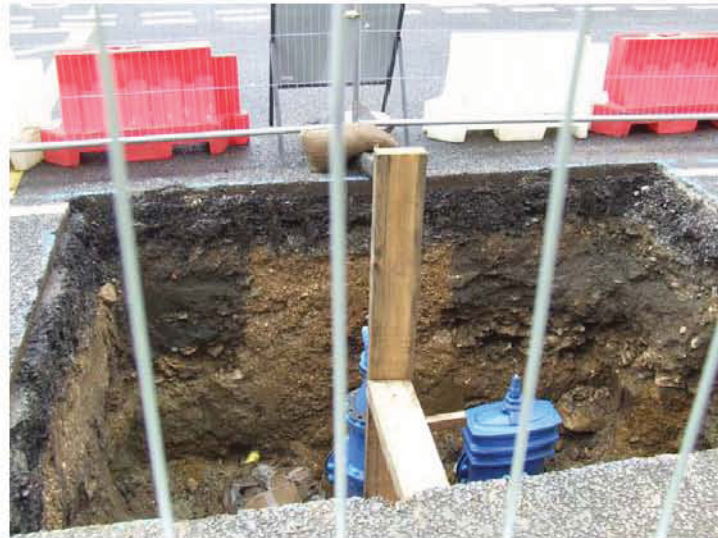
Plate 4: 19th century deposit/feature in Area 4.

- 4.6** Area 4 was a small, relatively shallow valve pit located outside Westgate Church. The southern side of the pit had exposed a deposit of mid brown sandy silt that was cut by a vertical sided pipe trench backfilled with a mid yellowish brown sandy gravel (Plate 4). Rapid investigation illustrated that the mid brown sandy silt contained small fragments of well fired ceramic building material (cbm). Further dating evidence was not recovered.

- 5.4 A further deposit of mid brown sandy silt was observed in a valve pit outside Westgate Church. The sandy silt contained small fragments of very well fired ceramic building material and was cut by a 20th century pipe trench. The observed evidence suggests that this deposit dates to the late post medieval period.

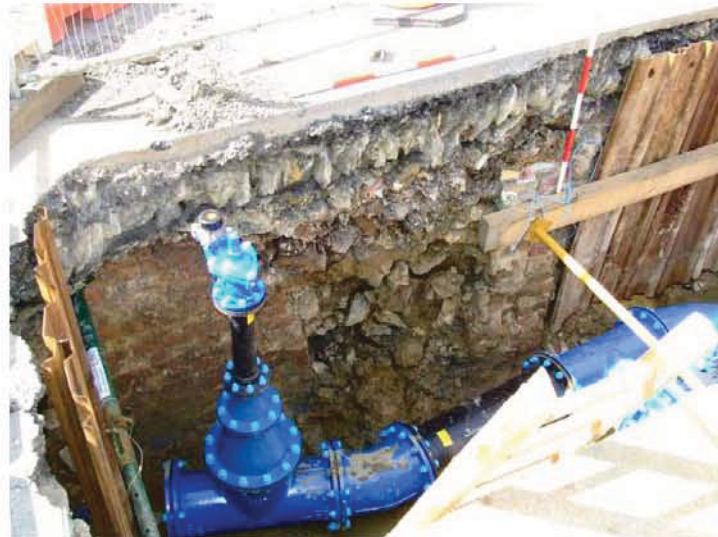
Plate 5: 20th century brick built inspection chamber in Area 5.

- 4.7** Area 5 was a deep valve pit excavated across the junction of Lincoln Road and Westgate. The western half of the pit had been shored and was consequently obscured, although a deep undifferentiated deposit of yellow sandy gravel ballast was partially visible behind the shoring. Two brick walls located on the southern side of the eastern half of the trench were constructed with frogged bricks and appeared to define the location of a possible

inspection chamber for an earlier 20th century service pipe (Plate 5). The inspection chamber had been backfilled with stone and brick rubble prior to being sealed by a stone surface that underlay the modern asphalt and was formed from laminar stone clasts set on edge. The northern side of the pit revealed three earlier service pipes within an undifferentiated matrix of mid yellowish brown sandy gravel. No archaeological finds or features predating the modern period were observed at this location.

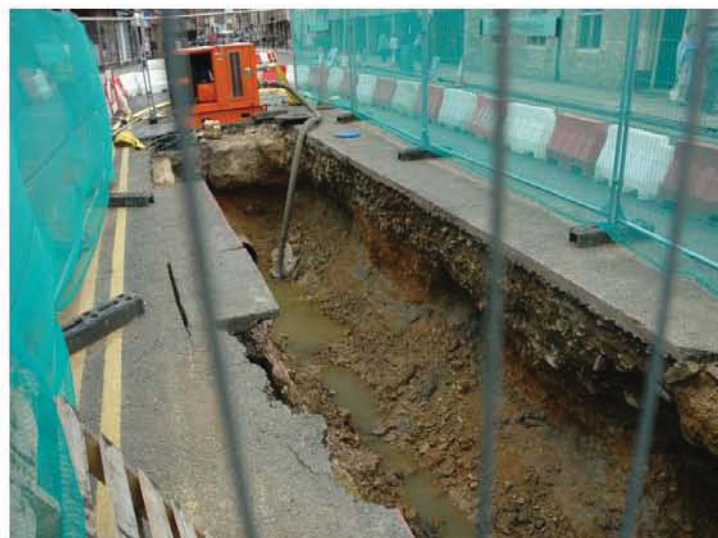
Plate 6: Trench west of Lincoln Road revealing earlier surfaces (almshouse visible top right).

4.8 The sections of pipe trench located immediately east and west of Area 5 showed that the modern asphalt road surface overlay a sequence of earlier deposits. The earlier deposits were best preserved east of Lincoln Road and the observed stratigraphy consisted of:

- 5.5 Preserved elements of earlier surfaces were revealed in sections of the pipe trench at the eastern and western sides of Lincoln Road. The upper deposits (100-105) were dated to the late post medieval period by fragments of clay pipe and sherds of glazed earthenware observed within (105). Dating evidence was not recovered from (106) and its date of deposition remains unclear. A small, c.0.01m, unabraded fragment of ceramic building material or large storage jar was recovered from the intermittent basal deposit (107) and could suggest that it predates the post medieval period.

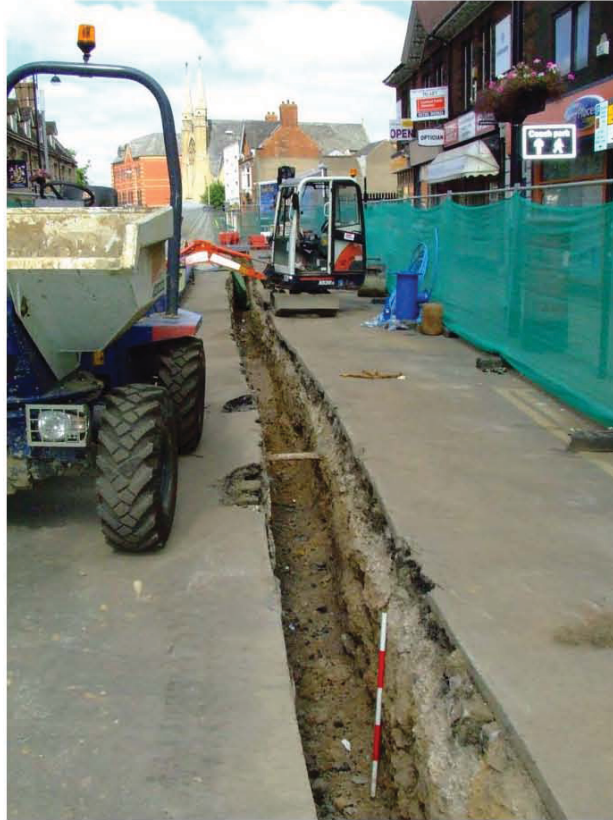
Plate 7: Trench east of Lincoln Road revealing earlier surfaces.

Rapid investigation showed that (105) contained occasional fragments of clay pipe stem and a small sherd of brown glazed 19th century earthenware pottery. A small, unabraded, c.0.01m fragment of well fired cbm or large storage jar with one buff surface, orange oxidised exteriors, a grey reduced core and mineral inclusions was recovered from one of the lenses of basal dark blackish grey organic silt (107).

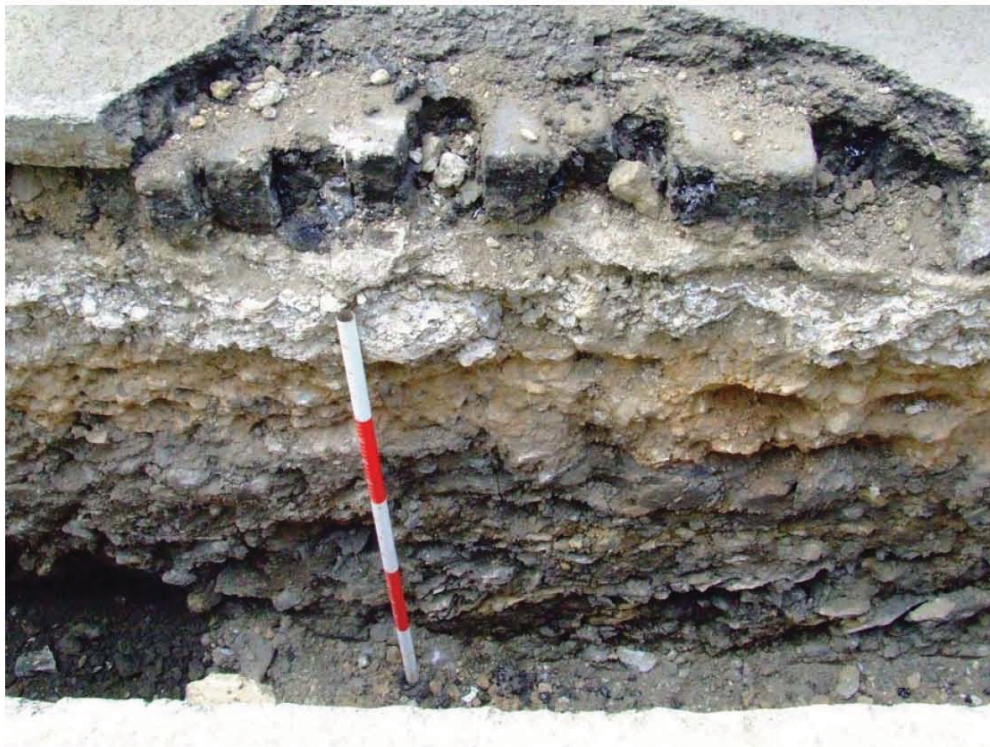
Plate 8: Detail of earlier surfaces underlying modern asphalt east of Lincoln Road.

| (100) | c.0.07m | asphalt |
| (101) | c.0.1m | granite setts |
| (102) | c.0.05 | mid grey concrete |
| (103) | c.0.1m | light grey pebbly concrete |
| (104) | c.0.3m | mid yellowish brown pebbly sand |
| (105) | c.0.2m | mid blackish grey organic silt |
| (106) | c.0.3m | mid yellowish grey gravelly sand (occasional large limestone clasts) |
| (107) | c.0.1m | occasional lenses of dark blackish grey organic silt (freq oyster shell, coal and small wood fragments) |
| (108) | | unknown depth of mid yellowish brown gravelly sand. (natural?) |
