WATCHING BRIEF: MANOR FARM, CHURCH ROAD CHOLSEY OXFORDSHIRE

on behalf of Pineapple Developments Ltd

November 2007

ASC: 903/CMF/2

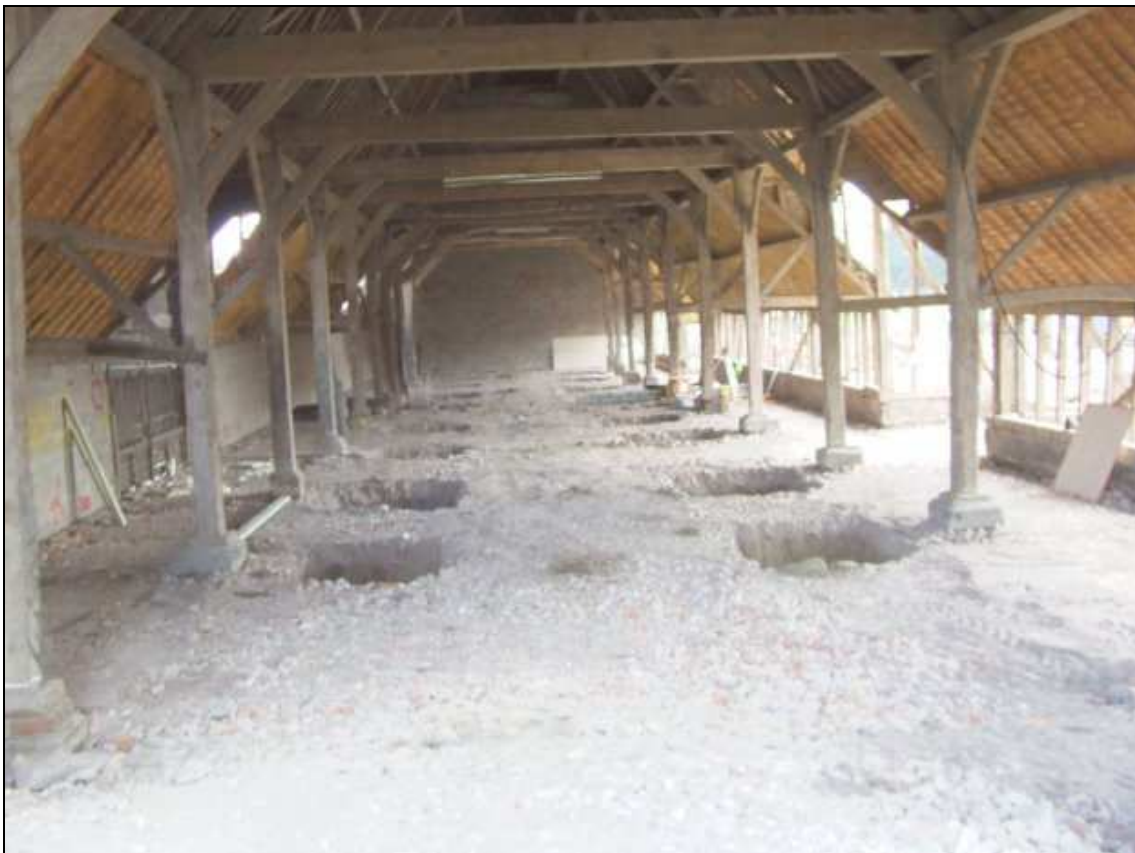
- 4.2 The natural strata comprised yellow sandy gravel, overlying yellow to blue grey clays (Plate 2).
- 4.3 Within the north-eastern barn sixteen 1.5 x 1.5m pits for the supports for the mezzanine floor were excavated (Plate 1). Each pit was *c.* 600mm deep, the upper 150-200mm comprising modern building debris, below which the natural yellow sandy gravel was observed.

Plate 1: Excavated pits for the mezzanine floor supports in the northeastern barn

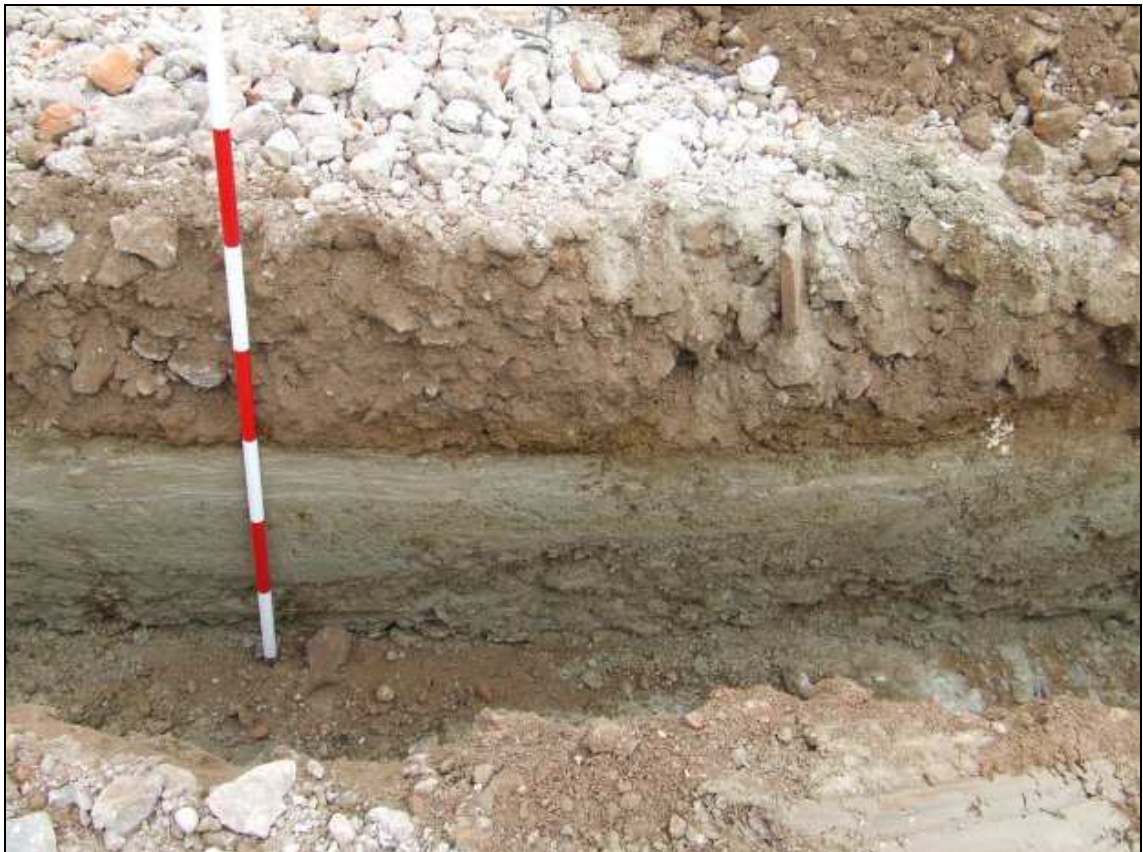
- 4.4 Outside the barns a series of 500mm service trenches were excavated. Each trench was monitored for the presence of archaeological remains. Within the trenches a number of possible shallow features were observed. None of these features produced any dating material. However it has been suggested that these features might relate to the more recent occupation of the site. A series of compacted chalk farmyard surfaces were also observed in the service trenches. These features are discussed in detail on the Field Monitoring Sheets (Appendix 1). A similar deposition profile was noted in each trench, comprising 300-500mm of modern debris (C19/20th) above the natural.

Plate 2: Typical profile seen in the farmyard trenches

- 5.3 The soil profiles observed within the new service trenches clearly demonstrate that much of the land around Manor Farm has been disturbed to a depth of *c.* 500mm in relatively recent times. Whilst the wall footing seen towards the southeast side of the site contained some small handmade bricks, the presence of modern frogged bricks clearly shows that this wall was built in recent times, though it is possible that it is on the line of an older wall.

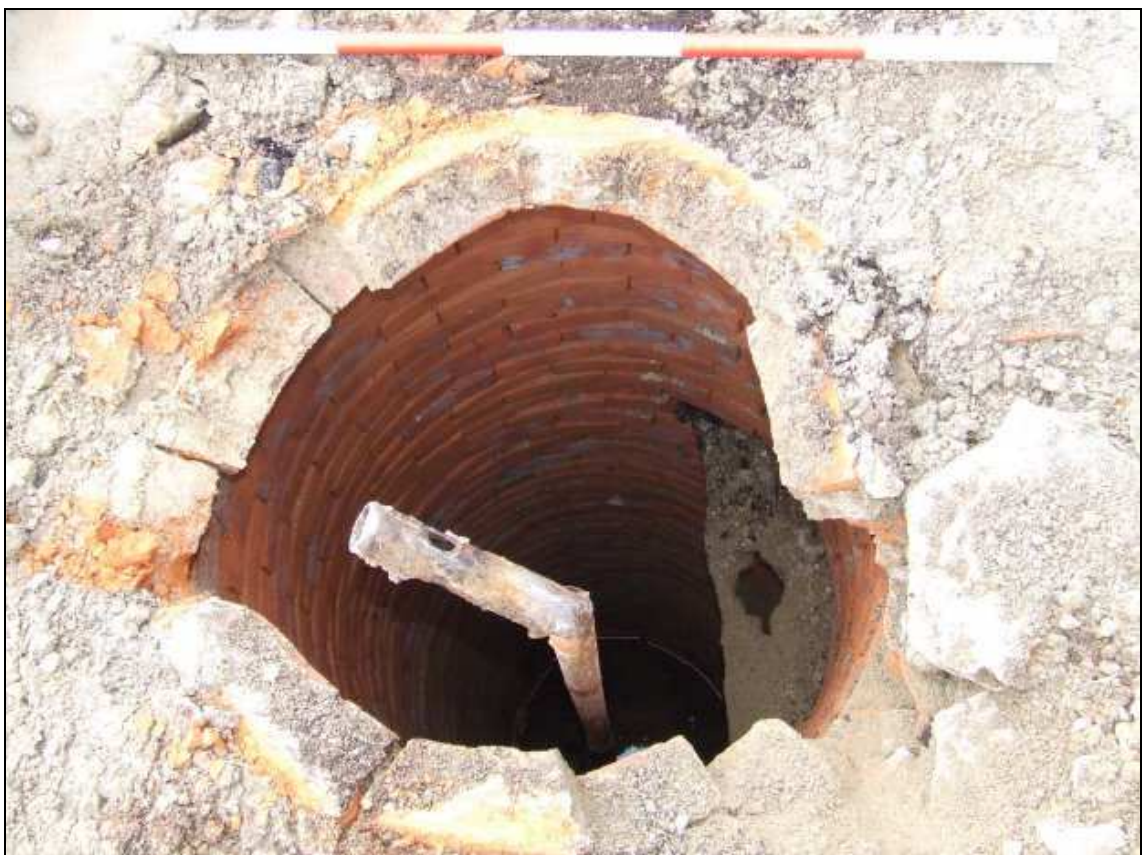
- 4.5 A 1.05m diameter brick (64x105x23mm) lined well was located to the south west of the north easternmost barn in the angle between two smaller barns. The well was *c.* 7m deep and had a metal pipe rising up its centre. Prior to the start of the watching brief during the preliminary site clearing, a vaulted capping over the well shaft had been removed, exposing a metal pipe (Plate 3).

Plate 3: Well and pipe for the pump

- 5.2 The brick lined well revealed in the farmyard probably started life as a simple bucket on a rope type well but by the end of its life the metal pipe had been installed, presumably with a pump on top.

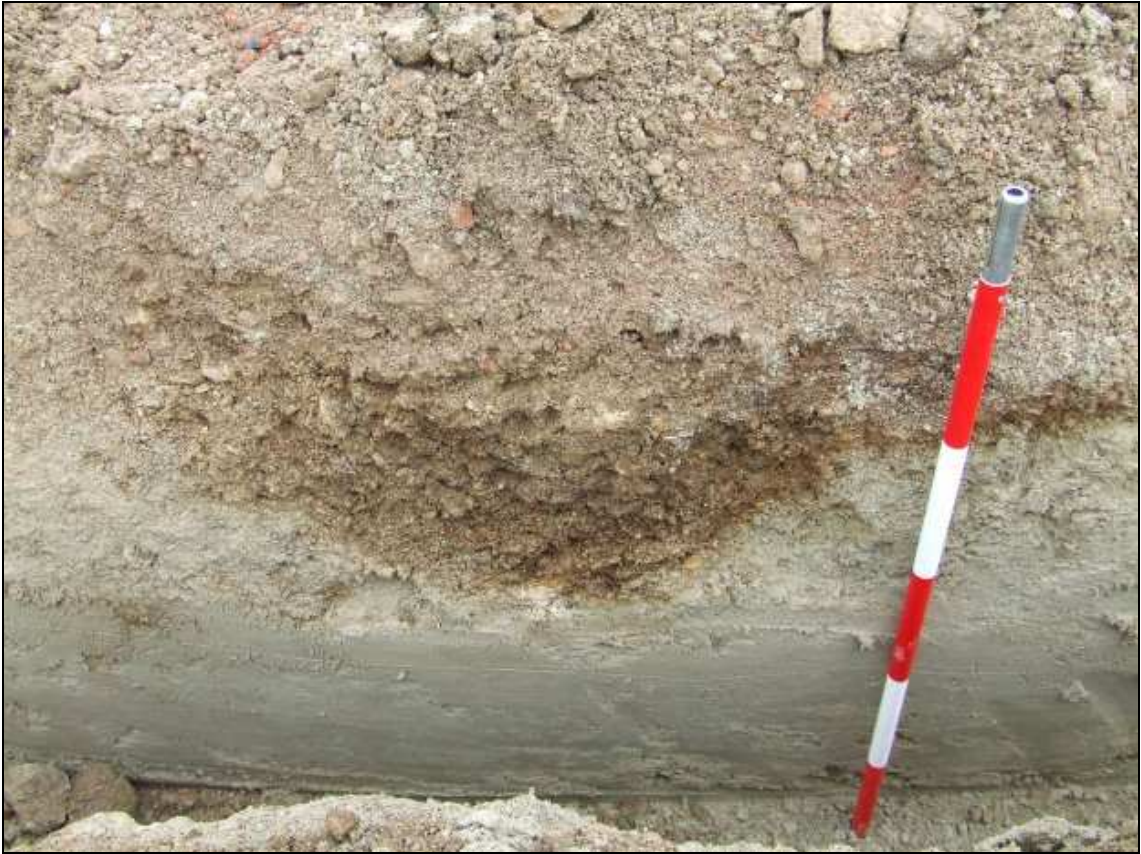
Plate 4: Possible drainage gully below the farmyard surface and associated makeup

- 5.4 A number of small gullies probably associated with drainage around the farm yard were observed sealed below the debris. As no dating material was recovered from any of these small features it is impossible to say with any certainty when they were in use, however it seems likely that they are associated with the farm.

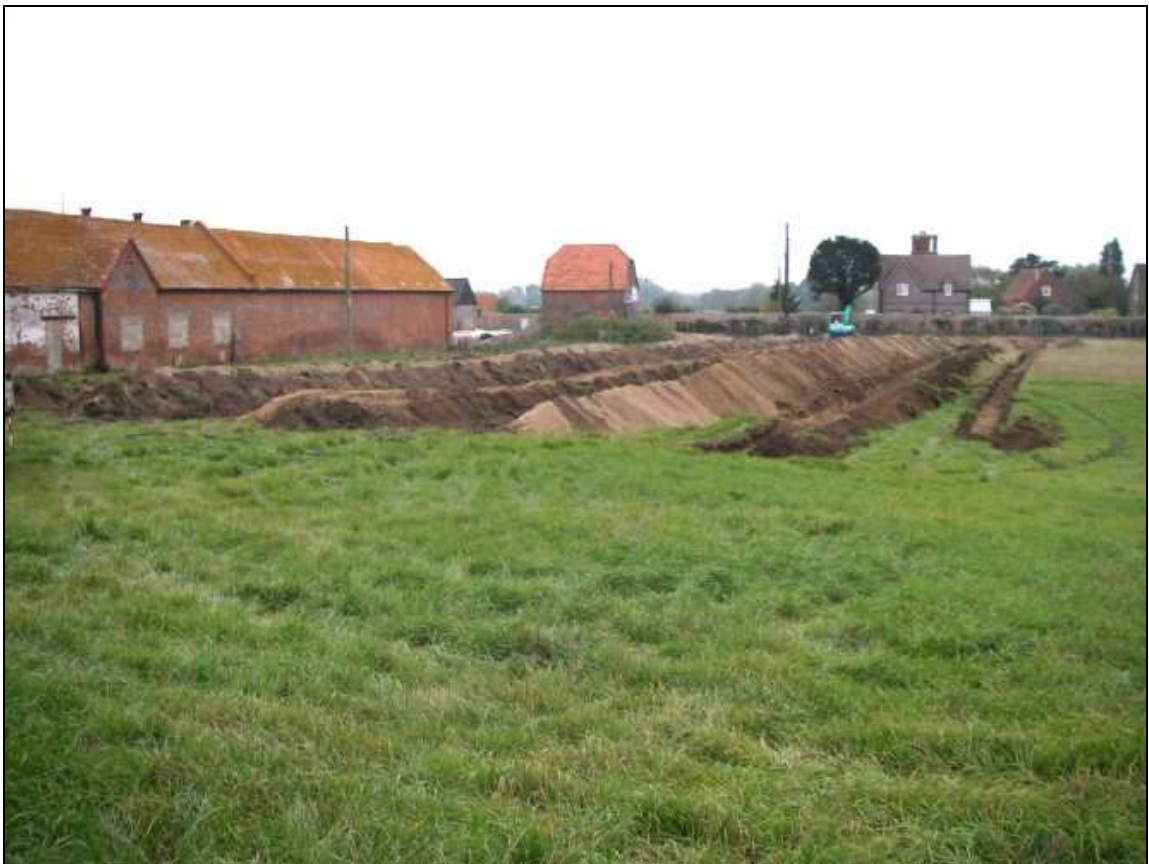
- 4.7 Five parallel 85m long SW – NE trenches for a geo-thermal heating system were excavated in the field to the south of the farm. The trenches were centred *c.* 5m intervals and were 1m wide and 1.5m deep. Topsoil over the field was *c.* 0.2m deep. At the base of the topsoil there was a light scattering of broken tile and brick across the whole field. Below the tile scatter natural coarse sands were observed. The only features observed cut into the sand were a number of irregular pits ranging in size from *c.* 1.0 -0.5m across. It seems likely that these pits were originally dug to acquire sand or gravel.

Plate 5: Location of the geo-thermal pipe trenches

- 5.6 Though human burials were found in the field to the south-east of the farm when an earlier sewer pipe was constructed, observation of the five long trenches for the geo-thermal heating pipes failed to reveal any additional burials. The light scatter of broken tile observed below the topsoil is entirely consistent with what would be expected in a field next to a long established farm. The pits observed in the trenches were probably for sand and gravel extraction.
