ARCHAEOLOGICAL EVALUATION: LAND REAR OF 15 HIGH STREET OVER CAMBRIDGESHIRE TL 7055 3755

on behalf of Camstead Homes Ltd

January 2008

ASC: 952/OHS/3

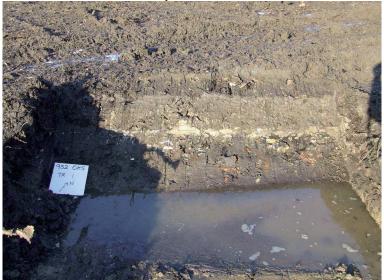
Plate 2: Boundary ditch in Trench 1

- 4.1.3 A boundary ditch was observed in Trenches 1 and 3 (Contexts [304] and [104]). This was filled with a dark blackish brown silty clay with inclusions of brick fragments and cement mortar (Contexts (103) and (303)). It aligned with the current boundary of 17 High Street, which comprised short trees and bushes.

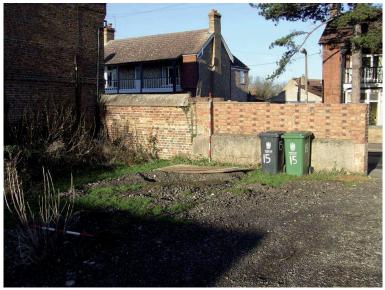
Plate 12: Wall from south showing concrete capping

- 4.2.3 Several repairs to this wall were evident, including concrete capping to the western section of the wall (Plate 12). The eastern part of the wall appeared to have been rebuilt from c.1m above ground level with frogged bricks with cement mortar, and both sides of this part of the wall had been rendered with concrete to strengthen the wall (Plates 12 & 13). The concrete was beginning to come away from the wall on its northern side, revealing bricks similar to those forming the western part of the wall (Plate 16).

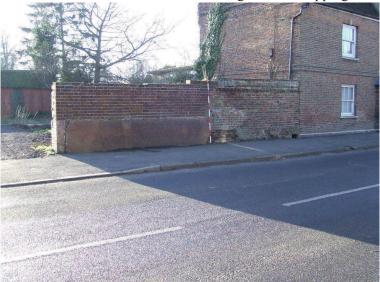
Plate 13: Wall from north

- 4.2.2 The wall is predominantly constructed of red brick, although some pale greyish yellow bricks had also been used in the western section. The western section of the wall is constructed of hand made bricks, which vary slightly in size, with an average size of 250x101x62mm. These bricks were bonded with a lime mortar and contained inclusions of flint gravels (Plates 12-14).

- 4.2.6 A drain was observed in the base of the wall, adjacent to 17 High Street, this was formed by a gap in the brickwork with a metal plate to span the gap for the brickwork above (Plate 17). The lower part of the wall on the northern side showed evidence of frost damage (Plates 13 & 16).

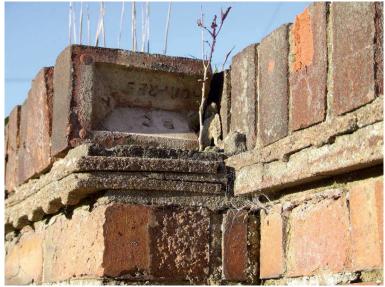
Plate 15: Detail of capping to modern section of wall

- 4.2.5 On the north side of the wall, the upper courses of the western section of the wall were formed of a course of stretchers below a decorative course of dentillated bricks. Above this was a course of bricks set on their headers and leaning back towards the centre of the wall (Plate 14). A thin layer of concrete capped the eastern section of the wall with semi-circular decoration to its lower side, above this was an incomplete course of frogged bricks turned on their sides (Plate 15).

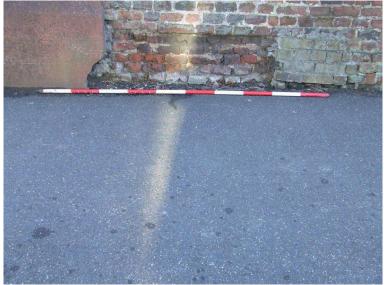
Plate 16: Detail of frost damage and repairs, showing older part of wall continuing behind concrete render.

- 5.4 The boundary wall of 17 High Street had a similar bond to the house and was constructed of similar bricks, but the wall forms a separate structure and the brickwork is not keyed into the brickwork of the house. Several repairs and alterations were noted, including the eastern section of the wall which appears to have been partially rebuilt in the 20th century using machine made bricks and cement mortar. The western section of the wall is the older part and is formed of hand made bricks bonded with lime mortar. It appears that only the upper portion of the western section of the wall has been rebuilt, and the earlier wall seems to continue behind the concrete render applied to the base of the wall.
