**HISTORIC BUILDING RECORDING:
BOTHY COTTAGE
TURNERS HALL FARM
ANNABLES LANE
HARPENDEN**

NGR: TL 0982 1552

January 2009

ASC: 1141/HBC/1

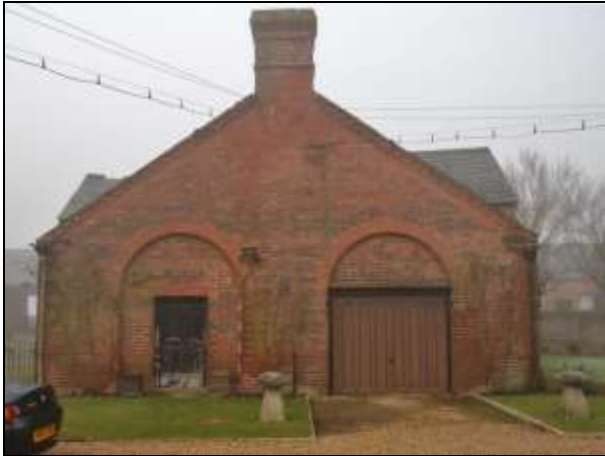
Plate 1: South elevation

This has two distinctive arches with the front door in the arch to the west and a modern garage door in the other arch. There is dentilated brickwork along the eaves, which terminates at a relatively large chimney. The front door has two panels above the lock rail and four planks below. The letterbox is still in place, but not functional. A flat arch and queen closers punctuate the door. There is a small iron door, which is likely to have provided access to clean the chimney, to the right of the western arch.

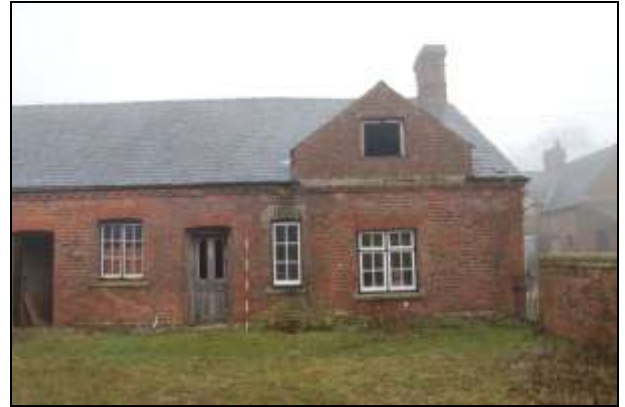
Plate 2: West elevation

There is a 4-panelled door under a segmental arch opening into the kitchen. To the south of it is a single light window under a flat arch and a 2-light casement window under a segmental arch. Both have stone sills. The central window is clearly a later addition, as there are no bullnose bricks in the opening or queen closers alongside. The dormer window has a cambered arch and a timber sill. All that remains is the outer frame. At the base of the wall is a plinth that is three courses high.

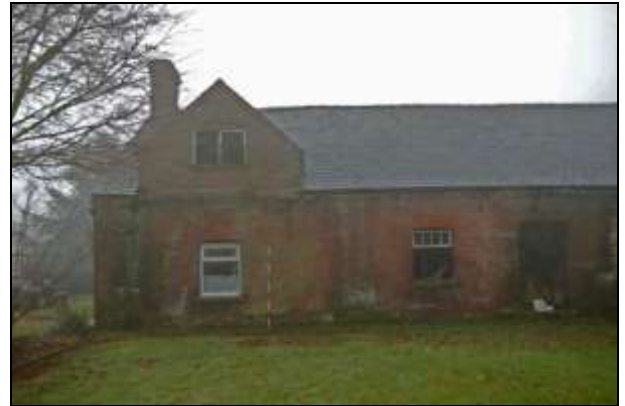
Plate 4: East elevation

This is punctuated by a modern window under a cambered arch and a 2-light dormer window with a cambered arch and timber sill.

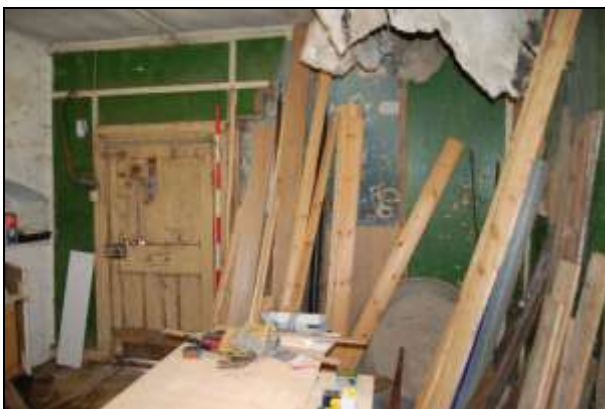
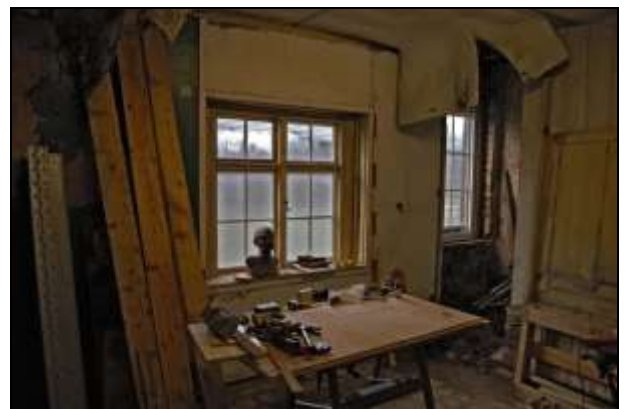
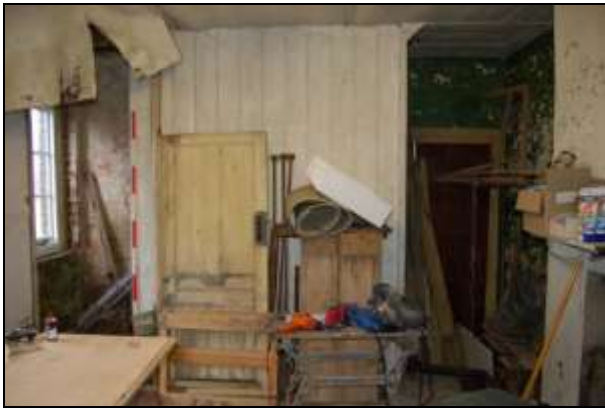
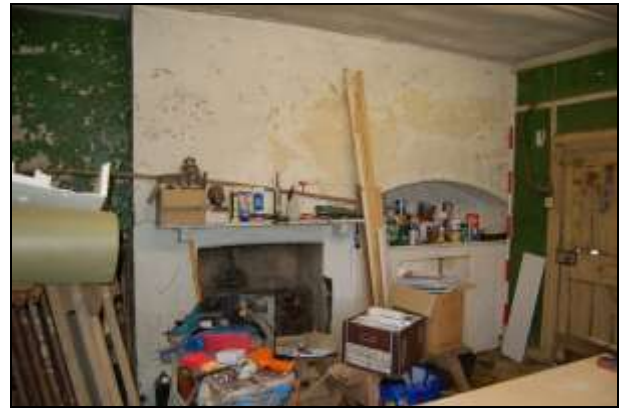
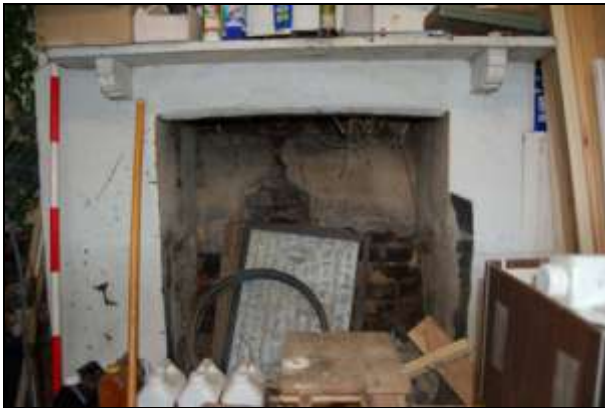
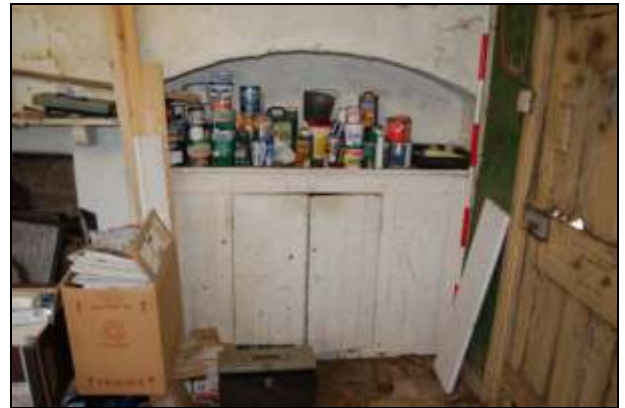
Description: The front door opens directly into this room. There is a brick fireplace with a timber mantelshelf in the east wall and a built in cupboard in an arched alcove to the south of it. In the recess in the northeast corner of the room is a blocked doorway to Room G2. There are two timber windows in the west wall, which have been described in Section 4.3.

There is matchline boarding on the north wall, behind which is the staircase to the upper floor. The northern window lights the stairwell, which formerly had a door at its base.

The east wall is painted brick and the other walls have been lined with plywood and then painted. There is a lath and plaster ceiling and red and yellow quarry tiles on the floor. The tiles are 15cm².

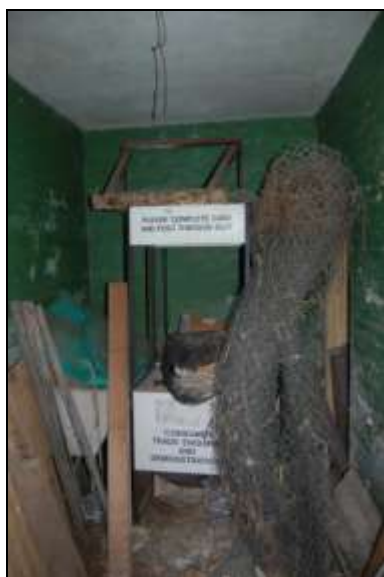
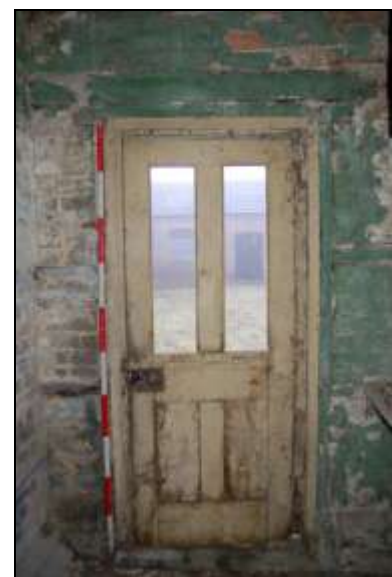
Description: This is a narrow room that is currently only accessible by the door in the west wall. The upper panels of this 4-panelled door are missing. There is a blocked door in the south wall to G1, but no windows. The walls are painted brick and there are bonding timbers in the west wall. The ceiling is lath and plaster and the floor, although difficult to see, is probably concrete. There is a plinth with a double chamfer along the south wall of the room and a sink in the northwest corner.

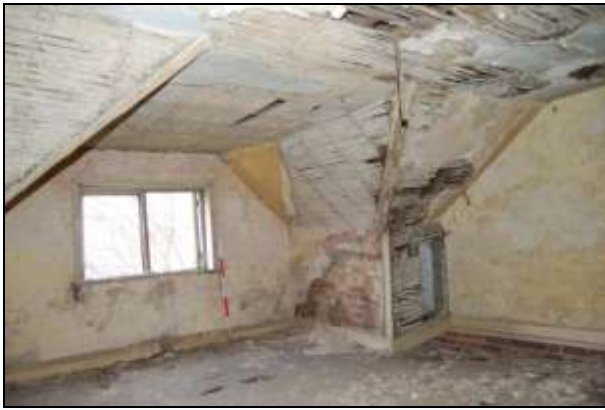
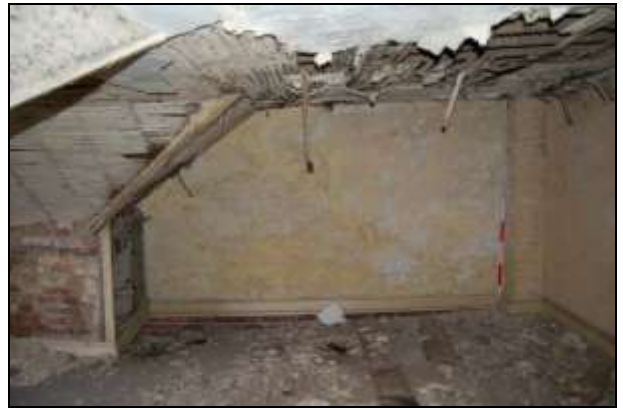
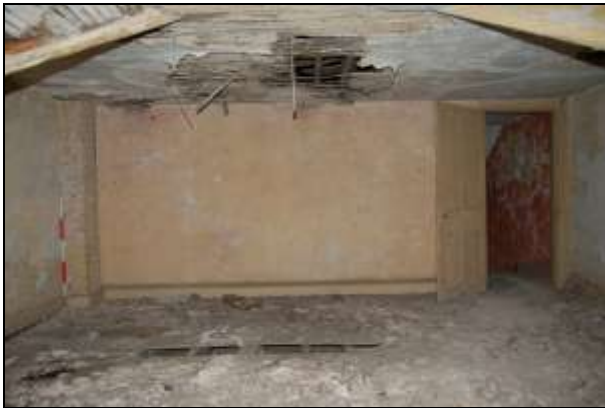
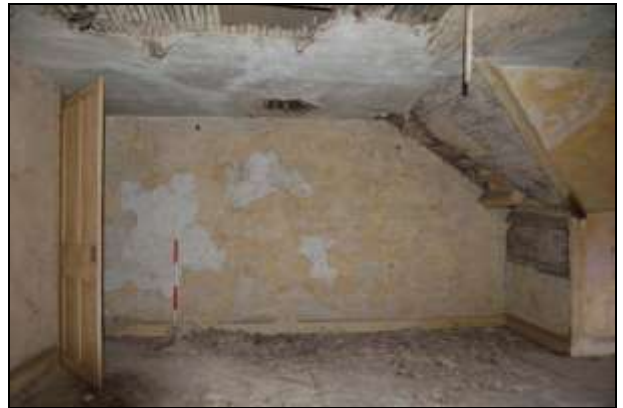
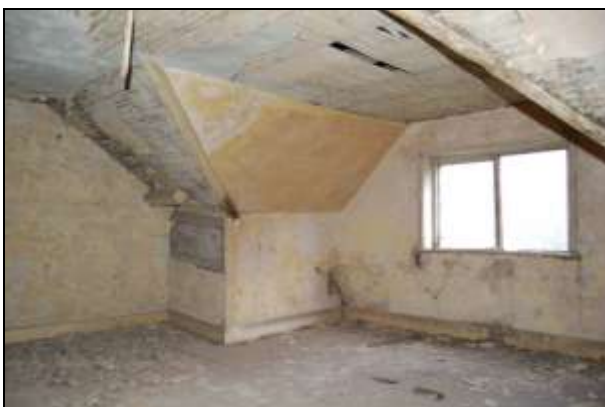
Description: This has a 4-panelled door in the west wall and the remains of a 2-light dormer window in the east wall. The west wall and the ceiling are painted lath and plaster. Much of the ceiling plaster has fallen off revealing the sawn laths. The north wall is painted brick. The floorboards are 23cm (9 inches) wide softwood timbers running north to south. The southern end of the floor is sagging, particularly to the southeast where it is being propped from below. There is a brick pillar in the southwest corner of the room.

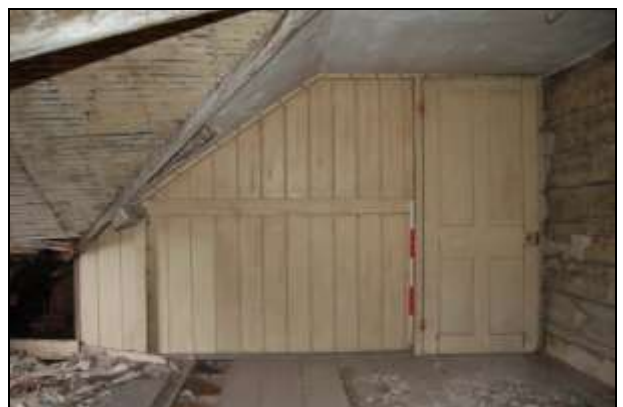
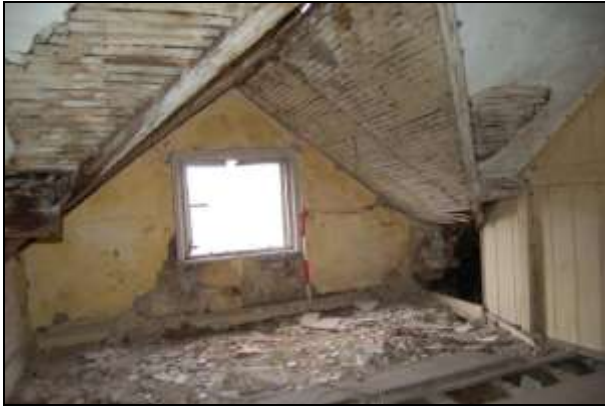
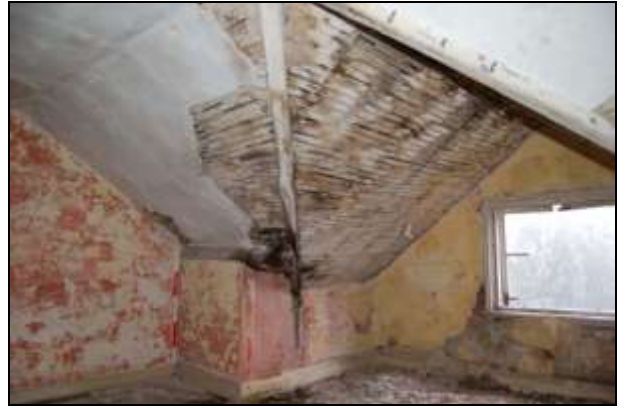
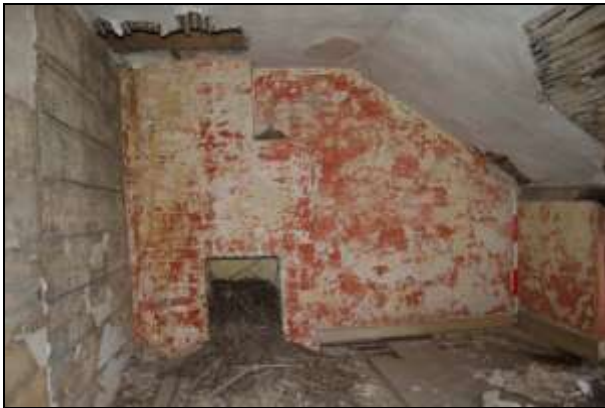
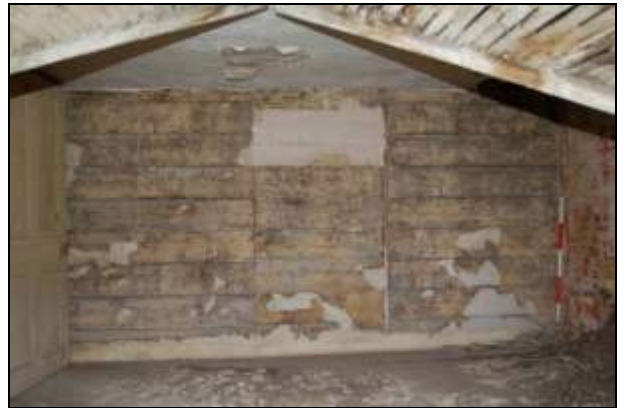
Description: This room has a brick fireplace in the southeast corner, matchline boarding along the north wall and horizontal planks lining the east wall. The planks, which were once papered, measure between 92 x 22cm (36 x 8½ inches) and 1.37 x 22 cm (53 x 8½ inches). The south and west walls are painted. The timber outer frame of a 2-light dormer window is in the west wall and there is a 4-panelled door in the north wall. The floorboards are as in Room F1.
