**WATCHING BRIEF:
CHURCH LOCK COTTAGE
GROVE
BUCKINGHAMSHIRE**

NGR: SP 9212 2248

JUNE 2009

ASC: 1143/GCL/2

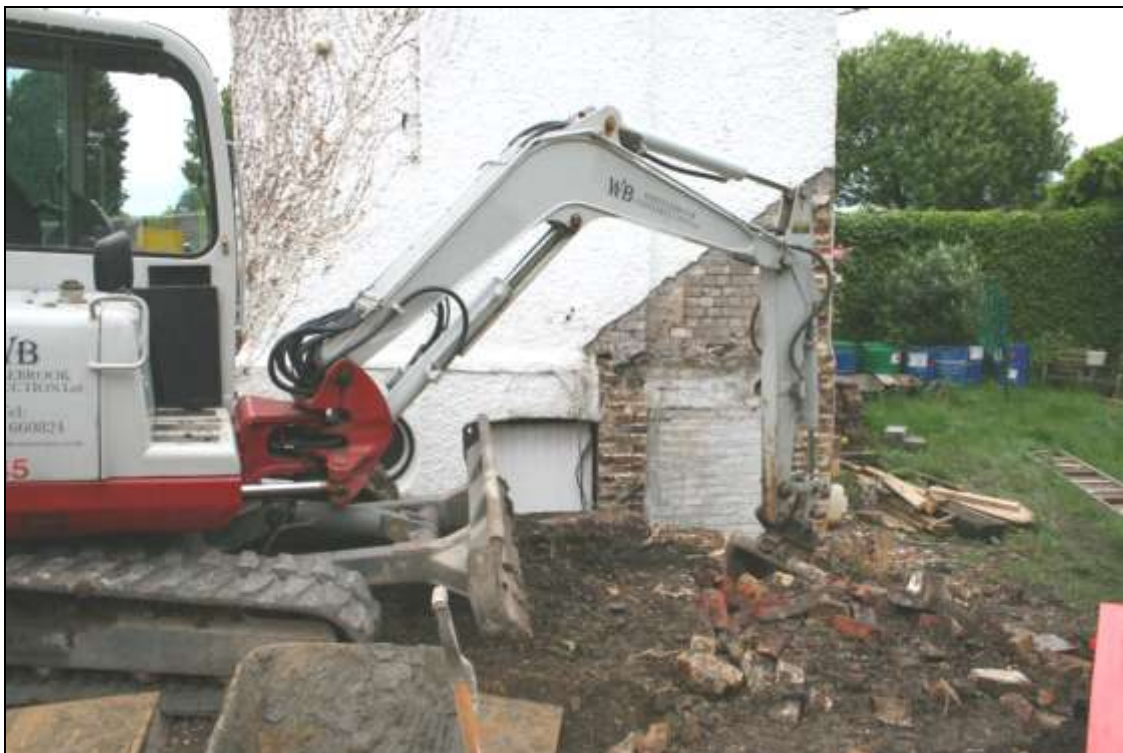
- 4.2 As previously noted, the original single-storey extension at the south-west end of the cottage had been demolished prior to the start of the watching brief (Plate 1). Its below-ground elements remained, comprising a dogleg flight of brick-built steps leading down from the road to a basement entrance in the gable end of the building, and a room $c.2.0 \times 1.2\text{m}$ internally, housing the central heating boiler (Fig. 3). These structures occupied an overall area of $c.4.5 \times 2.8\text{m}$, and were bonded to the main structure of the cottage.

Plate 1: Site before excavation, showing outline of former extension

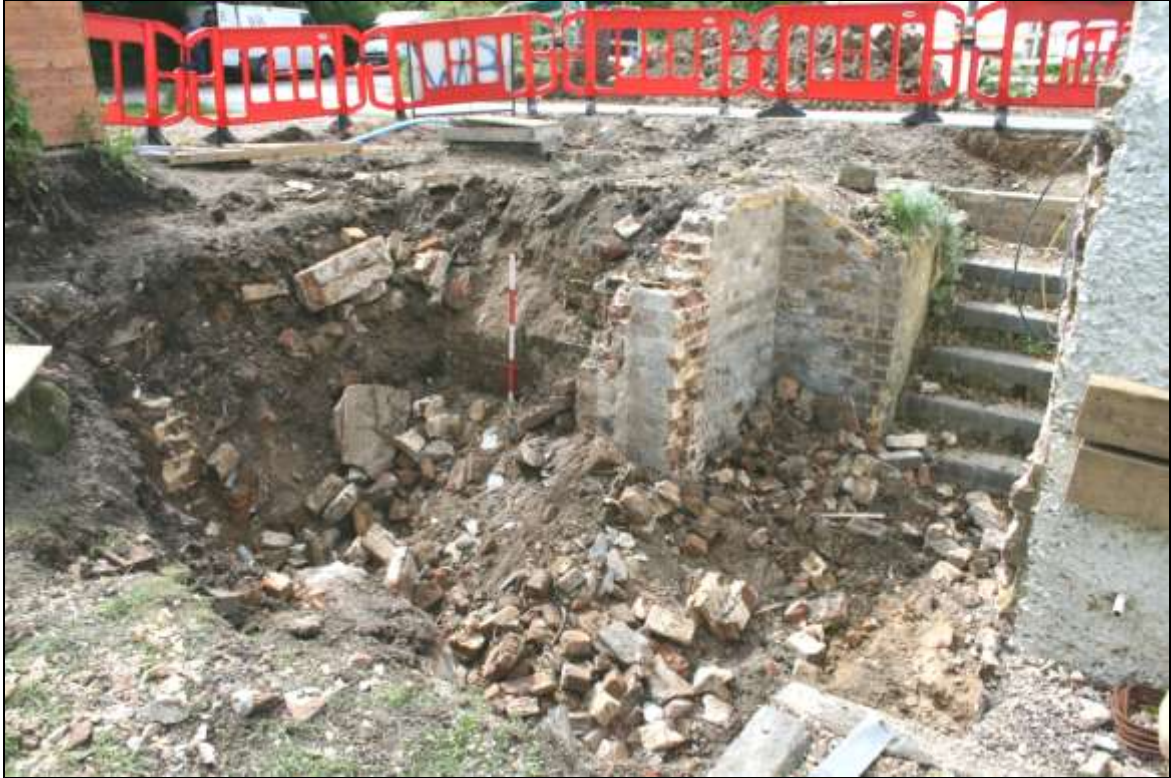
- 4.3 Excavations for the basement of the new extension revealed a second smaller basement room (Fig. 4; Plate 2), $1.0 \times 1.2\text{m}$ internally, on the south-west side of the boiler room, linked to the latter by a doorway that had subsequently been bricked up. The brick structure of this additional room was identical to that of the rest of the basement. The additional room, which extended beyond the recently demolished extension, had been backfilled with a mixture of soil and building debris.

Plate 2: Site during excavation: scale on north-west side of additional room

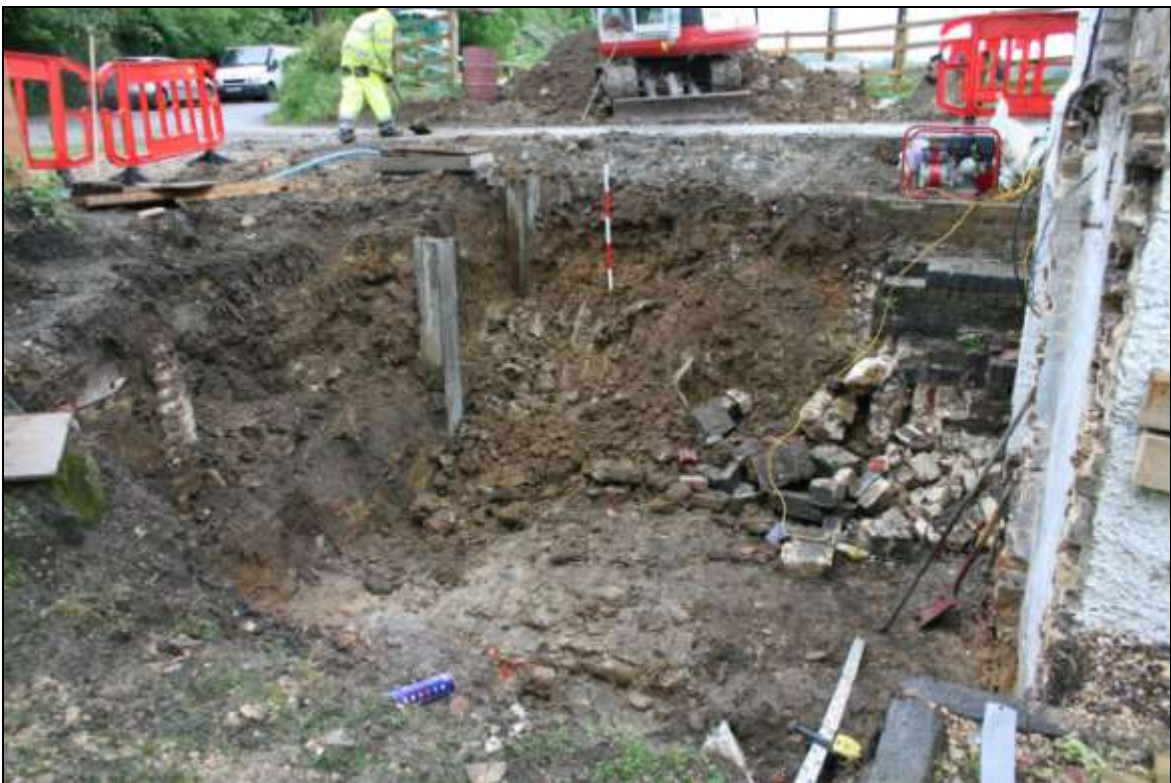
- 4.4 To the south-east and south-west of the basement structure, the soils revealed were all redeposited material, comprising a mixture of topsoil, clay and building debris. To the north-west, beneath the basement stairs and beyond the cellar structure, a layer of redeposited mixed gravel and clay up to $c.0.5\text{m}$ deep overlay undisturbed natural clay, which also extended beneath the cellar floor (Plate 3).

Plate 3: Site following removal of brick cellar structures

- 5.2 Where excavations for the proposed addition to the cottage extended beyond the existing extension, no finds or archaeologically significant deposits were noted. To the south-west and south-east only redeposited soils were found, most likely backfill of the excavation in which the original basement structure was built. To the north-west, the layer of mixed gravel and clay overlying natural was probably the material used to create the ramp leading up to the canal bridge.
