WATCHING BRIEF:

**CASTLE FARM
CASTLE ROAD
LAVENDON
MILTON KEYNES**

SCHEDULED MONUMENT NO. 19063

on behalf of KIM Construction

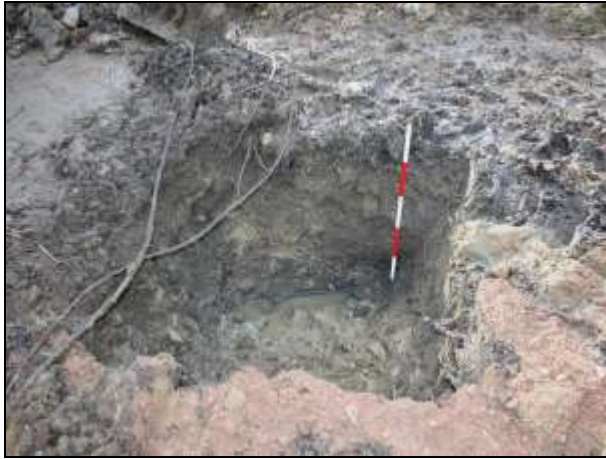
Plate 1: Test pit 1 (*scale 1m*)

Test pit 1 (Plate 1) stratigraphy comprised:

0-200mm topsoil: loose dark brown-black soil;

200-500mm subsoil: firm orange clayey soil;

500mm + natural: friable orange-brown sandy clay

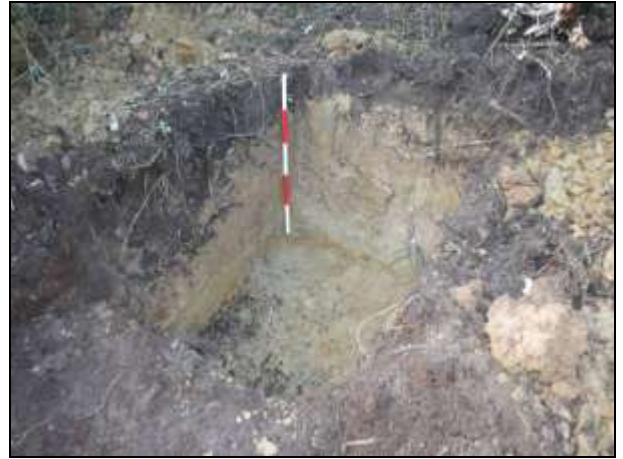
Plate 2: Test pit 2 (*scale 1m*)

Test pit 2 (Plate 2) stratigraphy comprised:

0-600mm overburden: redeposited dark brown soil containing building debris (brick, tile and limestone fragments). Cut on S side of test pit by E-W trench containing electricity cables, depth 200mm;

600-700mm layer of limestone rubble;

700mm + natural: firm orange-grey clay. Cut on W side of test pit by N-S water pipe trench, containing iron water pipe at depth of c.900mm. Cut for trench not visible in layer above.

No archaeological features, deposits or finds were observed in the test pits.

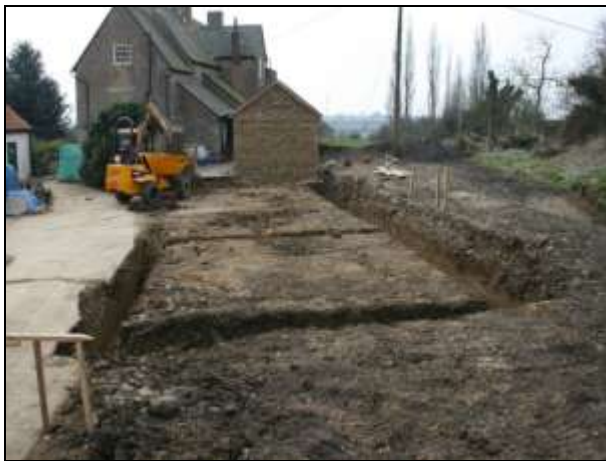
Plate 3: Demolished Barn: General view of site from east

In March 2009 the footings on the site of the demolished barn (Barn 2) were excavated (Plate 3). The concrete floors of the barn had been removed, revealing the subsoil, comprising brown-orange clay, up to 300mm deep. The footing trenches, 0.6m wide and 1.0m deep, were cut through the subsoil into the underlying green-grey clay (Plate 4). No archaeological features, deposits or finds were observed.

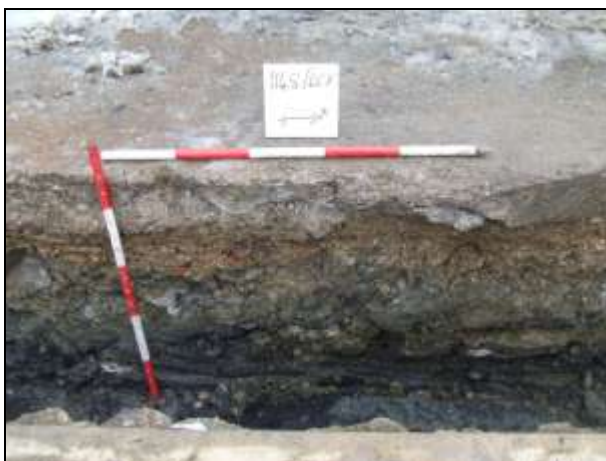
Plate 5: Yard Area Service Trench: Stratigraphy, looking west (*scale 2×1m*)

The service trenches within the yard area of the site measured 0.6m wide to a depth of *c.*0.94m. The stratigraphy comprised concrete, underlying which was *c.*0.15-0.26m in depth of made-ground consisting of dark black clay containing frequent broken up modern bricks, underneath which was *c.*0.65m in depth of natural strata clay containing bands of black peaty material (Plate 5). No archaeological features, deposits or finds were observed.

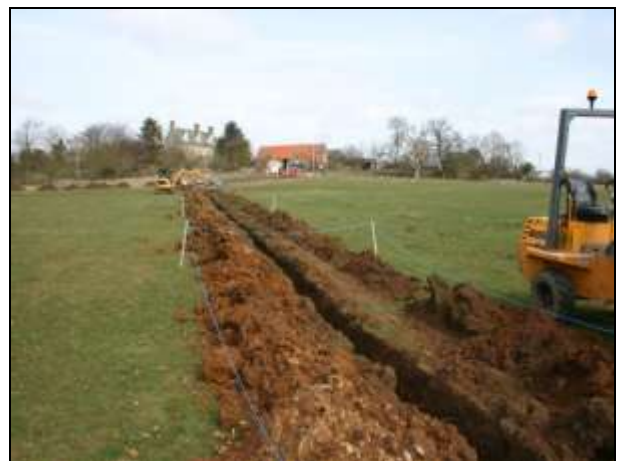
Plate 6: Field Area Service Trench, looking north

The service trenches within the field area of the site measured between 0.3-0.6m wide to a depth of 0.8-1.3m (Plate 6). The stratigraphy comprised *c.*0.15-0.3m depth of topsoil, underlying which was *c.*0.37m in depth of subsoil, beneath which was natural strata (Plate 7). The subsoil was present more towards the field boundary/roadway west of the site, whilst towards the property pathway the subsoil was patchy.

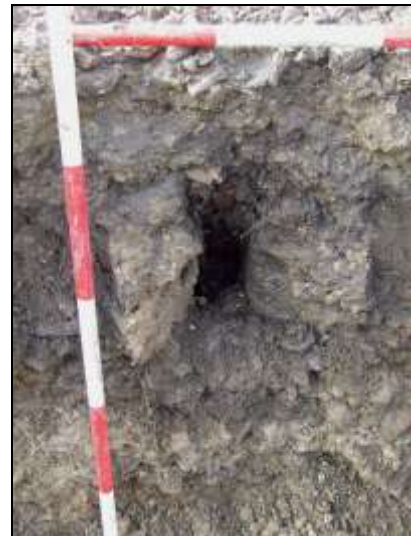
Plate 8: Remains of possible modern gateway, looking northwest (scale 2×1m)

The service trench continued to be excavated near to the property pathway, revealing the remains of two areas of a compact limestone wall with no mortar, between which were the remains of a vertical piece of wood. The walls measured between *c.*0.12-0.2m in width and *c.*0.3m in height, whilst the wood measured *c.*0.09m in width and *c.*0.3m in height. Underlying the wall area there was a disturbed area of ground that measured *c.*0.2m in depth, comprising brown silty clay mixed with small sub-rounded pebbles of limestone. It is possible that the wall area and wood represent a gateway (Plate 8).

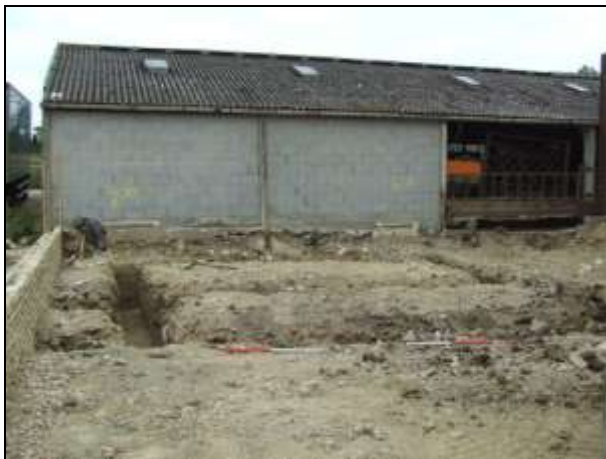
Plate 9: Unit 1 Garage footing trench, looking east (scale 2×1m)

The footing trench for the garage measured *c.*0.4m wide to a depth between 0.65-1.0m, within a *c.*48 sq m area (Plate 9). The stratigraphy comprised *c.*0.5m max depth of concrete and made-ground consisting of light yellow, gravely sand with frequent small-large sub-angular stones. Underlying this, the natural strata of light mottled yellow/grey, malleable clay was visible (Plate 10). Lenses of black soft clay peat-like deposit could also be seen within the natural clay.

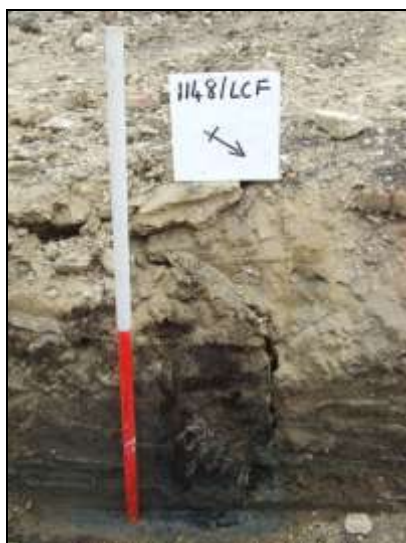
Plate 11: Unit 1 Garage footings: Wooden beam 1, looking southwest (scale 1×1m)

Two wooden beams were observed in section in the footing trench. Beam 1 measured 0.55m in height and 0.27m in width (Plate 11), and Beam 2

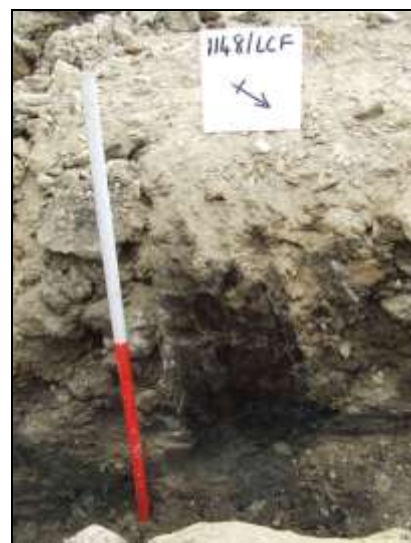
Plate 12: Unit 1 Garage footings: Wooden beam 2, looking southwest (scale 1 ×1m)

measured 0.45m in height and 0.2m in width (Fig. 5; Plate 12). It is likely that such beams formed either a fence or structure.

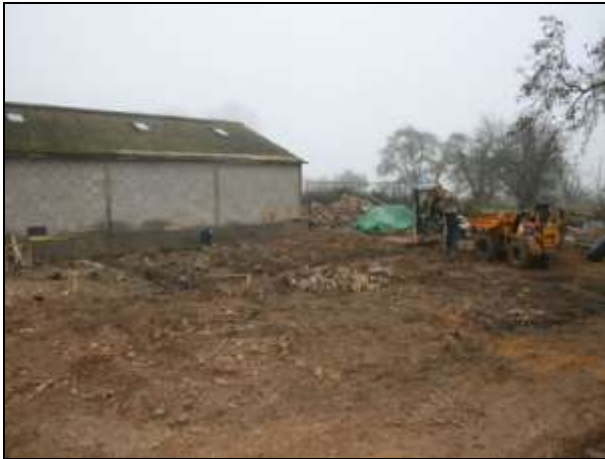
Plate 13: General view of footing trench for Unit 2 Garage, looking east

The footing trench for the garage measured *c.*0.6m wide to a depth of *c.*1.0m, within a *c.*70 sq m area (Plate 13). The stratigraphy comprised natural clay with no topsoil or subsoil (Plate 14). No archaeological features, deposits or finds were observed.

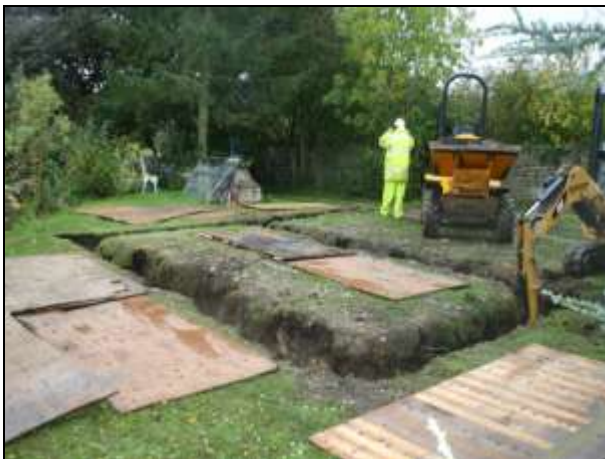
Plate 15: Footing trench for the farmhouse garage

The footing trench for this garage was *c.*0.4m wide and *c.*1.0m deep, within a *c.*60 sq m area (Plate 15). The stratigraphy comprised *c.*0.25m depth of topsoil/turf. Underlying this was *c.*0.2m of limestone rubble containing concentrations of burnt material, above natural clay (Plate 16). No archaeological features, deposits or finds were observed. The area in which this footing trench was excavated appears to have been built up with rubble/building debris, the date of which was uncertain.
