Archaeological Services & Consultancy Ltd

**WATCHING BRIEF:
THE OLD RECTORY
BAINTON ROAD
BUCKNELL
OXFORDSHIRE**

April 2009

ASC: 1173/BBR/2

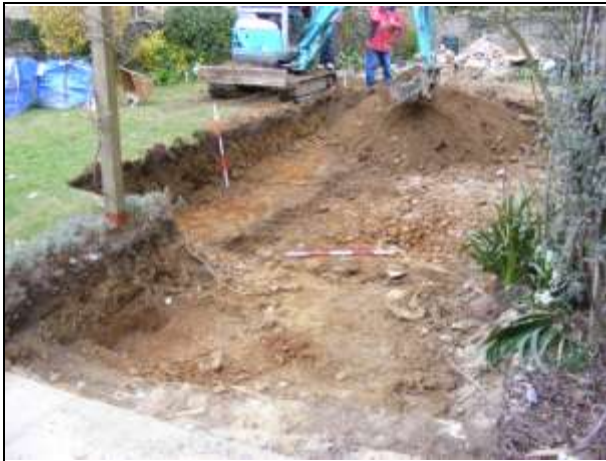
Plate 1: Development area, looking southwest 2x1m scale

- 4.2 The development area measured c.4.2m x 8.9m and was located south of the Old Rectory (Plate 1). Excavation revealed possible structural remains comprising a possible wall, posthole and a stone lined drain (Fig 4).

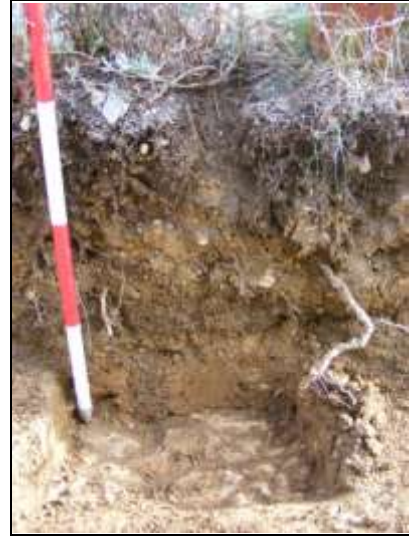
Plate 2: Stratigraphic makeup of the site, looking south, 1m scale

- 4.3 The ground makeup underneath the demolished conservatory consisted of c.0.25m of concrete and modern brick rubble overlying c.0.35m of mid brown yellow silty subsoil with frequent limestone fragment inclusions. The natural geology of orange clay overlying cornbrash limestone was reached 0.60m below the current ground level. The areas undisturbed by the previous structure were only different in that the modern debris from the conservatory was replaced by dark brown silty topsoil to a depth of 0.25m (Plate 2). The subsoil layer contained medieval and post-medieval pottery as well as medieval floor tile and bone fragments (not retained).

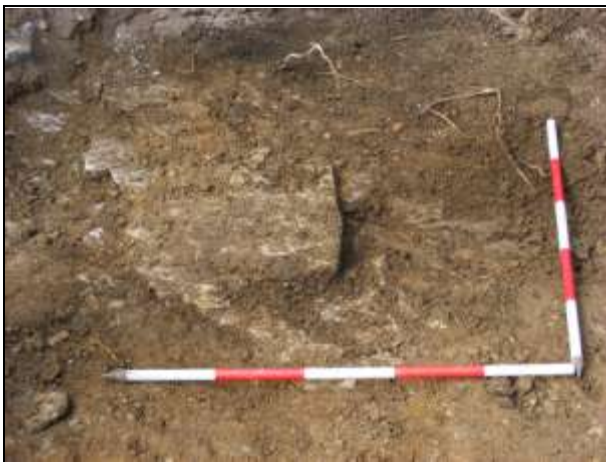
The possible north-south wall began 1.7m from the current house. It was cut by the footing trench for the southern wall of the Old Rectory. The wall was 0.7m in width and consisted of only one course of limestone fragments set in a beige-yellow clay mortar with frequent chalk inclusions. The eastern face of the wall was worked and faced.

Plate 3: Possible wall, looking north, 2x1m scale

- 5.2 The possible wall was cut by the current southern wall of the Old Rectory indicating it is of earlier date. The significance of the wall though cannot be determined due to its limitations in length and that only one course of stone remained.

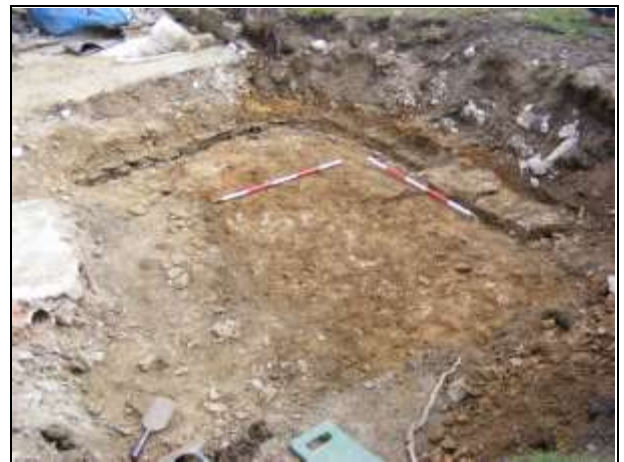
Two stone lined drains were revealed, c. 0.60m below the current ground level. They were of dry limestone construction 0.45m wide and 0.2m deep, with a limestone base. They were capped with large limestone fragments c.500mm across and these ran along the full length of both drains.

Plate 4: Stone lined drain, looking southeast, 2x1m scale

- 5.4 The stone lined drains are contemporary or possibly later than the present house as they cut the foundation trench for its southern wall and the drains exit point was discovered below the floorboards within the current kitchen.

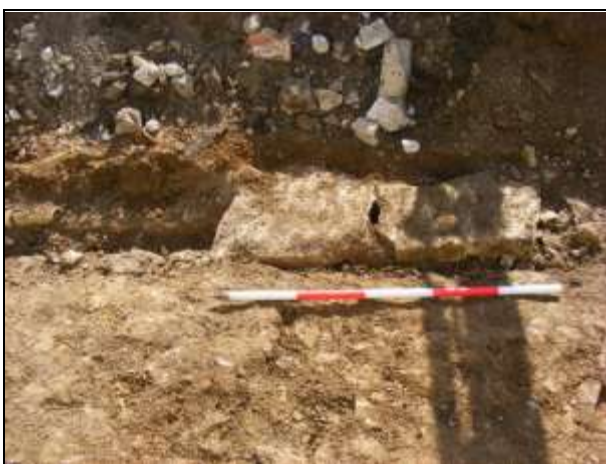
Plate 5: Capping stones over limestone drain, looking south, 1m scale

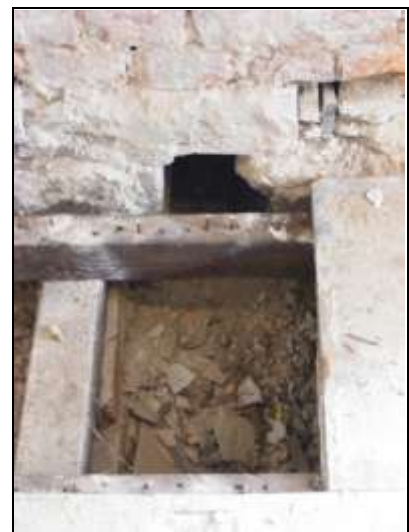
The western drain ran out of what is now the kitchen area of the old rectory, and its exit point from the house could be seen below the floorboards within the southern wall. It ran south away from the house and then turned west after 3m and continued beyond the excavated area

Plate 6: Internal exit point of drain, running out of the kitchen
