**WATCHING BRIEF:
WESTBURY PRIMARY SCHOOL
WEST VIEW
LETCWORTH
HERTFORDSHIRE**

NGR: TL 2110 3200

on behalf of Hertfordshire County Council

ASC: 1133/LWP/2

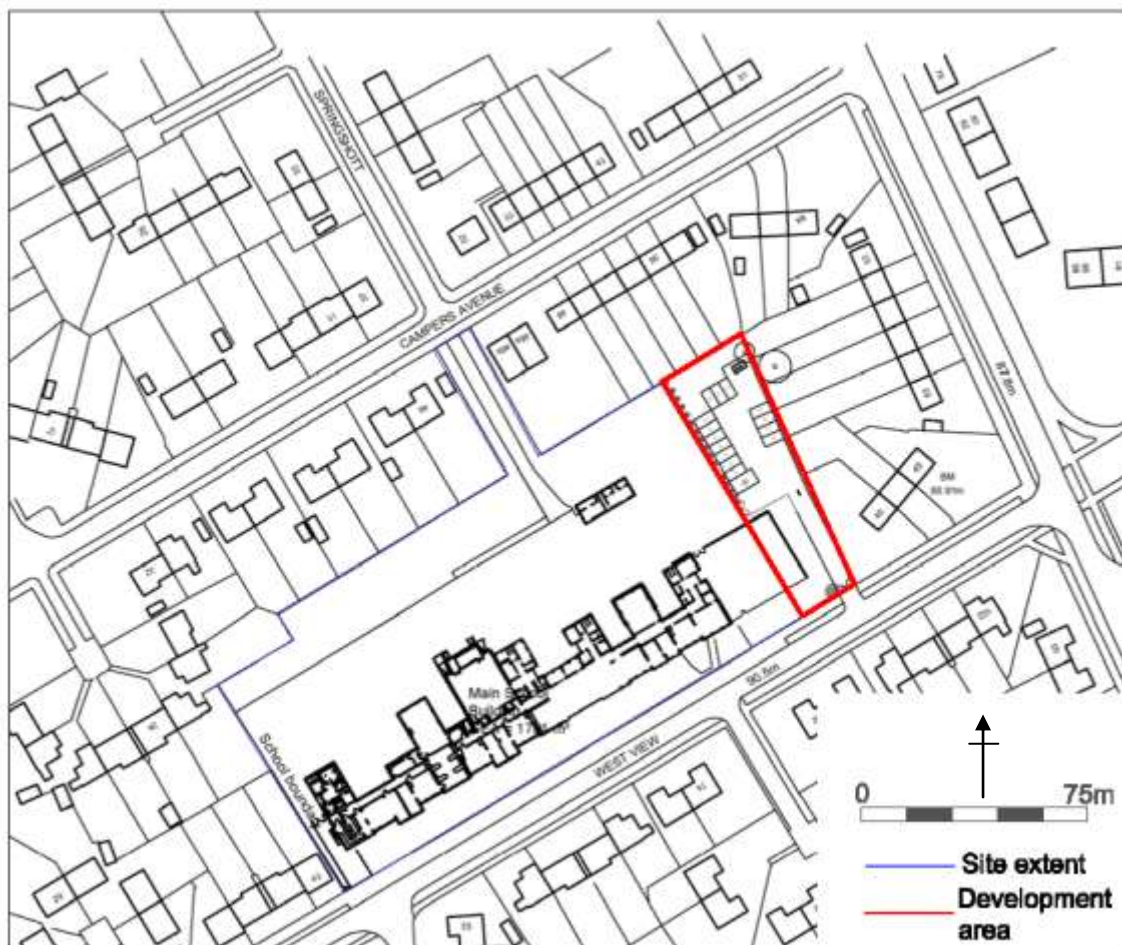
Figure 2: Site plan (scale 1:2500)

The school grounds cover a sub-rectangular area of 9425 square metres (Fig. 2). The proposed development area lies to the northeast of the existing school buildings and covers an area of 274 sq m.

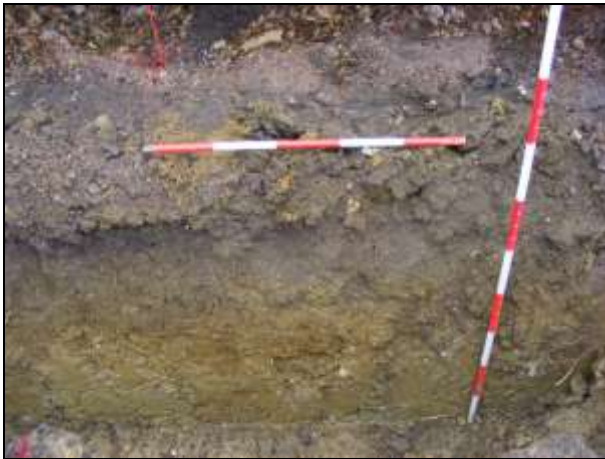
Plate 1: Footing trench stratigraphy, looking northeast

The footing trenches were 0.6m wide and between 1.5m and 2.1m deep. They were cut through *c.*0.2m of modern made ground comprised of asphalt and brick, *c.*0.3m of mid brown silty clay subsoil, and then into undisturbed natural strata which comprised *c.*0.25m of orange-brown clay overlying olive green clay with frequent medium to large chalk inclusions.

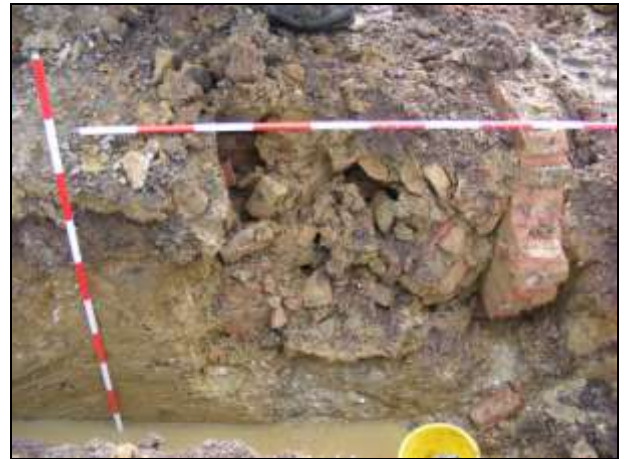
Plate 2: Air raid shelter revealed within footings trench, looking southeast

Brick foundations were revealed in plan and also within the footing trenches. They were of Fletton brick construction bonded by cement mortar, and were two courses thick. The base of each wall was seen within the footing trench *c.*1.5m below the present ground level.

- 5.1 It is known that four Second World War air raid shelters were constructed on the site in 1941. The exact location of these shelters was not accurately mapped. The walls revealed within the excavated areas are likely to be the remnants of these air raid shelters. They were all constructed of Fletton bricks and were two courses thick, all the walls adjacent to each other were all 1.4m apart including the possible entrance ways revealed within the footing trench and within service trench B. This width seems to be standard among air raid shelters of this type and of those of concrete construction (Zeepvat & Semmelmann 2007, 10). It looks like each shelter had four turns and formed a shape resembling the number two. This zig-zag configuration was used to reduce the effects of a blast (Brown et al 1996, 67).

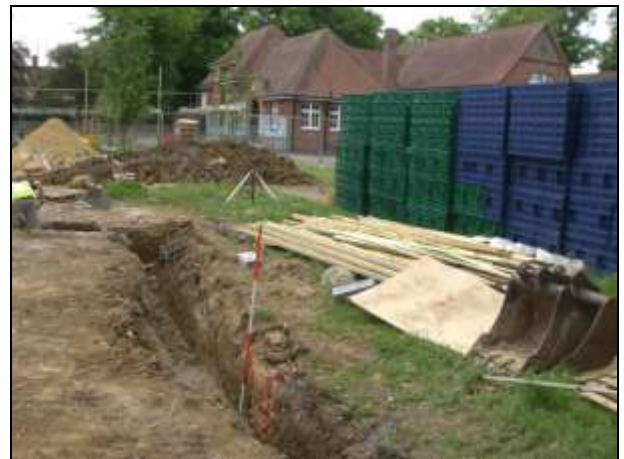
Plate 4: Boundary wall footing trench, looking south

This footing trench was 0.5m wide and 1.1 deep and ran down the western edge of the site. It was cut through 0.1m of topsoil, *c.*0.3m of mid brown silty clay subsoil, and then into the natural strata, which comprised *c.*0.25m of orange-brown clay overlying olive green clay with frequent medium to large chalk inclusions.

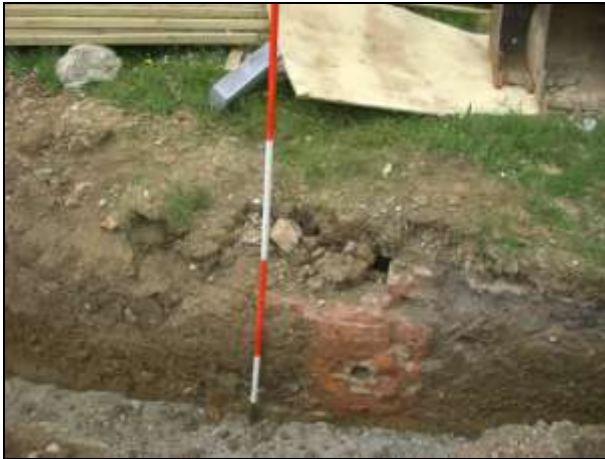
Plate 5: Wall within boundary wall footing trench, looking west

About ten metres from the northern end of the trench, a modern wall was revealed, constructed of red brick and bonded with cement mortar. It was 0.35m wide and 0.5m deep and aligned with the wall revealed in the footing trench and soakaway 1. No other features were revealed in the boundary wall footing trench.

- 5.2 The smaller wall running across the northern end of the site is most likely a boundary wall associated with the school
- 5.3 No other archaeological features were observed in the excavated areas. While the existence of individual, isolated archaeological features, away from excavated areas cannot be entirely excluded, it is unlikely that large numbers of archaeological features or artefacts are present on the site.

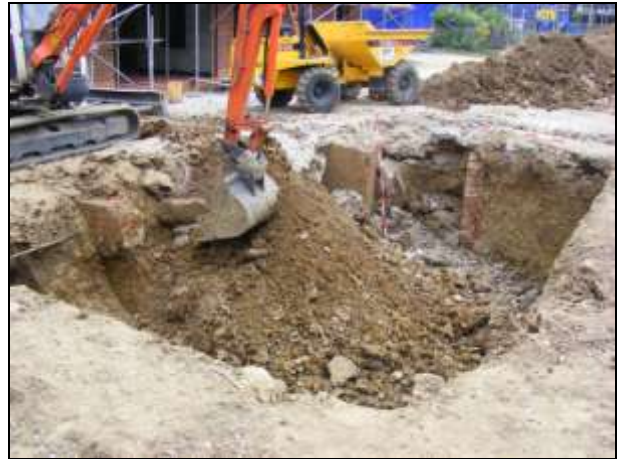
Plate 6: Soakaway 1, looking southeast

The excavation for this soakaway was 4.5 x 7m across and 1.8m deep, and cut through 0.2m of mixed topsoil, 0.5m of orange mid brown silty clay subsoil, and then into the natural clays. It was located 7.5m west of the new building.

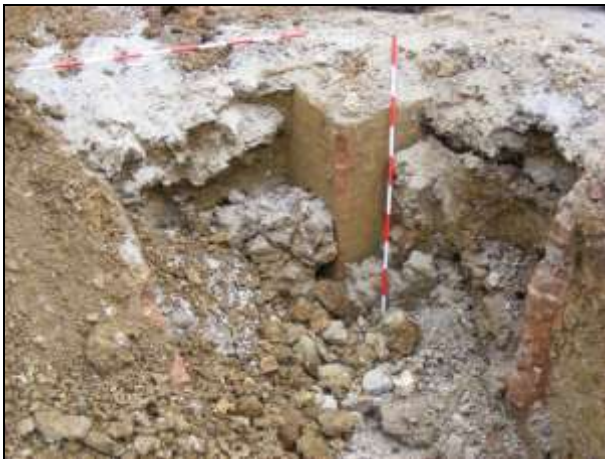
Plate 7: Air raid shelter within Soakaway 1, looking southeast

Two adjacent walls, 1.4m apart, were revealed in the southeast corner of the soakaway. They ran west across the soakaway then turned and headed south beyond the limit of excavation. The base of each wall was seen within the footing trench *c.*1.5m below the current ground level. Both walls were of Fletton brick construction, two courses thick, and were bonded with cement mortar.

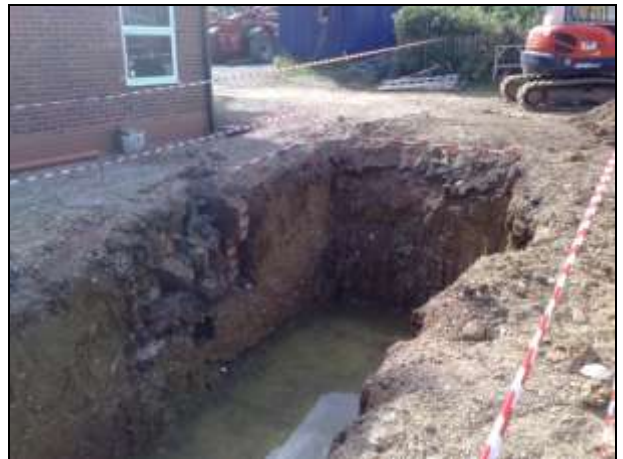
Plate 8: Soakaway 2, looking southeast

This soakaway was 2.5 x 14m across and 2.5m deep, and was located c.4m from the southwest corner of the new building. It was cut through the same deposits as soakaway 1.

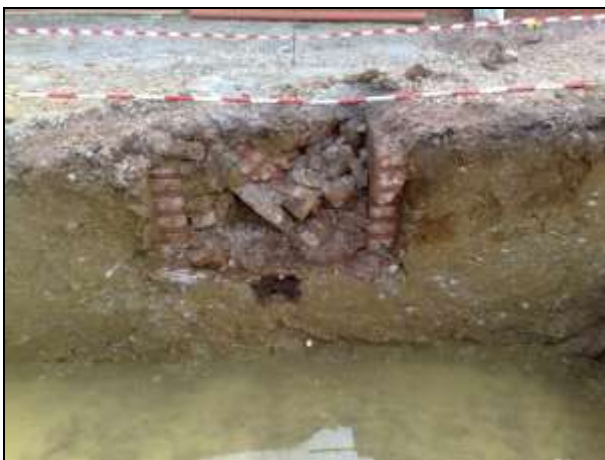
Plate 9: Air raid shelter within Soakaway 2 looking northeast

Two adjacent brick walls running east–west across the soakaway were revealed. They were 1.4m apart, and were constructed of Fletton red brick, bonded with cement mortar. Both walls were two courses thick and the base of each was revealed 1.5m below the current ground level.

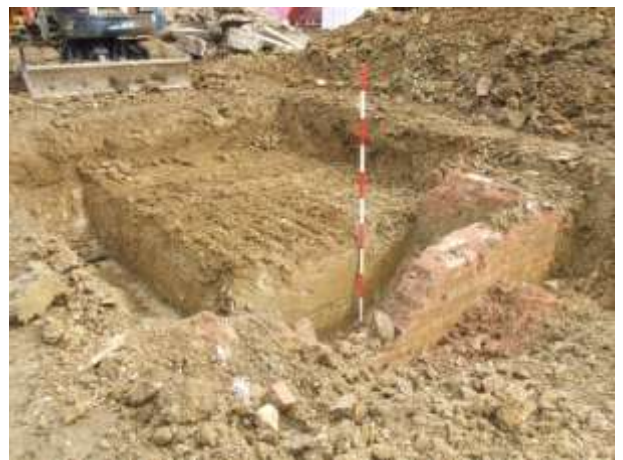
Plate 10: Soakaway 3, looking north

Soakaway Three measured 4.5 x 4.5m across and 2.5m deep and cut through the same deposits as soakaway One. The soakaway was located c.18m from the new building.

A brick wall was revealed running east – west across the soakaway at its southern end. The wall was of Fletton brick construction and was two courses thick. The base of each wall was revealed 1.5m below the current ground level.

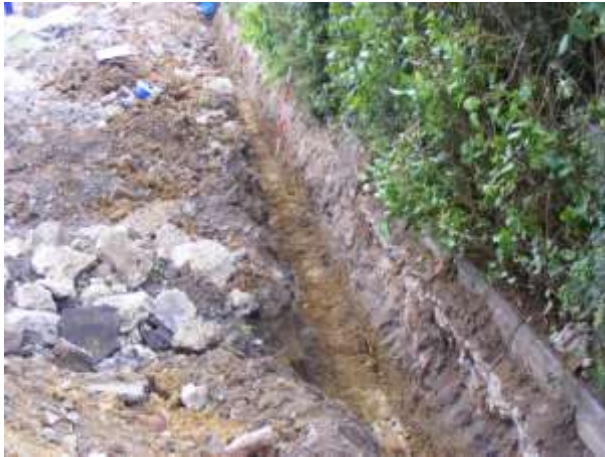
Plate 11: Service trench A, looking north

Service trench A ran southwards from the new building towards West View Road. The trench was 0.6m wide and 0.8m deep and cut through 0.5m of made ground, 0.2m of orange mid brown silty clay subsoil and into natural clay. No archaeological remains were revealed within this trench.

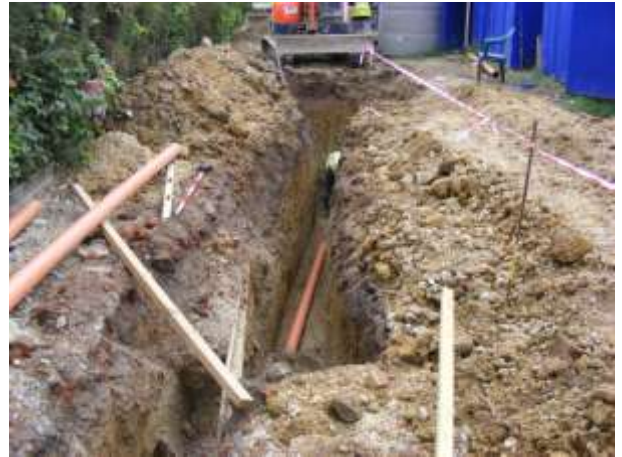
Plate 12: Service trench B, looking southeast

Service trench B ran adjacent to trench A and was 0.5m wide, and 1.0 to 2.0m deep. It cut through the same deposits as service trench A. Two manholes were excavated along the length of the trench. The first was located 17m from the new building and the second was at the southernmost end of the trench, close to West View Road. Both manholes measured 2 x 2m across and 2.5m deep: both were cut through the same deposits as the service trench.

Two brick walls were revealed c.22m from the new building, running east–west across the trench. The walls were 1.4m apart and the base of each wall was revealed c.1.5m below the current ground level. They were constructed of Fletton bricks bonded with cement mortar. Neither continued into service trench A.

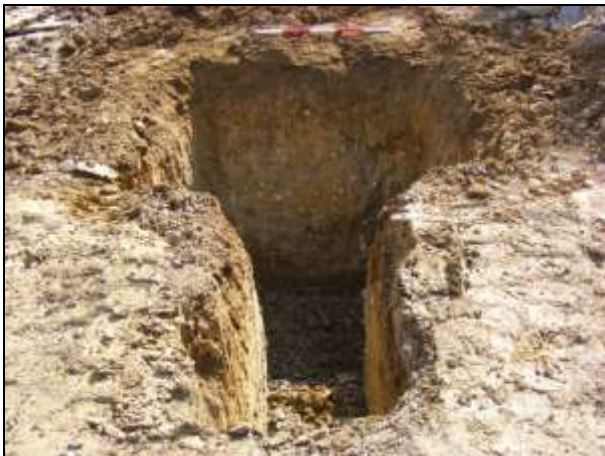
Plate 13: Manhole C, looking east

A manhole was excavated c.2.5m east of Soakaway 3. It measured 1.2 x 1.4m across, and 1.8m deep. It was cut through 0.2m of subsoil and into the natural clays. No archaeological remains were revealed.

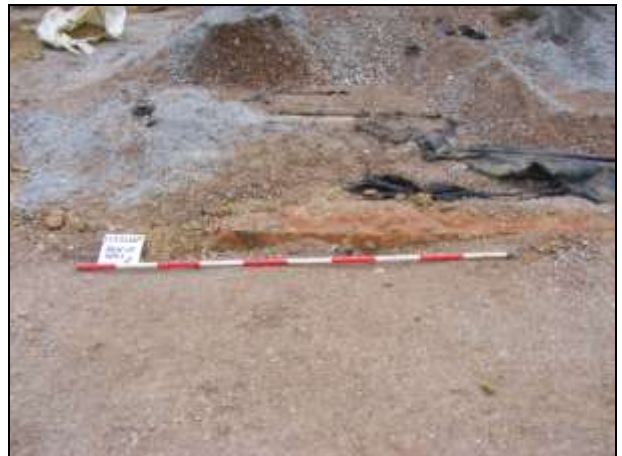
Plate 14: Brick foundations revealed within area of ground reduction

Ground reduction took place across an area west of service trench B. About 0.4m of made ground was removed to reveal the top of the orange brown subsoil layer. Brick walls were revealed in this area. All were of Fletton brick construction, bonded with cement mortar.
