**ARCHAEOLOGICAL EVALUATION:  
REDBOURN YOUTH CENTRE  
THE COMMON  
REDBOURN  
HERTFORDSHIRE**

NGR: TL 1067 1207

April 2009

ASC: 1151/RYC/2

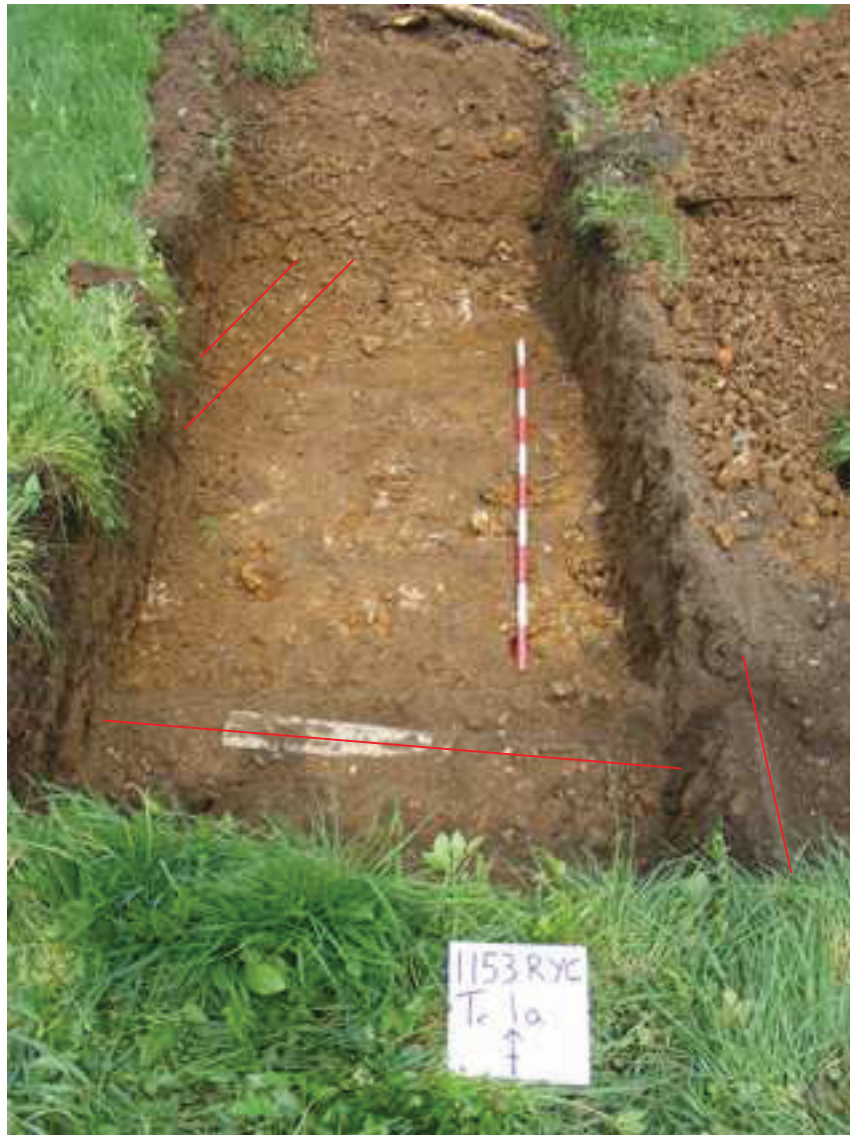
**Plate 1:** Trench 1 highlighting the high level of services within the area

Trench 1 was orientated on a northwest-southeast alignment, situated at the western end of the site. Initially the trench was to measure 15m in length by 1.5m in width, however, due to the high level of services present the trench was abandoned, recorded and backfilled. Thus Trench 1 measured 5m in length by 1.5m in width, and *c.*0.60m in depth. Stratigraphy consisted of *c.*0.20m of a dark black/brown, silty topsoil, overlying *c.*0.40m of mottled dark black/light orangey brown silty clay made ground. The natural geology was not encountered. Two pieces of worked flint were recovered from the spoil tip these were not retained.

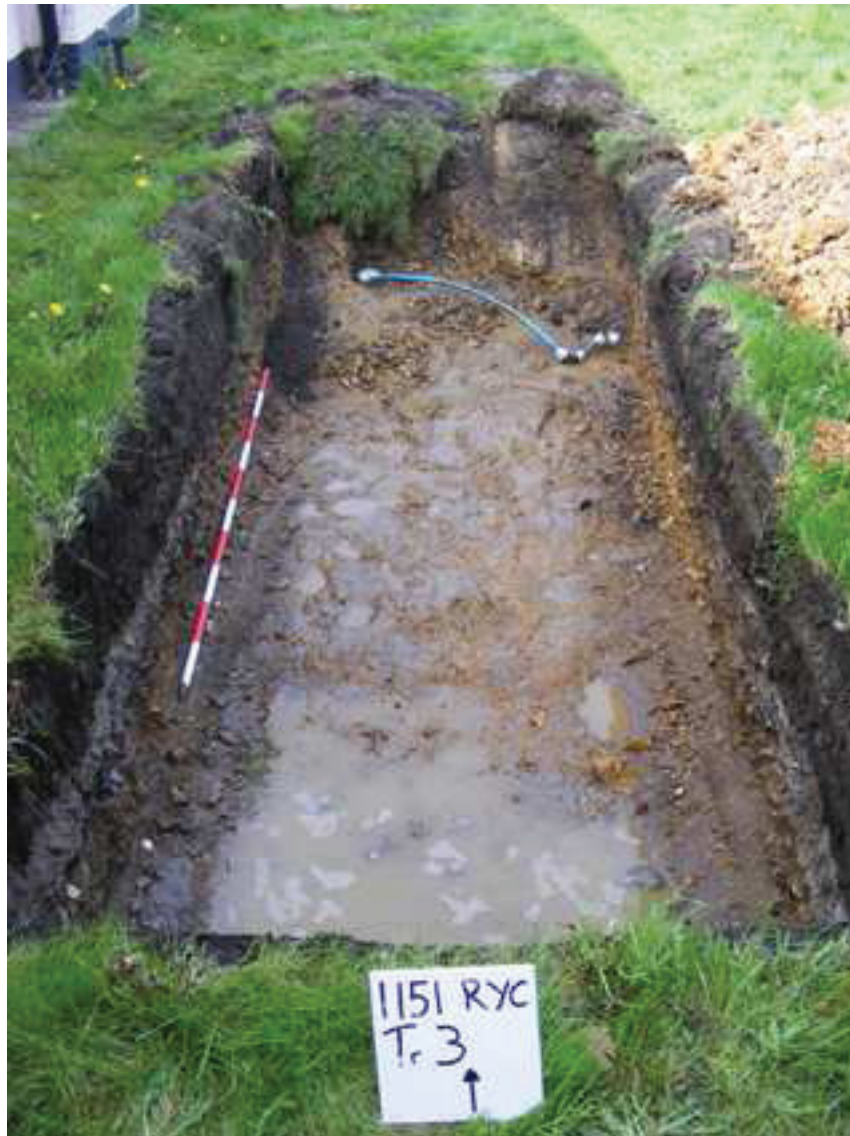
**Plate 2:** Trench 3 depicting the topsoil, made ground and natural geology of the site, and services

Trench 3 was orientated on a north-south alignment, situated at the eastern end of the site. It was 5m long by 1.50m wide, and 1.05m maximum in depth. The stratigraphy was the same as Trenches 1, with *c.*0.20m topsoil, and 0.85m of made ground. The natural geology was light brown orange clay, with frequent medium flint nodules, and small/medium sub-rounded/angular stone inclusions. Whilst mechanically excavating the trench a water pipe was hit, flooding the trench. Upon repairing the water pipe the trench was recorded and backfilled.

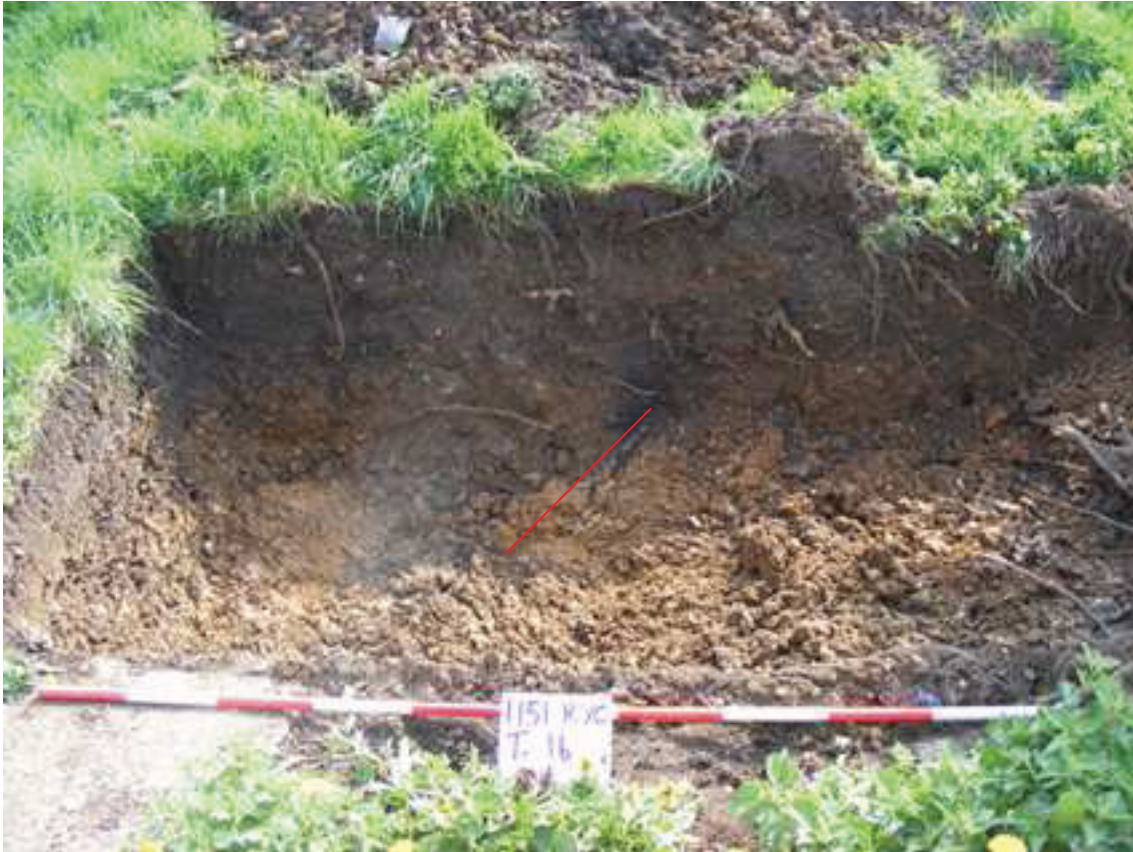
**Plate 3:** Trench 4 depicting the topsoil and made ground stratigraphy, and services

Trench 4 was orientated on an east-west alignment, situated at the southern end of the site. This trench was excavated to compensate for the reduced size of Trench 1. It was 3.30m long by 1.50m wide, and 0.85 in depth. The stratigraphy revealed was the same as Trench 1 and 3 with *c.*0.20m of topsoil, overlaying *c.*0.65m of made ground, whilst the natural geology was not reached. Due to the severing of an electricity cable, the trench was abandoned and was backfilled, following repair work and recording.

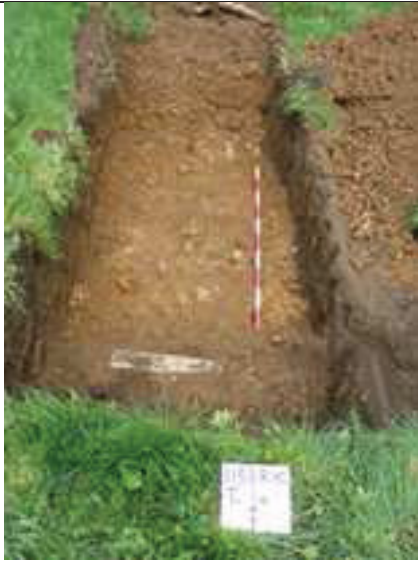
<b>Trench 1</b>

<b>Max Dimensions (m)</b>					
	<b>Length</b>	5	<b>Width</b>	1.50	<b>Depth</b>	c. 0.60
	<b>Levels</b>					
	<b>Trench base north</b>					
	<b>Trench top north</b>					
	<b>Trench base south</b>					
	<b>Trench top south</b>					
	<b>NGR Co-ordinates</b>					
	**				**	
	<b>Orientation</b>			Northwest-Southeast		
<b>Reason for Trench</b>			Evaluation			
<b>Context</b>	<b>Type</b>	<b>Description and Interpretation</b>		<b>Width (max: m)</b>	<b>Length (max: m)</b>	<b>Depth (BGL: m)</b>
1001	Topsoil	Dark black/brown, loose, silty		1.50	5	0.20
1002	Made ground	Mottled dark black/light orangey brown, silty clay, soft/malleable, frequent medium sub-rounded/angular stones/flint		1.50	5	0.40

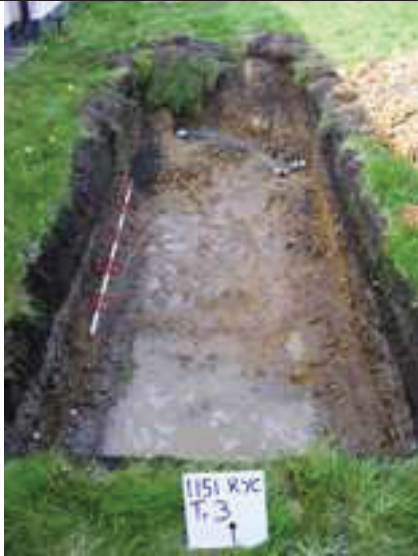
<b>Trench 3</b>

<b>Max Dimensions (m)</b>					
	<b>Length</b>	5	<b>Width</b>	1.50	<b>Depth</b>	1.05
	<b>Levels</b>					
	<b>Trench base north</b>		95.60m OD			
	<b>Trench top north</b>		96.43m OD			
	<b>Trench base south</b>		95.43m OD			
	<b>Trench top south</b>		96.41m OD			
	<b>NGR Co-ordinates</b>					
	**		**			
	<b>Orientation</b>		North-South			
<b>Reason for Trench</b>		Evaluation				
<b>Context</b>	<b>Type</b>	<b>Description and Interpretation</b>	<b>Width (max: m)</b>	<b>Length (max: m)</b>	<b>Depth (BGL: m)</b>	
3001	Topsoil	Dark black/brown, loose, silty	1.50	5	0.20	
3002	Made Ground	Mottled dark black/light orangey brown, silty clay, soft/malleable, frequent medium sub-rounded/angular stones/flint	1.50	5	0.85	
3003	Natural	Light brown orange clay, frequent flint nodules, and small/medium sub-rounded/angular stone inclusions	1.50	5

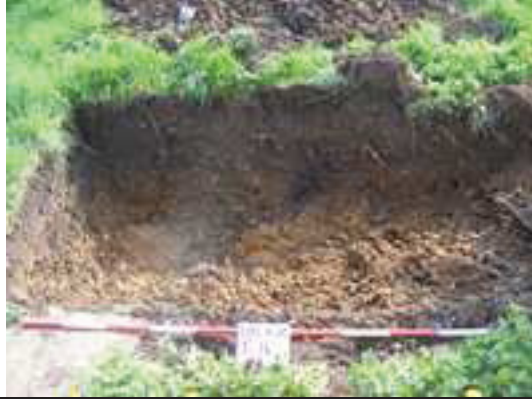
<b>Trench 4</b>

<b>Max Dimensions (m)</b>				
	<b>Width</b>	1.50	<b>Length</b>	3.30	
	<b>Depth</b>	0.85	<b>Level (top)</b>		
	<b>NGR Coordinates</b>				
	<b>Orientation:</b>		East-West		
<b>Reason for Trench:</b>		Evaluation			
<b>Context</b>	<b>Type</b>	<b>Description and Interpretation</b>	<b>Width (max: m)</b>	<b>Length (max: m)</b>	<b>Depth (BGL: m)</b>
4001	Topsoil	Dark black/brown, loose, silty	1.50	3.30	0.20
4002	Made ground	Mottled dark black/light orangey brown, silty clay, soft/malleable, frequent medium sub-rounded/angular stones/flint	1.50	3.30	0.65
