Archaeological Services & Consultancy Ltd

**ARCHAEOLOGICAL WORKS:
FURNEUX PELHAM PRIMARY SCHOOL
THE STREET
FURNEUX PELHAM
HERTFORDSHIRE**

June 2009

ASC: 1164/FPS/2

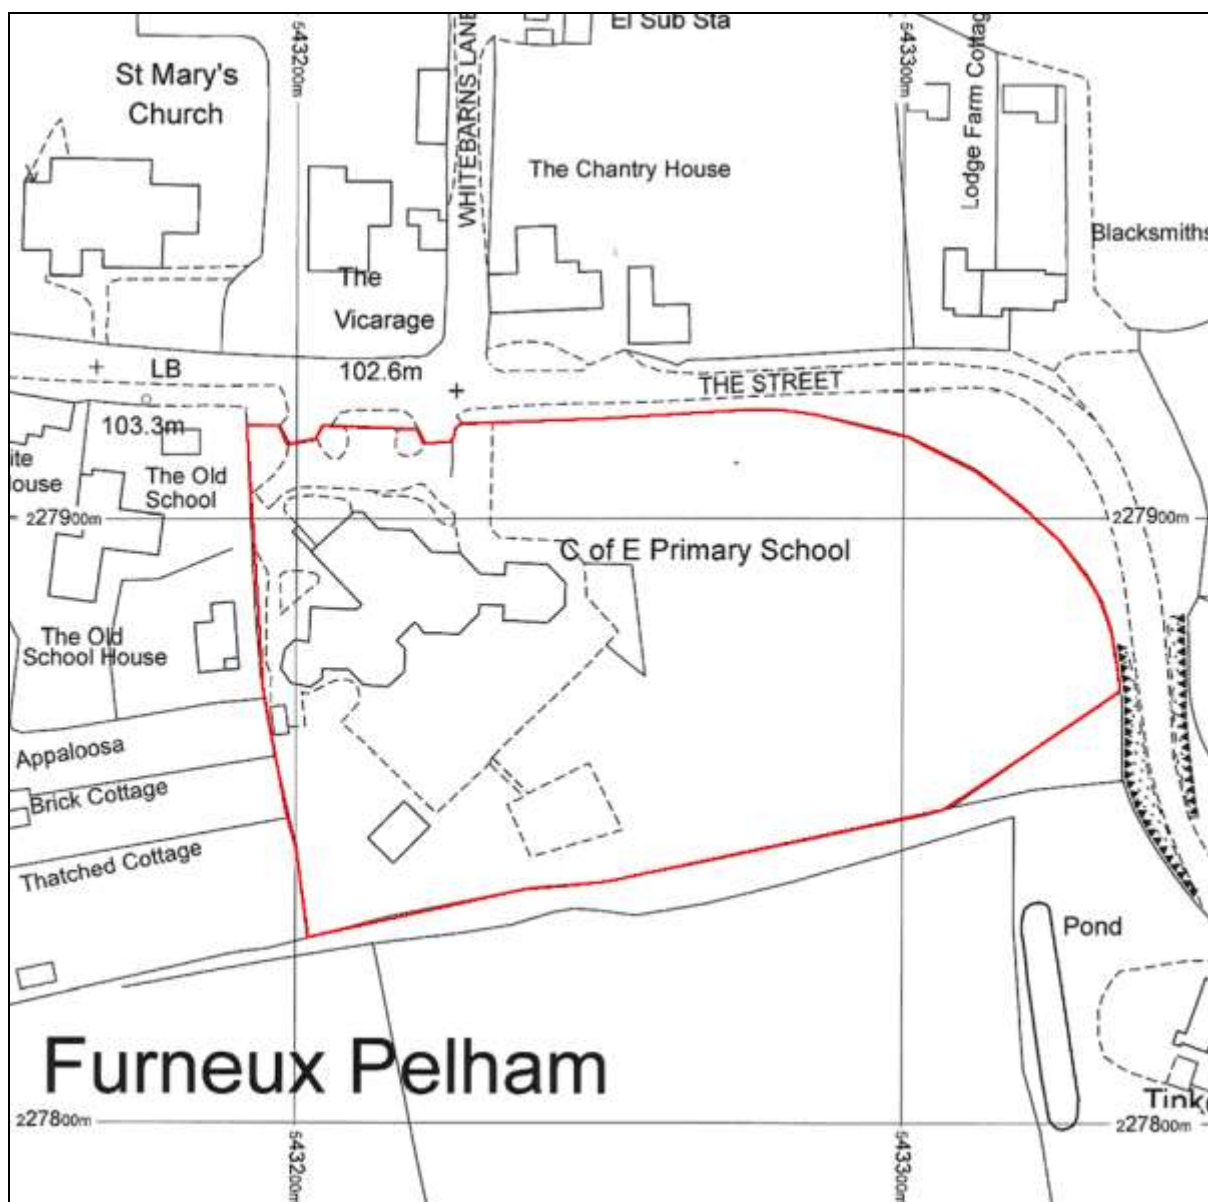
Figure 2: Site plan (scale 1:1250)

Furneux Pelham Primary School is located in East Hertfordshire in the parish and village of Furneux Pelham, centred on NGR TL 4232 2786 (Fig. 1). The irregularly shaped school site, covering c.9ha, is located on the south side of The Street, the main road through the village. It is immediately east of the Old School and the Old School House and diagonally opposite the village church and vicarage. Open fields belonging to Tinkers Hill Farm lie to the south of the school grounds (Fig. 2).

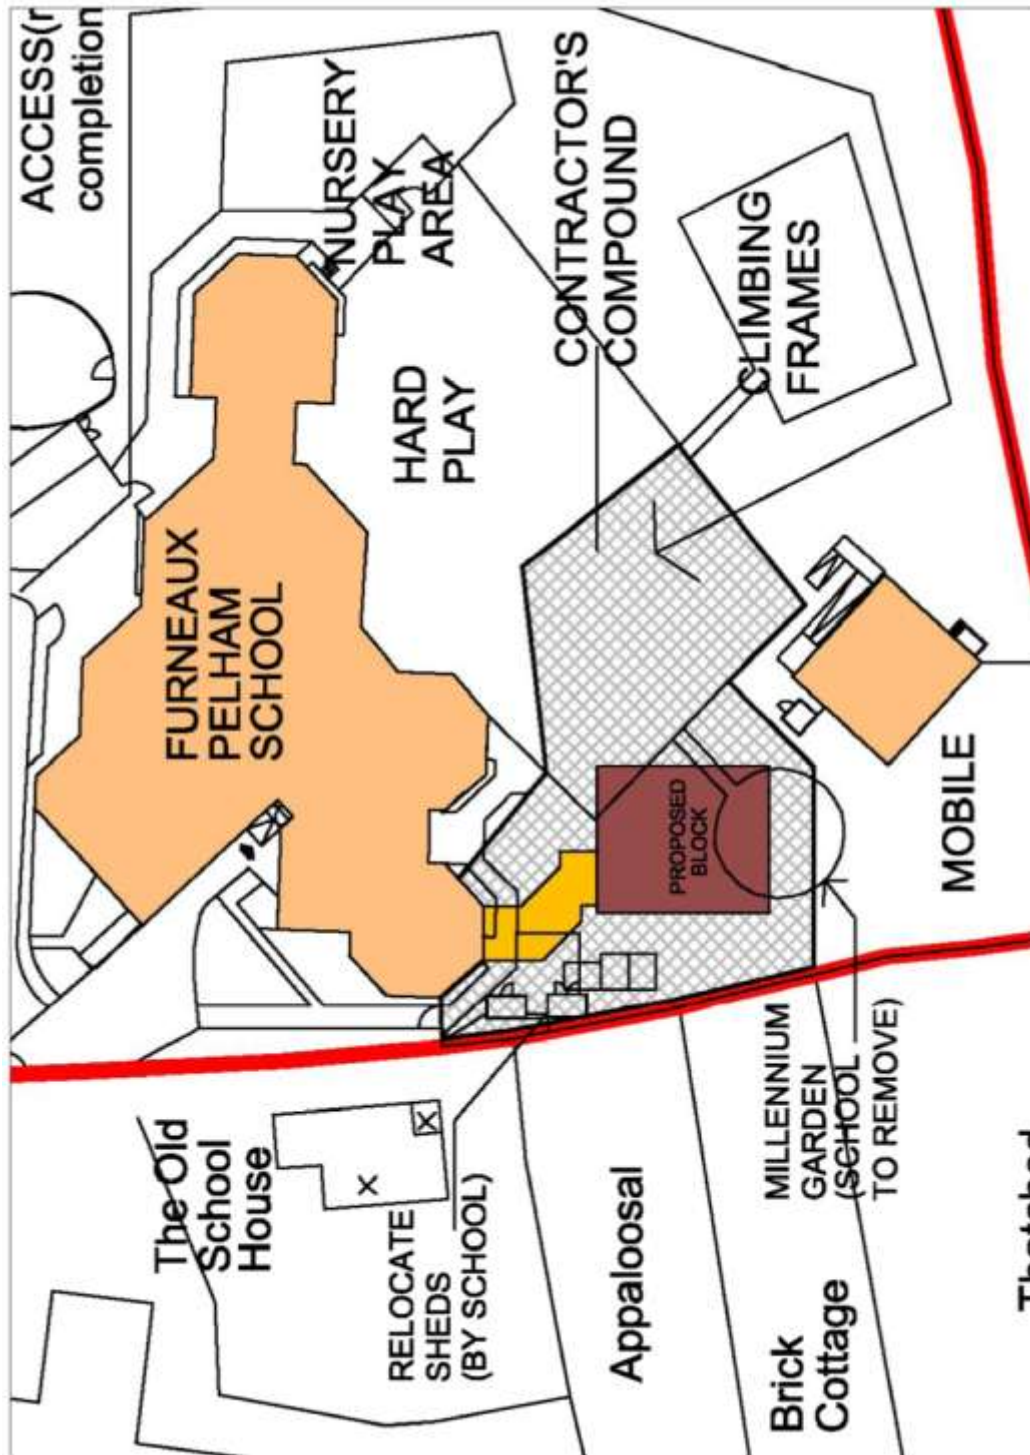
Figure 3: Proposed development (1:500)

To replace an existing mobile classroom with a classroom block with associated cloakroom, toilets and storage (Fig. 3).

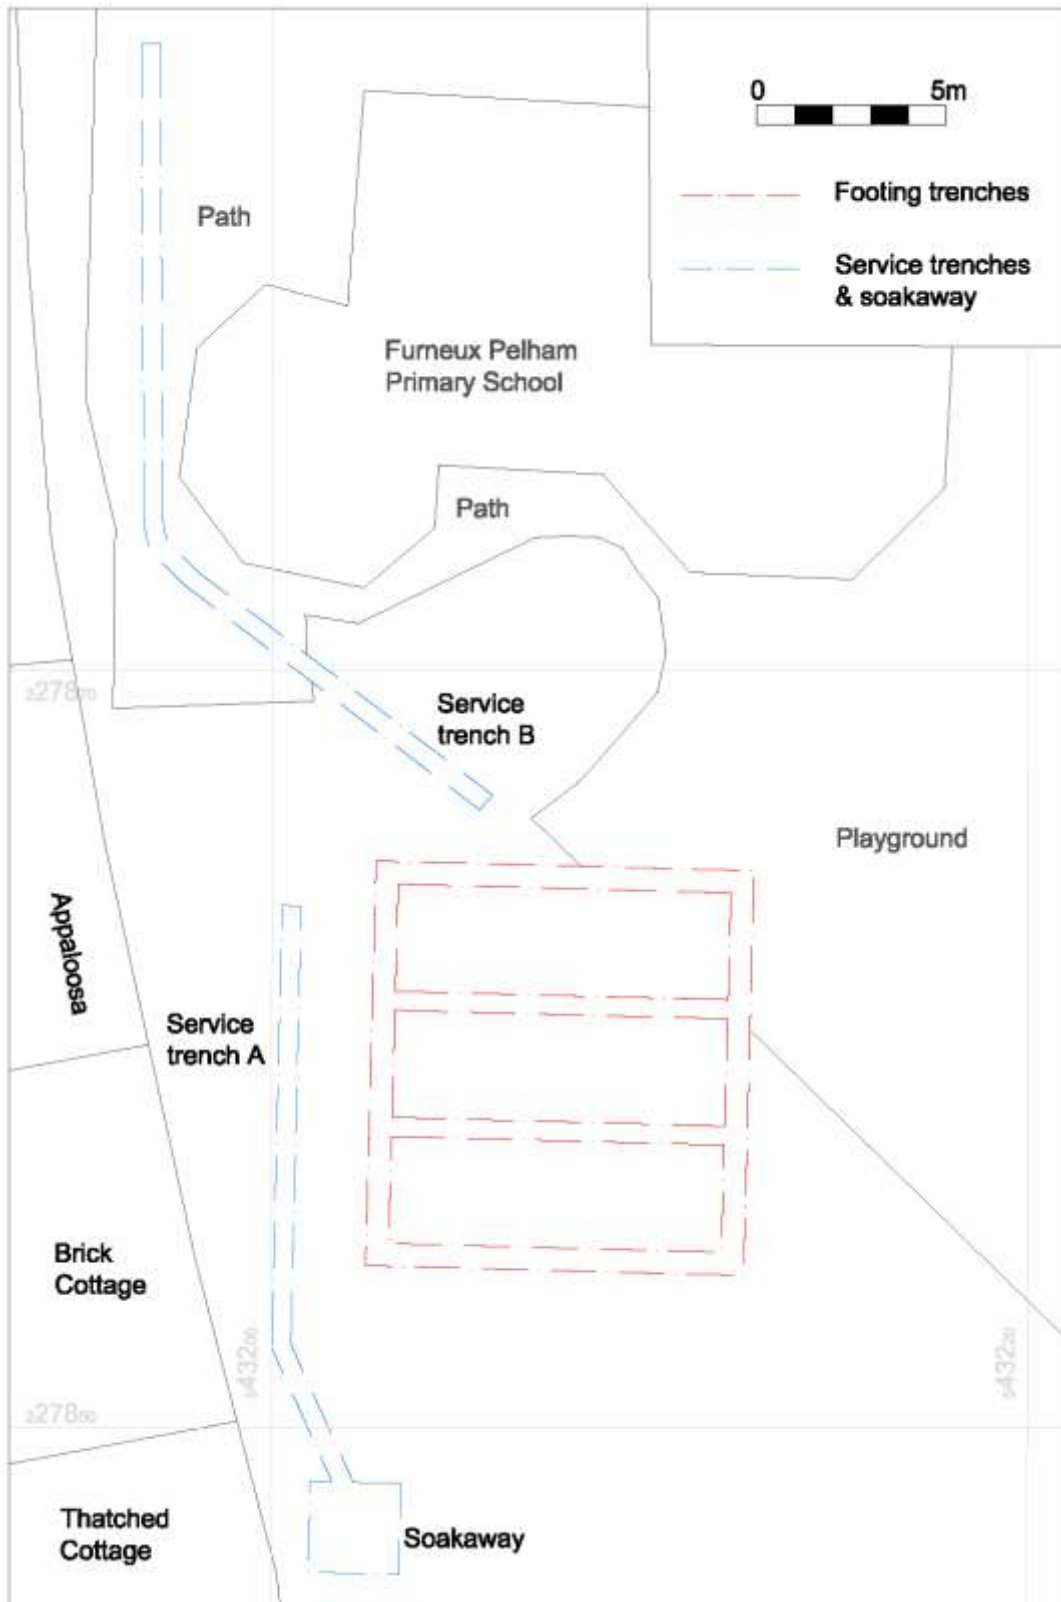
Figure 4: Development plan (scale 1:200)

4.1 The new development covers an area of c.1100sq m, and replaces temporary accommodation and part of the current playground and gardens (Fig. 3). In addition to the footing trenches, ground reduction was eventually carried out across the footprint of the new building, as well as the excavation of one soakaway to the south of the new building and two service trenches to the west and north of the new build (Fig. 4).

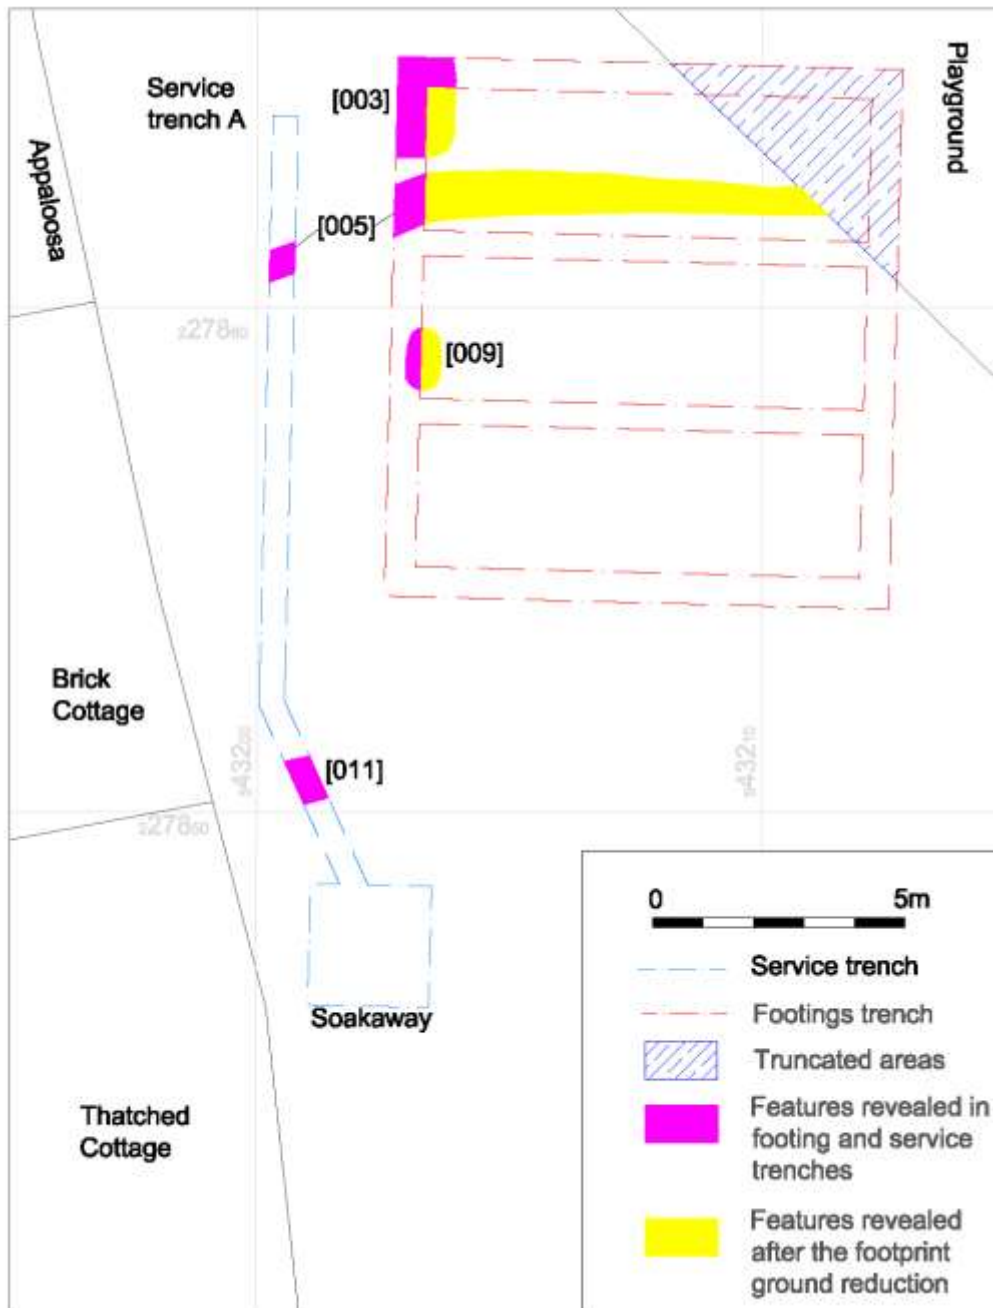
Figure 5: Archaeological remains within the area of the development, and in service trench A (scale 1:150)

4.2.4 Two ditches [003] & [005] and two pits [001] & [009] were revealed in section within the footing trenches. All were then revealed either partly or fully in plan when the overall ground reduction took place, and investigated.

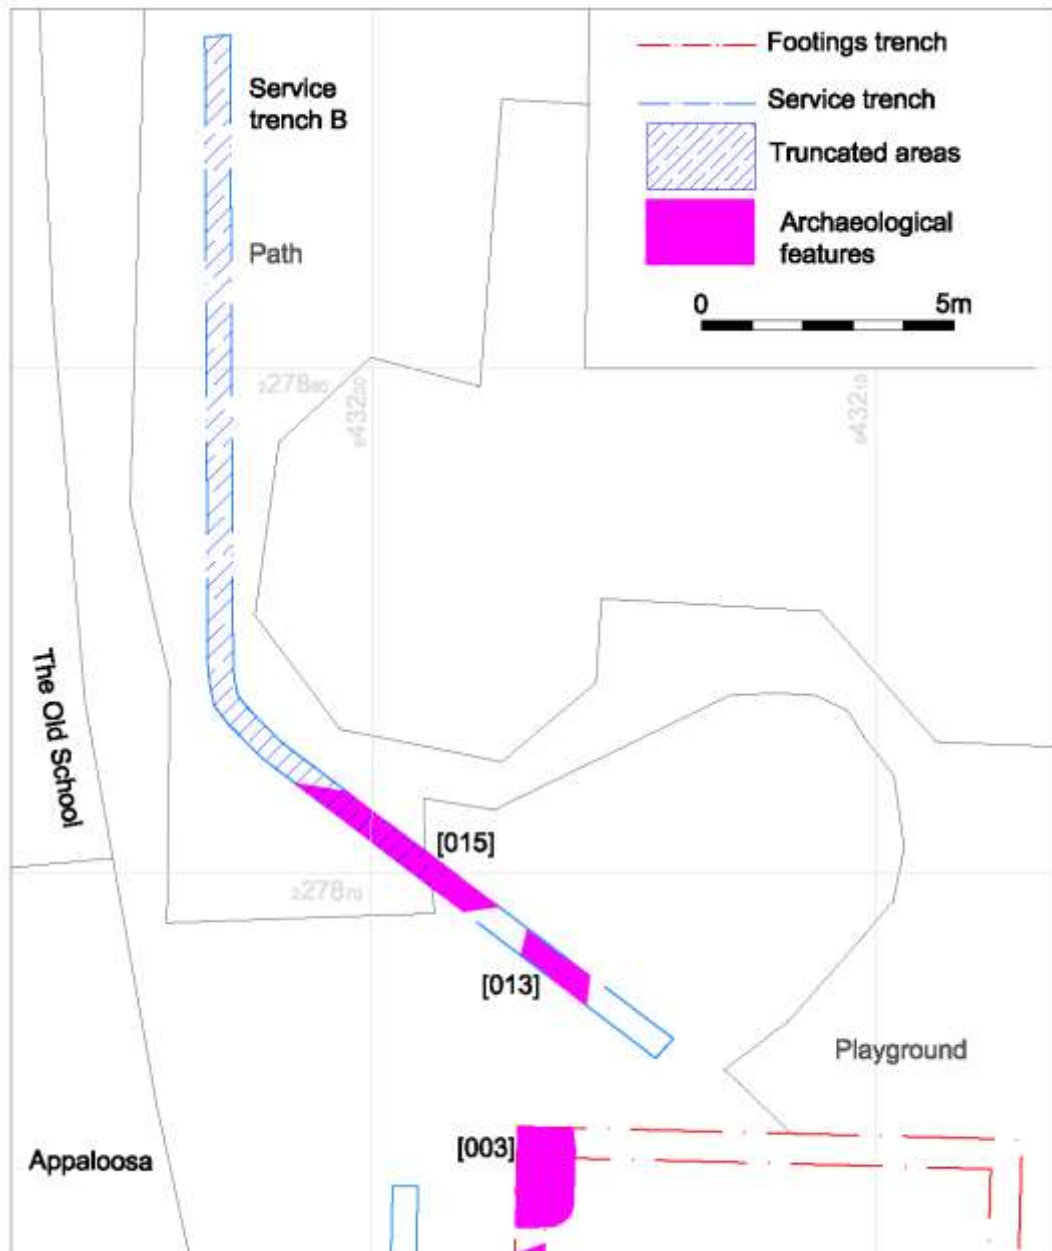
Figure 6: Archaeological remains within service trench B (scale 1:150)

4.4.1 The second service trench ran north from the most northern part of the new building and round the west side of the current school building. It was c.27m long, 0.5 wide and 0.8m deep (Plate 8).

4.4.2 Most of the service trench was cut through part of the playground and path, and the strata revealed was therefore severely truncated. Topsoil and most of the subsoil layers had been removed, apart from c.0.10m depth of the lower subsoil. The natural strata here was covered by c.0.4m depth of

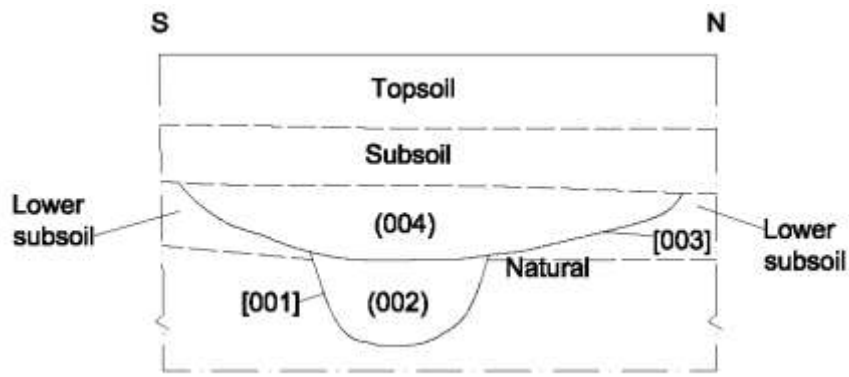
Figure 7: East facing section of pit [001] & ditch [003] (scale 1:25)

Pit [001] was visible in the east-facing section of the western footing trench. It was 0.54m wide and 0.4m deep. It was truncated by Ditch [003], and was filled with mixed mid brown silty clay, beige clay, chalk and occasional daub inclusions (002). The full dimensions of the pit were not revealed in plan.

Ditch [003] was revealed in the east-facing section of the western footing trench. It was c.1.6m wide and c.0.3m deep. Its fill (004) consisted of dark brown silty clay with occasional chalk inclusions, and included two sherds of pottery. The alignment of the ditch and its full dimensions could not be ascertained in plan.

- 5.2 Pit/Ditch [001] was only seen in one section of the footing trench. It was not fully revealed in plan when the footprint ground reduction took place, so its dimensions and orientation could not be ascertained. No archaeological finds were recovered from its fill.

- 5.3 Ditch [003] was seen in three sections in the northwest corner of the footing trenches and was partly revealed in plan when the ground reduction took place. Its dimensions and its orientation could not be ascertained. The fill of this ditch is very similar to that of ditch [013], which was revealed to the north in service trench B, and both features align.

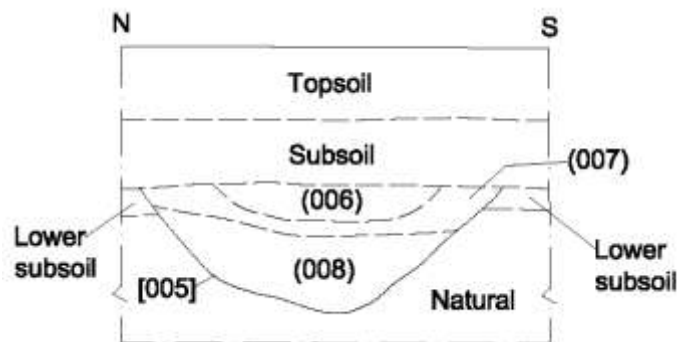
Figure 8: West facing section of ditch [005] (scale 1:25)

Ditch [005] was present in both sections of the western footing trench. It measured 1.2m wide and 0.42m deep. The ditch was also revealed in plan running east across the site when the overall ground reduction took place. It stopped abruptly at the point where the playground began and was not seen in section in the eastern footing trench. It had three distinct fills:

(006) consisted of soft-moderate mid brown silty clay with frequent lime mortar and chalk inclusions, overlying (007)

(007) comprised solid orange brown mortar or daub with occasional chalk fragments, overlying (008)

(008) was a malleable but firm mid brown silty clay with occasional chalk frags, forming the primary fill of the feature.

- 5.4 Ditch [005] was revealed in the footing trench, in service trench A and during ground reduction, running east-west across the site. It lines up with the land boundary that separates ‘Appaloosa’ and ‘Brick Cottage’, and is probably a continuation of that boundary, truncated when the present school was built in the 1970s. No finds were discovered in the fill of this ditch, but the fills themselves suggest deliberate backfill. The ditch stopped abruptly at the edge of the school playground, beyond which it appeared to have been truncated by the construction of the playground.

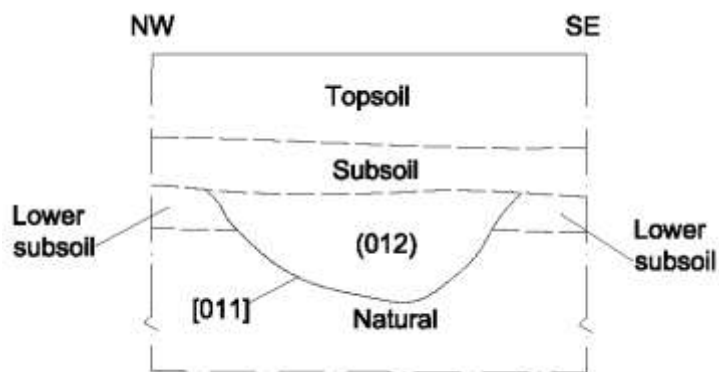
Figure 9: Southwest facing section of ditch [011] (scale 1:25)

Ditch [011] was located c.12.5m from the northern end, and was visible in both sections. It was 1.05m wide and 0.34m deep, and was filled with dark brown silty clay containing occasional chalk fragment inclusions (012). It also cut through the lower subsoil layer.

- 5.5 Ditch [011] was revealed in service trench A, but its dimensions and orientation could not be established. However, it lines up with the land boundary that separates ‘Brick Cottage’ and ‘Thatched Cottage’, and could possibly be a continuation of this boundary. No finds were noted in this feature.

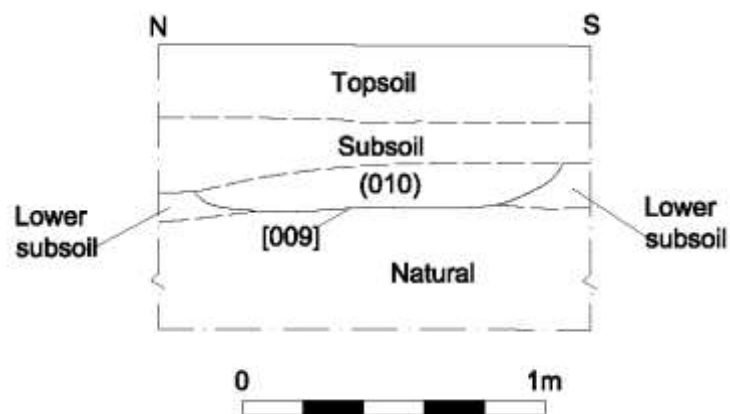
Figure 10: West facing section through pit [009] (scale 1: 25)

Pit [009] was revealed in the west facing section of the west footing trench, c.5.3m from its northern end. In section it was 1.2m wide and 0.17m deep and cut into the lower subsoil layer. Its fill (010) consisted of orange clay mortar, with occasional chalk fleck inclusions and rare chalk nodules. The full dimensions of the pit were revealed after the ground reduction took place. It was sub-circular in shape and 0.8m in length.

- 5.6 Pit [009] was present in the footing trench and was fully revealed in plan when ground reduction took place. No finds were discovered within this feature but its fill (010) appeared to represent deliberate backfilling, like ditch [005].

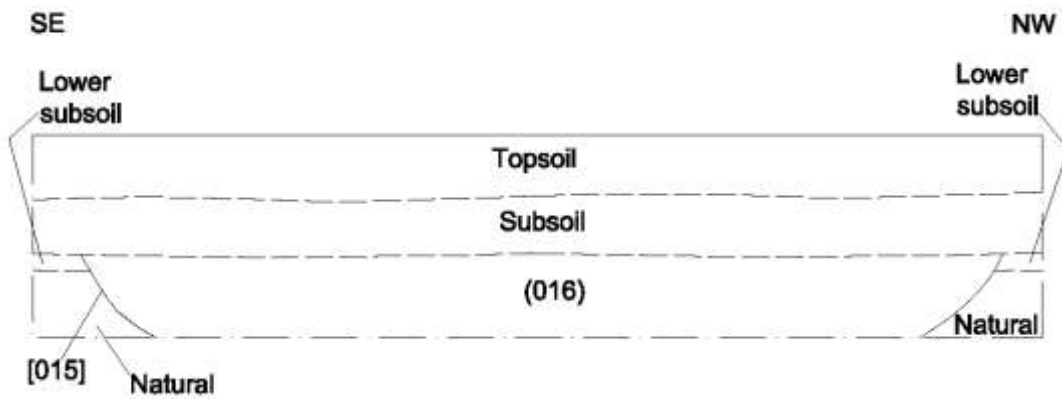
Figure 11: Northeast facing section of ditch/pit [015] (scale 1:30)

Ditch [015] was encountered in both sections of the service trench, *c.*5m from the new building. It was *c.*4m wide and 0.3m deep and was filled with almost stoneless dark grey silty clay soil (016). The ditch was severely truncated by the path and was only revealed in the lower part of the trench.

- 5.7 Feature [015] was highly truncated by the path surrounding the school. Its dimensions and orientation could not be established, and no finds were discovered within its fill.

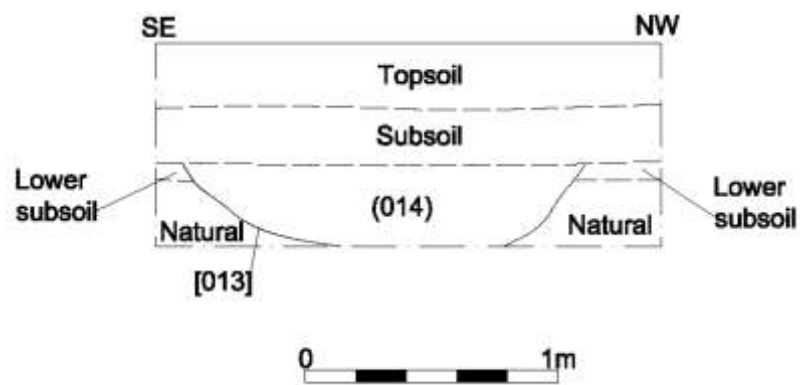
Figure 12: Northeast facing section of ditch [013] (scale 1:30)

This possible ditch/pit was seen in both sections of the service trench, *c.*2m from the new building. It was *c.*1.5m wide and 0.3m deep and was filled with dark-brown silty clay soil (014). Seven sherds of pottery were discovered within its fill.

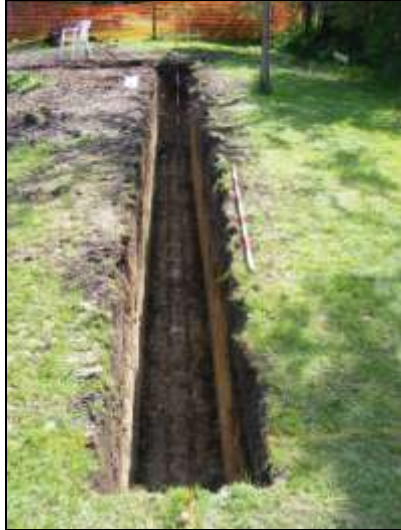
4.2.1 The footing trenches were 0.5m - 0.6m wide and 1.5m deep. The trenches were cut through c.0.25m of dark brown silty-clay topsoil, c.0.3m of mid brown silty clay subsoil and then into the natural strata which comprised c.0.10m of orange-brown silty clay overlying yellow-beige clay with frequent medium to large chalk inclusions (Plate 1).

Plate 1: Footing trench, looking south

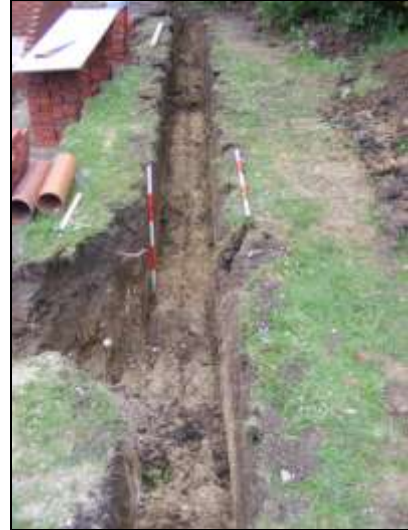
4.3.2 The service trench associated with the soakaway was located on the west side of the new building, running north-south across the site. It was c.17m long, 0.5m wide and 0.9m deep and encountered the same deposits as the footing trenches (Plate 2).

Plate 2: Service trench A, looking south.

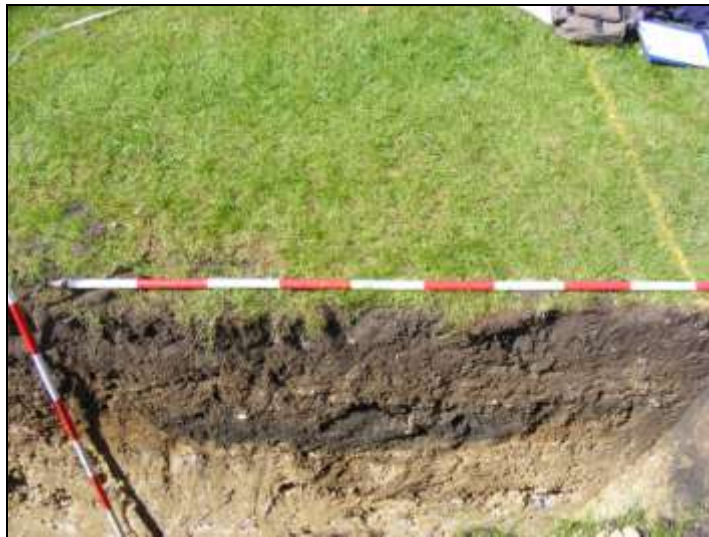
Plate 3: Pit [001] & Ditch [003] in footing trench, looking west.

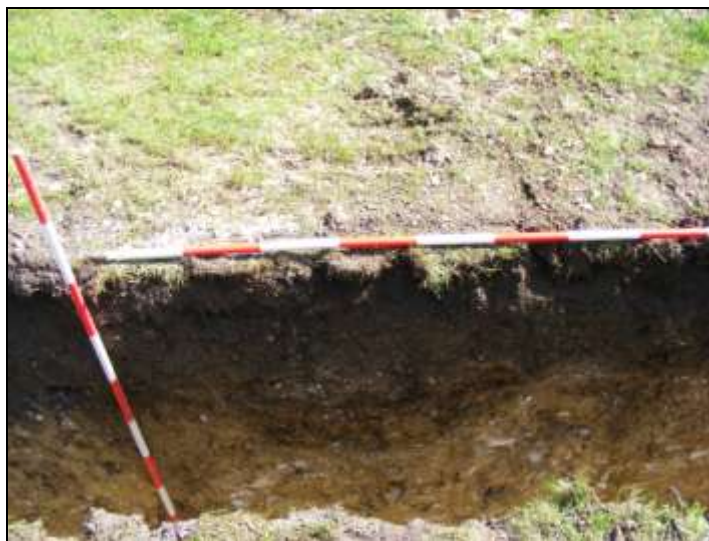
Plate 4: Ditch [005] in footing trench, looking east.

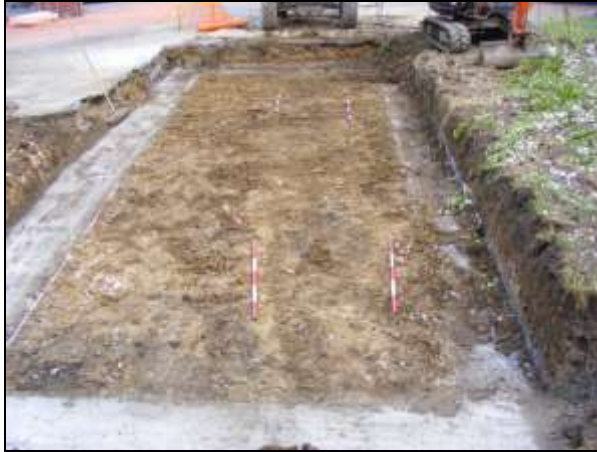
4.2.3 After the excavation of the footings trenches, ground reduction across the footprint of the new building took place. Overburden to a depth of 0.6m was removed, revealing undisturbed natural strata (Plate 5).

Plate 5: Ditch [005] in plan.

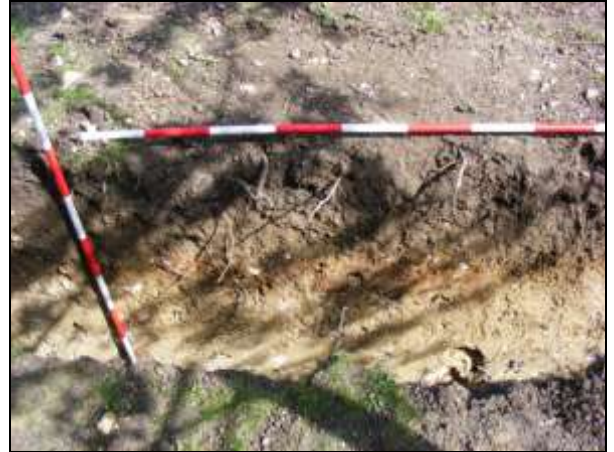
Plate 6: Pit [009] in footing trench, looking east.

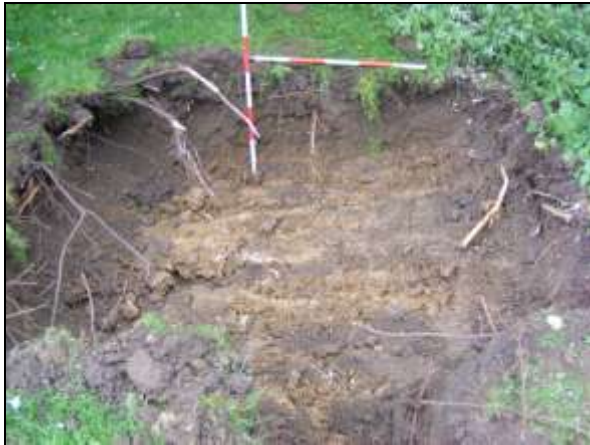
4.3.1 The soakaway was located c.4.4m south of the most south-westerly corner of the new building. It measured 2.4m² across and c.2m deep, and was cut through the same deposits as the footing trenches (Plate 7). No archaeology was revealed within the soakaway.

Plate 7: Soakaway, looking south.

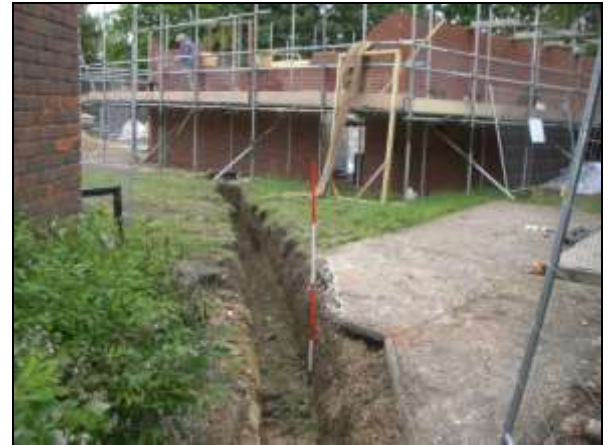
Plate 8: Service trench B looking south-west.

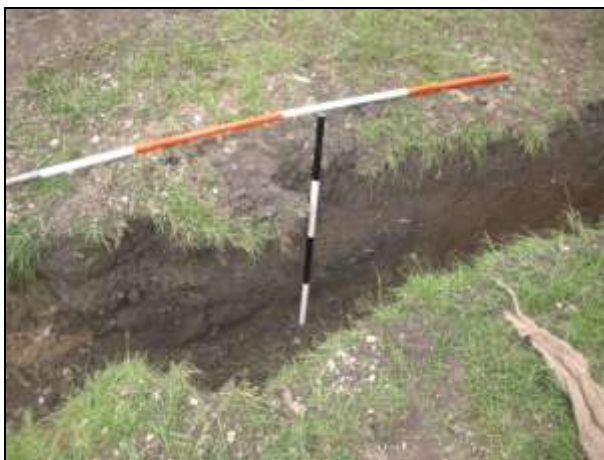
Plate 9: Ditch [013] in service trench B, looking east.

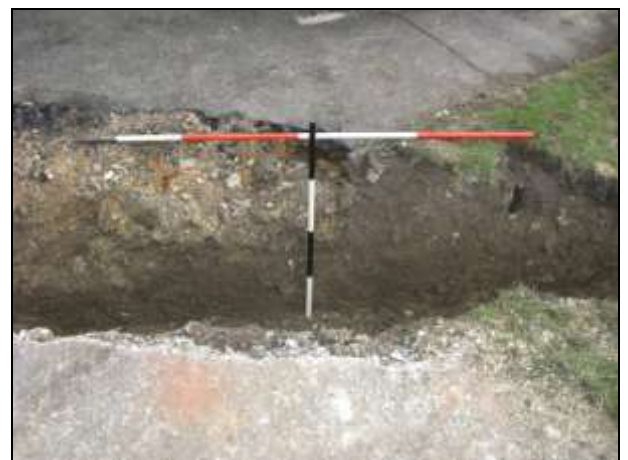
made ground and hardcore (Plate 10). One feature [015] was revealed in the trench:

Plate 10: Service trench B, modern disturbance from path covering feature [015], looking east.
