ARCHAEOLOGICAL EVALUATION: 1-2 THE GREEN BROMHAM BEDFORDSHIRE

NGR: TL 0086 5129

June 2009

ASC: 1180/BTG/2

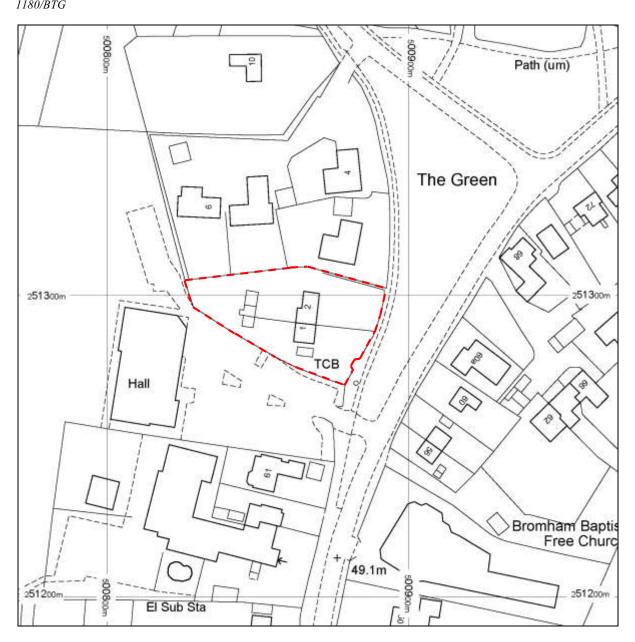
Figure 2: Site plan (*Scale 1:1,250*)

The site comprises an approximately rectangular area of land, of c.1600 sq m, and is currently occupied by disused two semi detached cottages, with outbuildings to the rear (Fig. 2).

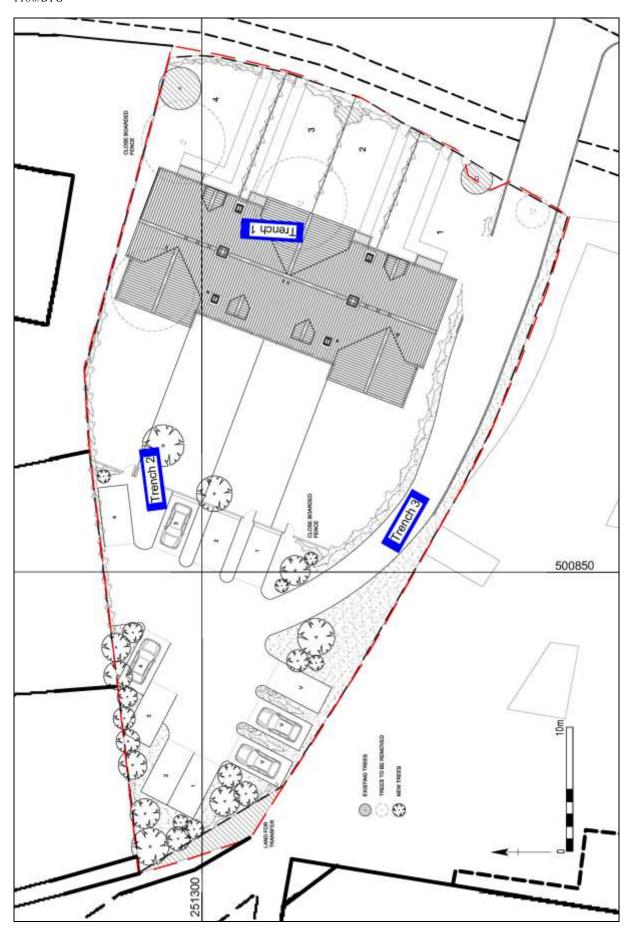
The development proposal comprises the demolition of the existing buildings on the site and the construction of a row of four terraced houses (Fig. 3).

- Excavation of c.24 sq metres of trial trenches. Three trenches, each c.5m long and c.1.6m wide were excavated. Trench locations are shown in Fig. 3.
- A contingency had been allowed for an additional 4 sq metres of trenching, in order to investigate further any significant archaeological features or deposits which may be present

Trench 1 was located within the footprint of the proposed building, on the western side of the site, and was orientated north to south (Fig. 3). Due to the presence of an electricity cable, it had to be relocated 5m further north than was originally proposed.

Trench 2 was located within the footprint of the proposed car park, on the northern side of the site, and was orientated approximately northeast to southwest (Fig. 3). The dark brown topsoil overlay 0.5m of made ground containing 19th and 20th century building debris, and firm yellowish brown with grey mottling, clay natural (Plate 3).

Trench 3 was located within the footprint of the proposed access road, on the southern side of the site, and was orientated approximately northwest to southeast (Fig. 3). The topsoil in this area of the site overlay a firm, mid brown, silty clay subsoil, and a yellowish brown with grey mottling clay natural (Plate 4).

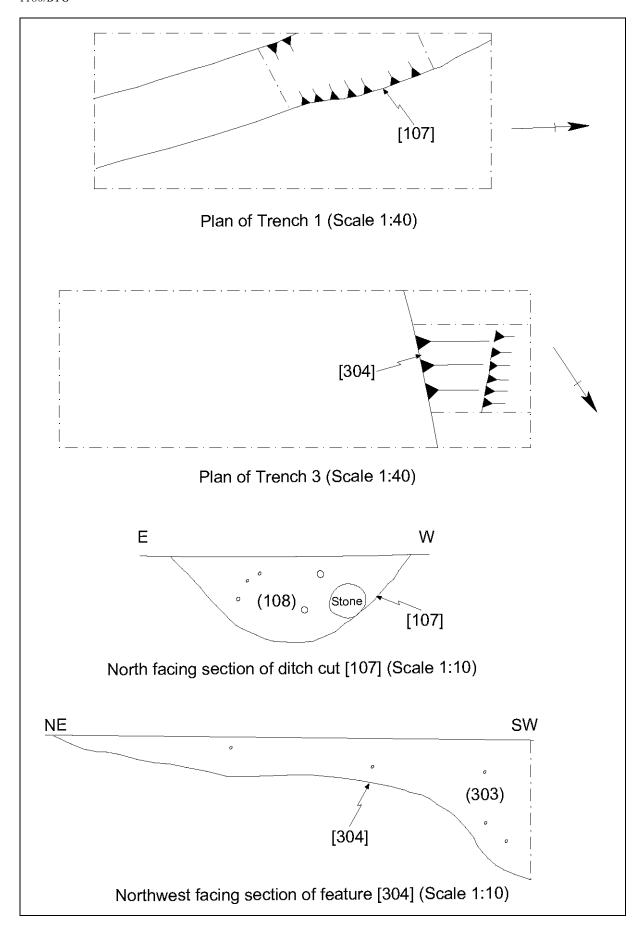
Figure 5: Trench plans and feature sections

Below this layer, cut into the olive green/grey clay natural, was a linear feature [107], U-shaped in profile, measuring at least 4.4m in length, 0.7m in width, and 0.23m in depth (Fig. 4, Plate 2). It contained a single, fairly firm, dark grey with brown mottling, clay fill (108) which appears to be the product of back-filling (Fig. 5). Occasional limestone fragments, and sub-oval flint inclusions, less than 90mm in diameter were noted with the fill, together with pottery sherds, animal bone and oyster shell.

At the northwest end of the trench was a cut feature which may have been a pit, gully or ditch [304] (Plate 5). Its full extent could not be ascertained in any dimension, but it was at least 1.27m in width, 1.6m in length, and 0.28m in depth. If the feature is linear it is orientated north to south.
