**WATCHING BRIEF:  
FIRE AND RESCUE STATION  
HIGH STREET  
GREAT MISSENDEN  
BUCKINGHAMSHIRE**

NGR: SP 8960 0111

July 2009

ASC: 1198/GMF/2

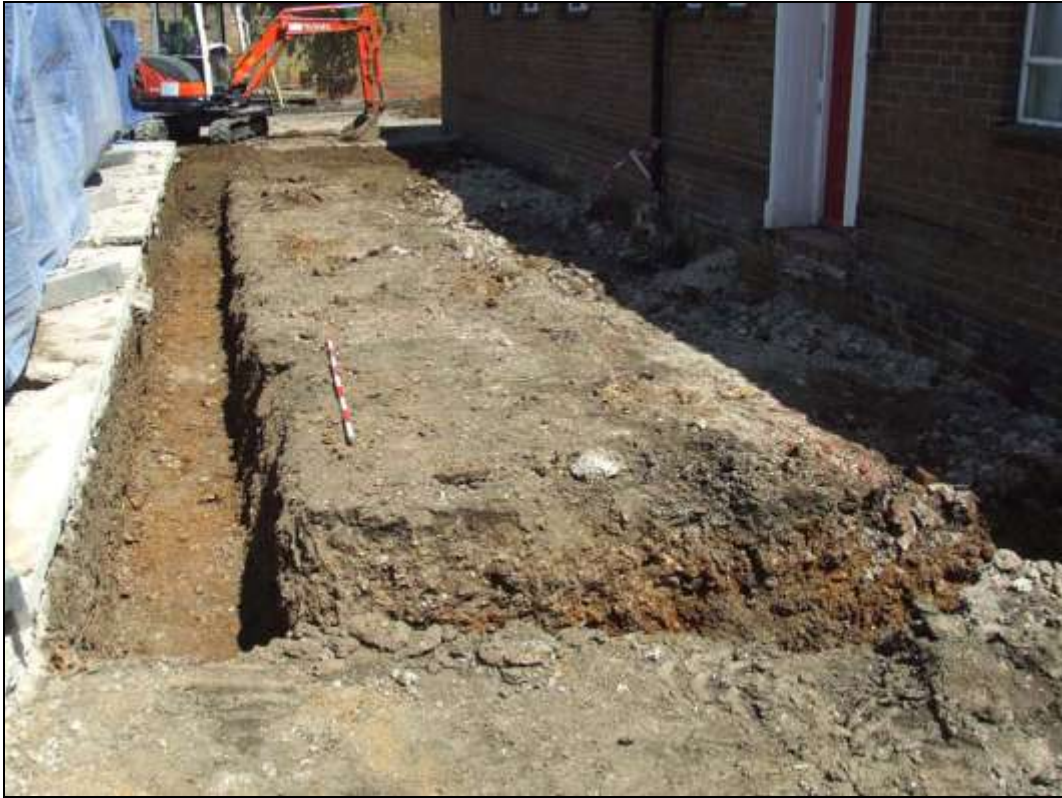
**Plate 1:** Development area and footing trench, looking east

The development area was oriented eastwest, and measured *c.*19.7m in length, *c.*4.4m in width, and *c.*0.2m in depth. The concrete slabs and made ground *c.*0.3m deep, were mechanically removed. At the western end of the area a modern brick soakaway was uncovered, measuring 0.8m in diameter, and *c.*0.9m visible depth.

The footing trench measured *c.*14.30m in length, *c.*0.60m width, and *c.*1.06m in depth. It was cut through concrete and made-ground, *c.*0.33m in depth, underlying which was *c.*0.47m of subsoil, and below that into natural clay. No archaeological features or deposits were observed.

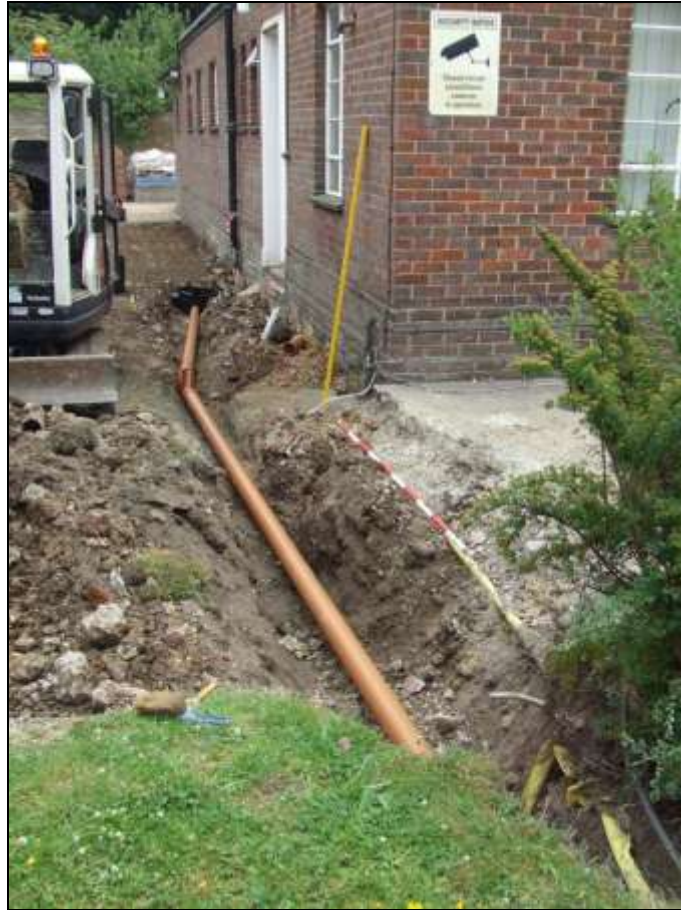
**Plate 3:** Foul drainage trench, looking east

The foul drainage trench measured *c.*19.70m in length, 0.30m in width, and at the western end *c.*0.65m in depth, and *c.*0.45m in depth at the eastern end. The foul drainage trench was within the made-ground. No archaeological features or deposits were observed.

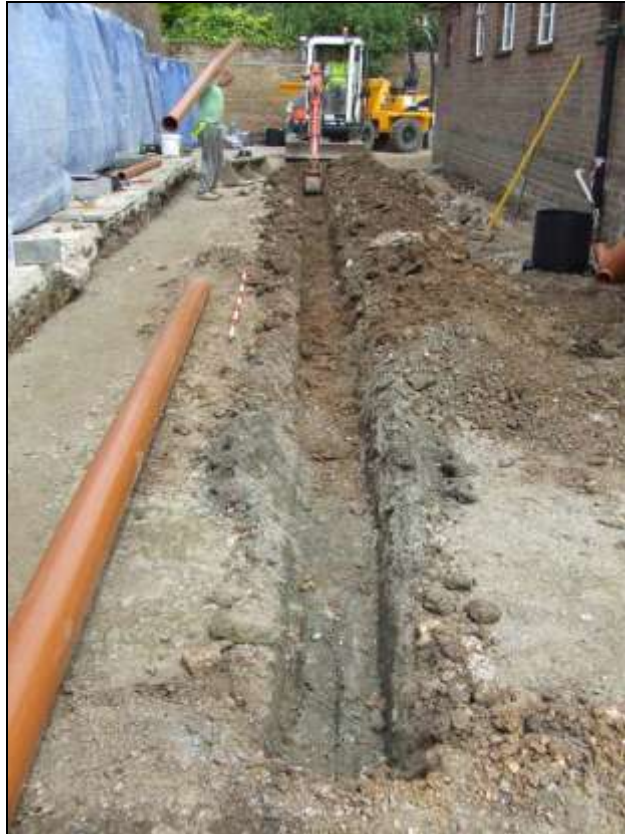
**Plate 5:** Storm drainage trench, looking east

The storm drainage trench measured *c.*16.55m in length, 0.30m in width, and was *c.*0.45m in depth at the western end, and *c.*0.61m in depth at the eastern end. The storm drainage trench was located within the made ground, encountering the underlying subsoil in places. No archaeological features or deposits were observed.

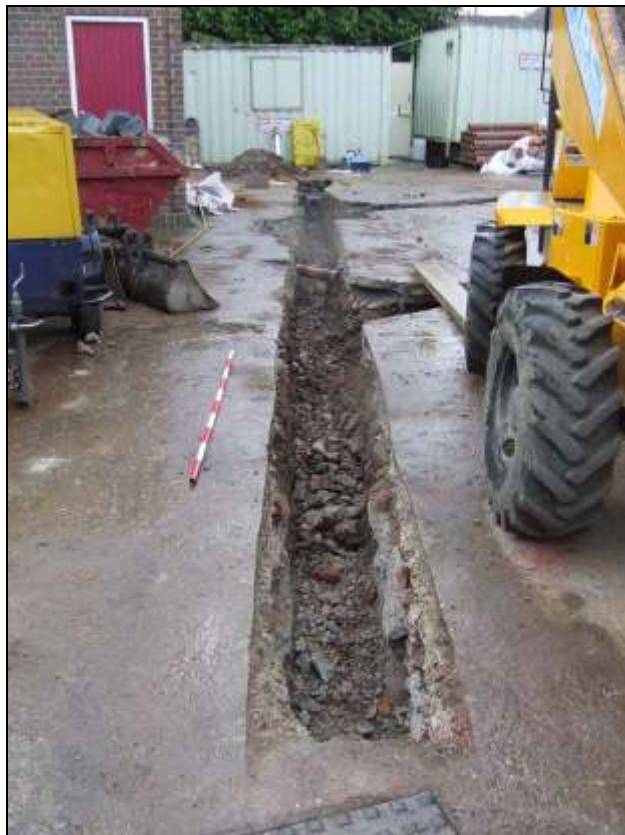
**Plate 6:** Drainage trench, looking southeast

A further drainage trench was excavated along the eastern and southern boundaries of the site. It measured *c.*0.5m in width, and was 0.7 - 1.3m in depth. The drainage trench largely followed the run of an earlier drainage pipe, and therefore was cut through disturbed ground. No archaeological features or deposits were observed.

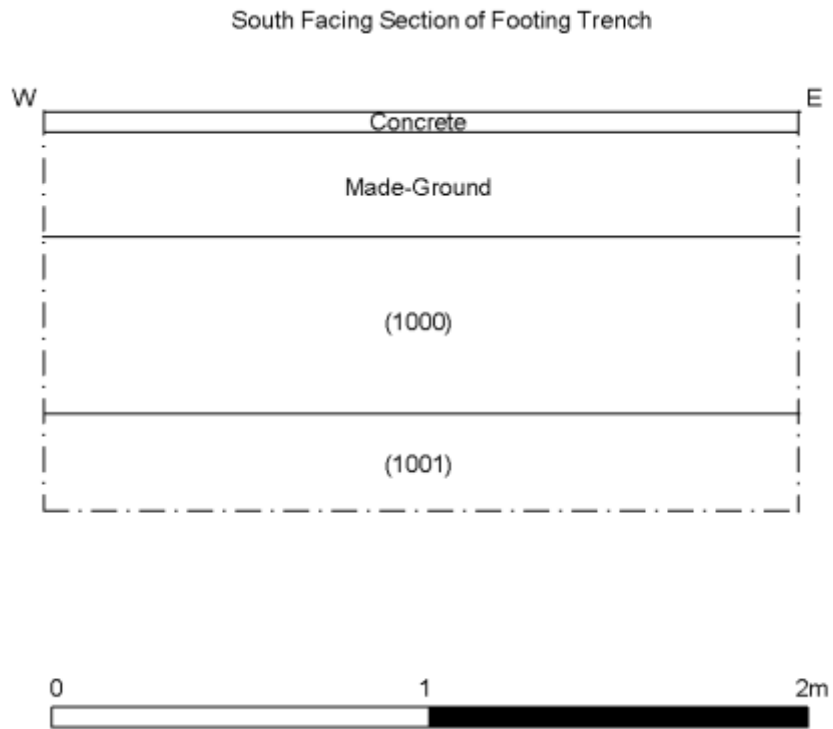
**Figure 5:** Section drawing of footing trench (*scale 1:20*)

In general, the stratigraphy encountered on the site consisted of two concrete slabs and made ground from a previously demolished structure that was once part of the Fire and Rescue Station (Fig. 4), overlying subsoil consisting of mid-dark brown, soft/friable, silty clay (1000). Below this was natural light orangey brown, firm clay (1001).
