**HISTORIC BUILDING RECORDING:
WINDMILL HILL FARM
WADDESDON
BUCKINGHAMSHIRE**

NGR: SP 7342 1550

on behalf of The Waddesdon Estate

June 2009

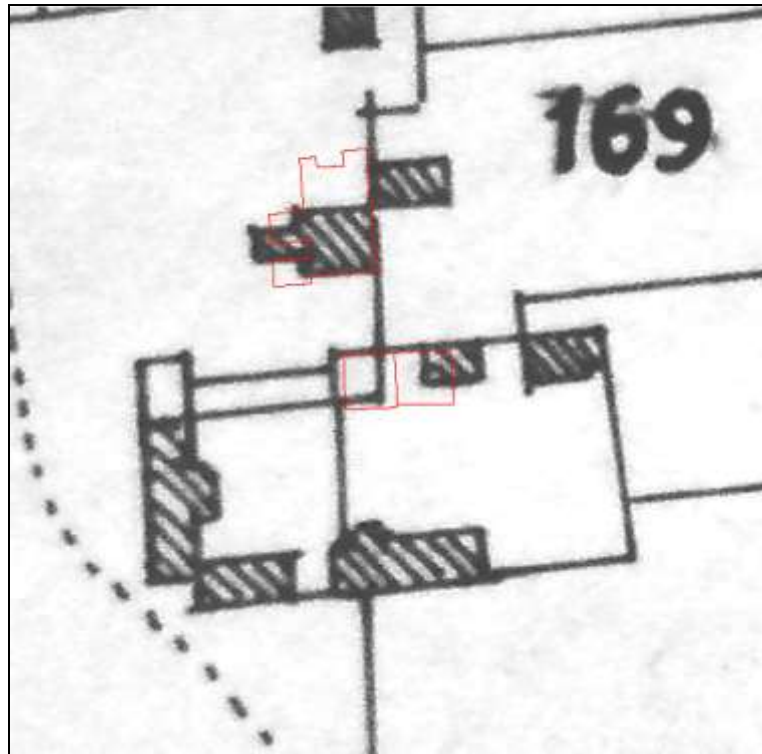
The Waddesdon Tithe Map (Fig. 3), of 1859 shows a building in the approximate location of Building 2. This structure is narrower than Building 2, and could be interpreted as an earlier structure. There may also have been an open structure in the vicinity of Building 1. The next piece of cartographic evidence is a sales particulars map, dated 1874 (Fig. 4). By this time, the building in the area of Building 1 is shown as a definite structure, and a small extension has been added to the eastern end of the farm house.

Figure 3: Extract from 1859 Tithe Map (*not to scale*)

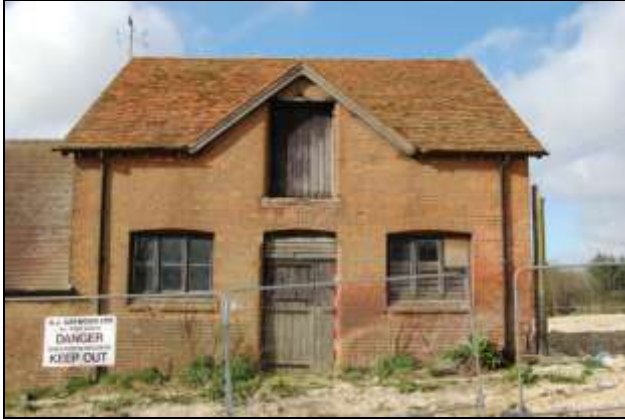
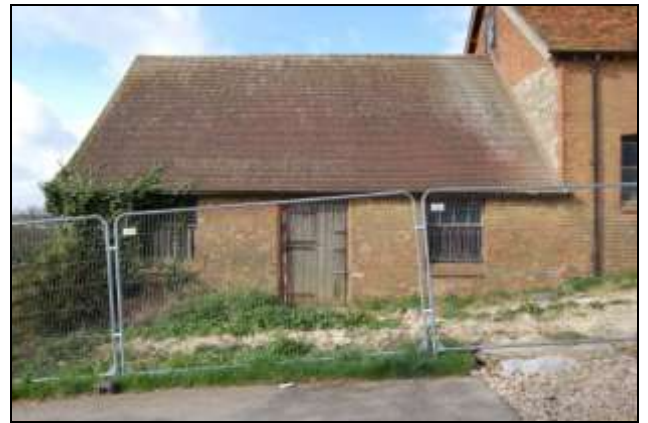
As in the south elevation, Building 1 has a central stable door that opens to the left, with ventilation slats above the door, topped by a two course cambered arch. The door opening is constructed of bullnose bricks with chamfer stops on the third course down from the boards. The door has iron hinges and Suffolk latches. There is a further plank and batten door to the grain store in the upper floor, with a timber lintel, set below a dormer. There are the remains of a winch above this door, and the opening is also constructed of bullnose bricks. There are two windows on the ground floor of Building 1. Both of these windows are 3-light casements with cambered arches of two courses above them. Both have sloping sills and are set either side of the main door.

The door in Building 2 is as in Building 1, without the section of boards and cambered arch. There are also two windows set either side of the main door, directly below the roofline. These windows have 4-lights set over ventilation bars, also with sloping sills.

Plate 1: Building 1, north elevation, 2m scale

Plate 4: Building 2, north elevation, 2m scale

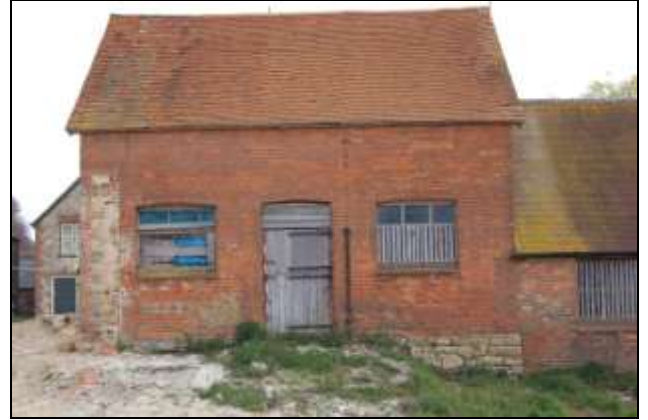
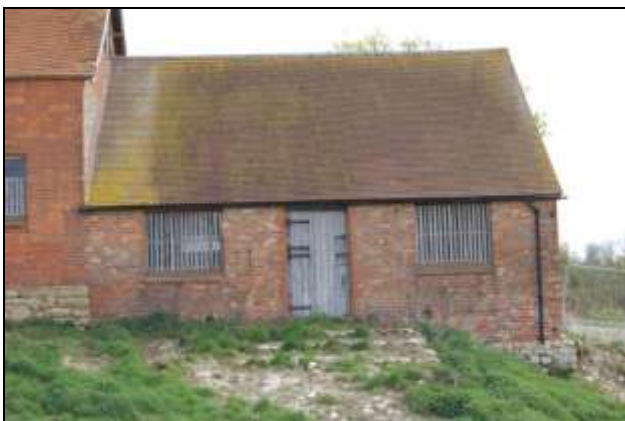
Building 1 has a central stable door that opens to the right, with ventilation slats above the door, topped by a brick arch. There are bullnose bricks to either side of the door, and the third course down from the arch has a chamfer stop carved into the bricks on each side of the door. There are two windows either side of the door, comprising 3-light casements under cambered arches. The sills consist of two courses of chamfered bricks on top of tiles. There is an area of rough ashlar stonework at the east end of Building 1, below the level of the doorstep.

Building 2 is as Building 1, but with no chamfer stops carved into the bricks either side of the door. There are 'hit and miss' windows either side of the door in this building, and the sills are made of bullnose bricks over an angled brick course above tile. As in Building 1, there is an area of rough ashlar stonework at the east end of Building 2, this time below the level of the floor.

Plate 2: Building 1, south elevation, 2m scale

Plate 5: Building 2, south elevation

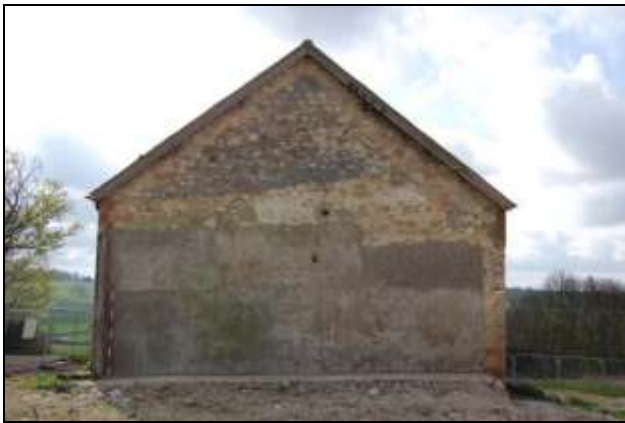
There are no doors or windows in this elevation. The main building material used in this elevation is rough ashlar stone, with red brick quoins. The lower half of the wall is unevenly rendered.

The remains of the roofline of the now demolished adjacent building are visible, and there is a large semi-circular stone, possibly a former millstone, below the apex. There is also a circular opening approximately three quarters of the way up the wall.

Plate 3: Building 1, west elevation, 2m scale

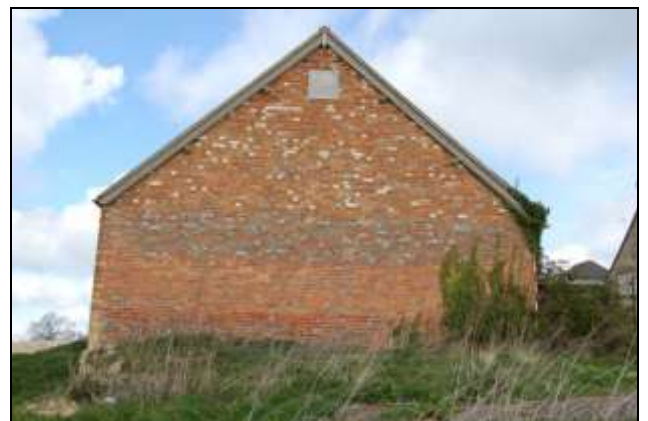
There are no doors in either building in this elevation. The wall of Building 1 is built of stone up to the level of the roofline, and brick built above. There is a 2-light window set into the brick wall, lighting the grain store. This window may be a later insertion. There is also a weather vane attached to the apex of the roof of this building.

The wall of Building 2 has been rebuilt in re-used brick, set in English bond in cement mortar, with queen closers. There is an opening below the apex, which has been boarded over.

Plate 6: Building 2, west elevation, 2m scale

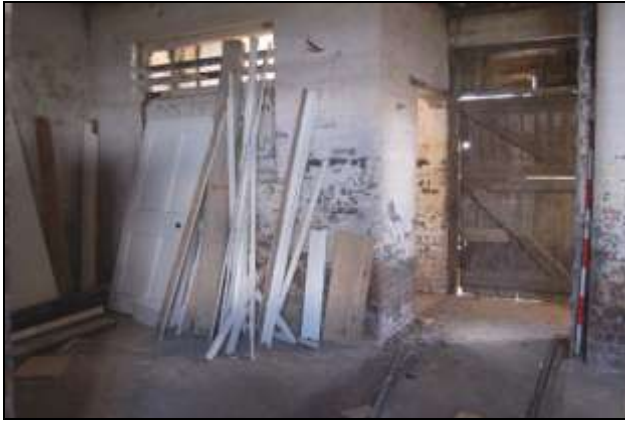
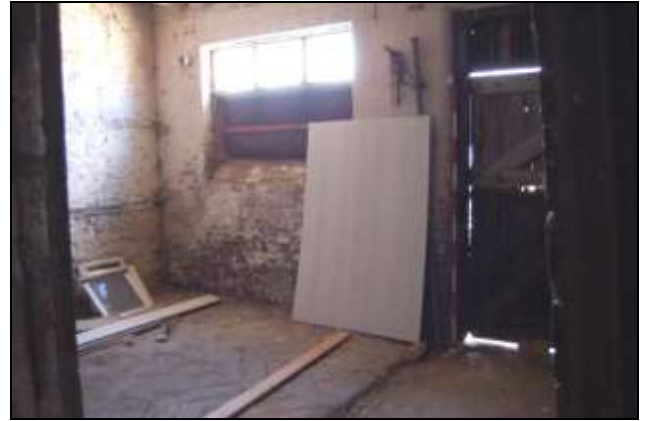
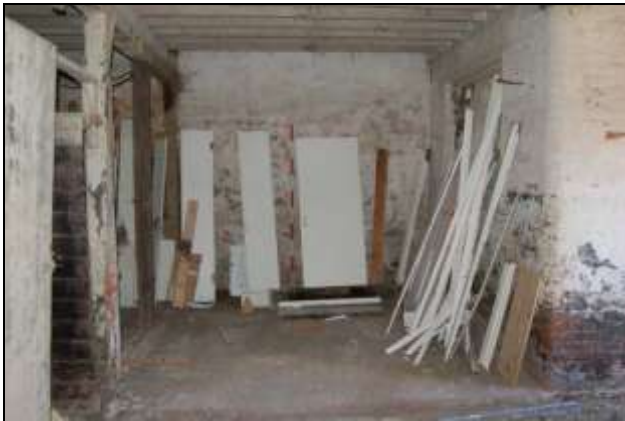
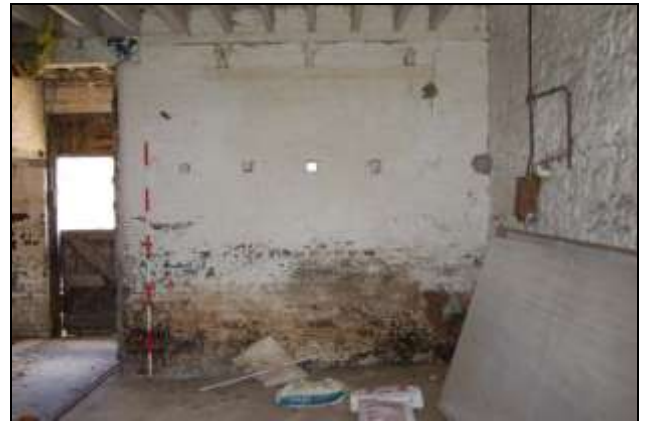
Description: This is a three-part building with centrally opposing stable doors in the north and south elevations, and separate rooms to the east and west of the north door. The internal and external walls of these rooms have rounded corners. The main section of the building (Area 1a) is divided by runnels, orientated north-south. These empty into drains located approximately halfway along each runnel. The floor in the main room has a central section of brick, with concrete either side of the two runnels. A central beam, aligned east-west supports the joists, and is used to partition the room.

The east and west walls are made largely of stone, while the north and south walls are mainly constructed of brick. The eastern wall was formerly divided into two, with the end of a timber from Building 2 protruding into each half. The southern timber has now been removed. Two lines along this wall suggest that there were formerly animal troughs attached to it. The upper line is immediately above the ends of the timbers from Building 2. There is also the possible silhouette of a manger on the southern wall. The window sills in the southern wall are offset and angled to allow water to drip onto the floor. Both windows have timber lintels.

The ceiling joists in the main room are aligned north-south, and rest on bonding beams. There are X-braces between the joists, which provide extra support for any heavy loads held on the floor above. There is a grain chute located near to the east wall, and a vertical ladder providing access to the upper floor, positioned to the east of the entrance to the north west room.

Plate 7: Building 1, Area 1a, looking north west, 2m scale

Plate 8: Building 1, Area 1a, looking south east, 2m scale

Plate 9: Building 1, Area 1a, looking west, 2m scale

Plate 10: Building 1, Area 1a, looking north, 2m scale

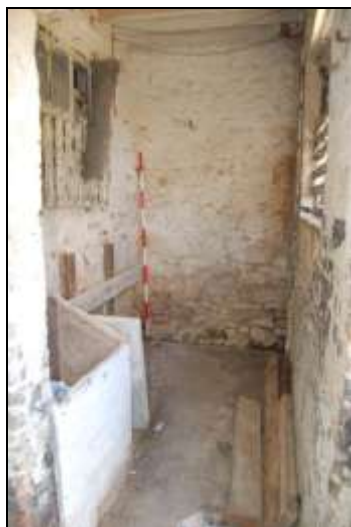
The north west room (Area 1b) has a stone western wall, which is partially rendered. The remaining three walls are of brick. The floor is timber, with a concrete apron located in the south east corner. A wooden bin is positioned on top of this apron. There is a three light window with horizontal bars in the north wall, and a window with 5 lights over a vent in the south wall. There is a possible grain chute from the upper floor in the north west corner, and wooden posts and a rail attached to the south wall. There is a timber lintel over the door opening, but no door or frame within it.

Plate 11: Building 1, Area 1b, looking west, 2m scale

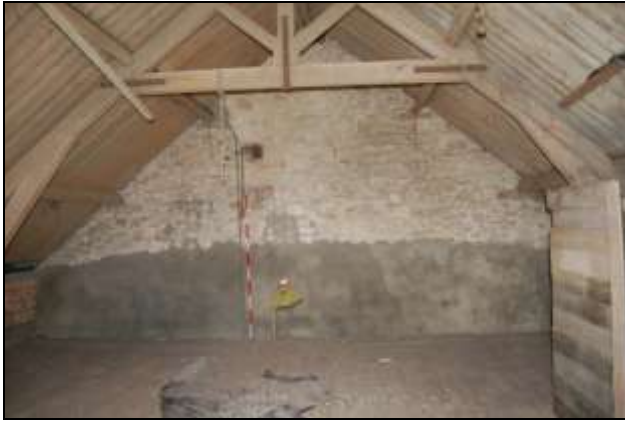
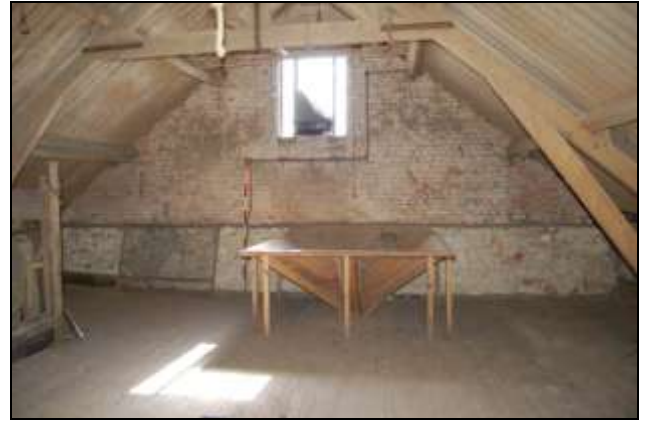
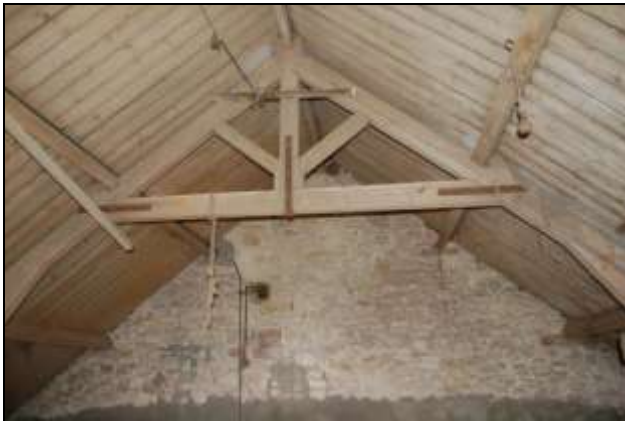
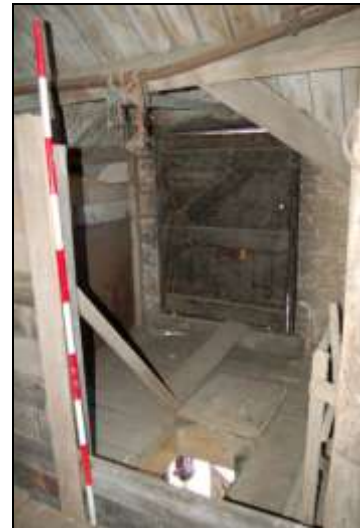
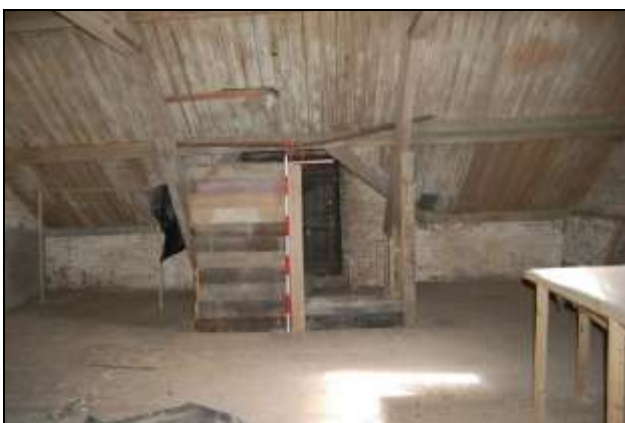
The upper floor of Building 1 was formerly used as a grain store. It is accessed by the vertical ladder mentioned above. There is a wooden enclosure around the hatch, and a large grain bin against the east wall. The floor consists of east-west aligned boards. The west wall is constructed of stone, and is rendered to approximately half height. There is a single light window in the east wall, above the grain bin. A plank and batten door is located in the north wall. The roof structure comprises toggled king posts with raking queen struts, and cleats. There is a concrete ledge at eaves height along the north, east and south walls.

Plate 13: Building 1, grain store, looking west, 2m scale

Plate 14: Building 1, grain store, looking east, 2m scale

Plate 15: Building 1, grain store, roof truss, looking west, 2m scale

Plate 16: Building 1, grain store, entrance hatch and door, looking north west, 2m scale

Plate 17: Building 1, grain store, looking north, 2m scale

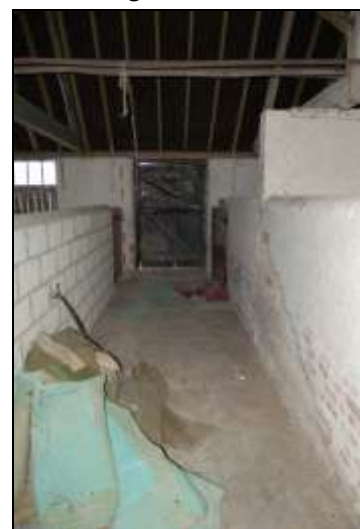
Description: This is a three-bay building, with opposing central stable doors. The east gable wall has been rebuilt in brick, beyond the original wall, with a 14cm offset between the two. The west wall is built of stone, with a 0.74m high brick offset and a brick apex. The building has a king post roof with raking queen struts. The western truss is a new replacement.

Plate 18: Building 2, looking south, 2m scale

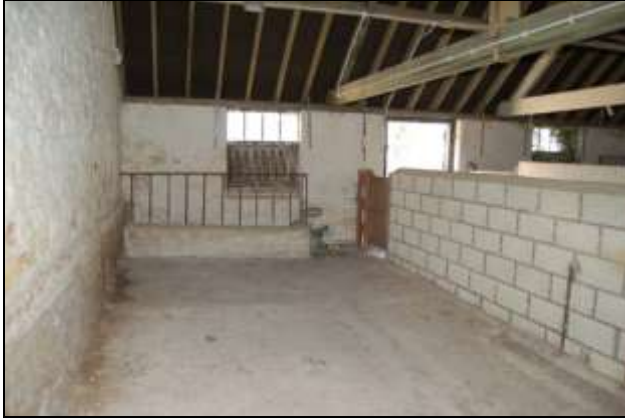
The western section of the building (Area 2a) has a 1.33m high breeze block wall separating it from the rest of the building. There are two gates providing access to this section, one each at the north and south ends. Both doors are plank and batten, with re-use decorative hinges. There is a possible trough at the northern end, with iron rails on a rendered base. There is a 4-light over hit and miss window in the north wall, above the trough. There is a further window in the south wall of this section which consists only of ventilation slats. Both windows have slanted, offset sills. There were originally three stalls within this section, as well as a runnel aligned north-south. These are still evident in the concrete floor.

Plate 19: Building 2, Area 2a, looking north, 2m scale

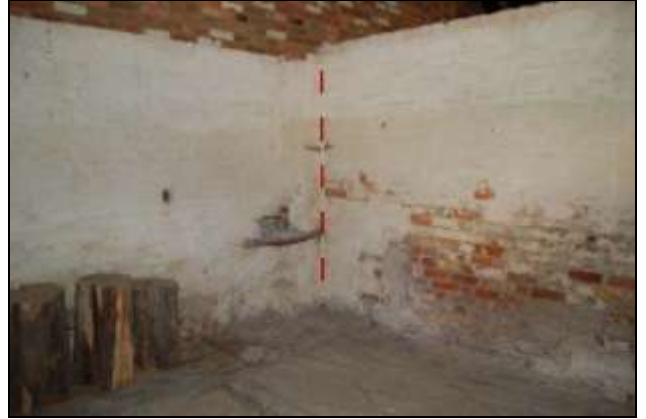
The eastern part of the building is split into two halves. The north east section (Area 2b) has a brick floor, with a 1.8x1.5m concrete base along the south wall. The south wall is built of red brick, and is offset in the south east corner of this section. The tie beam of the east truss rests on the south wall. The west wall of this section has been rebuilt in Fletton brick. It has a straight top, and is 1.54m high. The section is accessed by a plank ledge and braced door in the north west corner. The window in the north wall is the same as that in the western section.

Plate 20: Building 2, Area 2b, looking south east, 2m scale

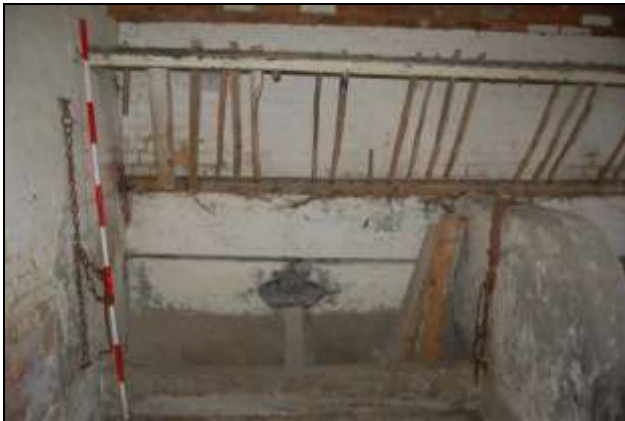
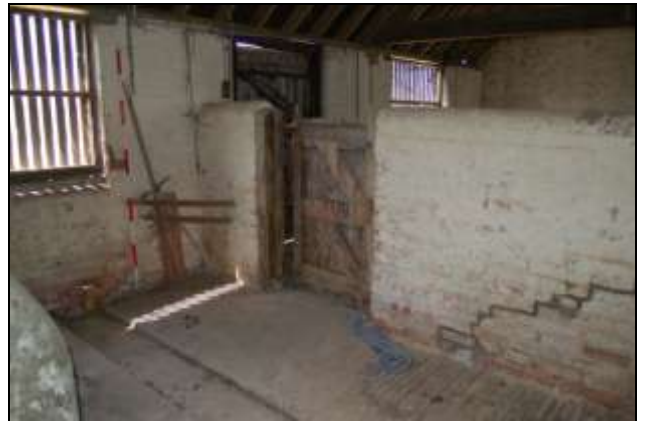
The south east section (Area 2c) has a concrete and gravel floor to the east, and a simple concrete floor to the west. The west wall is a continuation of that in the north east section, but topped with bull-nosed bricks. The window in the south wall is the

same as that in the western section. Access is through a plank ledge and braced door in the west wall. There is a north-south aligned runnel slightly off centre. This section is separated into two stalls, with feeding and water troughs along the east wall, and a manger constructed using roughly halved branches and complete branches with bark as studs. There is iron on the north and south walls, and on the central division for tethering cattle. The walls are concreted to a height of 1.25m in the feeding area. There are two horizontal iron bars located in the south west corner.

Plate 21: Building 2, Area 2c, looking east, 2m scale

Plate 22: Building 2, Area 2c, looking south west, 2m scale

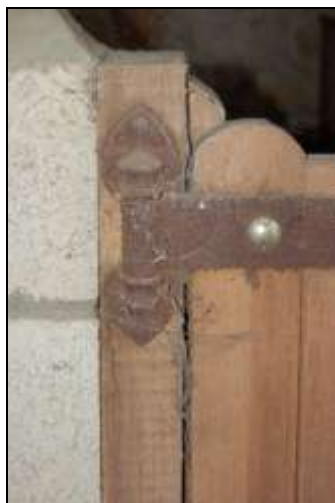
Plate 23: Building 2, detail of decorative hinges on doors in west wall

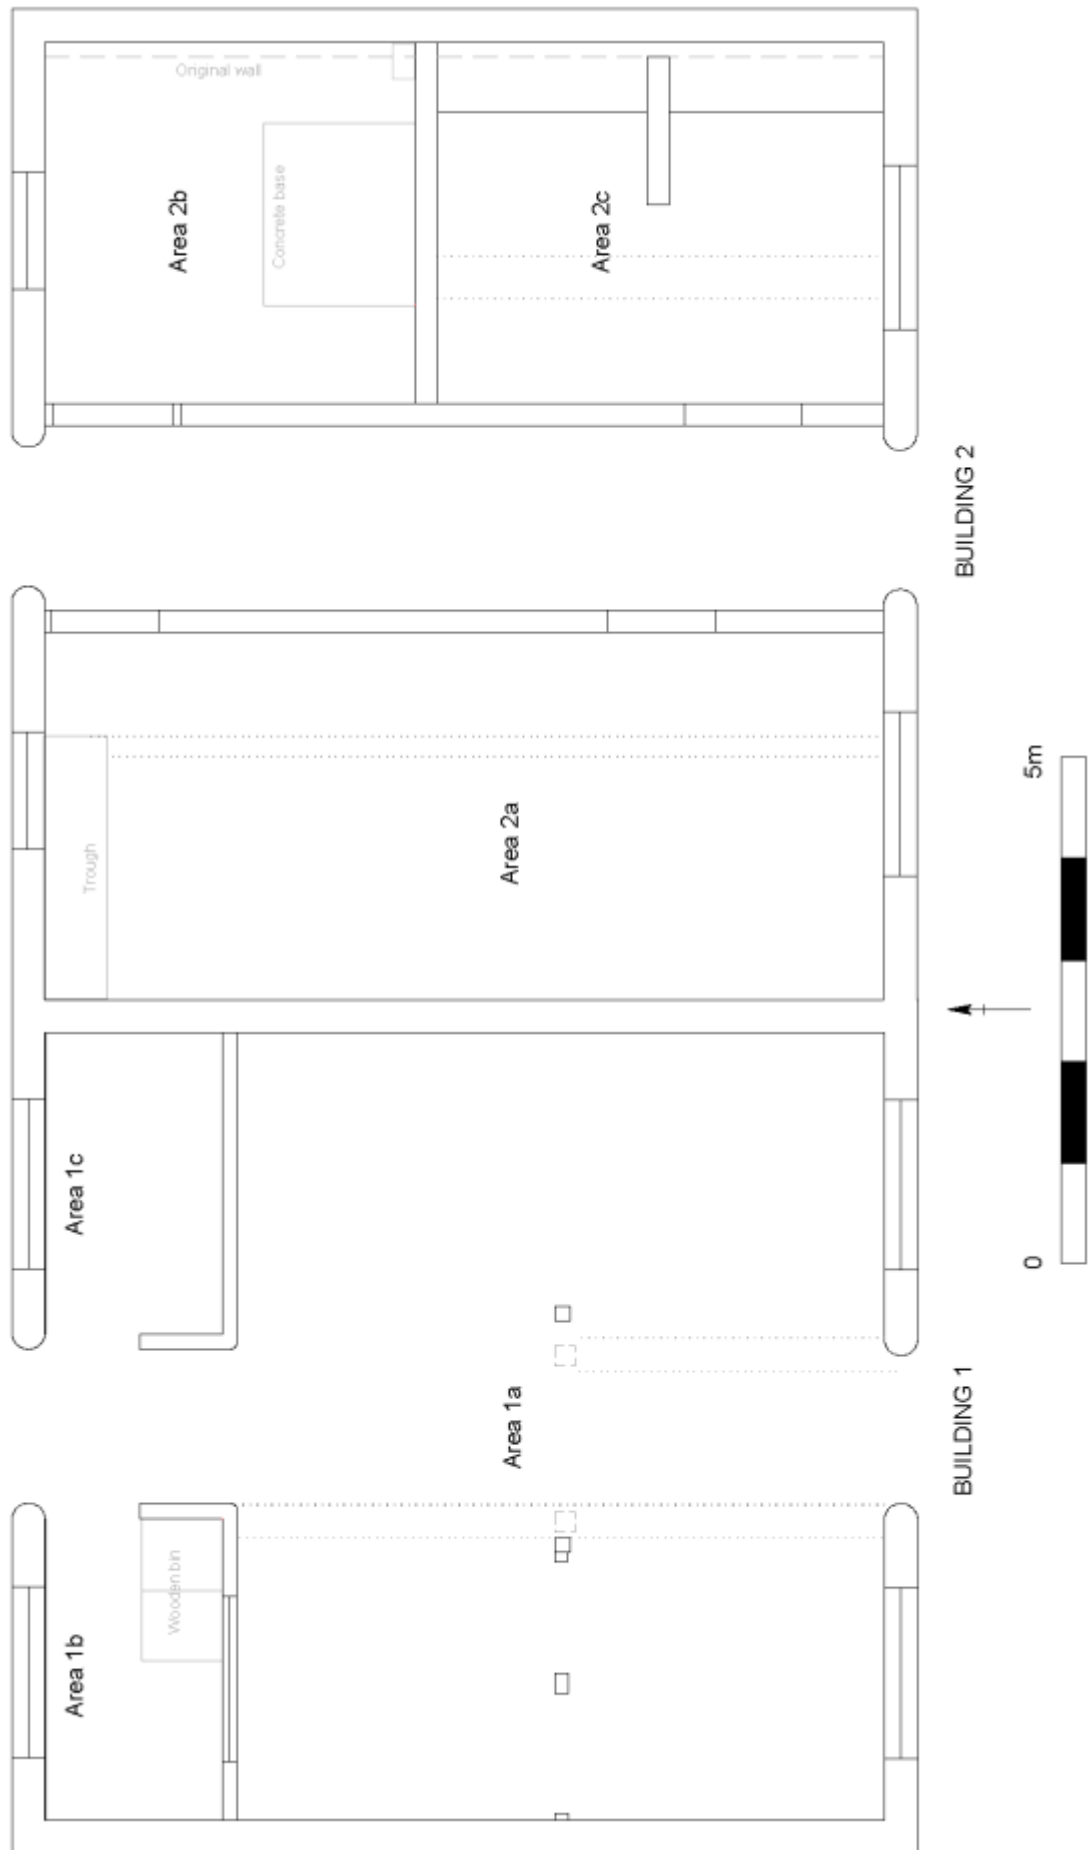
Figure 9: Buildings 1 & 2, Floor Plan, (scale as shown)

4.5 **Building 1** (Fig. 9, Plates 7-17)

4.6 **Building 2** (Fig. 9, Plates 18-23)
