ARCHAEOLOGICAL EVALUATION: THE MOAT HOUSE CHURCH ROAD COLMWORTH BEDFORDSHIRE

on behalf of Point Three Design

August 2009

ASC: 1001/CCR/4

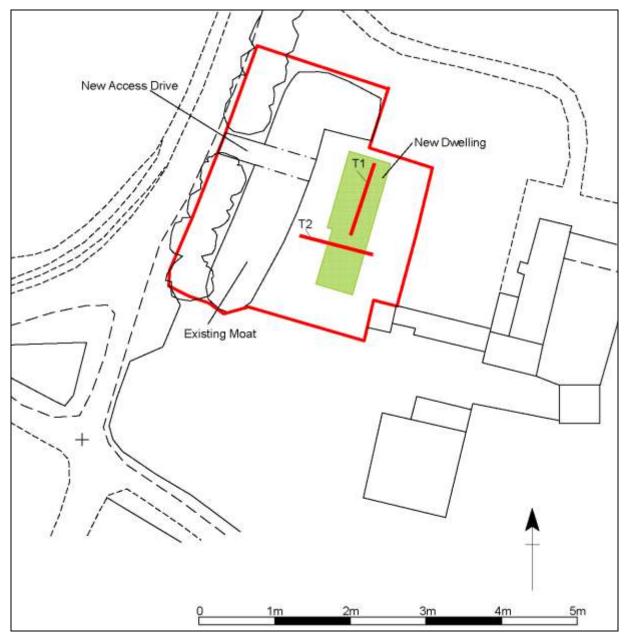
Figure 3: Proposed development and trench locations (scale 1:500)

The proposed development is for the construction of a dwelling with attached garage and the formation of a new vehicular access and bridge over the moat (Fig. 3).

- trial trenches totalling 65 square metres were excavated
- trenches were excavated under archaeological supervision by a suitable machine with a toothless bucket no less than 1.60m wide
- trench locations are shown in Figure 3

Two trial trenches measuring c.10m in length x 1.60.m in width targeted the proposed development area (Fig. 3). Both trenches were excavated down to the natural strata. The evaluation findings are summarised below. Detailed descriptions of the trial trenches and their contents are provided in Appendix 1.

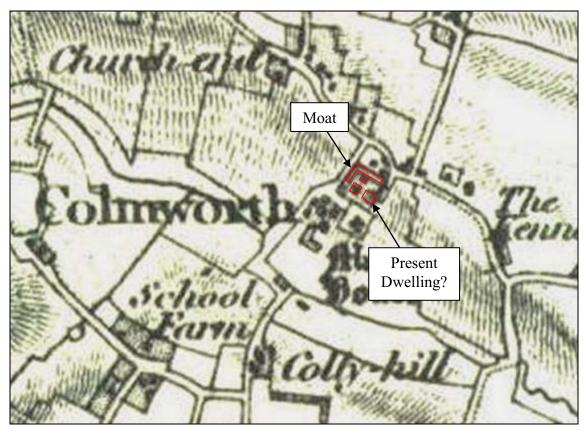
Figure 4: Extract from 1835 One Inch Ordnance Survey sheet for Colmworth, showing development area *(enlarged)*

- 3.8 The 1835 One Inch Ordnance survey map of Colmworth (Sheet 52) shows the moat and the possibly the existing dwelling within the excavation area, as well as two further structures that are no longer present (Fig. 4). One of the latter is within the trench 1 area.

The 1835 ordnance survey map of Colmworth (Fig. 4) depicts the moat and possibly the existing dwelling, as well as two further structures that are no longer present. One of such structures is within the trench 1 area, and may possibly be linked to the wall [106] and surface area [105], excavated in trench 1.

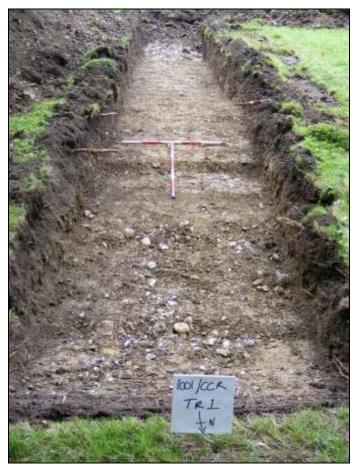
Plate 1: Trench 1, looking south (scales: 2m)

The trench was aligned north to south and measured 10m long x 1.60m wide x 0.92m depth.

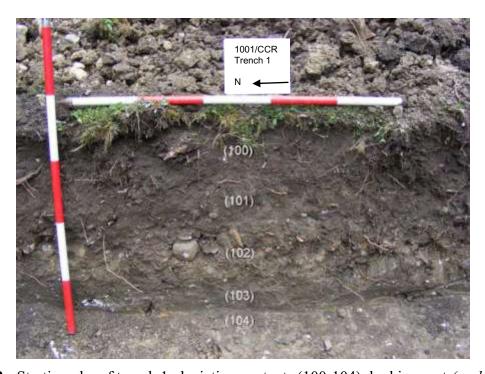
Plate 2: Stratigraphy of trench 1, depicting contexts (100-104), looking east (scales: 1m)

At the northern end of the trench the stratigraphy consisted of:

- 340mm in depth Topsoil (100)
- 240mm in depth Subsoil (101): mid black/brown, friable clay silt containing frequent flecks of charcoal, and small-medium rounded, sub-rounded/angular stone, flint and chalk
- 100mm in depth Natural strata (104): light yellowy brown, firm clay with frequent small-large rounded, sub-rounded/angular stone, flint and chalk

At the southern end of the trench the stratigraphy consisted of:

- 340mm in depth Topsoil (100)
- 240mm in depth Subsoil (101)
- 180mm in depth Redeposited natural strata (102): light yellowy brown, firm clay with frequent small-medium chalk nodules and small rounded, subrounded/angular stones
- 16mm in depth Deposit (103): mid brown, firm clay with frequent flecks of charcoal, small-medium, rounded, sub-rounded/angular stone, flint, and chalk
- Natural strata (104)

- 5.1 The stratigraphy in trench 1 revealed that underlying the subsoil (101); a redeposited natural layer (102) was present, underlying which was deposit (103) that contained two sherds of medieval pottery, 12th-13th century. A likely explanation for such layering is that initially the ground in the area was undulated, and in order to level the ground surface, redeposited natural was brought into the area. Deposit (103) contained evidence of medieval pottery 12th-13th century that may provide an indication as to when the ground was levelled.

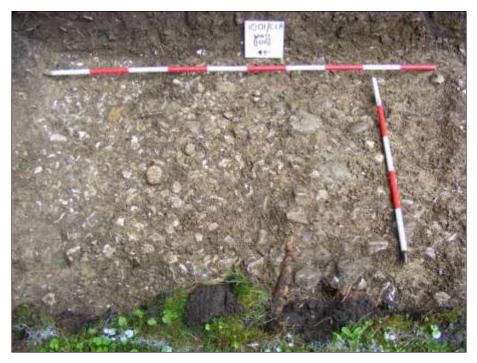
Plate 3: Wall [106] and surface area [105], trench 1, looking east (scales: 1 & 2m)

At the northern end of Trench 1, orientated east to west, the remains of a wall and surface area were excavated. The wall [106] consisted of sub-angular and rounded flint and pebbles. Maximum size of stones measured 0.15m in width, and 0.19m in length. No bonding material was used. The wall measured 1.60m in length x 0.40m in width x 0.24m in depth and ran beyond the limit of excavation; an actual cut for the wall was not visible.

The surface area [105] to the north of the wall orientated east to west, consisted of sub-angular and rounded chalk nodules and chalky limestone. Maximum size of stones measured 0.10m in width, and 0.13m in length. No bonding material was used. The

surface area measured 1.60m in length x 1.40m in width x 0.10m in depth and ran beyond the limit of excavation.

A deposit layer (107) was found overlaying the surface area [105], that measured 1.60m in length x 1.40m in width x c.20mm in depth and ran beyond the limit of excavation. The deposit consisted of mid brown grey silty clay, containing five fragments of ceramic building material, two pieces of which derived from brick and three pieces possibly derived from tile, also one body sherd of medieval pottery dating to the 12^{th} - 13^{th} century (see specialist report Appendix 4).

- 5.2 The excavation of trench 1 also uncovered the remains of a wall [106], and a stone surface area [105], which continued beyond the limit of excavation. Both features lacked the remains of a bonding material. The surface area [105] was overlaid with deposit (107) that contained one sherd of medieval pottery, 12th-13th century, and five pieces of ceramic building material, two of which derived from brick, and three pieces possibly derived from tile. The ceramic building material is likely to be of a comparable date as the 12th-13th century pottery as both materials were found within the same deposit.

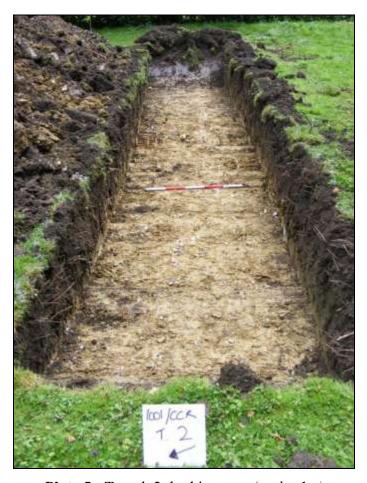
Plate 5: Trench 2, looking east (scale: 1m)

The trench was aligned east to west and measured 10m long x 1.60m wide x 0.70m depth.

No archaeological features or deposits were observed within the trench.

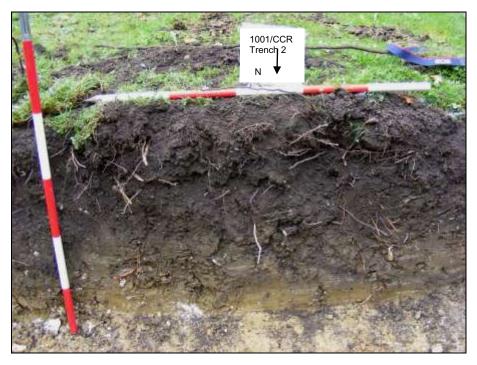
Plate 6: Stratigraphy of trench 2, looking north (scales: 1m)

- 400mm in depth Topsoil (200)
- 300mm in depth Subsoil (201): light brown-beige yellow, firm, clay, frequent flint and chalk nodules
- Natural strata (202)

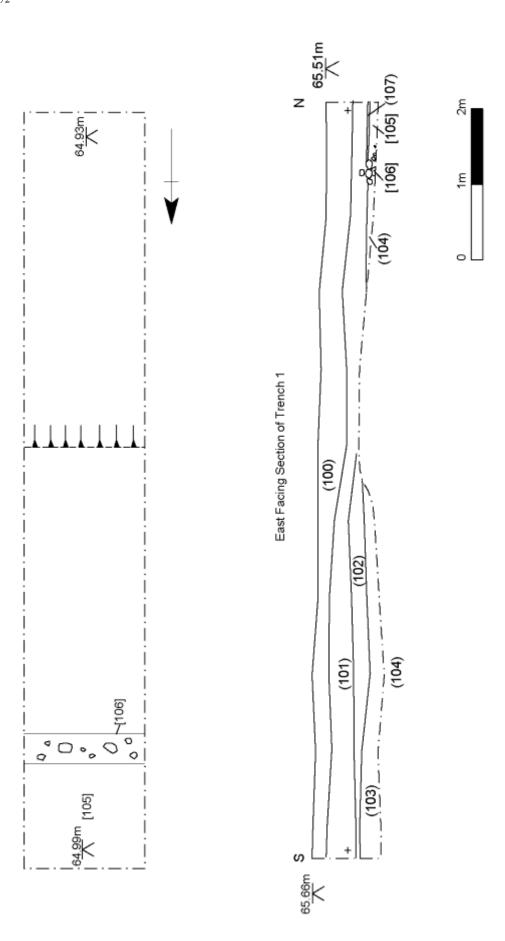
Figure 5: Plan and section drawing of trench 1 (scale 1:50)

The stratigraphy for the wall [106] and surface area [105] at the northern end of the trench consisted of:

- Topsoil (100)
- Subsoil (101)
- 100mm in depth Deposit (107): mid brown grey, silty clay
- 240mm depth Wall [106], and 100mm depth Surface area [105]
- Natural strata (104)
