**WATCHING BRIEF:
CEDAR COTTAGE
VILLAGE ROAD
DENHAM
BUCKINGHAMSHIRE**

NGR: TQ 0429 8695

on behalf of Mr P Williams

ASC: 1182/DCC/2

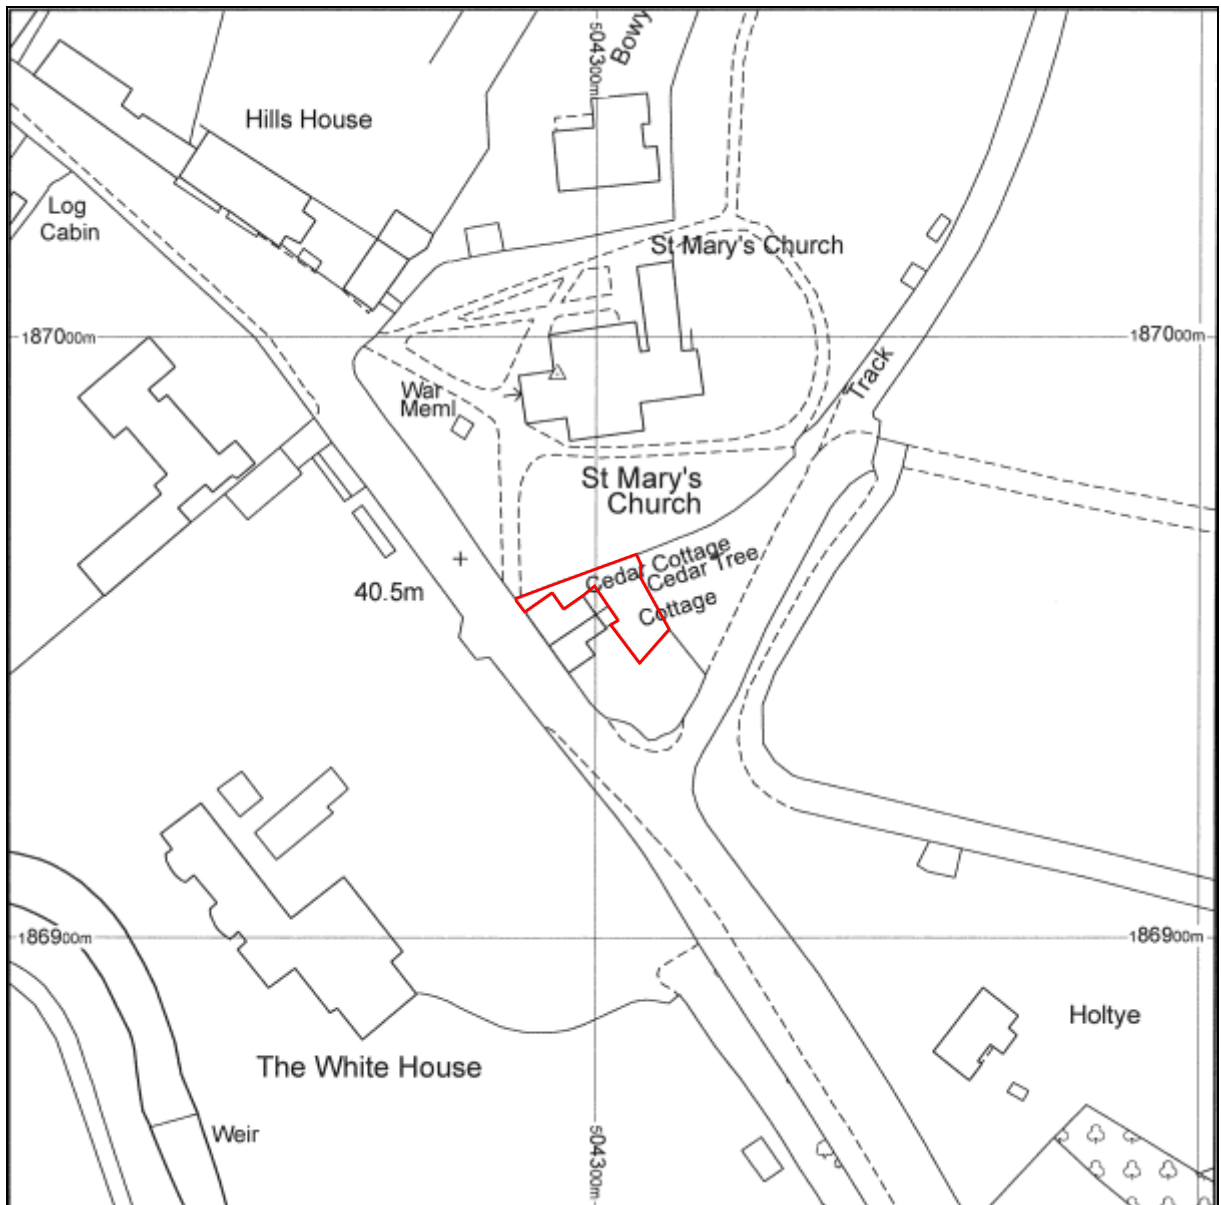
Figure 2: Site plan (scale 1:1250)

The site is located to the south of St Mary's Church, and the churchyard forms the northern boundary of the site. The site is accessed from Village Road, which forms the western boundary of the site (Fig. 2).

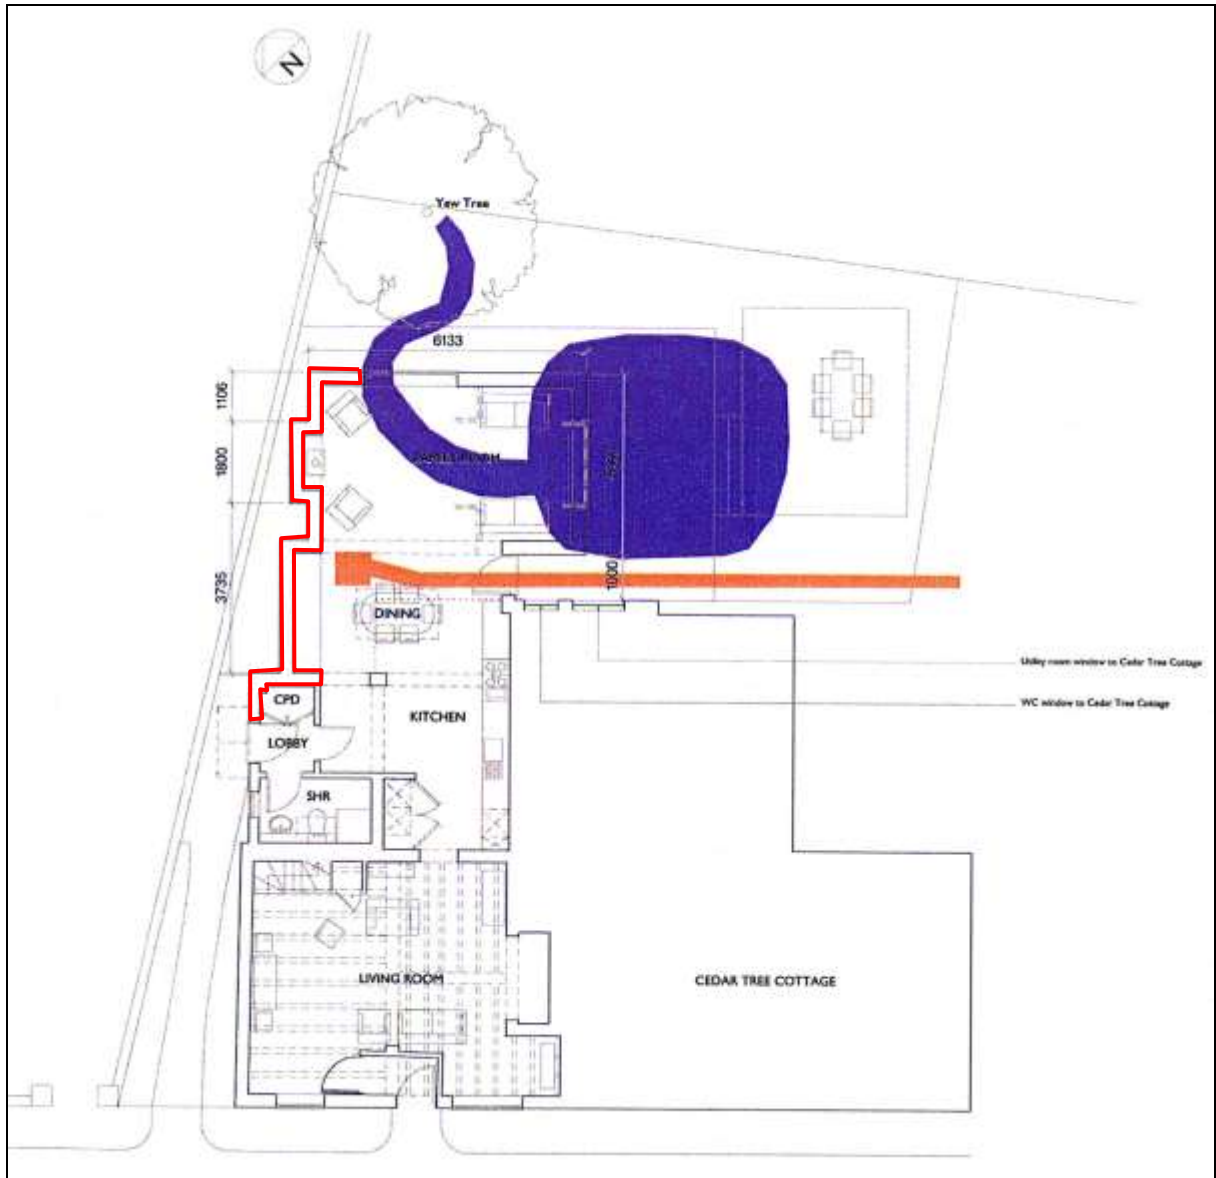
Figure 3: Development, with area monitored highlighted in red. The area of a former pond (now infilled) is shown in blue (*not to scale*)

4.1 The footings were excavated with the use of a mini digger with a 0.8m toothless bucket (Plate 1). The northwest footing was the primary area to be monitored; this was because the development area had been greatly disturbed by a former concrete fishpond, stream and soil channel (Fig. 3).

4.2 *Northwest Footing* (Fig. 3; Plates 2-3)

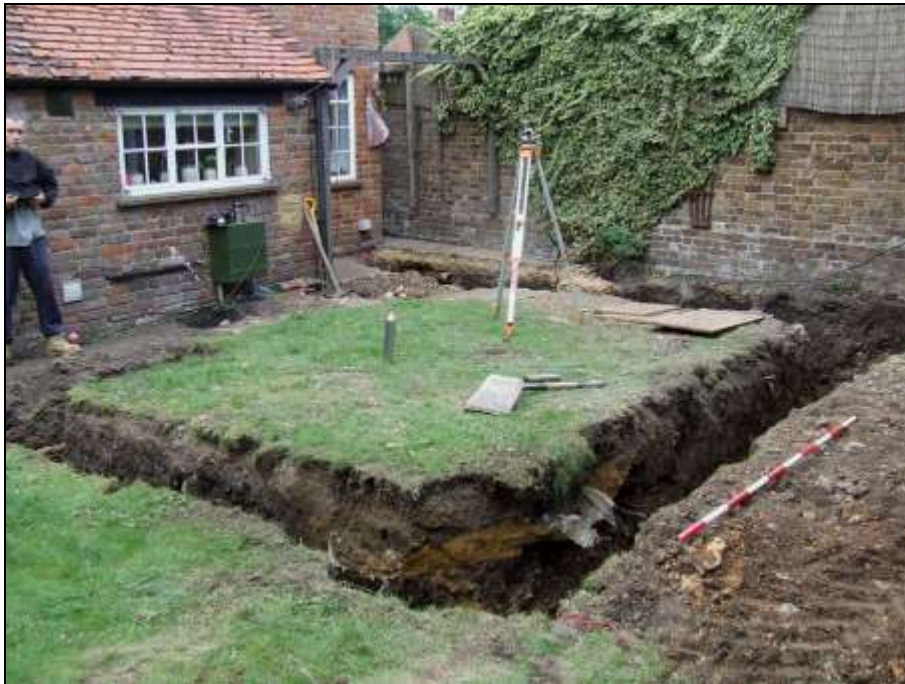
Plate 1: Overall footing trench, looking NW

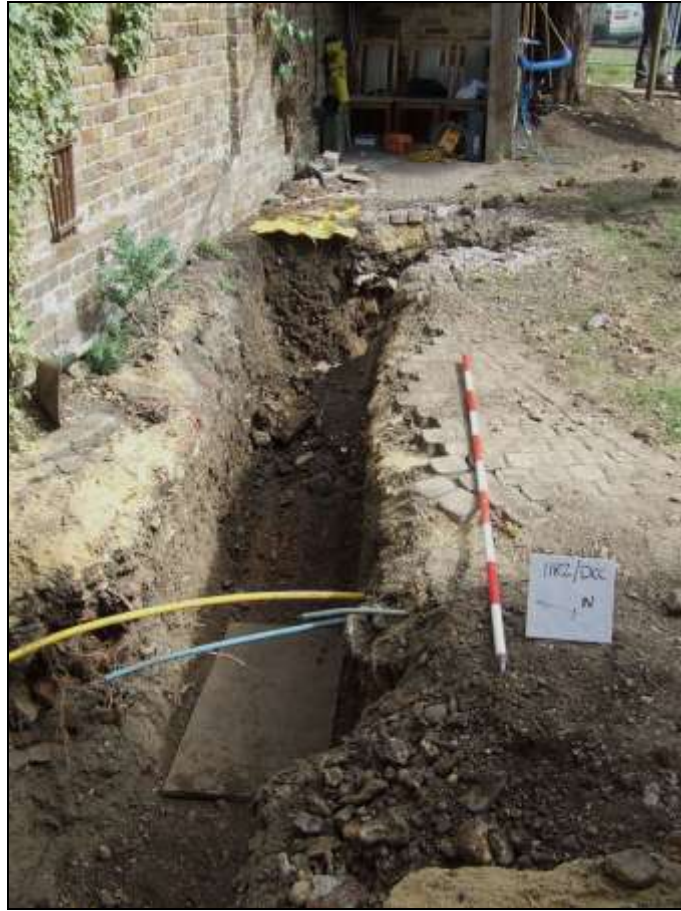
Plate 2: Northwest area of footing trench, looking east

The northwest footing measured *c.*0.8m width, *c.*7m in length and between 1.15-1.3m in depth. The stratigraphy comprised of *c.*0.3m of patio and sand, underlying which is *c.*0.85-1.0m of a mid brown, loose, clay silt layer with moderate small sub-angular/rounded and rounded stones, underlying which is a light orangey brown, loose, sandy/gravelly natural strata with frequent small sub-angular/rounded and rounded stones. The ground was much disturbed due to the laying of the patio, an earlier soakaway, and numerous services running through the area. No archaeological features or deposits were observed.

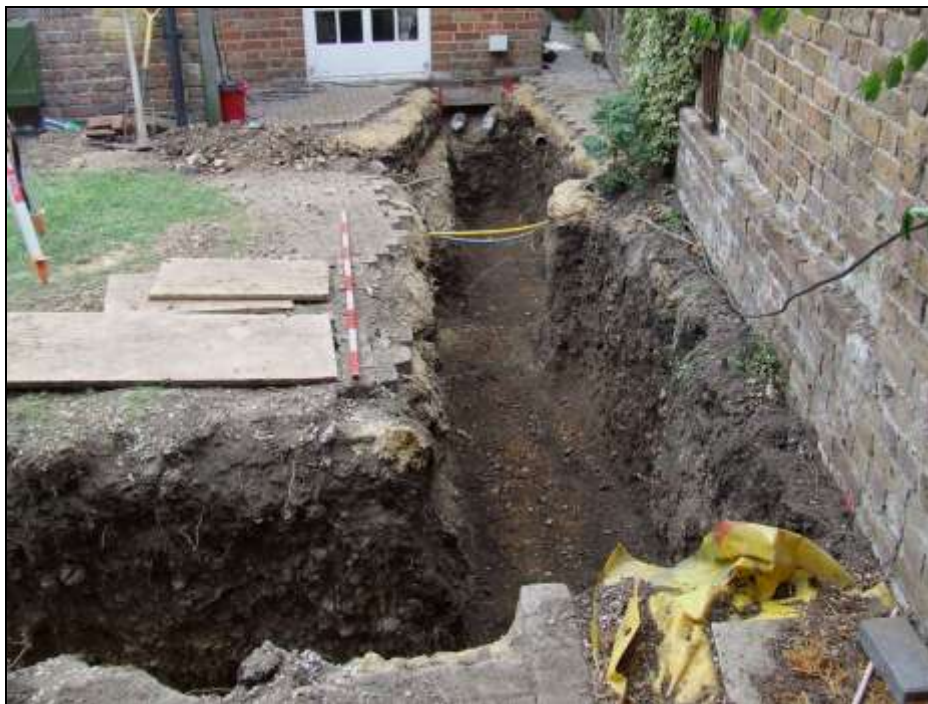
Plate 3: Northwest area of footing trench, looking west
