**HISTORIC BUILDING RECORDING:
QUAKER BARN
1 O Ving Road
WHITCHURCH
BUCKINGHAMSHIRE**

NGR: SP 80030 20957

on behalf of Richard Sarraff

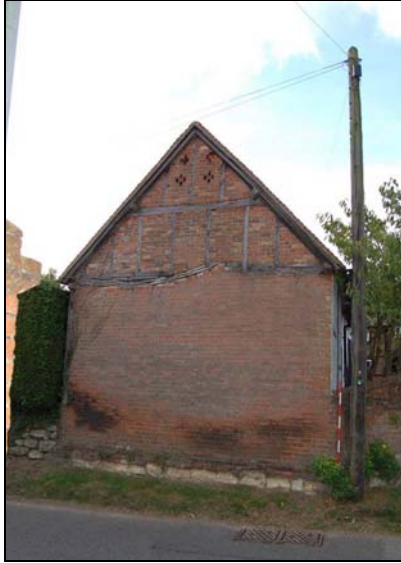
Plate 1: North elevation

Apart from some timberwork above the wall plate, this elevation is almost entirely brick built. The brick infill is earlier than the wall below the timberwork, which is set in a Flemish Bond. The timber horns have been left exposed.

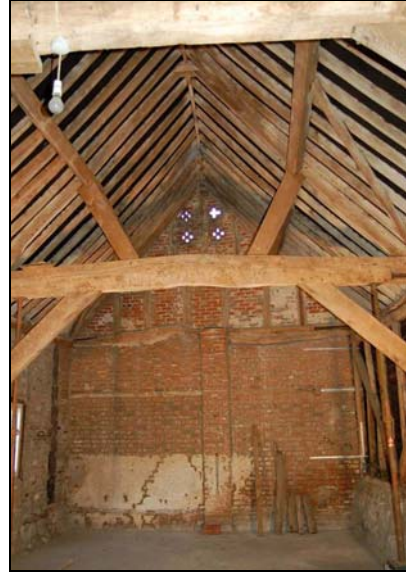
Plate 2: North wall

Internally there is a brick pillar in the centre of the wall and bonding timbers at two levels on either side of the pillar. Bonding timbers were commonly used in the 18th and early 19th century, which could indicate a date for the construction of this wall. The east wall is clamped to the north wall by modern ties. These supplement the earlier iron ties that clamp the wall plates and tie beam. Below the ridge are four cruciform air vents. The wall rests on a stone base, which can only be seen on the outside.

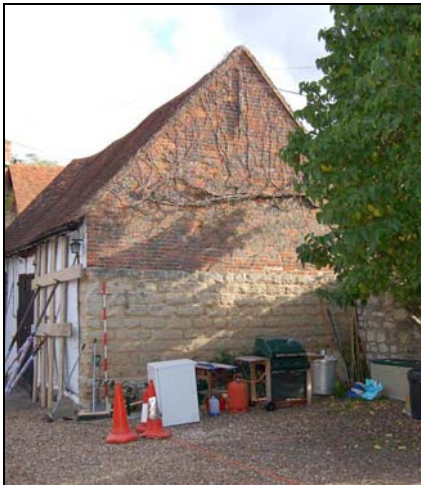
Plate 3: South elevation

The lower part of this wall is made of stone and the upper part of thin, dark red bricks. The bricks measure between 18 and 33cm in length but are all roughly 10cm high. They appear to be of the size commonly used in the late medieval/early post-medieval period. They have been set in a lime mortar.

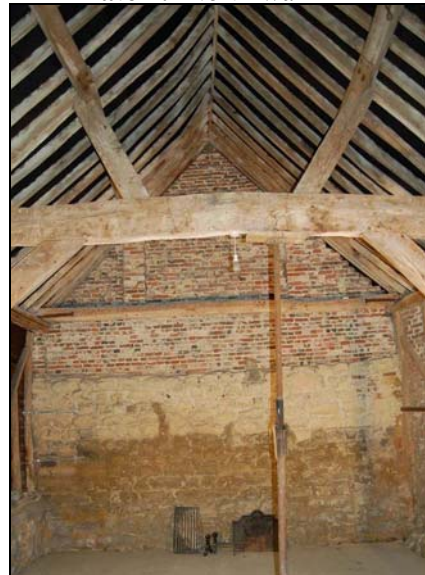
Plate 4: South wall

The internal elevation has been heavily mortared to a height of 1.62m and between this and the unmortared wall above is a broken line of tiles. Most of the stone is the local Portland Limestone, but there are some pieces of Whitchurch Sandstone intermixed in the lower part of the wall. It is possible that the tiles were inserted to provide a barrier between the lime and sandstones as they should not be mixed within the same wall. The mortar used to bond the upper part of the internal wall is also lime based.

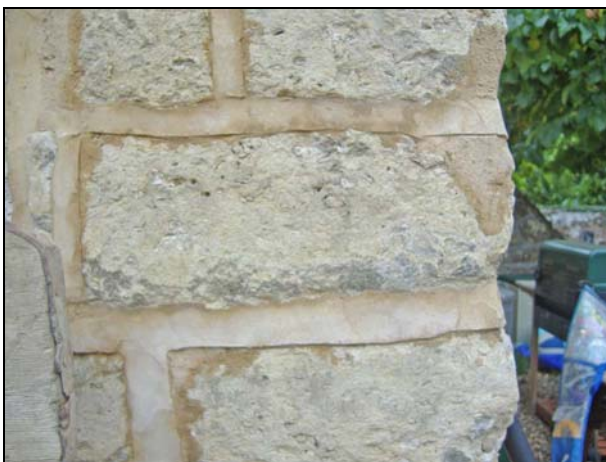
The external aspect of the south wall is of roughly ashlar Portland Limestone. This has recently been heavily repointed with cement mortar.

Plate 5: Ashlared Portland Limestone detail

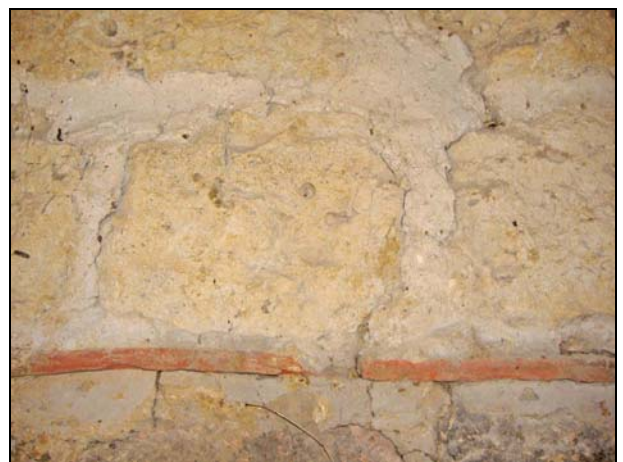
Plate 6: Interior stone work detail

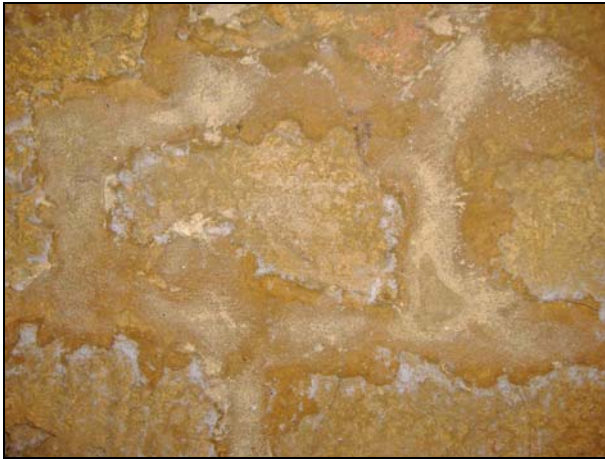
Plate 7: Mortared Whitchurch Sandstone

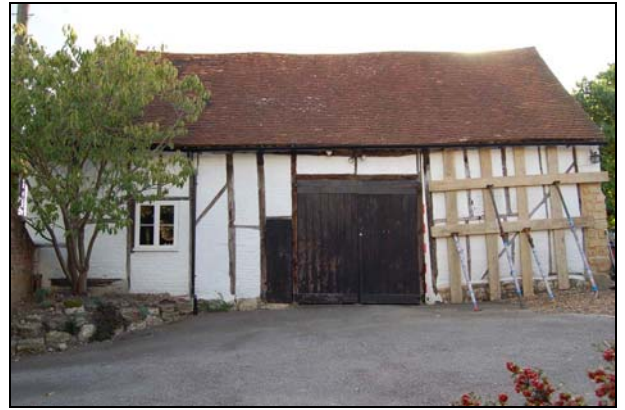
Plate 8: West elevation

The west wall appears to have been largely rebuilt and the brick infill has been repointed using cement mortar in recent times. The bricks used to infill the timber frame are of various sizes, colours and fabrics. Most are hand made and many have horizontal skintlings, which suggest that they were made after the latter part of the 18th century. The external elevation has been painted white.

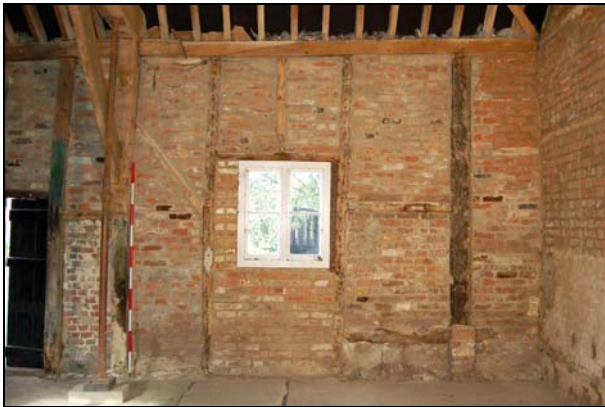
Plate 9: West wall: Bay 1

Bay 1 has a 2-light window set into modern brickwork. The studs to either side of the window have been re-used and have opposing mortices some 7-9cm long and centrally located staves for wattle and daub. There are bonding timbers to the north of the window and a diagonal brace to the south. The vertical post, which is located to the north of the window, is considerably more robust than the other timbers in the wall. It is approximately 21cm wide and is supported by a brick pillar, which measures 23cm wide x 50cm high. A small section of stone walling has survived on either side of the post, as have sections of the wall plate.

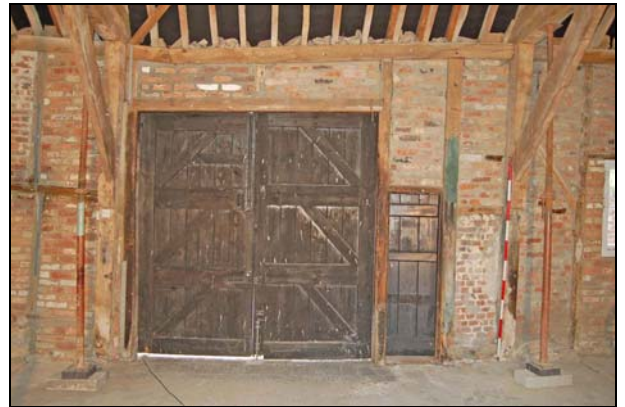
Plate 10: West wall: Bay 2

Bay 2 is largely taken up by the doors. The barn doors are boarded ledged and braced and the single door is a plank and batten type.

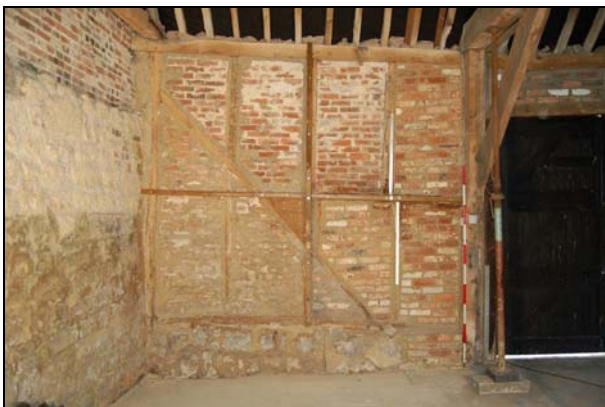
Plate 11: West wall: Bay 3

The southern end of the wall (Bay 3) has a considerable bow, and is currently being propped on the outside. The supporting dwarf wall has not survived in much of this elevation except for in this particular bay. It is mainly stone built, but a section has been rebuilt in brick at the northern end of the bay. The timbers have a lesser scantling than in the east wall and are likely to have been constructed at a later date. The vertical post and midrail have modern timbers attached to them in an attempt to stabilise the wall. However, the vertical post is not anchored to the ground and stabilisation is still an issue. Modern ties have also been added to the stud north of the vertical post and the post below the midrail. The southern wallplate and tiebeam were clamped in an earlier building programme using iron ties. Some timbers have been re-used; the stud to the south of the vertical post is studded with nails and the mid rail has a number of empty mortices.

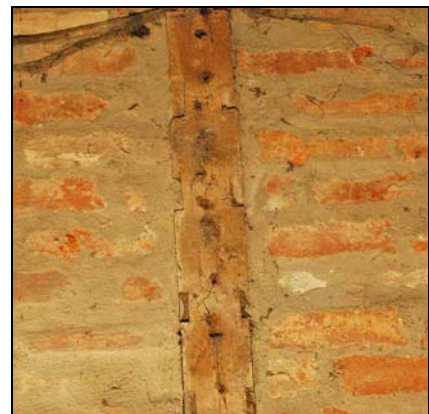
Plate 12: Re-used joist

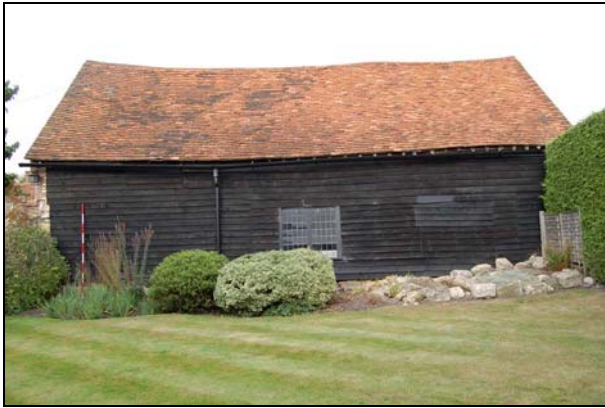
Plate 13: East elevation

The east wall appears to be earlier than that in the west wall in that the timbers are more robust and the supporting dwarf wall is largely intact. Some rebuilding appears to have taken place; the wall plate has been supplemented by another timber above, which necessitated the use of the reversed assembly method for the trusses. Other repair/alteration works are evident in the splicing of both jowlposts and the insertion of iron and modern steel ties on numerous timbers.

The supporting dwarf wall is mainly brick built with sections of limestone mainly in Bays 1 and 3. The timber frame is weatherboarded.

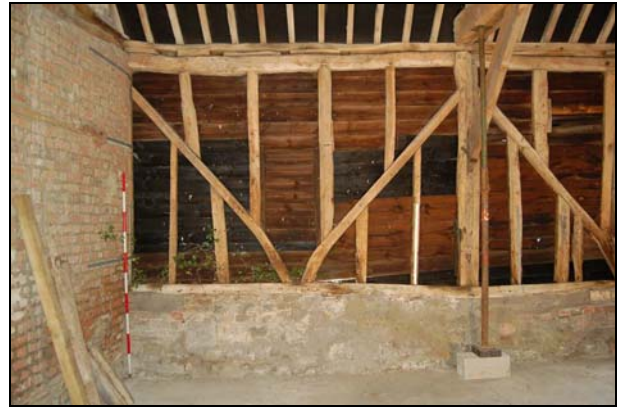
Plate 14: East wall: Bay 3

The dwarf wall in Bay 3 is mainly brick built to the north and stone set in yellow cement mortar to the south. The southernmost stud is extremely curved and tied to the

south wall by two modern steel ties. The timbers in the northern half of the frame have been replaced, possibly done at the same time as the wall plate was being heightened.

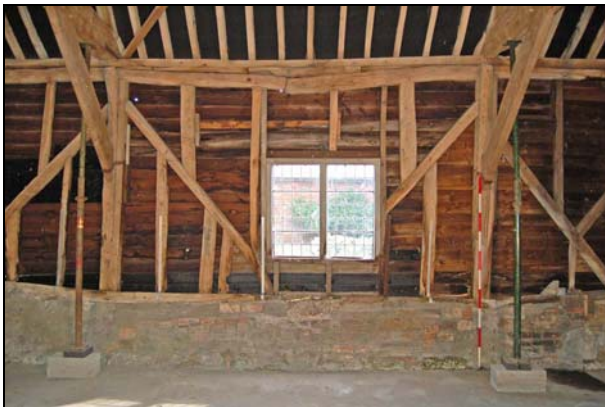
Plate 15: East wall: Bay 2

Bay 2 has a large 2-light multi-paned casement window. The frame, which cuts the southern brace and is therefore a later insertion, is painted white. There is a simple scarf joint in the wallplate, a style that was superseded by more robust joints as early as the 13th century. In this instance the scarf joint is likely to indicate the quality of the workmanship rather than a date, as much of the carpentry in the walls at least is rather rudimentary.

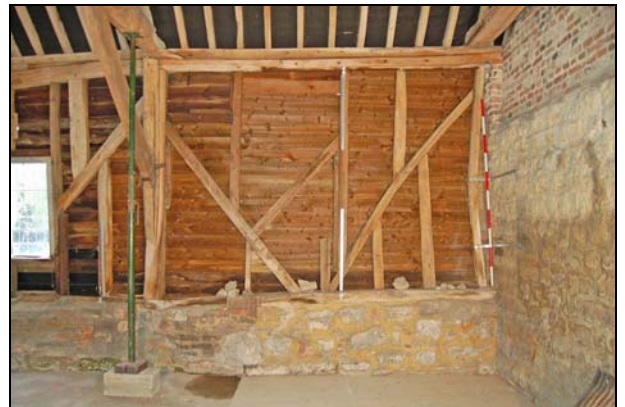
Plate 16: East wall: Bay 1

The supporting dwarf wall in Bay 1 is largely covered in mortar. The hollow chamfer moulding on the stud to the centre right suggests that this has been re-used from a domestic setting. A similar moulded timber has been set into Bay 2.

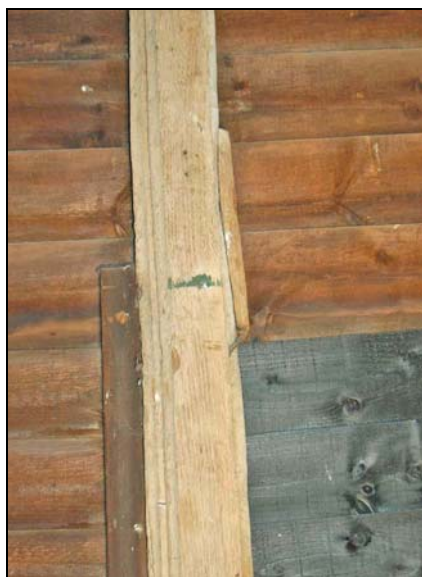
Plate 17: Hollow chamfer moulding on stud

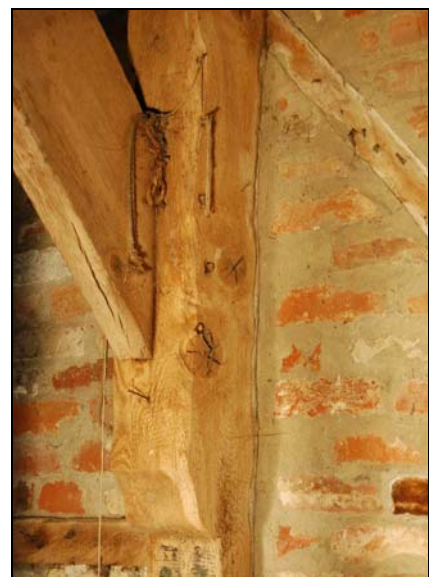
Plate 18: Moulded jowlpost

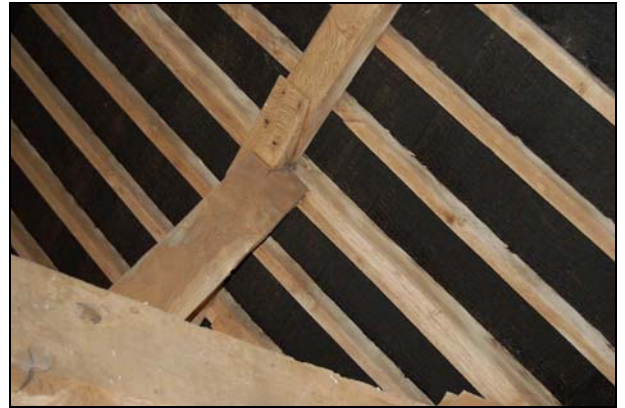
Plate 20: Simple splayed scarf joint

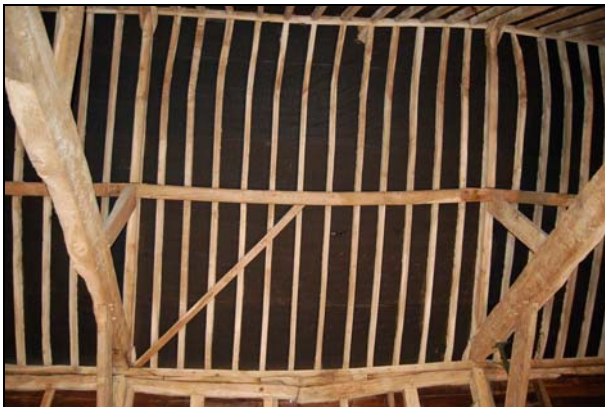
Plate 21: Roof detail

The barn has a clasped purlin roof with raking queen posts and roughly cambered tie beams. Both purlins have a delicate chamfer, which is unusual in a building of this size and function. Another unusual feature is the ogee moulding of the jowl posts. Carpenters assembly marks can be seen on the door side of both tiebeams. The west brace of each tiebeam is marked II and the east brace I. Of particular interest is the inscription on the northern tiebeam. The initials TF are carved between a pair of lozenges and underneath are the initials RS and BWF between July ye and 9 1794. TF is clearly Thomas Fowler who owned the house and barn at the time and it can be assumed that the inscription celebrates his daughter's marriage.

The roof has clearly been rebuilt and has the peculiarity of displaying the reversed assembly method in the eastern trusses and the normal assembly on the western side. This is entirely due to the discrepancy in height of the two walls, which has been rectified by adding timbers between the wallplate and the tiebeam on the eastern side. Additional timbers have supplemented some of the rafters, and others have been replaced. Tiles have replaced the thatch and there is very new roofing felt in place. The trusses are primarily of oak. Elm and softwoods have also been used in the frame and as subsidiary timbers.

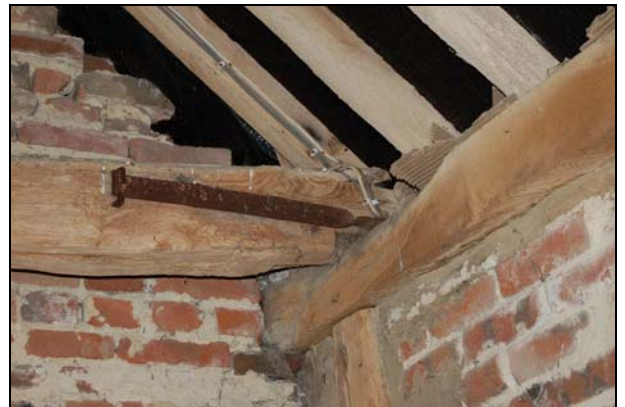
Plate 22: Iron tie & new rafters

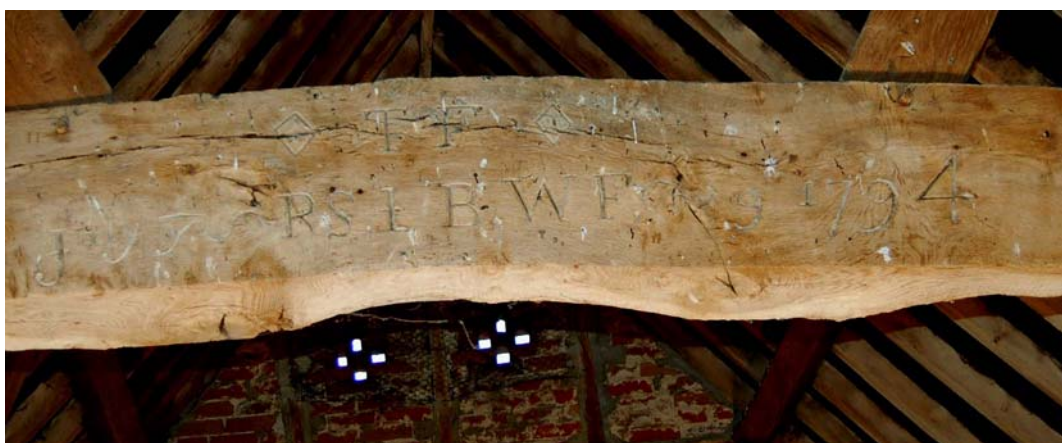
Plate 23: Inscription on northern tiebeam

- 5.6 Most intriguing is the inscription dated 9th July 1794. Although it has been taken to indicate the date of construction, it appears to celebrate the marriage of an RS with a BWF on that day. BWF is almost certainly a daughter of Thomas Fowler, who owned the house at the time and whose initials are at the top of the inscription. Although an inscription on one of the church bells tells us that he was also churchwarden in that year, the parish records fail to note a wedding in the Fowler family in that year. It is possible that the parish records are incomplete, but it is also possible that the wedding took place in the bridegroom's parish church.

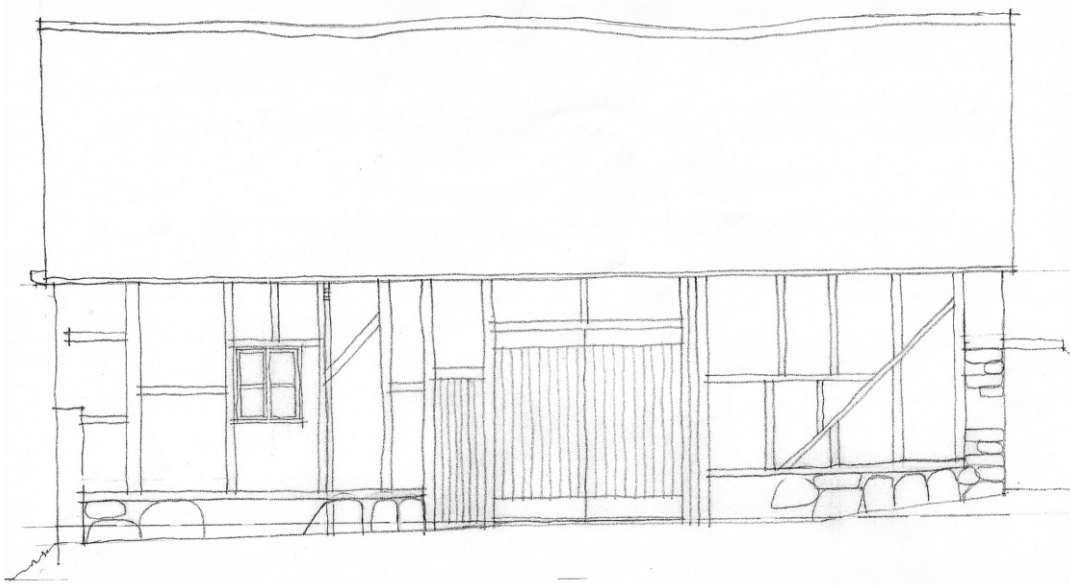
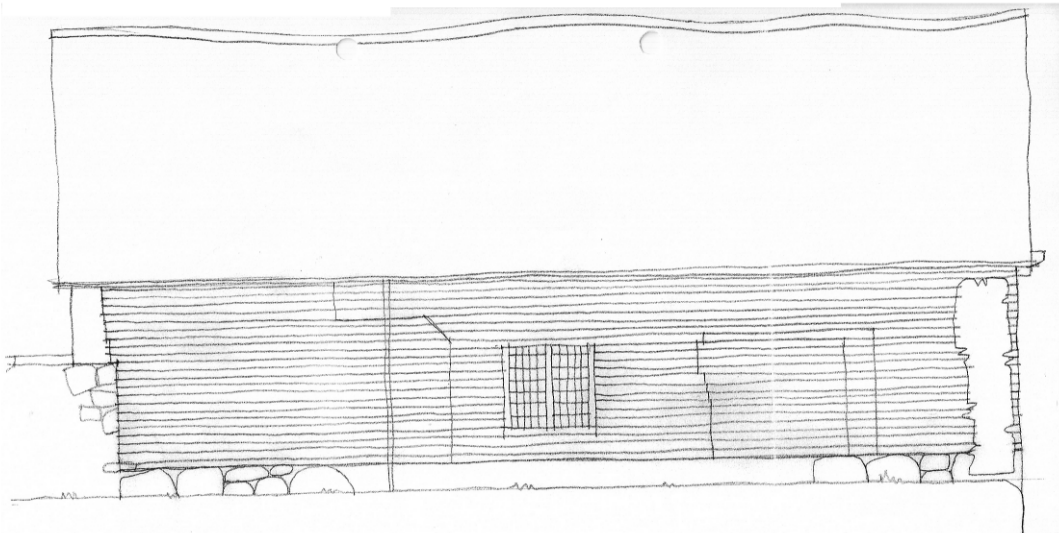
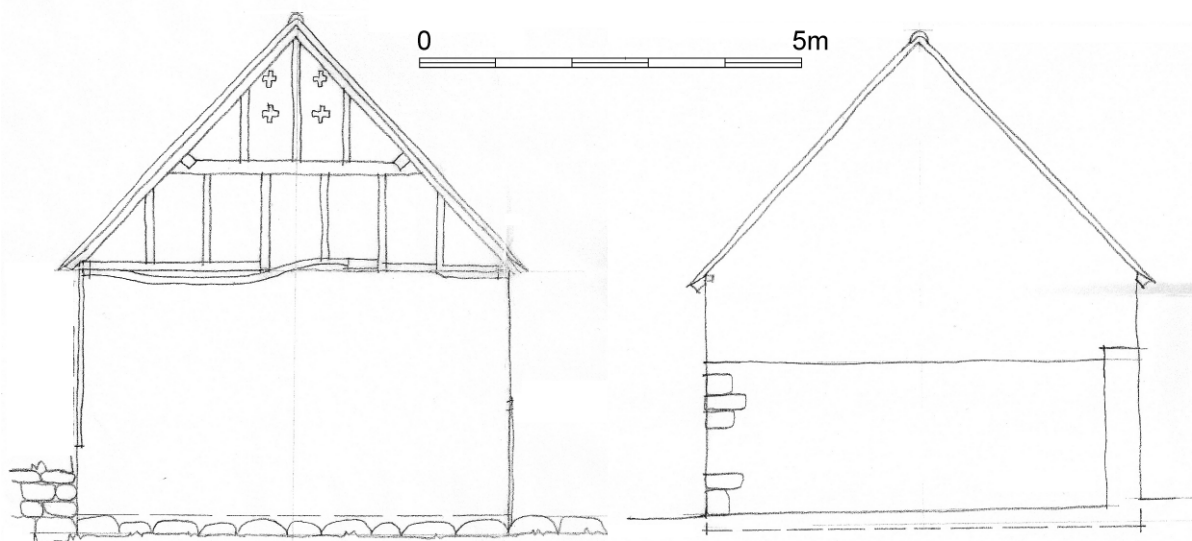
Figure 8: External elevations (scale: 1: 100)

The barn is an unaisled, 3-bay structure under a pitched clay tiled roof. It measures 11.37 x 5.50 x 6.19m high. The pitch (*c.*48 degrees) suggests that the roof was once thatched. The east and west walls are timber framed with brick infill, the north wall is largely brick built and the south wall is stone and brick. These are discussed in more detail below.
