HISTORIC BUILDING RECORDING: 'THE HURDLES' LANGLEY LOWER GREEN ESSEX

NGR: TL 4395 3423

for Barker Associates, on behalf of Mr & Mrs Hay

January 2010

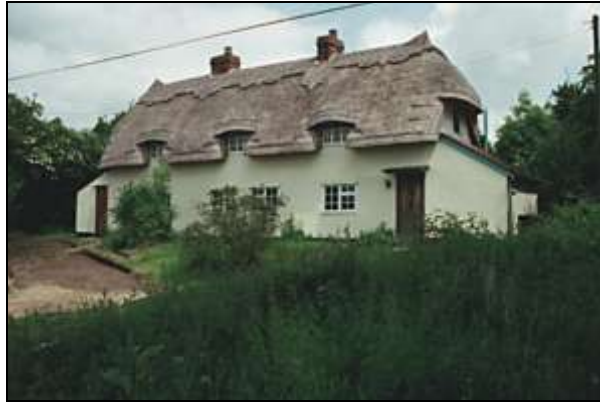
Plate 1: South elevation before the fire

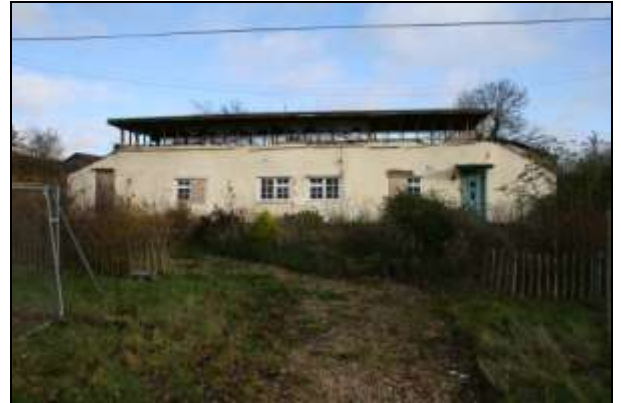
Plate 2: South elevation after the fire

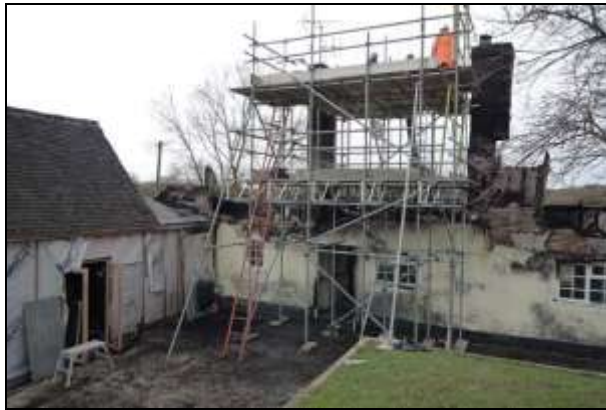
Plate 3: North elevation, showing full height of chimney stacks prior to removal

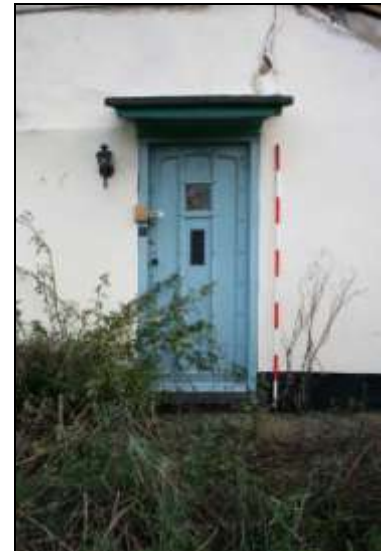
This is the main elevation with a door at both ends and four windows in between. The main door, at the east end of the building, is a medieval style timber door under a door hood. That in the west is a stable door with Suffolk latches, also under a door hood. It opens into the western extension and to the east of the door is a blocked door, which opened into the house itself.

Plate 4: Front door, looking north, 2m scale

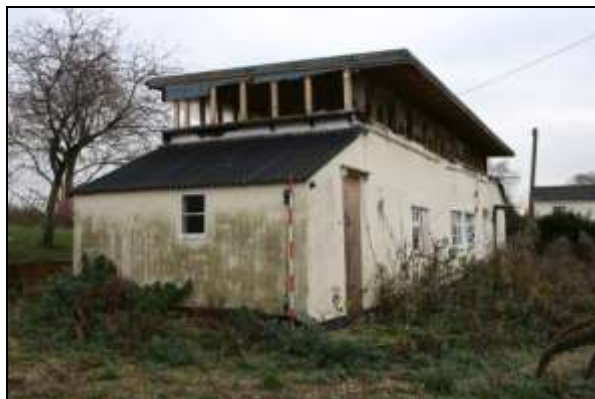
This elevation has a central fixed two-light modern timber window. The extension has a lean-to corrugated roof of flexible composite material. Immediately above the extension roof and below the level of the first floor window, which is now gone, is a narrow ledge supported by six brackets.

Plate 5: South and west elevations showing modern stable door, 2m scale

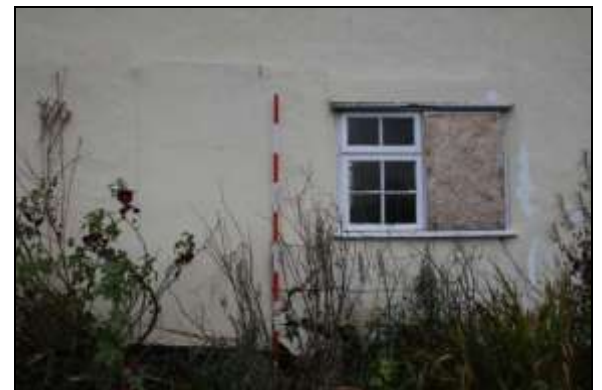
Plate 6: Blocked doorway in south elevation, looking north, 2m scale

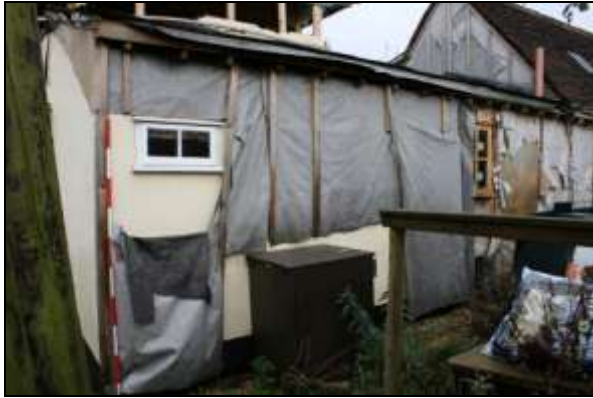
This elevation is largely covered by tarpaulin, so much of the detail is obscured. There is a modern timber window at the south end of the elevation with a single fixed light of 6 panes.

Plate 7: East elevation, 2m scale

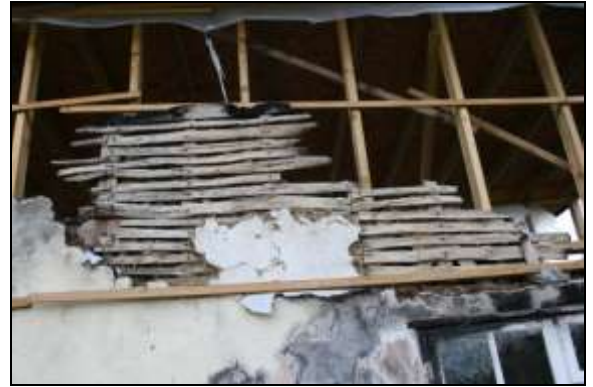
Part of the render has been removed, exposing the daub and riven laths behind.

Plate 8: Exposed area of original construction material in north elevation

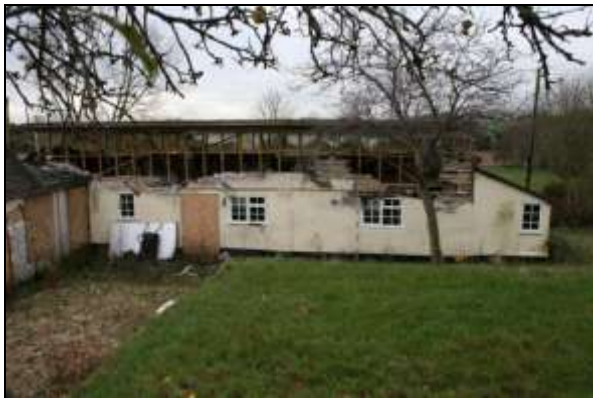
This has two two-light windows to the east of which is a French door into Room G2. A modern single light timber casement window lights each extension and a modern single light casement window lights the kitchen (Room G3). This appears to have replaced a two-light window similar to those elsewhere in the lateral elevations.

Plate 9: North elevation, 2m scale

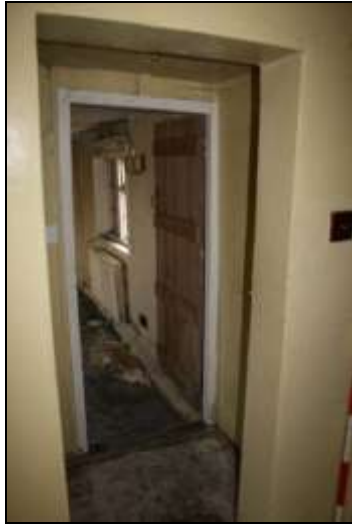
Description: Passageway. The west and south walls of this room are plastered and painted. Part of the timber framing is visible in the east wall, painted over with modern plaster in between. The ceiling is lath and plaster, and the floor is concrete. There are no windows in this room. There is an opening to G1 in the west wall. There are plank and batten doors with Suffolk latches in the north and east walls. The door in the north leads to a cupboard under the stairs, while the door in the east wall leads to the lounge (G2).

Plate 13: G1a, looking south east

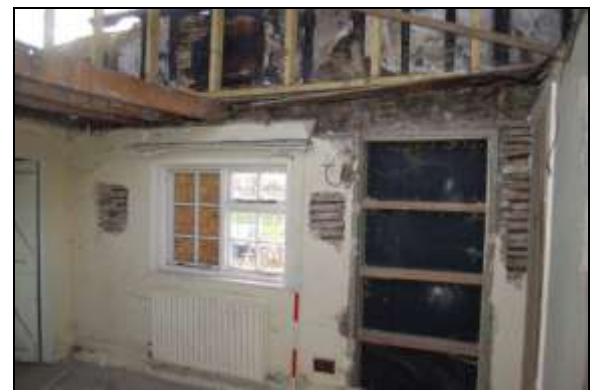
Description: Lounge. Although the plasterboard had not been stripped in this room, the historic building fabric was exposed to some extent in both the north and south walls. A skin of modern plaster, some 2mm thick had been applied to the daub, which

was 26mm thick. The riven laths, which appear to be of chestnut, are wide and close set. The supporting dwarf wall is apparent at the base of the north, south and west walls but an area of full height vertical planking obscures modern plumbing in the north east corner room.

Plate 18: G2, south elevation after removal of ceiling and some walling material, 1m scale

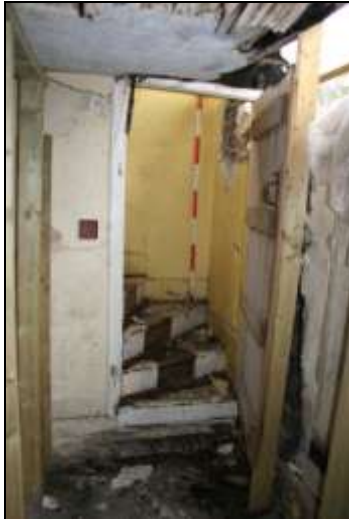
There is a step up to the door to Room G1a in the southwest corner, a ledged and braced door to Room G3 in the south east corner and a plank and batten door with Suffolk latches to the staircase in the north west corner. The staircase to the first floor is straight with a winder at the base and has a basic wooden handrail and eleven risers.

Plate 19: Stairs in northwest corner of G2, looking west, 2m scale

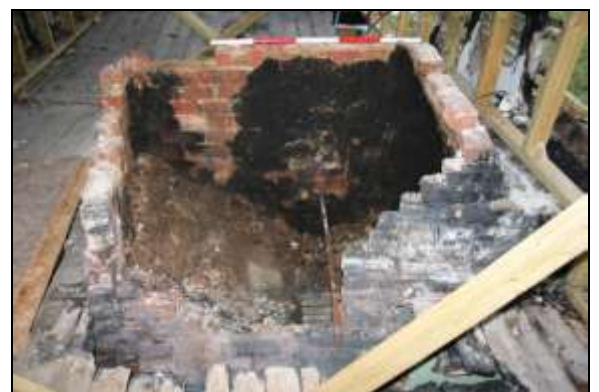
The fireplace in the west wall has a 20th century hearth with a woodburning stove beneath an earlier chimney stack. The bricks above the fireplace are red, handmade and measure c.22 x 10.5 x 6cm (8⁵/₈ x 4¹/₈ x 2³/₈ in). They have few inclusions and very little spanish. Some bricks lightly frogged and no skintlings were observed.

Two types of lime mortar were recovered from this chimney stack. One was from the side of the stack and is buff coloured with very few but fine inclusions. It is approximately 9mm thick. The mortar on the rear wall of the stack is brown, very sandy and has coarser inclusions. This is up to 15mm thick. The chimney is daub lined.

The brick sizes and the inclusion of spanish could suggest a 17th century date but the light frogging on the bricks is more indicative of late 18th/early 19th century date. The different brick and mortar types suggest that the chimney stack was repaired or rebuilt in the 19th century.

Plate 24: Top of chimney in G3, looking west, 1m scale

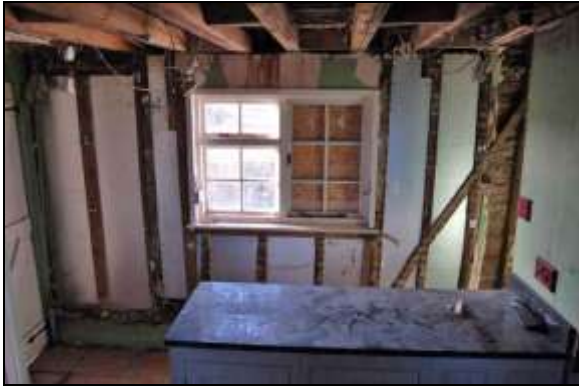
Description: Kitchen. The machine cut timbers in the south wall suggest that this has been largely rebuilt. The infill to the timber frame is obscured by the modern insulating panels. However, a 1m wide section in the north wall between the French door and the kitchen window contains a post made from a pole still with the bark intact. This is a characteristic of 19th century building techniques. To the east of this is a machine cut post and diagonal laths, behind which is relatively modern insulating material. The east wall consists of painted plasterboard and a cupboard below the eastern staircase. The fireplace making up the west wall has been removed and the opening tiled.

Plate 25: G4, looking south, after removal of plaster
2m scale

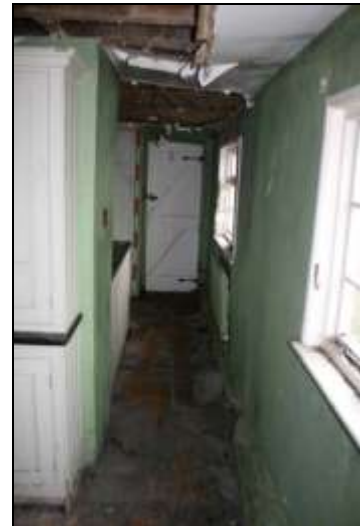
Plate 28: Passageway between G3 and G4, showing
reduced sole plate, looking east, 2m scale

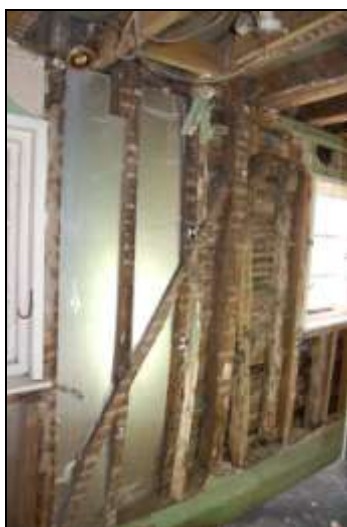
Plate 29: Passageway between G3 and G4, after
removal of plaster

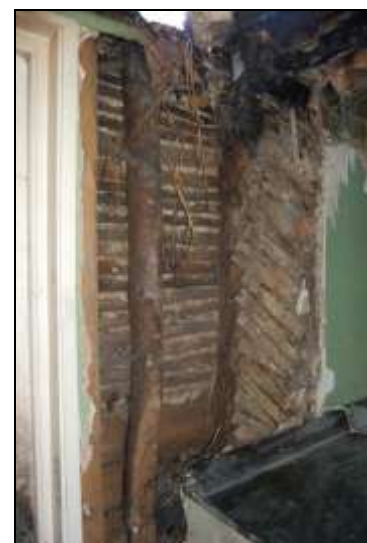
Plate 30: Exposed pole and diagonal laths in
northwest corner of G4

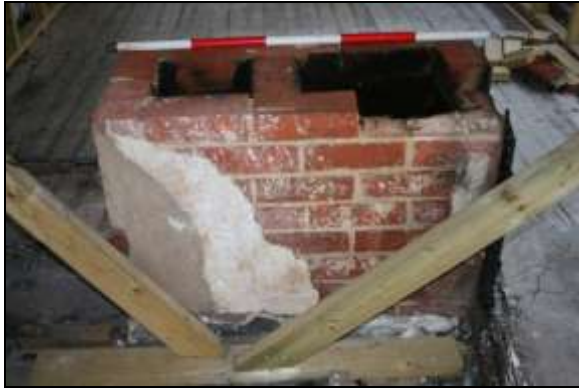
The chimney stack, which has two flues, is made of lightly frogged bricks with the letter C in the frog. They measure *c.* 23 x 11.5 x 6.5cm (9 x 4½ x 2½in) and are set in a friable, buff coloured lime mortar up to 11mm thick. The inclusions in this mortar are slightly coarser than those in the buff coloured mortar on the neighbouring chimney and contain a number of chalk fragments. The bricks, which have sharper arrises than those in the western chimneystack, are likely to be later 19th century. Modern kitchen units line the north and east walls and create a passage to the south of the working area.

Plate 31: Top of chimney in G4, looking west, 1m scale

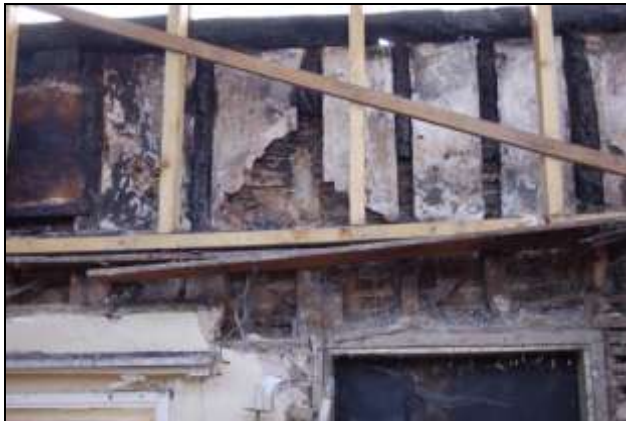
Although a measured drawing could not be undertaken for health and safety reasons, the survey was able to record the first floor timberwork photographically as well as with some field notes. The timber studs measured were largely 5cm wide on either 30cm or 40cm centres. The west wall appears to be a later addition as the timberwork in the west wall is more regular than in the north and south walls with 5cm wide studs set at 35cm centres. The laths are also wider.

Plate 39: Example of first floor studwork in the south wall

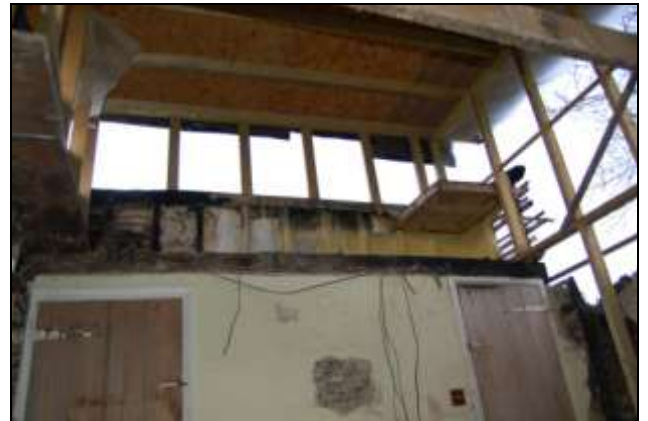
Plate 40: Studwork in west wall
