## **HISTORIC BUILDING RECORDING AND WATCHING BRIEF:**

**THE BARN  
163 HIGH STREET  
OLD AMERSHAM  
BUCKINGHAMSHIRE**

ASC: 1249/AHS/2

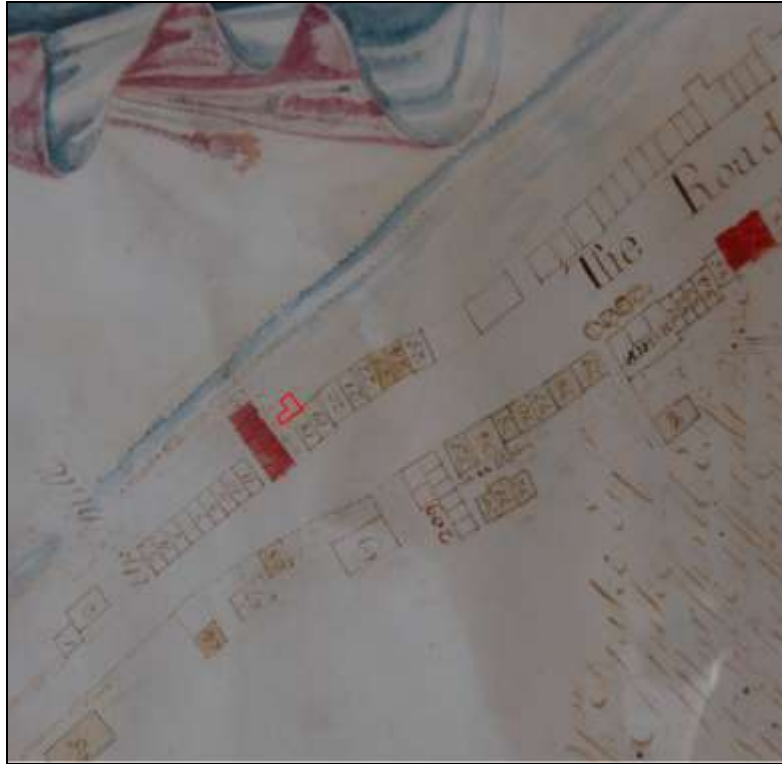
**Figure 4:** Extract from the 1742 map of the town of Agmondesham (*not to scale*)

The earliest detailed map showing the terraces at the western end of the High Street is that of 1742 (Fig. 4). However, neither this map nor the Tithe Map (Fig. 5), thought to date from c.1840, depicts the barn. The Tithe award lists twenty-five individuals associated with the houses, cottages and gardens in the terraces then owned by Thomas Tyrwhitt-Drake. By cross referencing the tenants names to the 1832 trade directory, one finds Edward Stone, chair maker and John Toms, brazier. Two families appear to have been represented although the Christian names are not the same; Edward Lee was a corn dealer and Thomas Atkins a dyer. It is highly likely that they were related to Samuel Lee and John Atkins who lived in the terraces when the Tithe award was drawn up.

One of the most influential families in the development of Amersham was the Drake family. William Drake bought Amersham manor in 1637 and had six almshouses built in 1657. His nephew, another William, was responsible for building the market hall (VCH online). One of the earliest maps detailing properties in the town was created to show which were owned by William Drake and on whose votes he could count on during parliamentary elections (Historic Town Assessment: 95). These included the terrace behind which the barn is located (Fig. 4). From the late 18<sup>th</sup> century the family was known as Tyrwhitt-Drake.

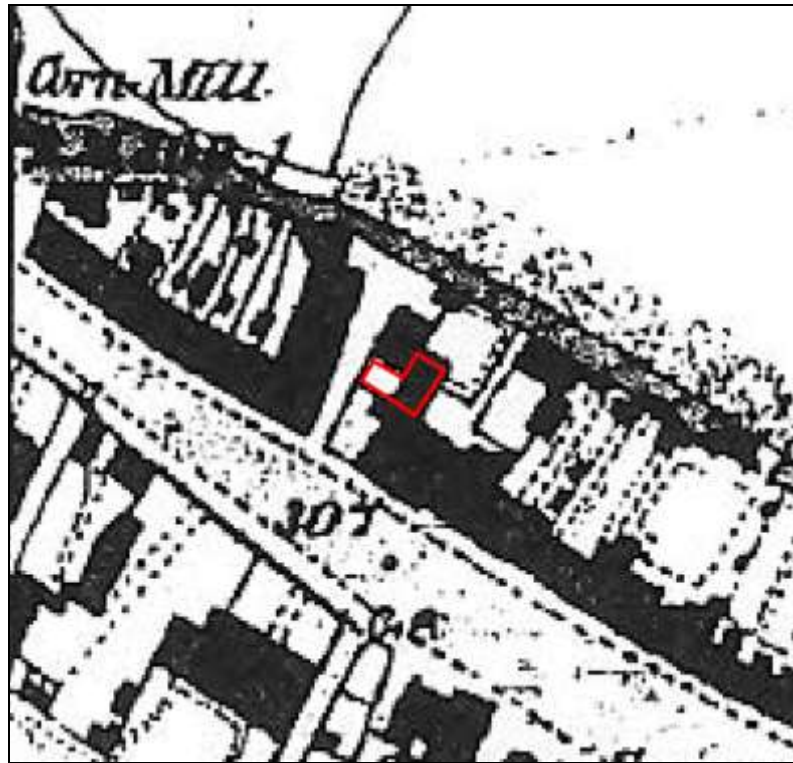
**Figure 6:** Extract from the 1880 Ordnance Survey Map (scale 50 inches to 1 mile)

The first edition Ordnance Survey map shows the building to have had an adjoining structure to the north of the present western extension (Figs 6-7). This was demolished and the present extension constructed before 1925 when a building was also present immediately to the east of the barn. The 1925 map suggests that the southern range of 169 High Street was part of the barn at that time (Fig. 7).

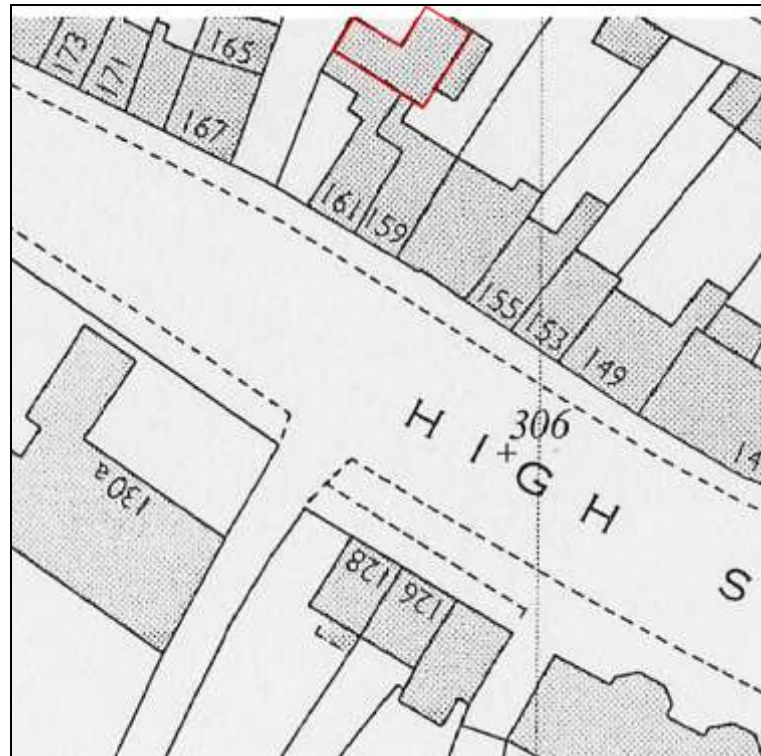
**Figure 8:** Extract from the 1962 Ordnance Survey Map (*scale 1:1250*)

By 1962 a passage or similar had been constructed between 159 High Street and the barn (Fig. 8). This would accord with the known history of the relationship between the house and the barn, which was a workshop used by the inhabitant of number 159. The eastern building has since been demolished.

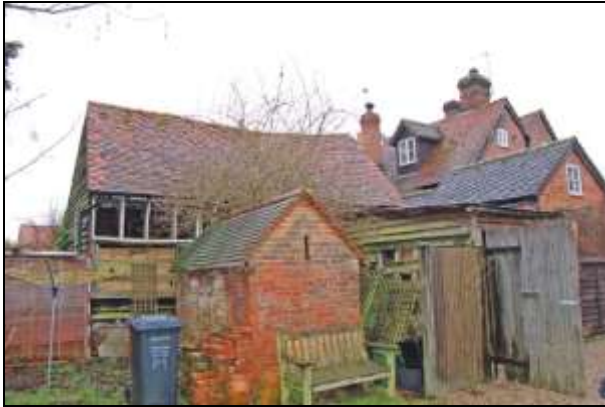
**Plate 1:** Barn and neighbouring privy from the east

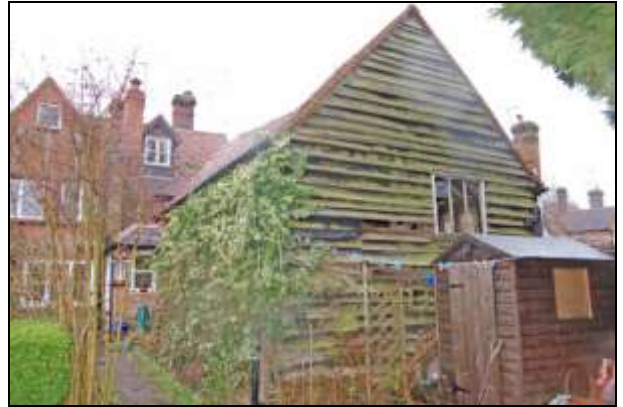
**Plate 2:** Exterior of the barn from the northwest

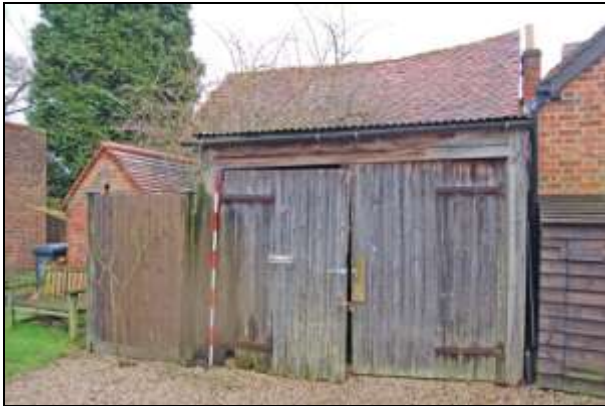
**Plate 3:** Western extension from the southwest

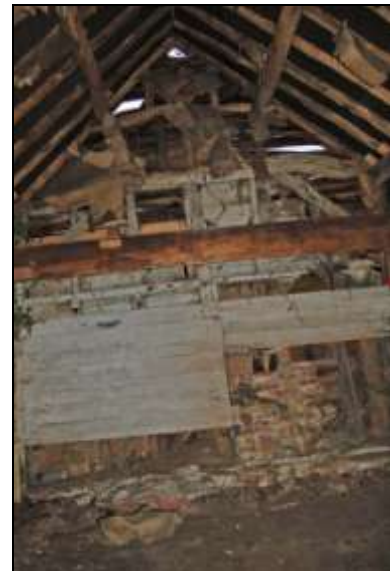
**Plate 4:** South wall

The lower part of the wall was partially covered by horizontal planks during the initial survey. This did not completely obscure the timber and brickwork behind. A rail was revealed approximately 40cm below the wallplate during the building works. Between this and the wallplate is a pair of curved braces. Both vertical posts have slightly sloping jowls.

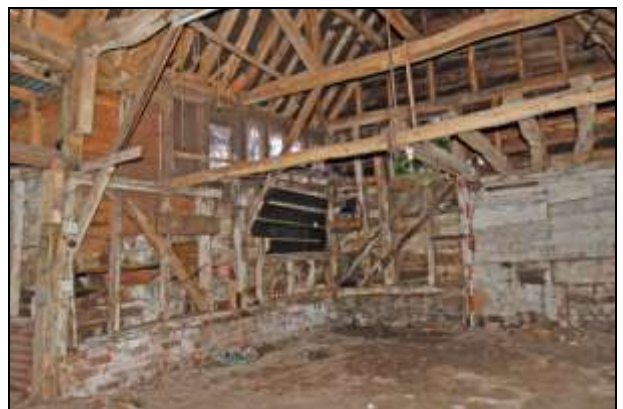
**Plate 6:** West wall

A window has been inserted in Bay 1, which truncates the primary bracing below. Bay 3, which opens into the garage area, has a bark covered pole tying the vertical posts. There is an edge halved butt joint in the wallplate of Bay 2.

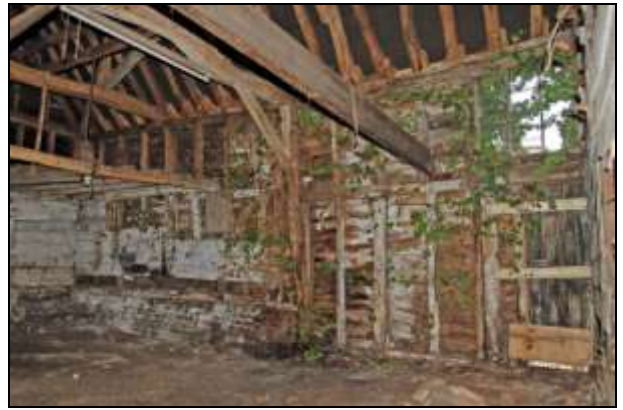
**Plate 8:** East wall

The brick supporting dwarf wall is only present in Bays 1 and 2, which would suggest that Bay 3 originally had a door. It now has vertical studs and no bracing, a narrow door and a window above. The primary bracing Bays 1 and 2 was largely obscured by panelling during the initial survey. An edge halved joint is present in the wallplate in Bay 2.

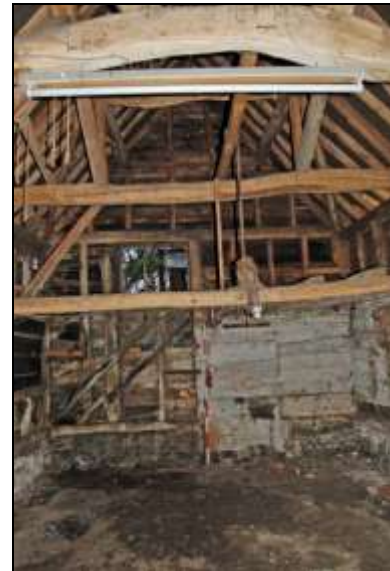
**Plate 10:** North wall

The north wall has gunstock jowlposts and the remains of a primary brace behind two additional diagonal braces that have been added to the front of the frame. A window has been inserted to the left of the vertical post and a mezzanine floor to the right.

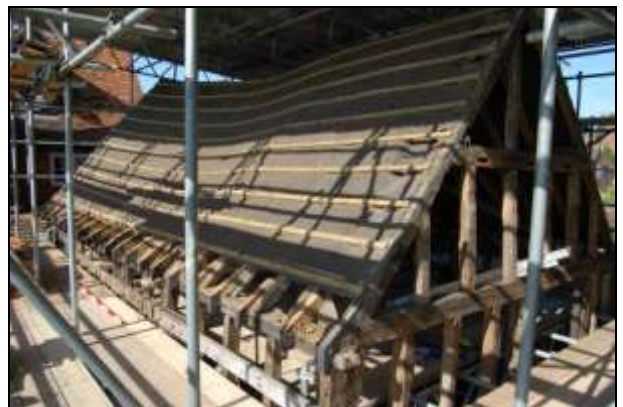
**Plate 12:** North wall and roof

The barn appears to have retained the original rafters but has new roofing felt and some replacement tiles. The purlins have edge halved butt joints which have failed and are being propped by wooden struts.

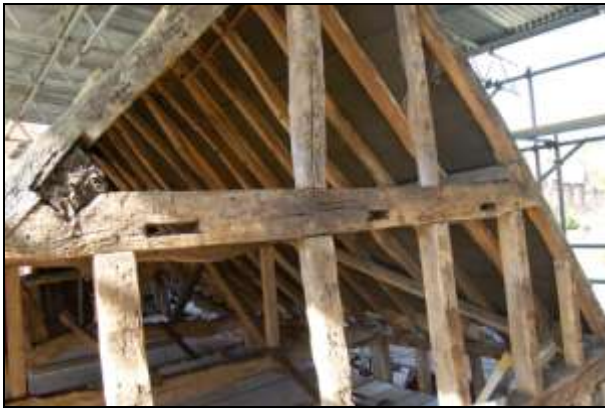
**Plate 13:** Mortices in north wall

During a subsequent visit three mortices were observed in the collar beam, which suggest that this is a re-used timber. Carpenters assembly marks in the shape of the letter V were also seen on the collar and the corresponding stud.

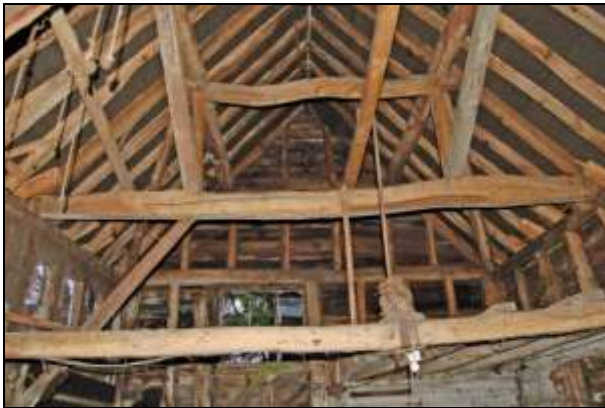
**Plate 15:** Truss 1

The northern truss (Truss 1) is set on unjowled vertical posts and has straight queen posts. There is additional bracing between this and the southern truss. Carpenters assembly marks IIII and III were noted on the eastern and western end of the collar and the associated rafters respectively.

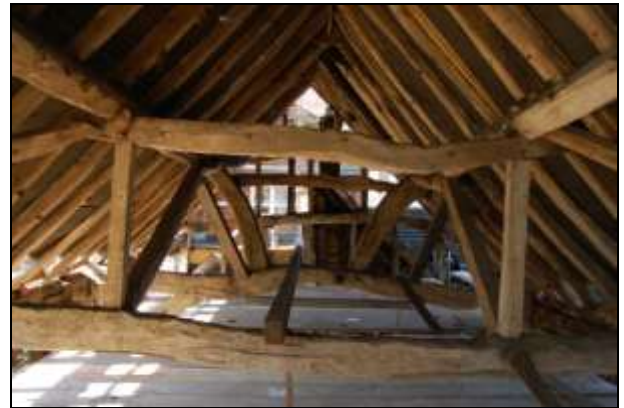
**Plate 16:** Trusses 1 and 2 from the scaffold

The southern truss (Truss 2) has curved braces and a pole has been used for the straining beam. The truss rests on squared off gunstock jowlposts and has a straight brace to the east and a modern timber nailed to the post and tiebeam to the west.

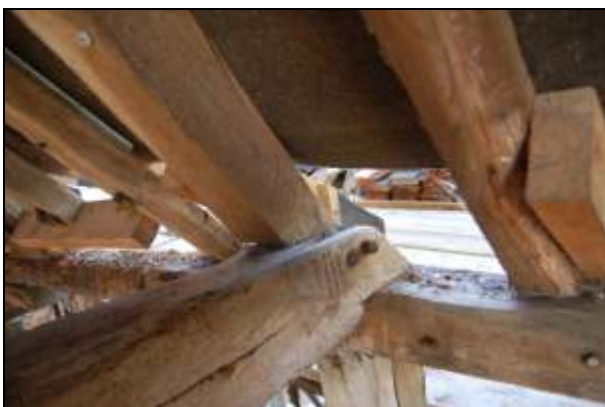
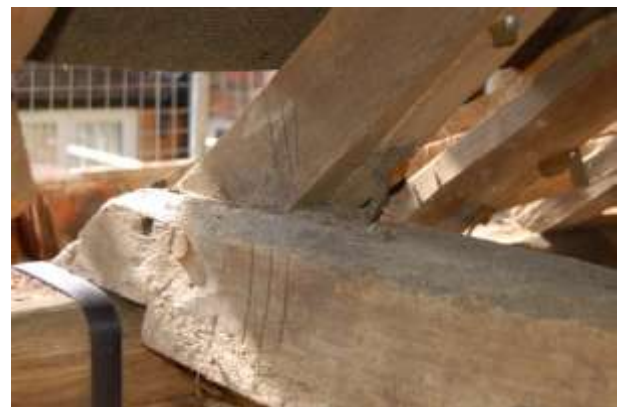
**Plate 17:** Carpenters assembly marks on Truss 1

**Plate 18:** Carpenters assembly marks on Truss 1

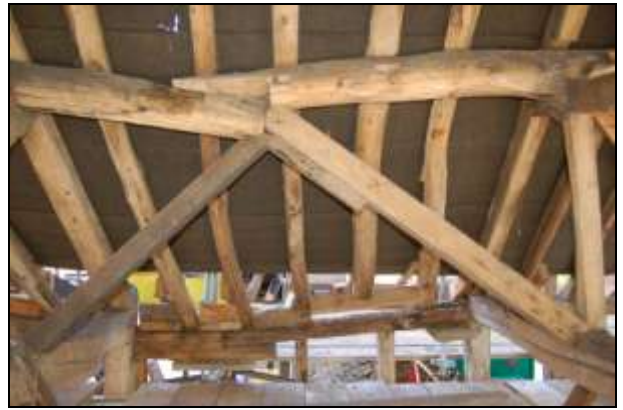
**Plate 20:** Edge halved scarf joints and purlin props

- 5.2 A feature that would be considered anachronistic in Hertfordshire and Essex is the edge halved scarf joint, found here in the wallplates and purlins. The use of edge halved scarf joints had generally given way to counterbladed scarf joints by the time this barn was constructed, but it is not unusual to find anachronistic building methods in lower status buildings. Indeed, a barn associated with King James I in Royston had similar characteristics to this building; the use of edge halved scarf joints (although in the Royston barn counterbladed scarf joints were also used) and different styles of jowlposts (Semmelmann 2003). In Buckinghamshire the edge halved scarf joint appears to have continued in used in the post-medieval period in domestic settings as well as outbuildings (*cf* Trench 1998:53).

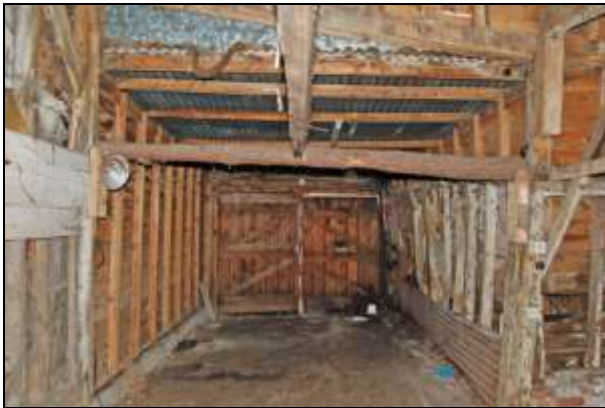
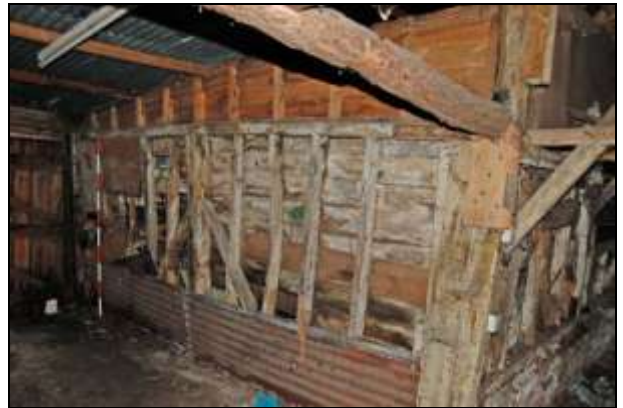
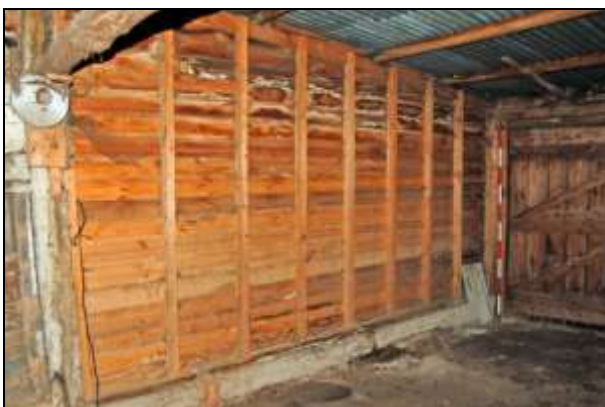
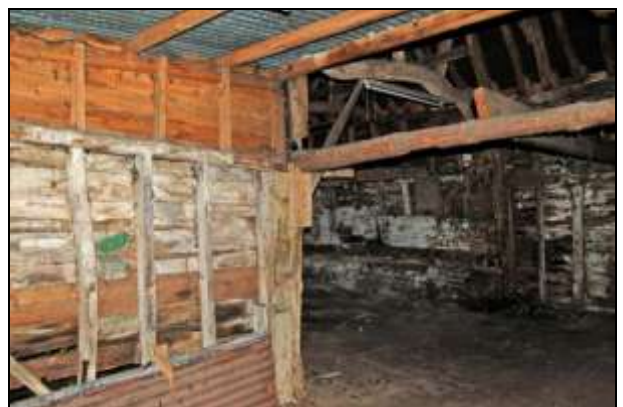
The western extension is a late 19<sup>th</sup>/early 20<sup>th</sup> addition to the barn and has a modern south wall. The north wall has primary bracing with waney edged and machine cut timbers. The wall has been heightened above the frame to create a sloping roof.

**Plate 21:** Western extension: west wall

**Plate 22:** Western extension: north wall

**Plate 23:** Western extension: south wall

**Plate 24:** Pole at barn/extension juncture

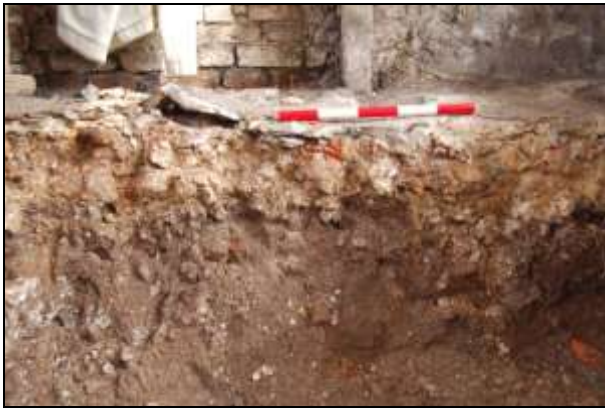
The floor was seen to consist of concrete over a conglomerate of materials some 170mm deep. This contained brick and tile fragments as well as quantities of 19<sup>th</sup> century domestic debris. Between this and the silts beneath was an intermittent layer of

chalk. Another chalk layer, approximately 150mm deep, was present *c.*400mm below the modern floor level. Below this was clean, undisturbed silts.

Two postholes were revealed 400mm from the northern end of the barn. The western one was 230mm in diameter and filled with a very dark, sooty, oily matrix containing large amount of modern detritus. The eastern posthole was 170mm in diameter and similarly filled. A third posthole some 200mm in diameter filled with bottles was found against the east wall, 900mm from the southeast corner of the barn.

**Plate 25:** Stratigraphy at northern end of the barn

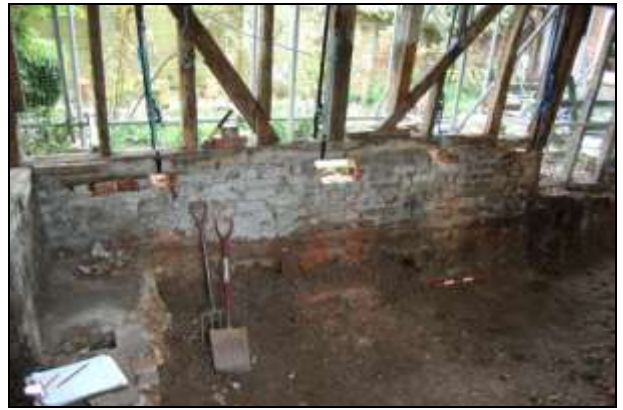
The ground was reduced by c.600mm throughout the barn. This was done in two phases to allow for the underpinning.

**Plate 26:** Ground reduction along the east wall

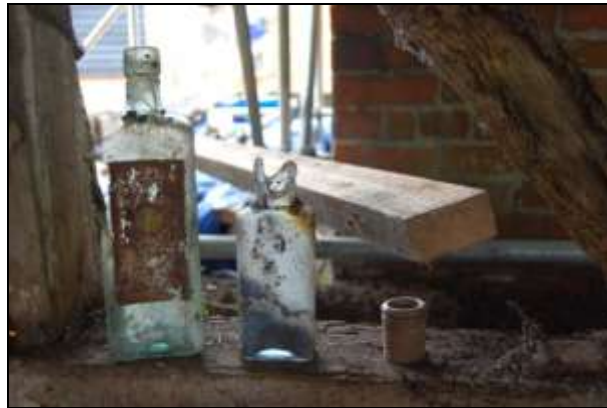
**Plate 27:** Samples of the ceramic remains in the barn floor
