Archaeological Services & Consultancy Ltd

**WATCHING BRIEF:
22 MENTMORE ROAD
CHEDDINGTON
BUCKINGHAMSHIRE**

February 2011

ASC: 1263/CMR/2

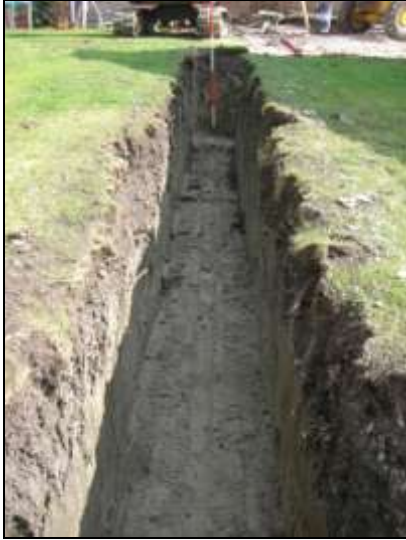
Plate 1: Trench to north of site, looking southeast.
2m scale

The footing trenches located to the north east of the existing building were approximately 0.70m wide and 1.30m deep (Plate 1). The general stratigraphy in these trenches comprised *c.*0.25m of topsoil over the natural grey gault clay. A loose crumbly spread of chalk, approximately 0.10m deep was revealed *c.*0.50m below ground level. It was 1.55m wide and appeared to run parallel to the rear of the house for 9m (Plate 2). A drain run was present at the eastern end of the feature. Post-medieval red ware pottery fragments were recovered but not retained.

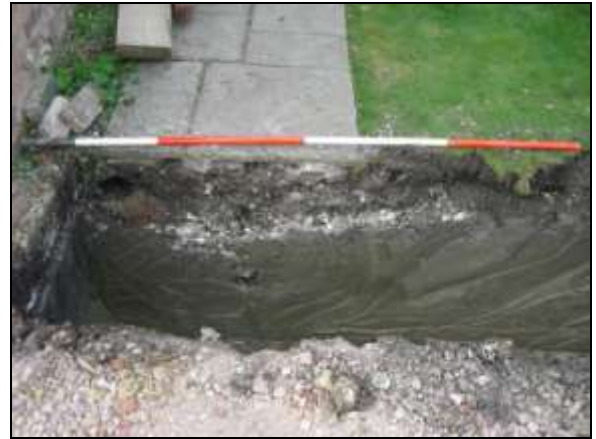
Plate 2: Area of disturbance, looking north west.
2m scale

- 5.1 The only archaeological feature observed during the watching brief was the area of disturbance within the footing trench to the north of the existing building. This appears to have been associated with the installation of the drain and path running alongside the house.

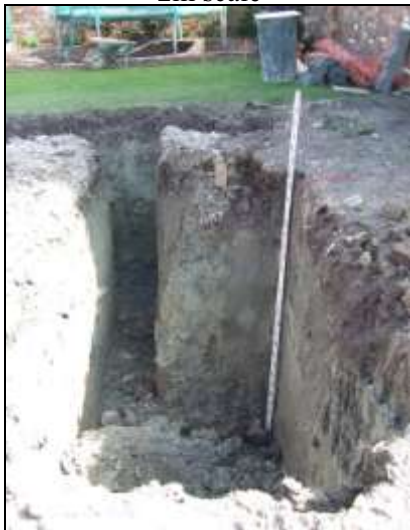
Plate 3: Trench to south of site, looking north east

The footing trenches excavated to the south east of the existing property for the music room and garage had a maximum depth of *c.*2.4m (Plate 3). Topsoil was only observed along the north eastern edge of the footing trench. It was some 0.40m deep and lay over the natural gault clay. The remainder of the trenches were excavated through *c.*0.4m of made ground and *c.*2m of natural grey clay (Plate 4). No archaeological finds or features were observed within these trenches other than the foundations of the recently demolished garage in the south east corner.

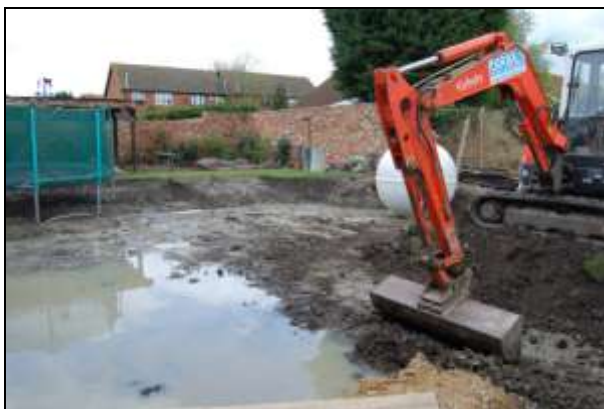
Plate 5: Ground reduction to the front of the
house

The ground level in the area of the former garage and the extension to the east of it was reduced by up to 0.70m (Plate 5). The stratigraphy was as described above. The only evidence for previous activity observed in this area was the garage foundations. The ground was reduced by *c.*0.30m to the rear of the house to the same gault clay found elsewhere on the site (Plate 6).

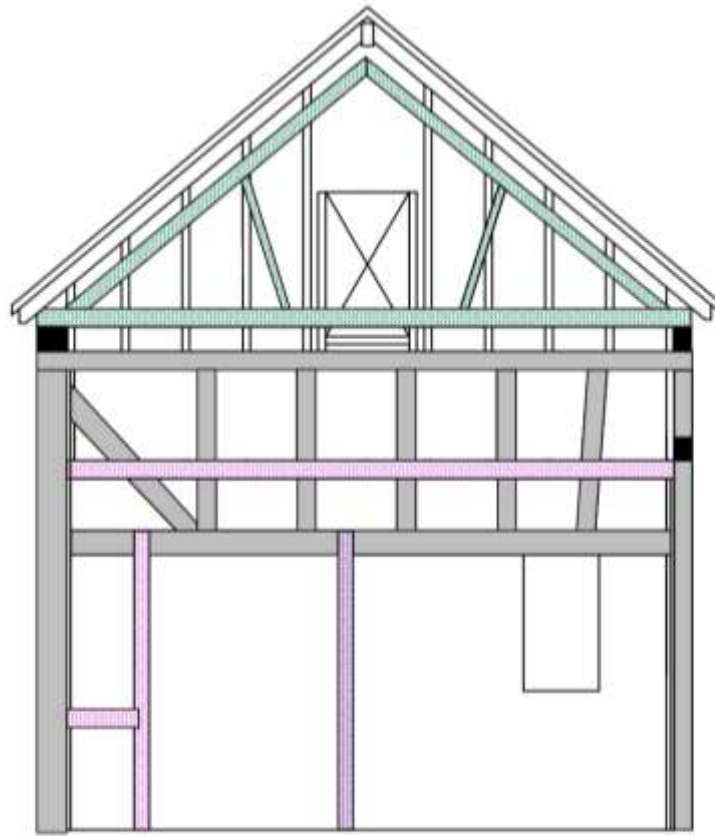
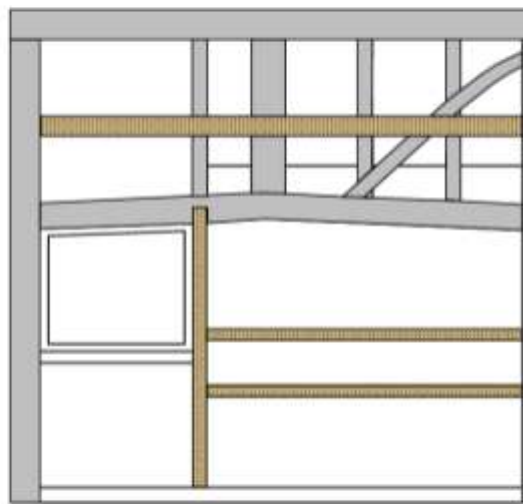
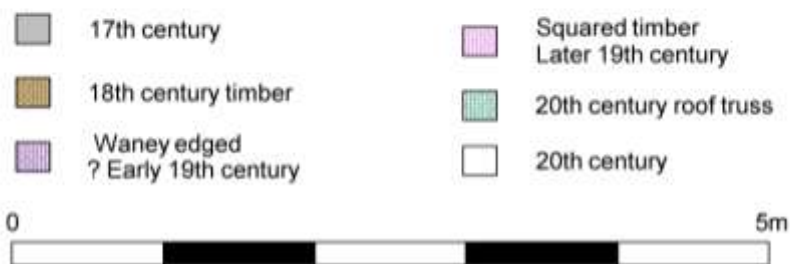
Figure 5: North & east forge elevations (scale 1:50)

Part of the original 17th century frame has survived in the east, north and south elevations of the forge. The timberwork in the north and south walls continues westwards into the house. Apart from the corner posts, this timberwork is all at upper level in the forge. Most of the timberwork exposed within the forge itself appears to be 18th century. These are predominantly waney edged timbers, with just a few worked ones.

Some timbers appear to have been added to the east elevation in the 19th century, but the most extensive reworking of the timberwork in the forge was the early 20th century roof truss. This has machine cut timbers with small cleats and is pegged and nailed.
