**ARCHAEOLOGICAL EVALUATION:
MANDEVILLE PRIMARY SCHOOL
ST ALBANS
HERTFORDSHIRE**

NGR: TL 1470 7550

on behalf of Hertfordshire County Council

April 2010

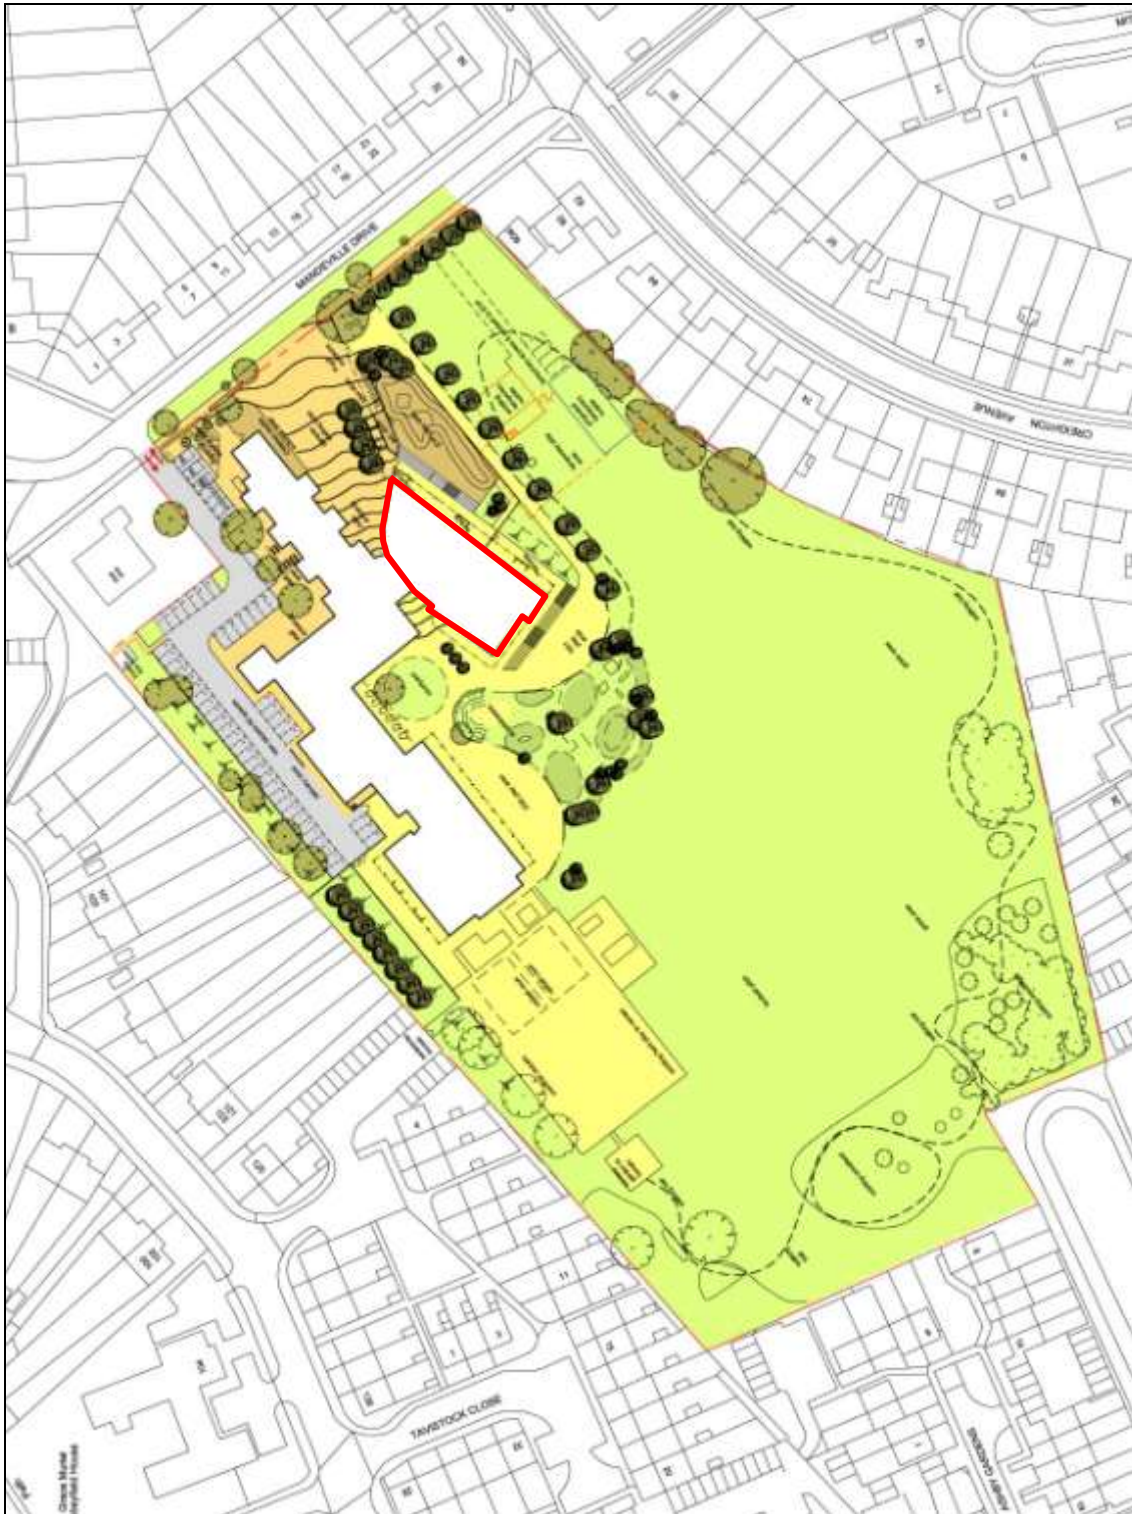
Figure 3: Plan of the site with area of proposed new build outlined in red (not to scale)

The proposed development comprises the partial demolition of one of the blocks, replacement with a new building extending to the southwest, and associated landscaping (Fig. 3).

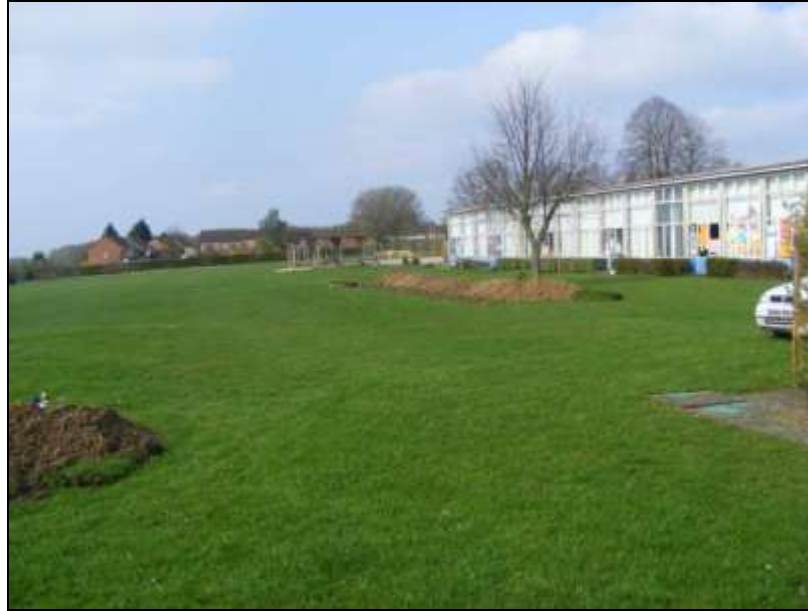
Plate 1: General view of the site looking southwest. Trench 1 in the background

The proposed new building and associated landscaping (below, section 1.4.3) will largely be developed in the playing fields to the southwest of the school buildings (Plate 1). The area is laid out to grass and a number of trees are present.

- 4.2.1 No archaeological features or artefacts were present in the trenches.
- 4.2.2 The sequence of soil layers was similar in all three trenches. The upper layer comprised turf and topsoil (100, 200, 300) which was *c.*100mm thick. The underlying subsoil (101, 201, 301) was *c.*250mm thick and comprised mid greyish brown sandy silt with large numbers of rounded stones. The subsoil in Trench 1 contained a small quantity of modern debris, indicating that the area had been disturbed, perhaps during the construction of the adjacent classroom during the 1960s/70s. The subsoil in the remaining trenches did not contain any manmade material and the remaining areas are probably undisturbed. The natural strata (102, 202, 302) comprised orange brown sand and gravel and was present at a depth of *c.*350mm.

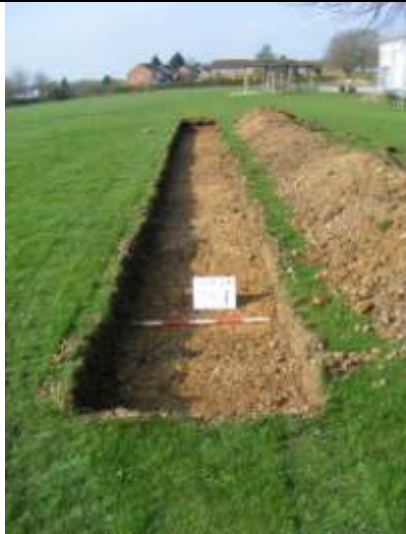
Trench 1

Max Dimensions (m)					
	Length	19m	Width	1.2m	Depth	0.35m
	Levels					
	Trench top	n/a				
	Trench base	n/a				
	Trench top	n/a				
	Trench base	n/a				
	NGR Co-ordinates					
	SW	TL 14696 05519	NE	TL 14727 05531		
	Orientation		NE - SW			
Reason for Trench		Evaluation of area of proposed landscaping				
Context	Type	Description and Interpretation	Width (max: mm)	Thickness (max: mm)	Depth (BGL: mm)	
100	Layer	Turf comprising mid grey brown silty clay. Turf & topsoil.	-	100	0	
101	Layer	30% mid grey brown sandy silt & 70% rounded stones. Occasional frags. of modern debris. Subsoil.	-	250	100	
102	Layer	Compacted orange brown sand and gravel. Natural gravel strata.	-	-	350

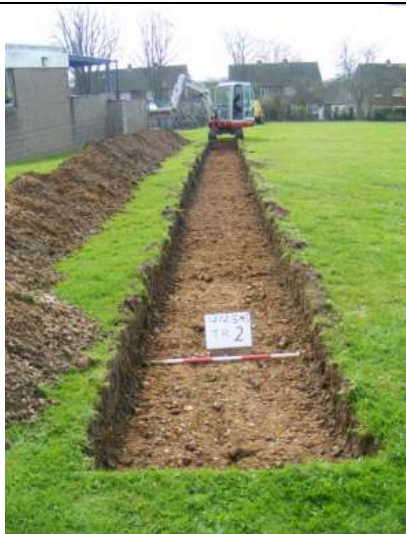
Trench 2

Max Dimensions (m)					
	Length	23m	Width	1.2m	Depth	0.35m
	Levels					
	Trench top	n/a				
	Trench base	n/a				
	Trench top	n/a				
	Trench base	n/a				
	NGR Co-ordinates					
	NW	TL 14728 05533	SE	TL 14746 05518		
	Orientation		NW - SE			
Reason for Trench		Evaluation of area of proposed new building				
Context	Type	Description and Interpretation	Width (max: mm)	Thickness (max: mm)	Depth (BGL: mm)	
200	Layer	Turf comprising mid grey brown silty clay. Turf & topsoil.	-	100	0	
201	Layer	30% mid grey brown sandy silt & 70% rounded stones. Subsoil.	-	250	100	
202	Layer	Compacted orange brown sand and gravel. Natural gravel strata.	-	-	350
