**HISTORIC BUILDING RECORDING & TEST PITTING:
ORCHARD COTTAGE
WESTLEY WATERLESS
CAMBRIDGESHIRE**

NGR: TL 6204 5622

May 2010

ASC: 1278/WWO/2

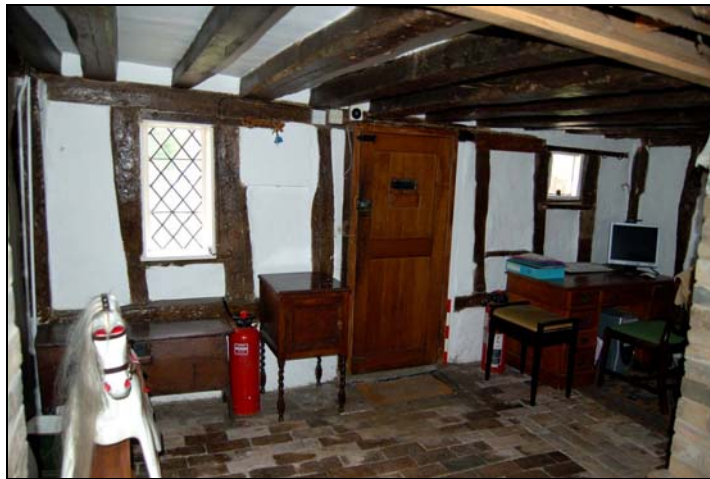
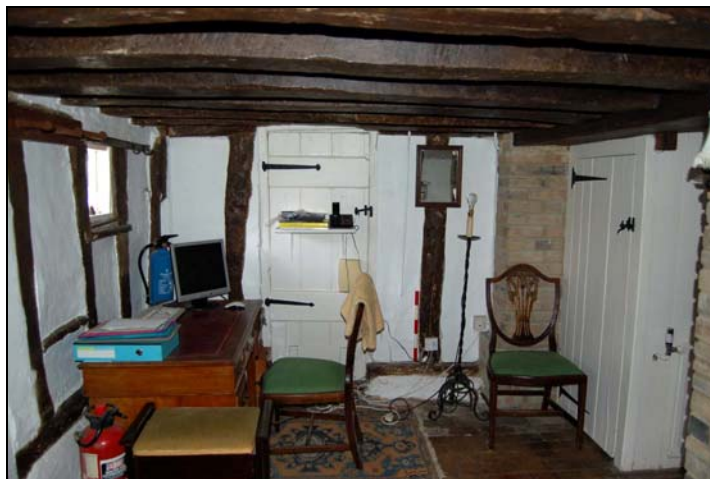
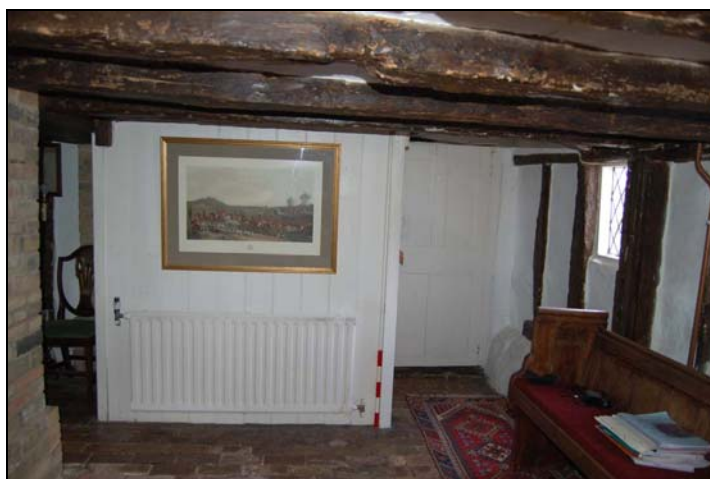
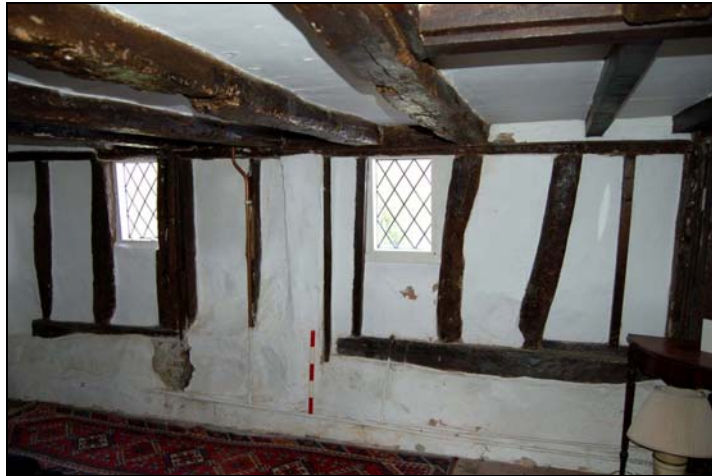
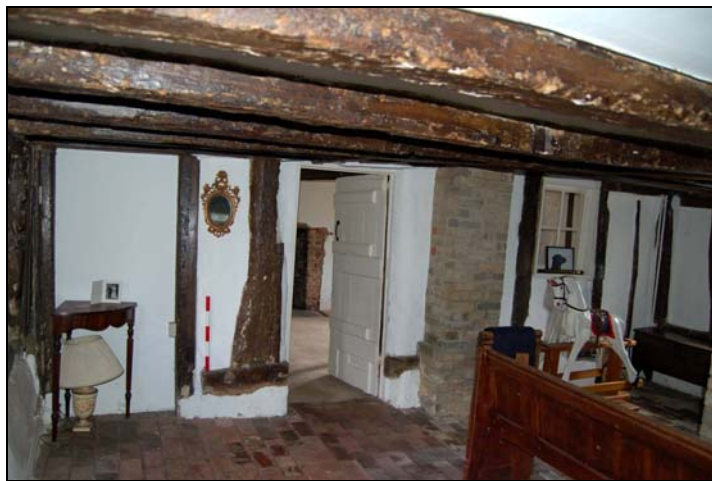
Description: This room, which is entered directly from the front door in the south wall, provides access to the dining room to the east, the living room to the west and the first floor by way of the inserted staircase in the northwest corner of the room.

It is lit by two modern windows in the south wall and a further two in the north wall. A window has also been inserted into the east wall which separates the reception from the dining room. The front door is a modern timber replacement but the plank and batten doors in the east and west walls are of some antiquity. The southern door in the west wall has three boards, long strap hinges and hangs on pintles. The northern one is a later 4-panelled door. That in the east wall has five boards and hangs on hinges. Both are later insertions as is clear by the cut sill beams.

There is evidence for two original doors in the east wall, both of which are now blocked. The timbers flanking the northern door opening are moulded, which is not the case elsewhere.

The bridging beam has been removed and replaced by a lesser beam supported by three modern brick pillars. The joists are tenoned into the modern timber and some saw cut joists have been added to the south of the new beam. Three saw cut timbers have also been added to the earlier frame in the north wall.

Plate 1: Reception: south wall

Plate 2: Reception: west wall, south

Plate 3: Reception: west wall, north

Plate 4: Reception: north wall

Plate 5: Reception: east wall

- 5.1 The evidence from the timber frame, fenestration and inserted staircase indicate that the reception has been altered on several occasions since first built. The east wall originally had a door at the northern end, which has subsequently been blocked. The southern end of the east wall was altered to provide a doorway and later a window. The present door to the dining room is the latest opening to have been cut into the timberwork on this side. The southern, plank and batten door in the west wall also appears to be a later insertion. The 4-panelled door at the northern end of the west wall may be of a later style than the plank and batten doors, but no evidence was noted during the survey for the frame having been cut here to create a doorway. The most substantial alterations have been the insertion of the staircase and the modern ceiling beam. The latter has resulted in the insertion of the brick pillars to support it, which are completely out of keeping with the rest of the room.

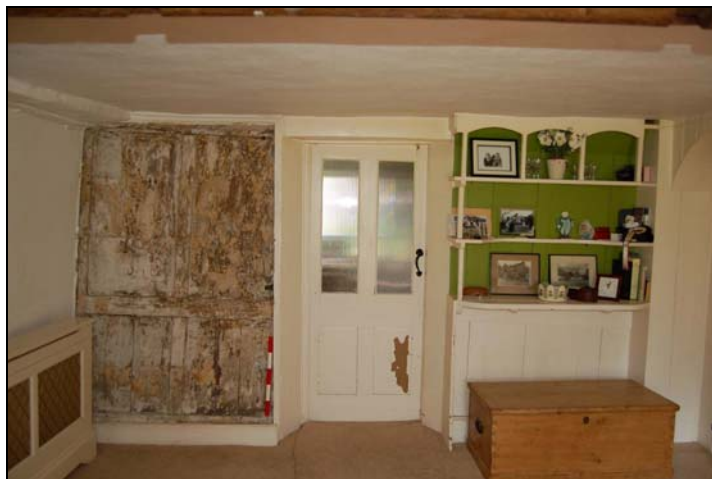
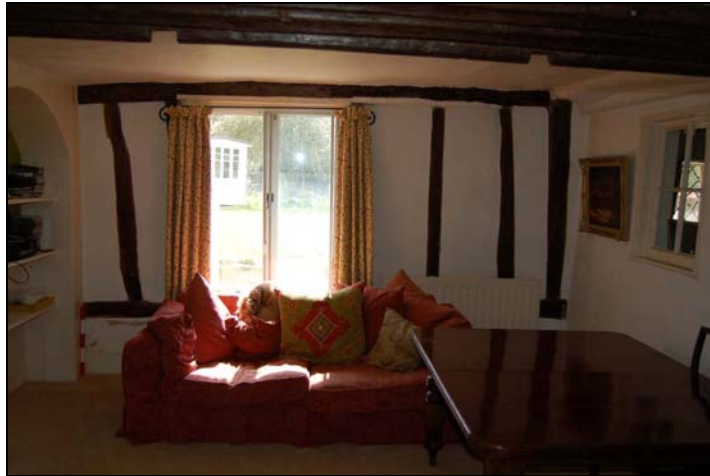
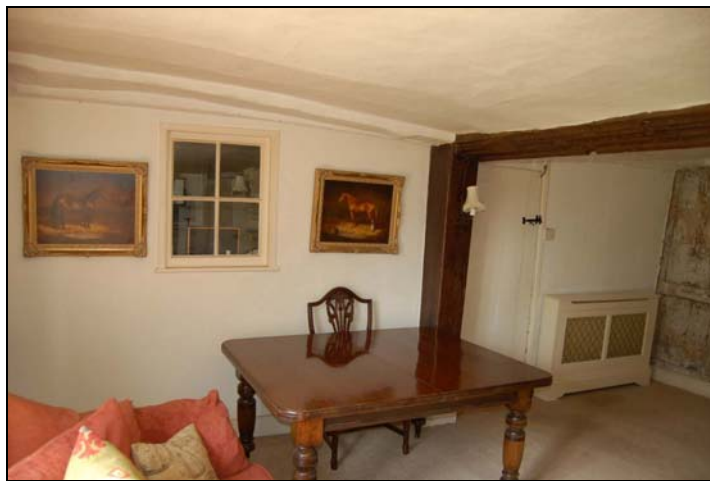
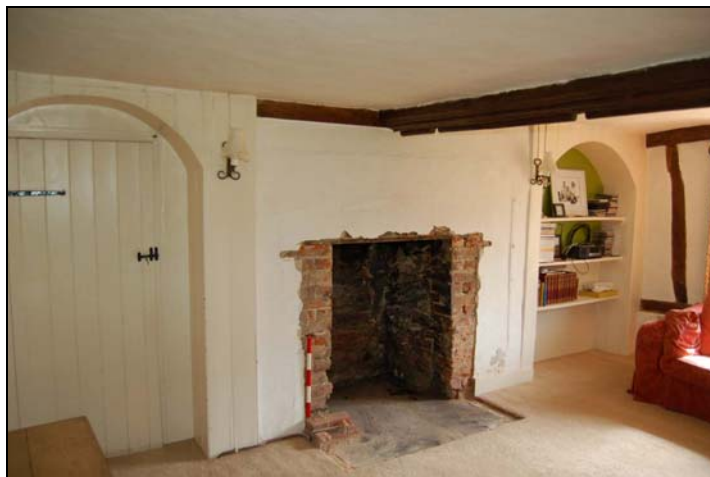
Description: The dining room has a blocked fireplace in the east wall with a recess on either side. The northern recess contains a door that opens into a single storey addition housing two service rooms. A window has been inserted into the frame in the south wall. The beam, which is late 15th century, is scarred by notches for earlier partition work.

The north wall separates the dining room from the kitchen, the half glazed door to which is located in a recess in the centre of the wall. The wall coverings to the west of the door were removed in order to establish the nature of the historic fabric beneath. This revealed some post-medieval panelling with the very fragmentary remains of different layers of wallpaper. The boards appear to be late 18th/early 19th century and

could be of elm. A panel was removed after the initial survey revealing some of the timber frame, which had both historic and modern plasterwork.

Plate 6: Dining room: north wall

Plate 7: Dining room: south wall

Plate 8: Dining room: west wall

Plate 9: Dining room: east wall

- 5.2 The scantling and distribution of the timbers in the south wall of the dining room suggest that this was a later addition to the building. The window in the south wall and the doorway and panelling in the north wall are later insertions. The panelling appears to be late 18th/early 19th century as do the bricks at the front of the inglenook fireplace.

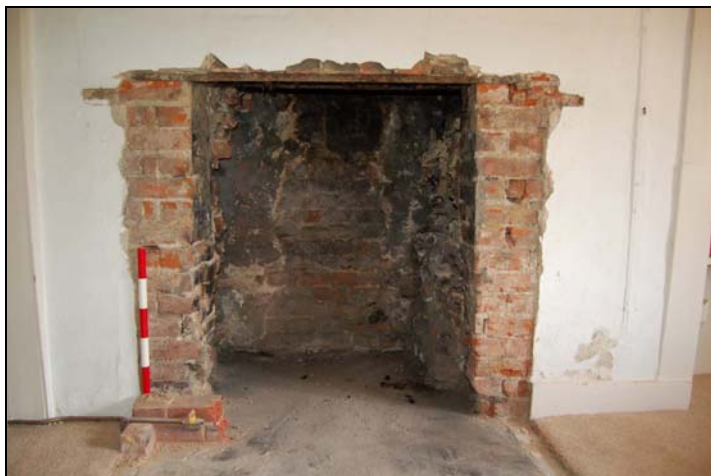
The fireplace was exposed for the purposes of this survey. The original inglenook has been rebuilt and reduced in size. The later bricks, which are friable, measure approximately 22 x 10 x 6cm and are set in a lime mortar. The brickwork at the back of the return walls is highly irregular, which is, no doubt, the result of the rebuilding. An iron lintel has been inserted as part of the reduced fireplace. The bricks in the rear wall of the fireplace are a deeper red and appear to have been plastered.

Plate 10: Dining room: fireplace detail

- 5.4 The fireplace shows two phases of construction; the original 17th century plastered brickwork to the rear and 18th/19th century rebuild to the front and sides.

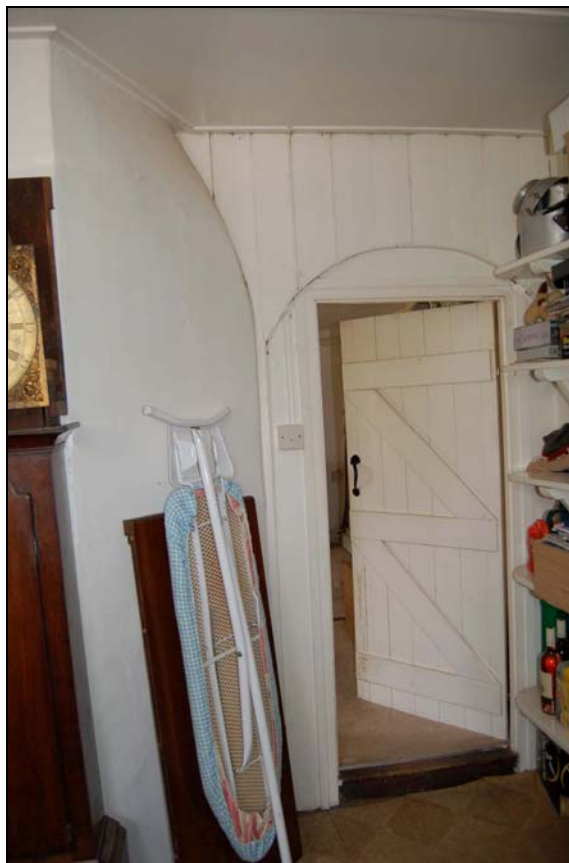
The utility and boot rooms are within a single storey extension at the eastern end of the building. The characteristic features in both are the rear of the fireplace and the boards making up the west wall.

Plate 11: Boot room looking west

Plate 12: Utility room looking west

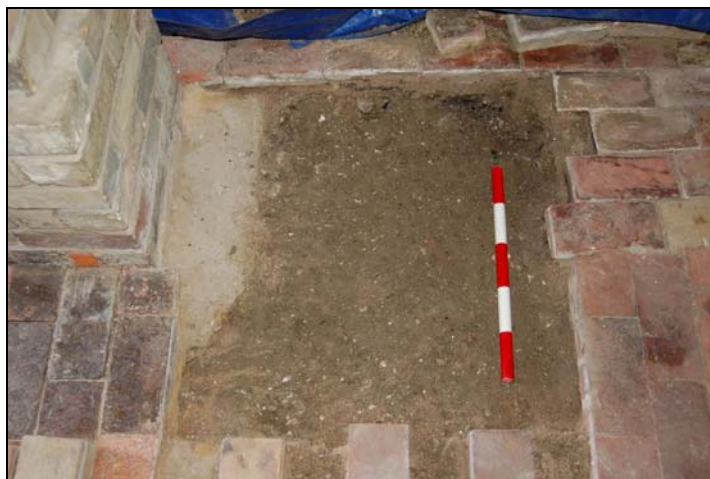
This was located immediately north of the free-standing brick pier in the centre of the hall. The brick floor was laid in stretcher bond: this ran east – west, east of a line level with the east side of the pier, and north - south to the west of that line. The brick pier was set on a concrete base of slightly larger dimensions than the pier, set into the natural clay.

The area of floor laid on a north-south alignment was comprised mainly of red handmade bricks measuring $c.226 \times 115 \times 45\text{mm}$. These were laid on a bed of dark brown/black soil containing pieces of flint and charcoal, $c.60\text{-}70\text{mm}$ deep. Beneath this layer was undisturbed natural green/grey clay.

The area of floor laid on an east – west alignment was comprised mainly of LBC stock bricks measuring $220 \times 106 \times 67\text{mm}$. These were laid on a bed of weak mortar mix, $c.30\text{-}50\text{mm}$ deep, overlying the natural clay, and also the concrete base of the brick pier.

No archaeological finds were recovered from Test Pit 1.

Plate 13: Test pit 1 looking west

- 5.3 Although the red floor bricks appear to be 19th century or earlier, the finds, LBC bricks (which perforce postdate the late 19th century) and mortar mixes suggest that the floors have been laid fairly recently. The grey/green clay which was reached between 6 and 13cm below the base of the bricks, appeared to be undisturbed natural.

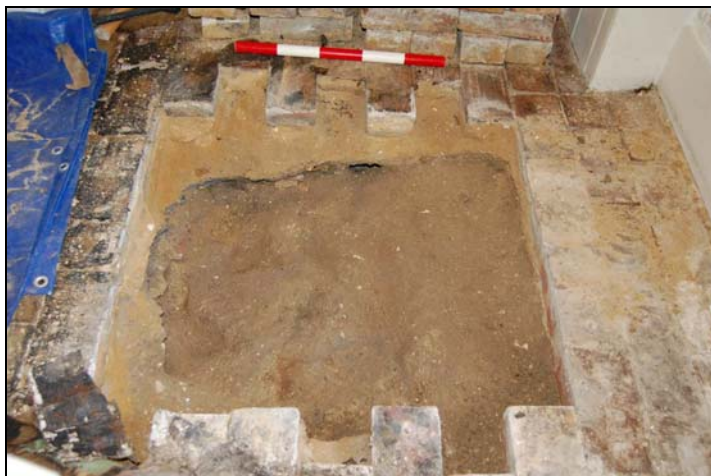
This was located in the south-west corner of the dining room. The brick floor was laid in stretcher bond, aligned east – west, and was comprised of a mixture of frogged bricks, $225 \times 110 \times 65\text{mm}$, and unfrogged bricks, $225 \times 110 \times 40\text{mm}$. These were laid in a weak mortar mix $c.40\text{-}60\text{mm}$ deep. Beneath this in the north part of the test pit was the remains of a possible mortar floor, $c.100\text{mm}$ below the present floor level. Beneath the possible floor was a layer of loose dark soil containing charcoal, $c.20\text{-}30\text{mm}$ thick, extending across the whole of the trench, overlying uneven natural clay. Beneath the possible mortar floor to the east of the trench was a void, the full extent of which could not be determined.

A glass fragment, a piece of animal bone and a small piece of pipe stem were recovered from Test Pit 2. The glass was not patinated, fairly thin and appeared to be 19th century or later.

Plate 14: Test pit 2 looking east
