**WATCHING BRIEF:
24 BRITTENS LANE
SALFORD
BEDFORDSHIRE**

NGR: SP 9338 3931

ASC: 1227/SBL/2

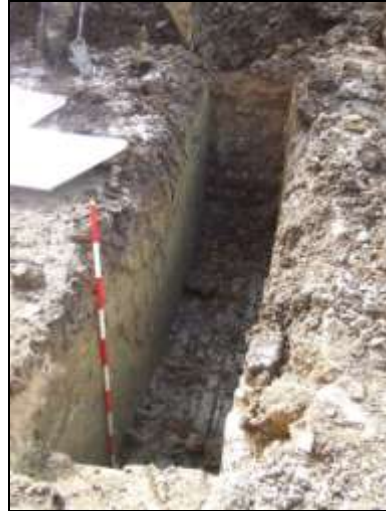
Plate 1: Western arm of footing trench, looking south (*scale= 2m*)

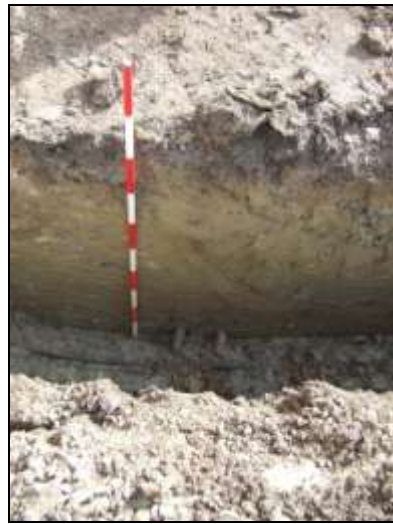
Plate 2: Sample section of footing trench, looking north (*scale= 2m*)

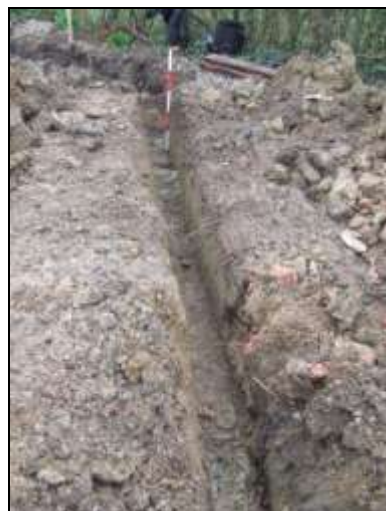
The service trenches were excavated on the same alignment as the eastern and southern footings, with a further arm excavated north west into the driveway (Plate 3). The trenches were *c.*0.3m wide and *c.*0.6m deep. The stratigraphy was similar to that described above.

Plate 3: Service trench extending into driveway, looking south east (*scale= 1m*)

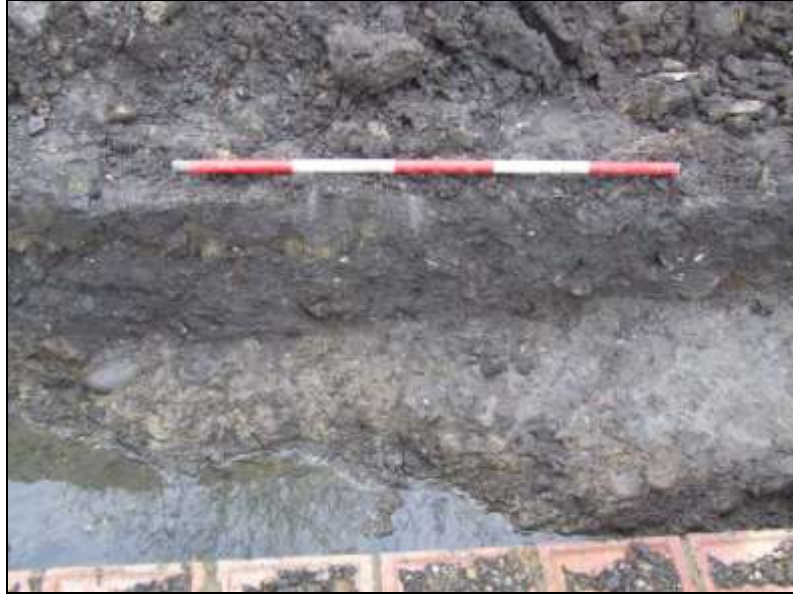
An area of cobbles was encountered in the eastern arm of the service trench *c.*0.6m below ground level (Plate 4). No dating evidence was recovered from the cobbled surface noted in the southeastern corner of the development, but it lay *c.*0.6m below the ground level of the back garden. Mr Majoor commented that the ground level in the garden, including the area where the cobbles were uncovered, had been raised by 0.6-0.8m within the last 10 years when it was renovated by the client. He also remembers garden features in the area, and it is possible that the cobbles represent a former garden path.

Plate 4: Cobbled area in eastern arm of service trench, looking east (*scale= 1m*)

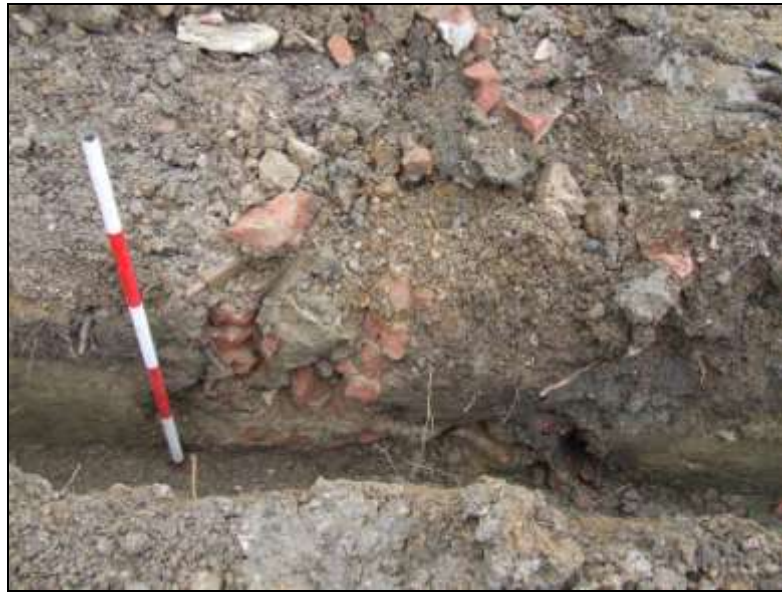
The corner of a brick built, filled in former manhole was encountered along the southern edge of the service trench that was extended into the driveway, *c.*3.5m from the southwest corner of the development (Plate 5). No further archaeological finds or features were observed with in the service trenches.

Plate 5: Disused modern manhole, looking south west (*scale= 1m*)
