**HISTORIC BUILDING ASSESSMENT:
FORMER ST JOHN'S NATIONAL SCHOOL
1A PEMBERTON GARDENS
ISLINGTON
LONDON N19**

May 2010

ASC: 1286/IPG/1

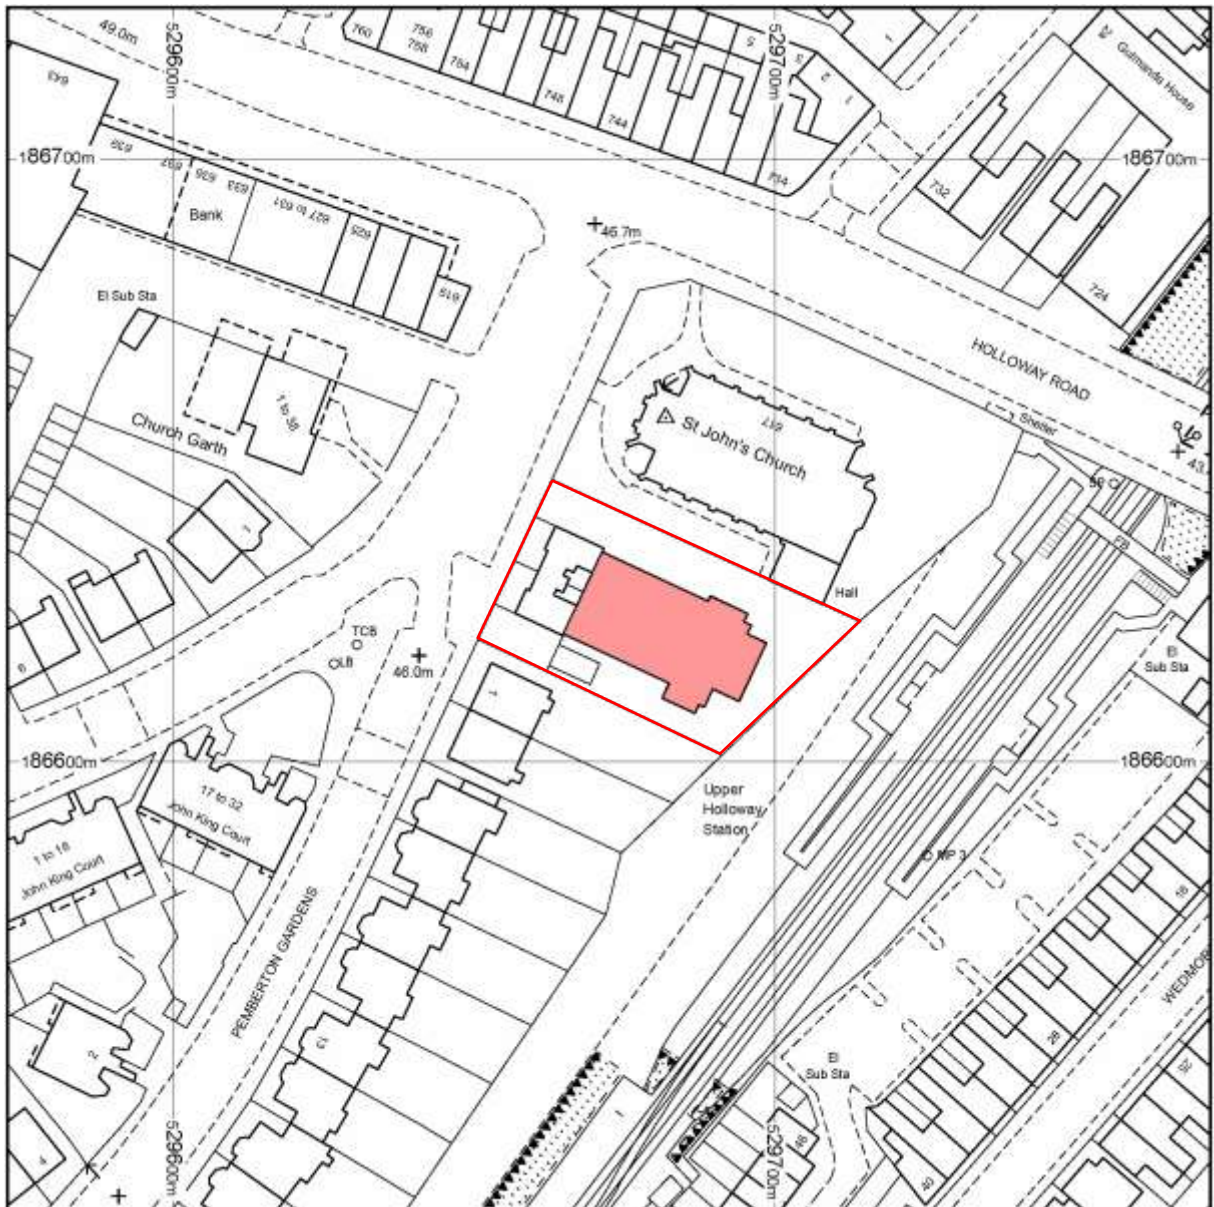
Figure 2: Site location, showing (shaded) the extent of the assessment (*scale 1:1250*)

The assessment site is located in Pemberton Gardens, in the London Borough of Islington, at Ordnance Survey National Grid Reference TQ 2967 8663 (Fig. 1). The site, which consists of the former St John's National School, cottages and school grounds, covers a total area of *c.*1500 sq. m, bounded to the north by the churchyard of St John's Church, to the east by Upper Holloway Station, to the south by residential properties and to the west by Pemberton Gardens (Fig. 2).

In line with the requirements of the LPA, the assessment was focused on the school building (Fig. 2), in order to inform the proposed conversion. A basic record was also made of the exterior of the cottages, for completeness' sake, and to assist in understanding the relationship between the two elements.

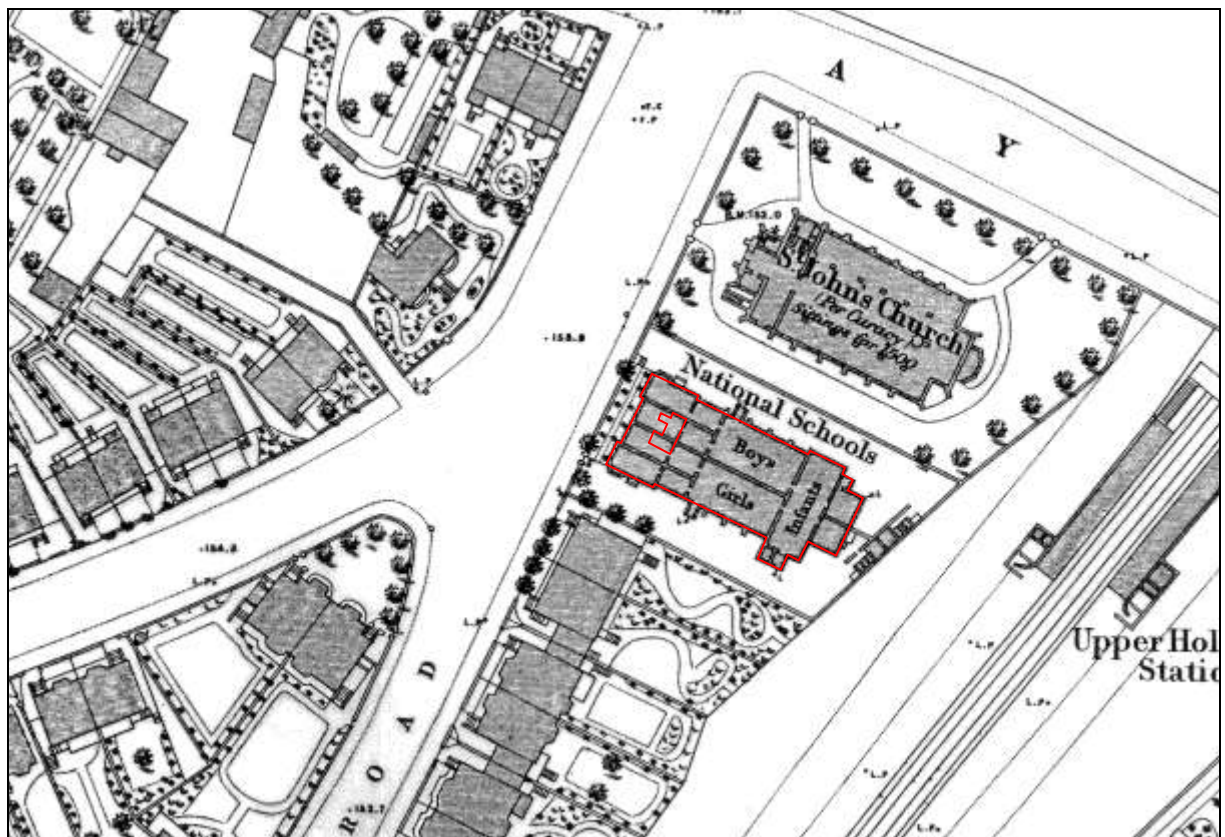
Figure 4: Extract from First Edition Ordnance Survey 60" sheet, 1877 (scale c.1:1250)

The earliest available map to show the school and cottages in any significant detail is the First Edition Ordnance Survey 60" sheet of 1877 (Figs 3 & 4). The site is labelled ‘National Schools: the school is divided internally into three large classrooms, with ‘Boys’ to the north, ‘Girls’ to the south, and ‘Infants’ across the east end. The boys’ and girls’ classrooms each have entrance porches: the entrance to the infants’ classroom is through a porch at its south end. All three porches have lights above them. There are two rooms to the east of the infants’ classroom, with a small porch at the north end. At the west end of the complex, the cottages are each shown as having two rooms, with doors leading through to four rooms in the link building area, and further doors to the main classrooms. East of the school building, a range of small structures along the east boundary of the site are presumably outside toilets. Other details shown include the arrangement of alternating windows and buttresses along the north and south elevations, the porches and bay windows on the north and south elevations of the cottages (omitted on many later, smaller-scale maps), and the original locations of doors and windows.

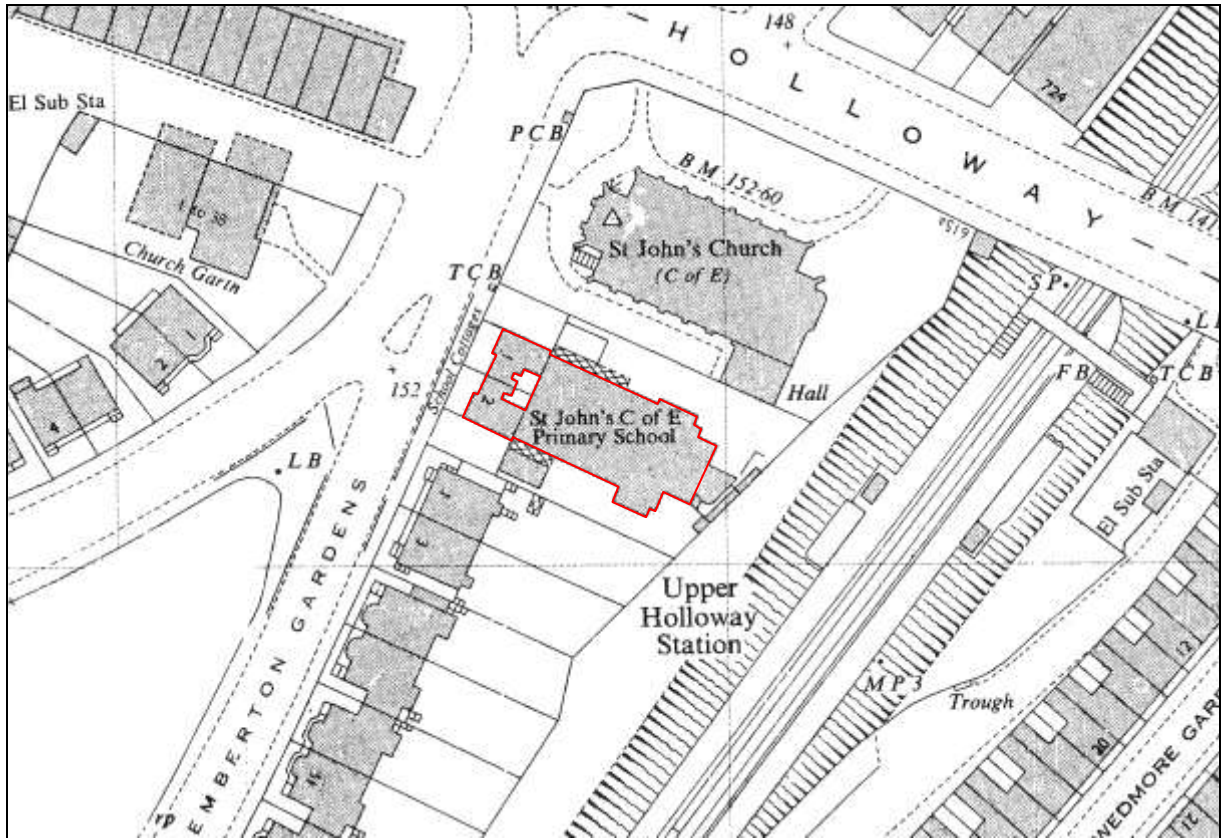
Figure 9: Extract from Ordnance Survey 1:1250 sheet, 1974

The 1:1250 Ordnance Survey sheet of 1952 (Fig. 8) is the first to show the cottages as two separate entities, labelled 'School Cottages, with the numbers '1' and '2', and with open yards to the rear. Other changes include the shortening of the glazed canopy on the south side of the school, the apparent removal of the roof of the northern outbuilding, and the construction of a roughly trapezoidal structure between the east end of the school, and the outside toilets. The next 1:1250 sheet, dated 1974 (Fig 9), shows no change to the buildings. The site is labelled 'St John's C of E Primary School'.

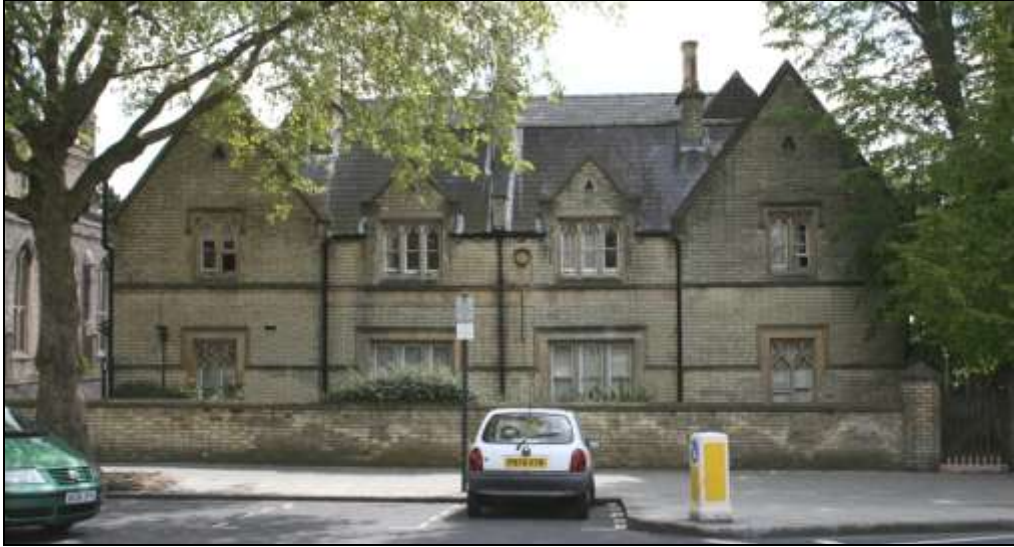
This is the front of the complex, and the street frontage of the cottages, which are built in a Gothic style. This elevation has gable ends to north and south, flanking a central section with two dormer windows at first floor level. Like the rest of the cottage, this elevation is constructed in white bricks (22 × 10 × 7cm) laid in Flemish bond with cement mortar, with a plinth 36cm high, and fine limestone dressings. The ground-floor windows are flat-arched with rectilinear tracery, except the innermost which have three flat-arched lights with sashes. Over these windows is a string course, rising to hood mouldings above the windows. Over the central windows is a stone band, engraved 'ST JOHN'S NATIONAL SCHOOLS' in Gothic script. There is a stone string to the sills of the first floor windows, all of which are flat-arched, of two and three lights with trefoiled tracery, the central pair (3 lights) in full dormers, the outer windows (two lights) in the gabled bays, with hood mouldings. There are trefoil vents at attic level in the gables and dormers. The roofs above are slated, with a central party wall and three stacks set axially along the ridge, all with panelled chimneypots.

Plate 1: Cottages: west elevation, from west

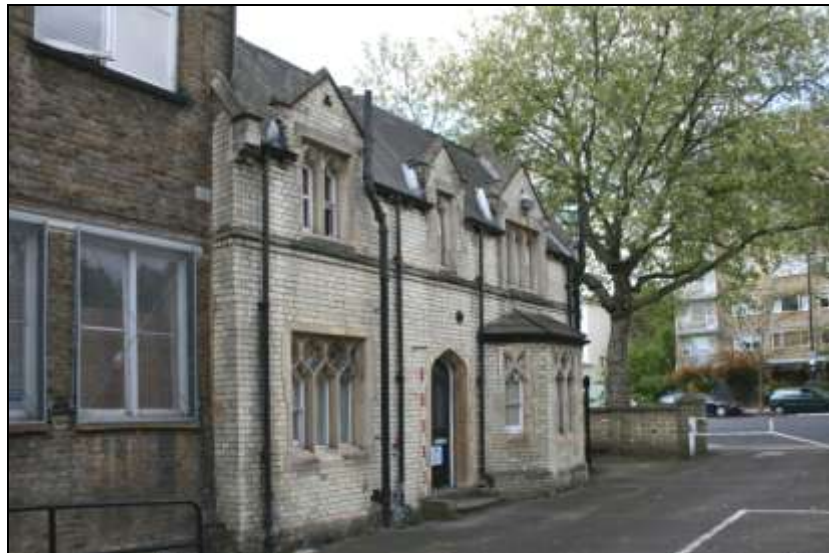
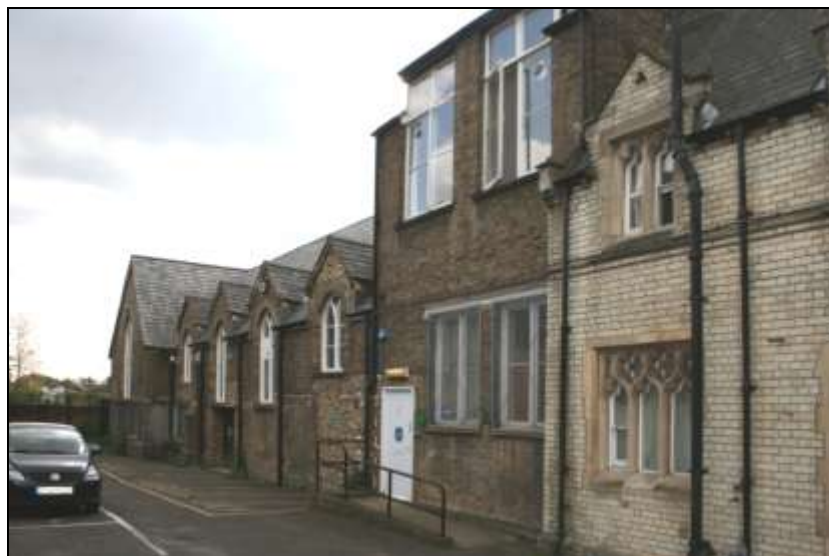
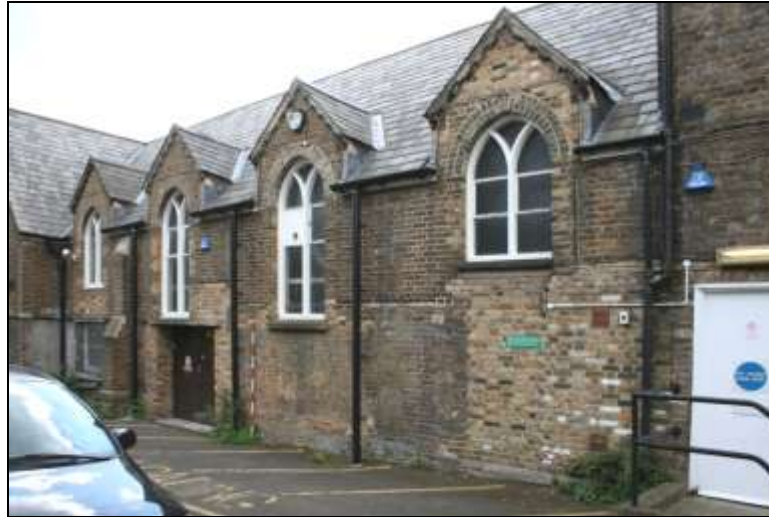
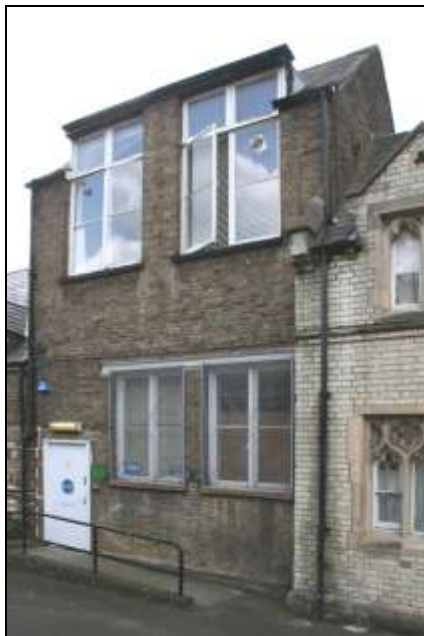
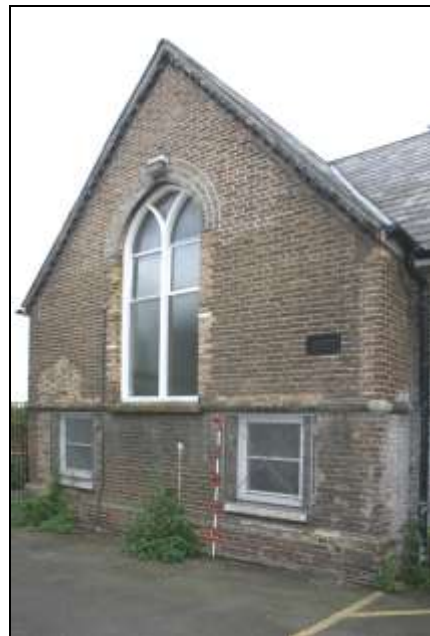
This elevation, facing the church, consists of four parts. The west end, *c.*7.0m in length, is the north elevation of the cottages, built in the same materials and style as the west elevation. At ground floor level is a central entrance, with a Tudor arched stone surround, and door with three glazed panels. Flanking this to the west is a canted single-storey bay window with trefoiled tracery: to the east is a three light window, also with trefoiled tracery. There is a stone string to the sills of the three first floor windows, all of which are set in full dormers, and are flat-arched, of two, one and three lights (east to west). There are trefoil vents at attic level in the larger outer dormers.

Adjoining the cottages, and evidently of later build, the second part of the elevation, c.4.3m in length, comprises a two-storey wing constructed in yellow bricks (22 × 10 × 6cm) laid in Flemish bond, in cement mortar, with a low plinth. This wing, which rises c.1.5m above the ridge height of the cottages, consists of two storeys under a slate roof. At ground floor level are two tall 2/2 light timber frame windows, and a modern flush panel door, approached by a concrete ramp with tubular iron handrails. At first floor level are two large flat-arched studio windows with opening casements, beneath a flat-roofed dormer.

East of the two storey wing is the main body of the school. This consists of four bays, separated originally by full height stepped buttresses, each surmounted by a dentillated dormer containing a pointed-arched window with Y tracery glazing bars. It is constructed in yellow-brown brick similar to the two-storey wing, laid in Flemish bond with cement mortar. The easternmost bay has a plinth, and a stone string course at sill level (2.1m above ground level), both extending into the next bay to the west. Although these features are not present further west on the elevation, it seems likely that they have been removed by subsequent repairs and alterations. Only one buttress remains, but the positions of the others are visible in the brickwork. Other alterations or repairs to this elevation are as follows:

- Far west bay: areas of rebuilding (including possible blocked door?) below and above window. The window in this bay is shorter than those in the central bays: the degree of repair around it is such that it is not certain whether or not this window has been shortened.
- Centre east bay: inserted double-leaf door beneath inserted concrete lintel: areas of repair to west of door and window.
- Far east bay: original arched window shortened: modern 1/1 light window inserted in wall beneath it.

At the east end of the main body of the school is a projecting cross-wing, of similar construction to the main building, with a plinth, stone string course, and dentillation to the gable, which has a central pointed-arched window with Y tracery glazing bars. Between the string course and plinth, two modern 1/1 light windows have been inserted. The cross-wing has a slate roof, rising to the same height as the main body of the school. The elevation terminates in a second, smaller cross-wing, built of similar materials and brick bonding, with dentillation to the gable. In the centre of the gable is a tripartite window under chamfered concrete lintels, with a plain concrete sill. This has been bricked up, leaving only the upper part of the taller central section as a 1 light window, with an inserted concrete sill. In the angle between the two cross wings is a slate roofed brick built porch, with a pointed-arched door facing north.

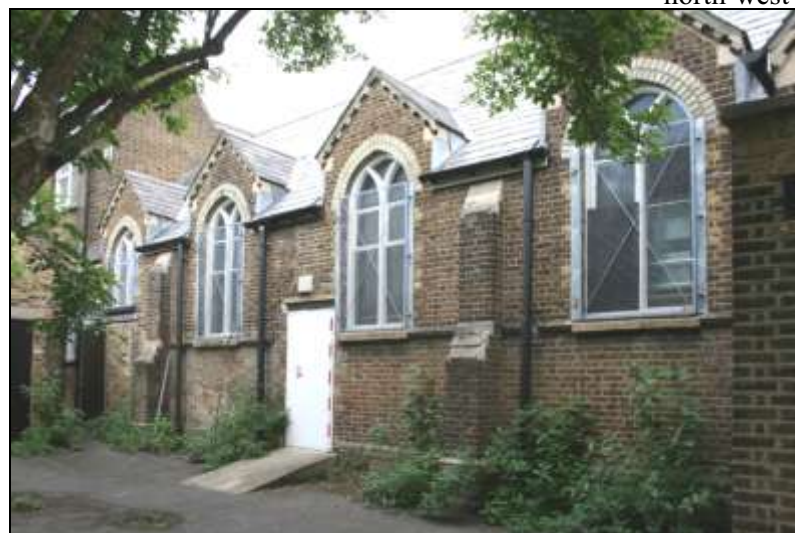
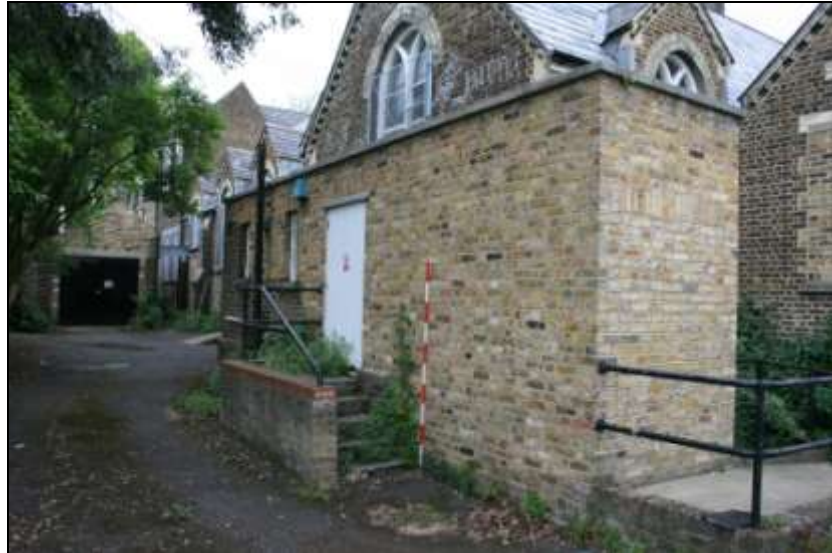
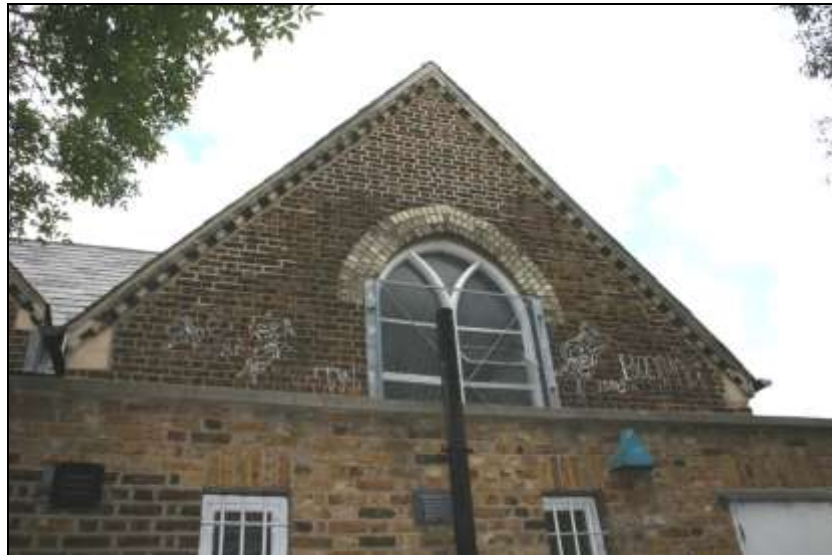
This is essentially a mirror image of the north elevation. The east end mirrors the north elevation of the cottages. The two-storey section has the same fenestration as its north elevation, but no external door. The elevation of the main body of the school retains most of its original detailing: the plinth and string course are more or less complete, and there is a bricked-up doorway below the westernmost window, which appears to have always been shorter than the other windows to accommodate this. A door inserted next to the blocked doorway provides access to the upper floor of the

two-storey wing. The buttress between the central bays has been removed, and a door with a concrete access ramp and lintel inserted. Moving to the east, the larger cross wing has the same dentillation on the gable, and the same pointed-arched widow with Y tracery. The lower part of the elevation is hidden behind a modern brick-built, single-storey, flat roofed extension, which incidentally does not appear on any Ordnance Survey mapping of the site, and which probably postdates the use of the building as a school. In the smaller cross wing, the same bricked up tripartite window is present.

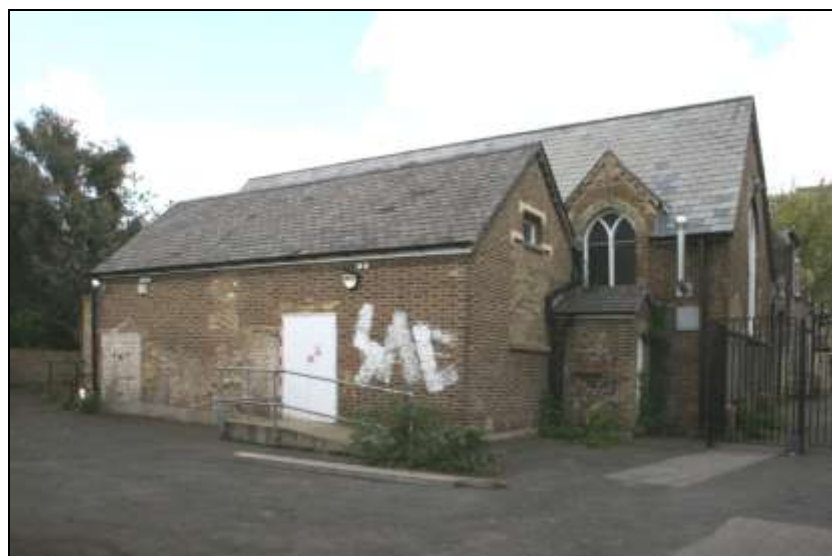
The larger of the two eastern cross-wings is largely obscured by the smaller cross-wing, on which the only feature is a modern two-leaf door, with a concrete access ramp with tubular metal handrails. The larger cross wing has two pointed-arched windows with Y tracery, beneath small dormers. The roofs of both cross wings are slated. The small porch described above is located beneath the northern window.

Plate 10: School: east elevation, from north-east

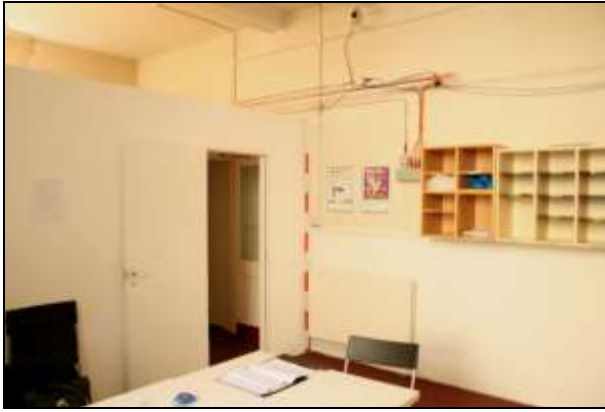
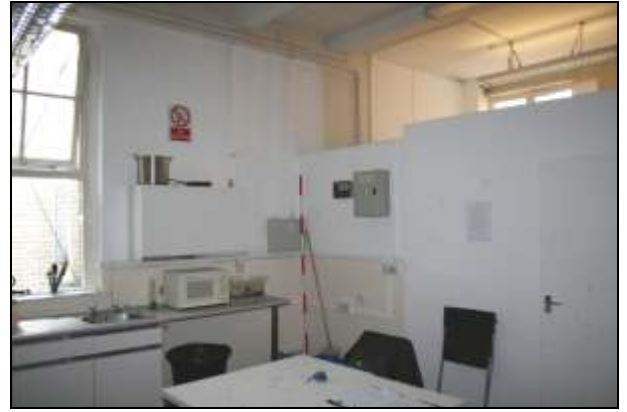
Description: Floor carpeted, over concrete. Walls plastered and painted, with plain skirting and dado rail. North wall is modern studding. Ceiling painted, with east-west support beams. Door to lobby in partition to north, glazed door to G2 to south, opening to passage to west. Window to yard to west: top light pivots horizontally. Modern kitchen units & sink in south-west corner.

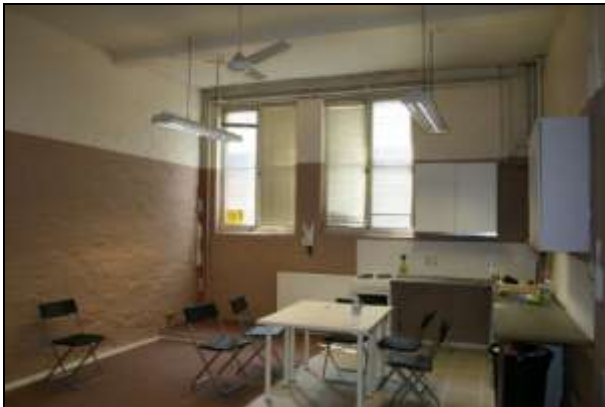
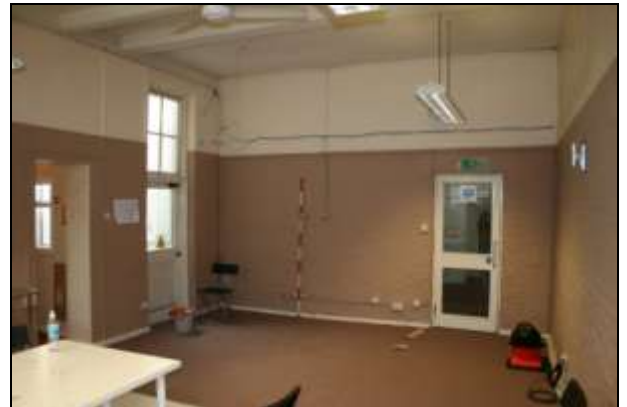
Description: Floor carpeted, over concrete. West wall plastered and painted, other walls painted brick, all with plain skirting. Ceiling painted, with east-west support beams. Glazed door north to G1, doorway to cottage to west, half-glazed external door with fanlight above to enclosed yard to west. Two tall 2/2 windows to south. Modern work surfaces, sink etc in south-west corner.

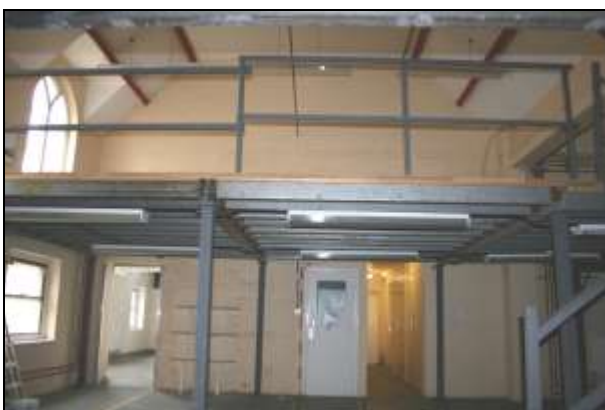
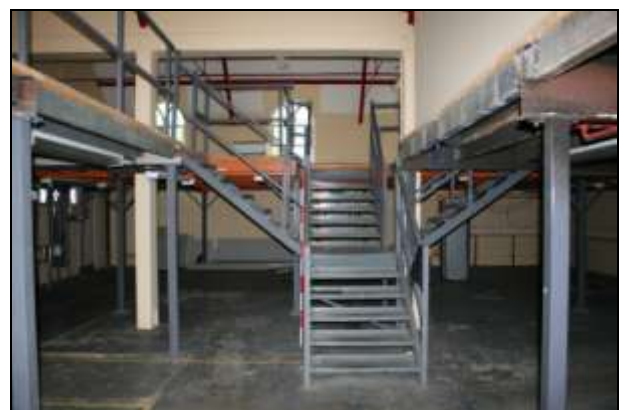
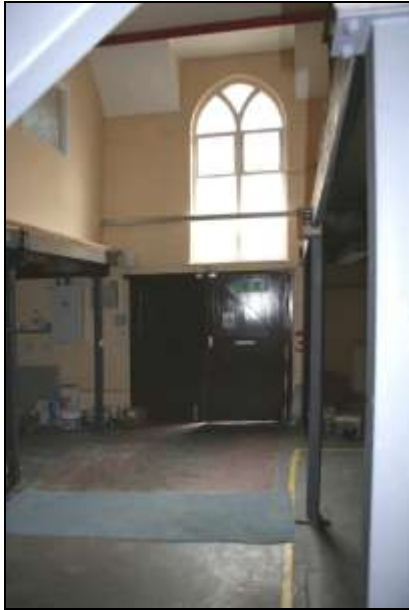
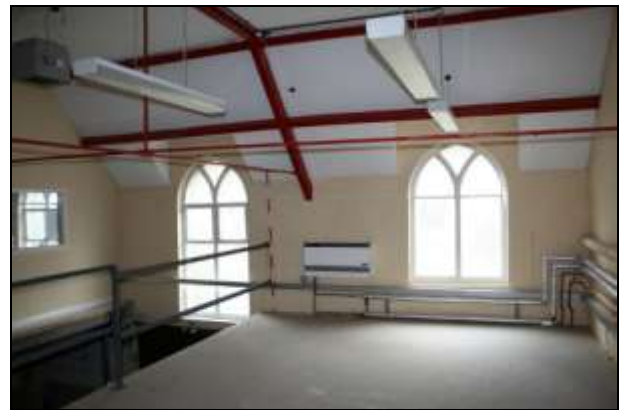
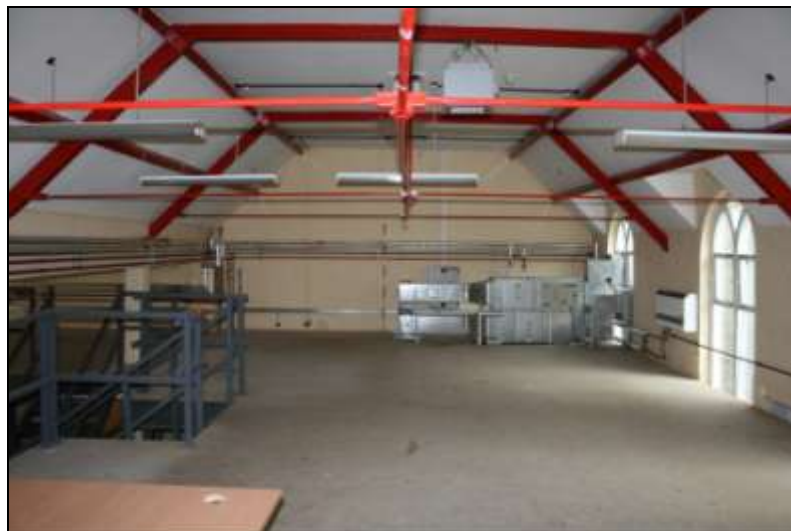
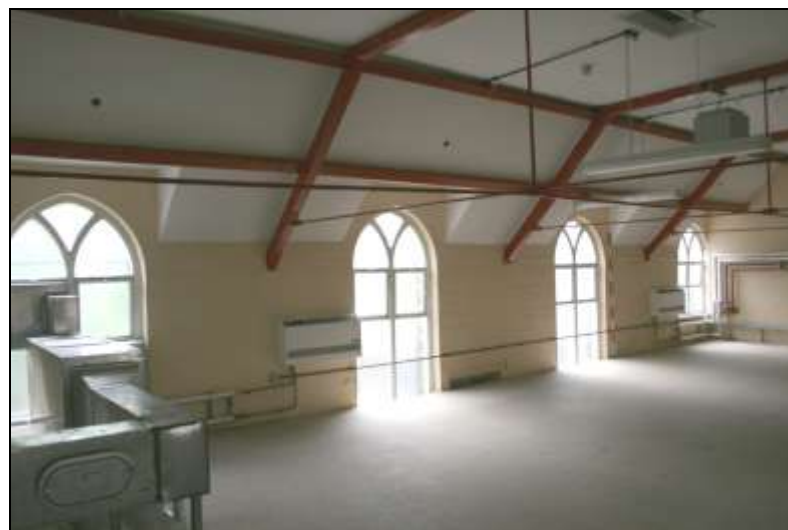
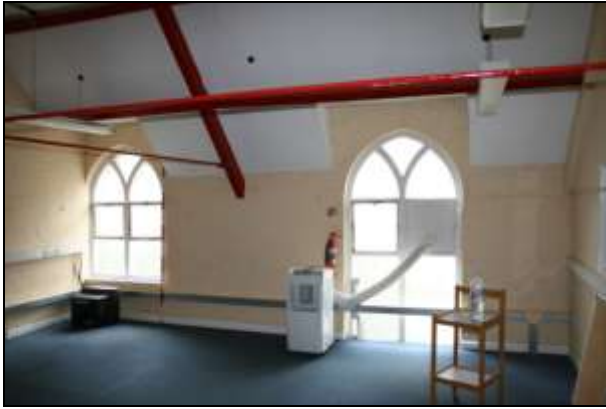
Description: Painted concrete floor, painted brick walls, room open to roof with ceiling at roof collar level. Exposed steel trusses, with cross-ties and hangers of iron rod: also two exposed purlins on each pitch of roof. Central valley of roof carried on east-west reinforced concrete beam, supported by three concrete pillars (line of former wall?). Ceiling recessed over dormer windows. Main external entrance to north: fire exit to south. Both are later insertions. Doorways to east to G4 and G6: door with glazed panel to G9. Arched windows with Y tracery to north and south, four each side: those at the west end appear to have been shorter, while the eastern window on the north side has been shortened. Beneath it a modern 1/1 light window has been inserted.

The mezzanine floor inserted by Islington Council consists of steel framing supporting a timber floor, with steel handrails around the open area inside the main entrance. It is accessed by a central steel staircase. The north-west corner of the mezzanine is partitioned off with studding and board walls to form a separate office (F2: 5.95 × 5.02m, height 3.43m). Other modern fixtures and fittings in G1 include ventilation / air conditioning equipment on both floors, fluorescent lighting throughout, and work benches in the south-west corner of the ground floor.

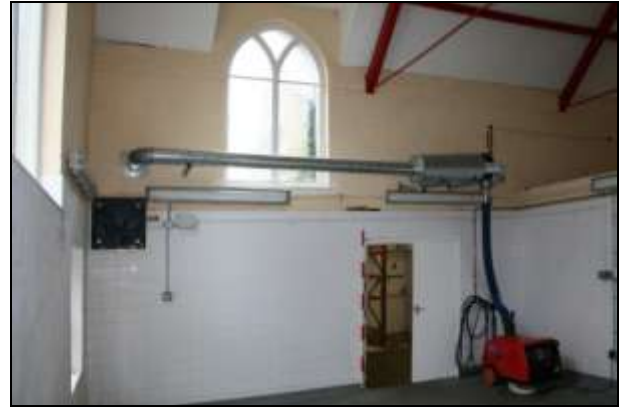
Description: This room occupies the north end of the large cross-wing. It has a rubberised floor and is open to the ceiling, which is of similar construction to that in G1. The walls are covered with glazed white ceramic tiles to a height of c.2.3m, and are painted brick above. The south-west corner of the room is partitioned off to form a WC with a small lobby, accessed from G1. The south side of the room is a breeze block partition wall, c.2.5m high, separating G4 and G6. To the west is the doorway to G3, to the east double doors lead to G5. To the east and north are arched windows with Y tracery: the latter is flanked at ground-floor level by two inserted modern 1/1 light windows.

Plate 22: G4, view south-east

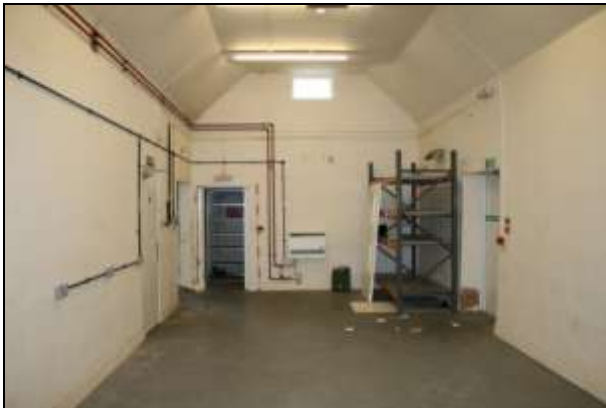
Description: This room occupies the whole interior of the smaller cross-wing. It has a concrete floor, plastered and painted walls with plain skirting, and a hipped ceiling

with a hatch to the roof space at the south end. Set in the end gables, just below ceiling height, are small one-light windows. To the west are the double door to G4 and a flush panel door to G6, to the east a modern external fire exit door. A doorway at the north end leads to the small external porch, which has been most recently fitted with shelves and used for storage.

Plate 23: G5, view north

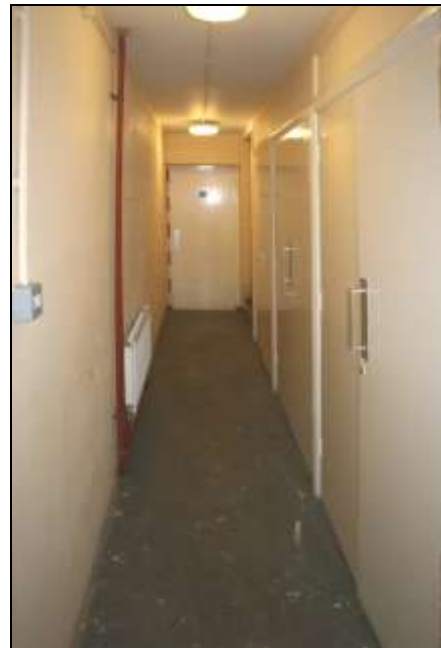
Description: This passage links storage areas G3 and G5, and the technicians' area (G7-G10). It has a concrete floor, a painted breeze block wall to the north, and a row of full height fitted cupboards to the south. There is a doorway to G3 to the west, a flush panel door to G5 to the east. Also at the east the passage turns to the south to a flush panel door to G8, rising up two steps.

Plate 24: G6, view east

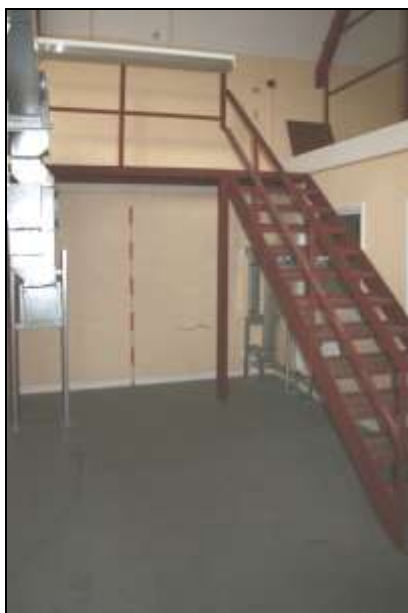
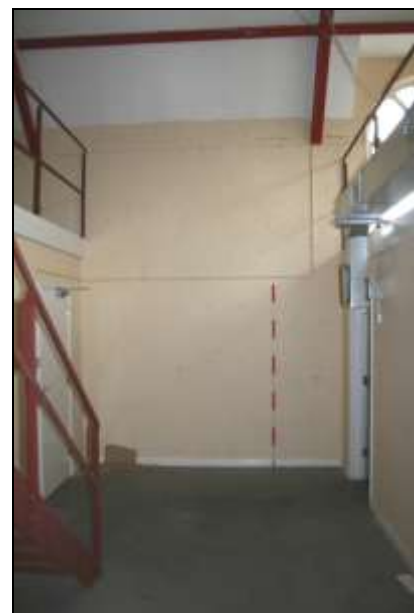
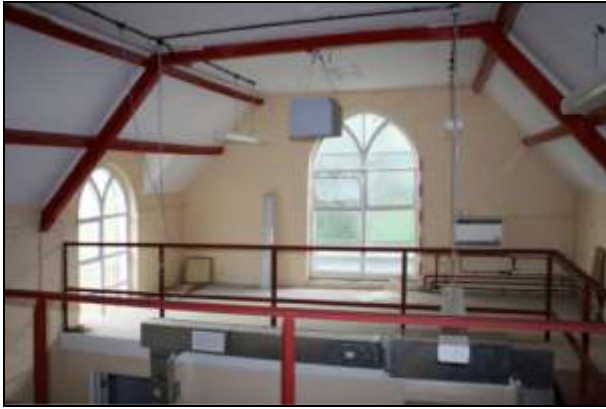
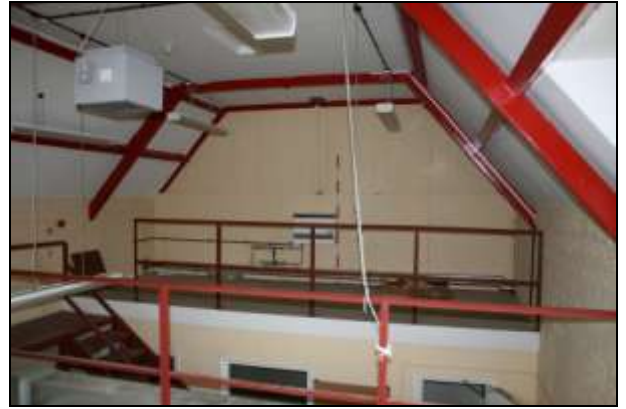
Description: This room occupies the central part of the principal southern room of the larger cross-wing. It has a rubberised floor, painted brick walls to the west and east, and modern studding partition walls to the south and north. It is open to the ceiling of the cross-wing, which is as described for G1 and G3. There is a short lobby to the north leading to G6 and G7, with flush panel doors to both rooms. A flush panel door to the south leads to G9. There are two glazed panels in the north wall, but no external windows. A steel staircase rises against the north wall to give access to F3. On the south wall is modern ventilation / air conditioning equipment.

Above G7 and G9, the technician's storage area (F3) occupies the whole area of the principal southern room of the larger cross-wing (6.11 × 8.2m). It has a board floor, carried on steel joists, and is accessed by the stair from G8. As with G8 the walls are painted brick, though the upper part of the north wall is matchboarded. There are arched windows with Y tracery to the east and south.

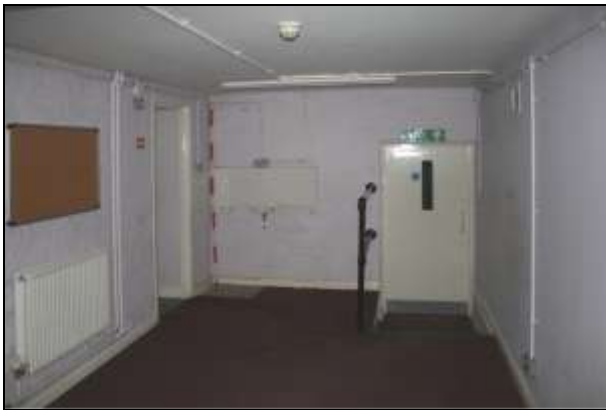
Description: This room occupies the south part of the principal southern room of the larger cross-wing. It has a carpeted concrete floor, painted brick walls to the west, south and east, a studding partition wall to the north and a painted ceiling. There are flush panel doors to the north (G8), south (former kitchenette) and west (G3), the latter

down two steps, with an iron handrail. A doorway to the south leads to G10. The lower part of a Y traceried window lights the room from the east.

Plate 29: G9, view south-west

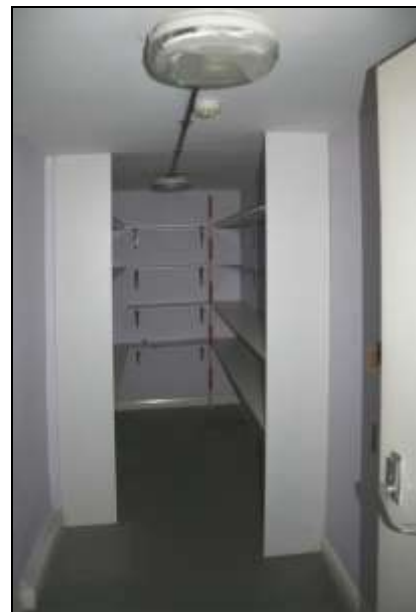
Description: Room G10 consists of three distinct areas. All have rubberised floors and painted plastered walls and ceilings, with plain skirting. From west to east they comprise:

- Kitchenette, 1.5m long. Part tiled walls, small 2-light window to south, door to G9 to north
- WC, 2.1m long. Modern WC and hand basin, small 2-light window to south, door to lobby to east
- Lobby/store, 4.3m long. Lobby with doorway to G9 to north, door to WC to west, doorway to store to east, and external fire door to south. Store fitted with shelves.

Plate 30: G10, view east
