**WATCHING BRIEF:
ALL SAINTS CHURCH
CHURCH ROAD
MARSWORTH**

NGR: SP 9198 1460

on behalf of Marsworth Parochial Church Council

ASC: 1270/MAS/1

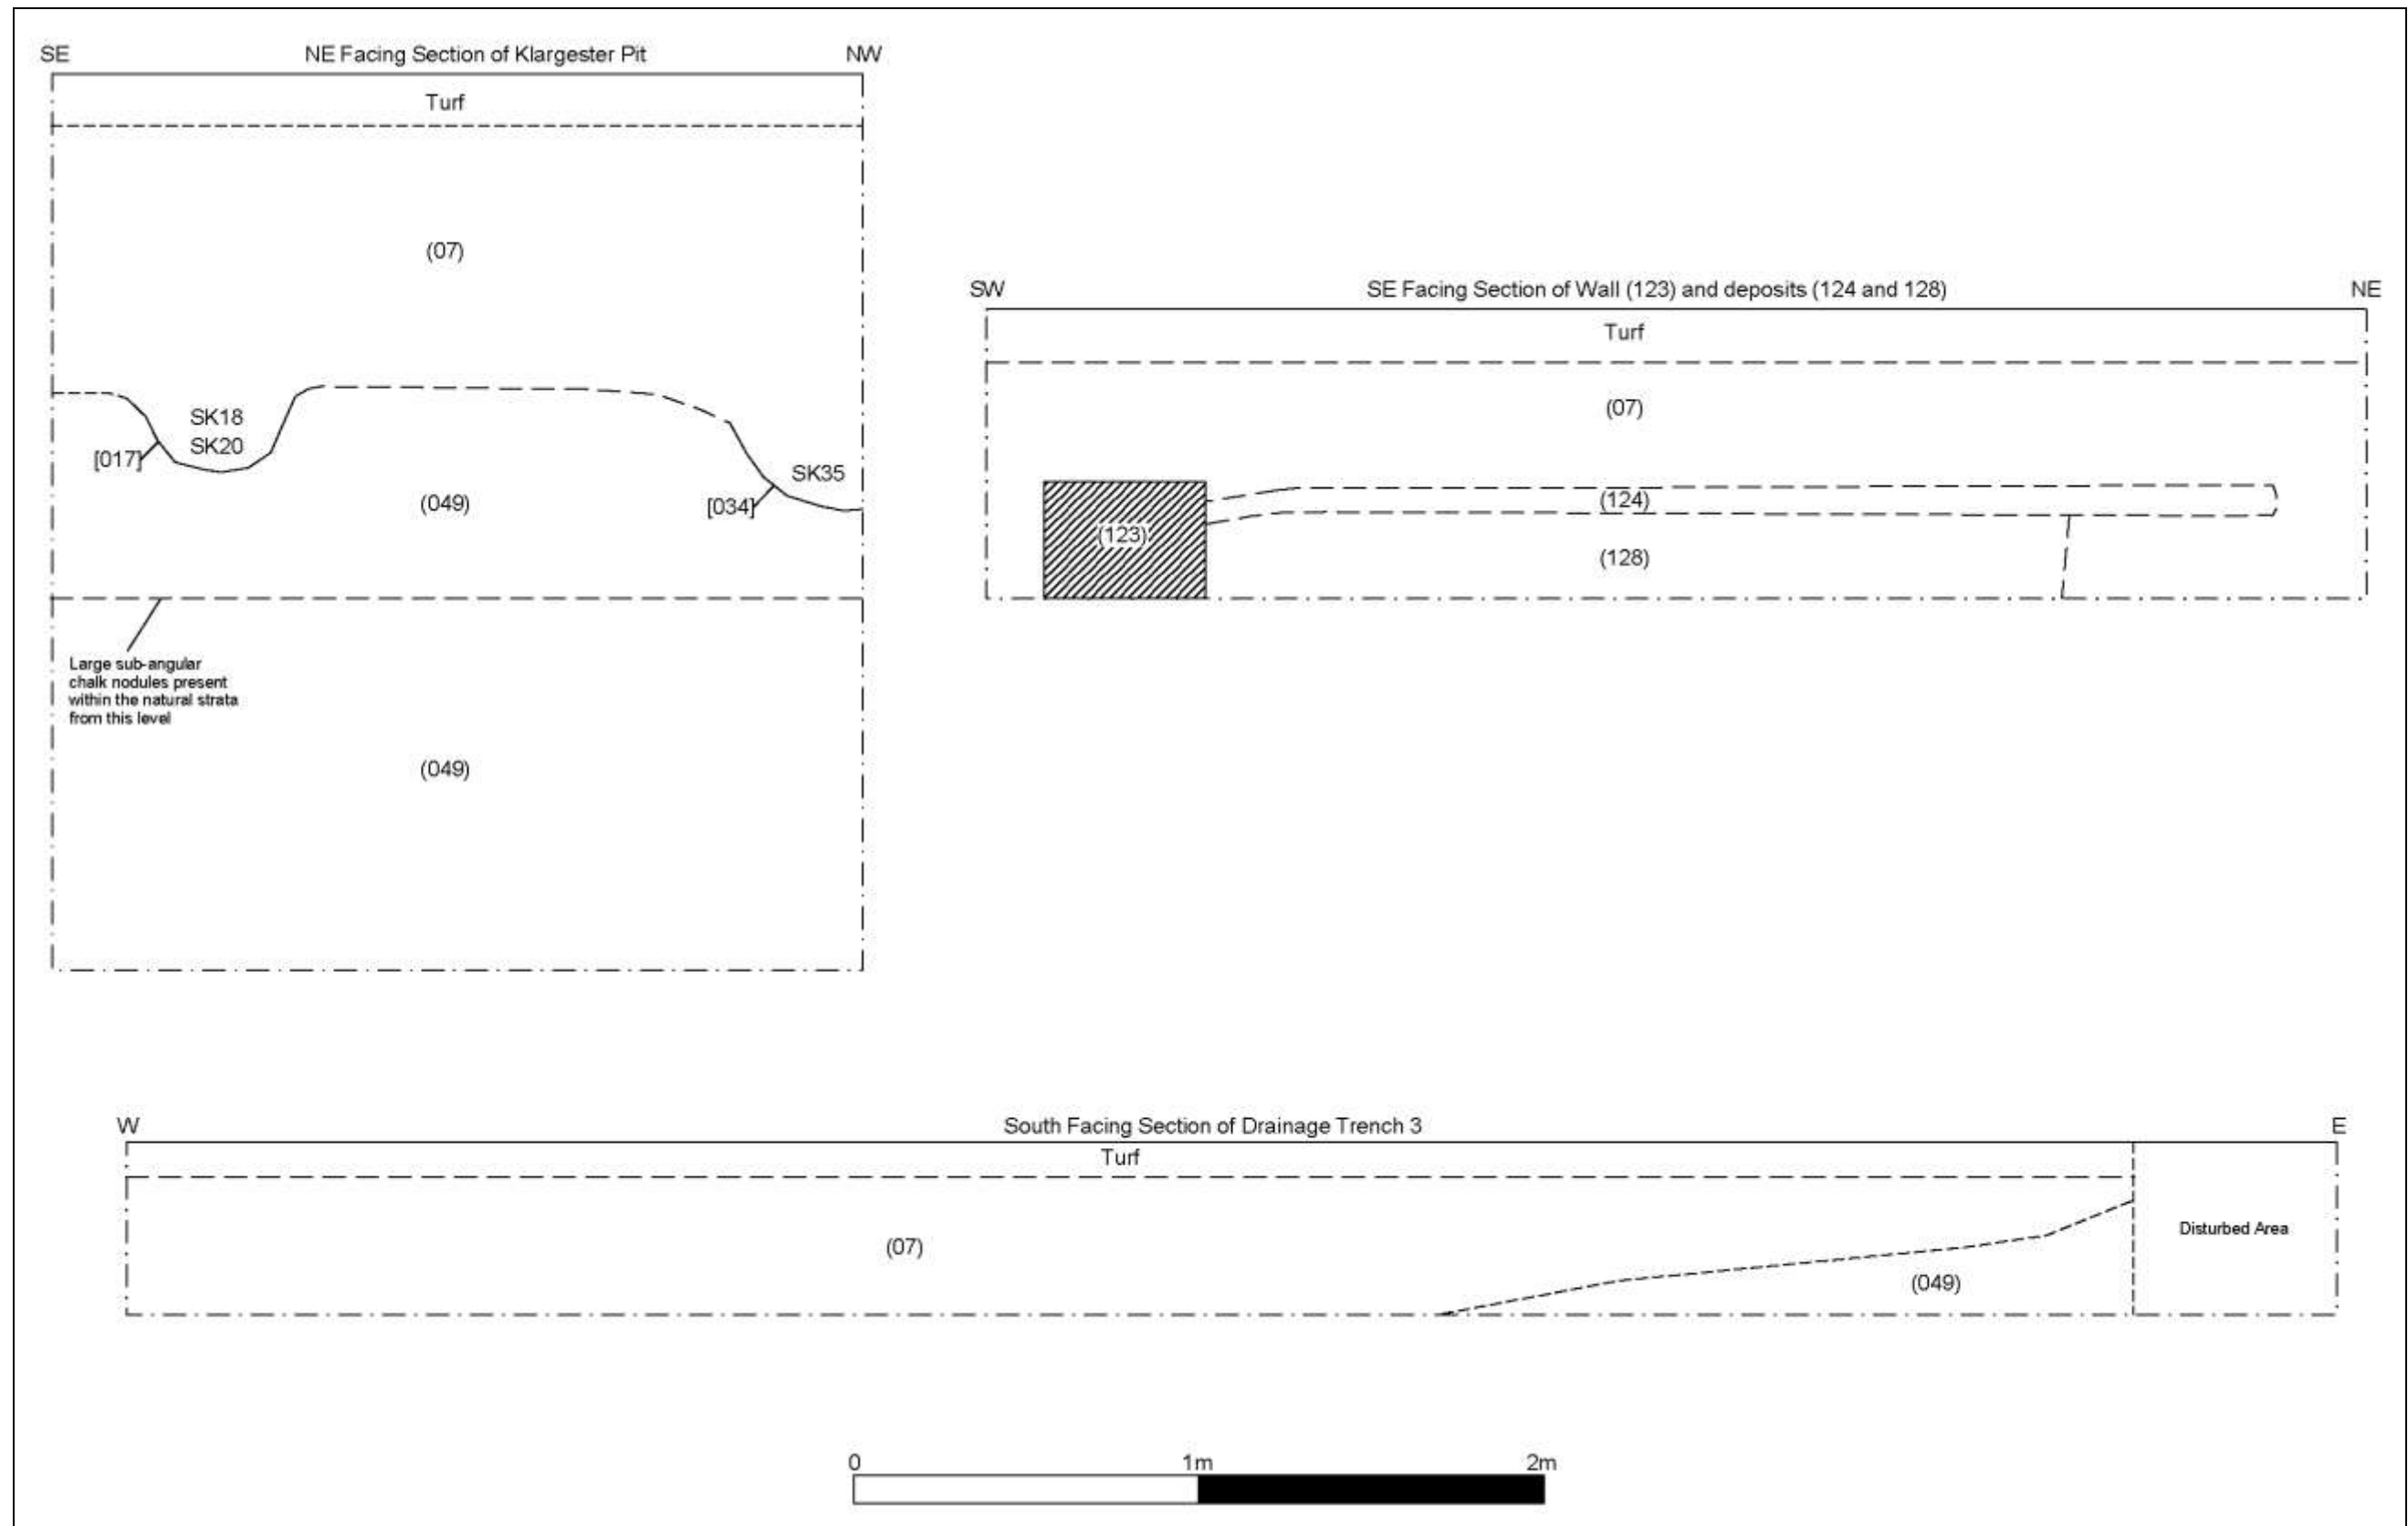
Figure 7: Section Drawings (scale 1:20)

4.1 *Stratigraphy* (Fig. 7; Plates 3, 5 & 10)

The stratigraphic sequence for the site consisted of *c.*0.10-0.15m of turf, beneath which was *c.*0.07-1.00m of cemetery soil (07) consisting of mid brown/grey, friable silty clay with moderate small-medium sub-angular chalk inclusions. The natural strata was light grey/white, friable, small-large chalk nodules. It was noted that the chalk nodules become larger at *c.*1.50m BGL.

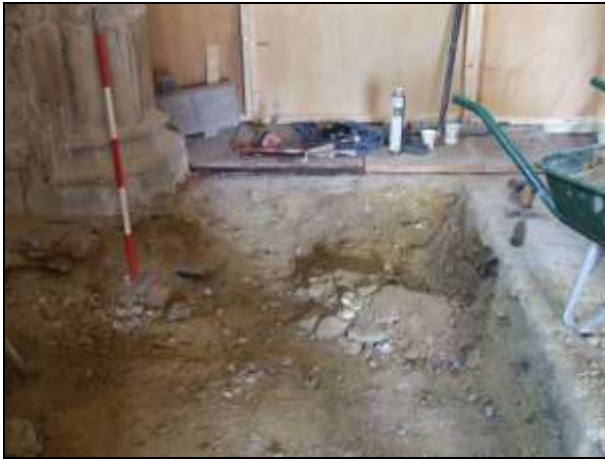
Towards the south-west part of the church, within the south aisle, groundworks to accommodate the new WC and Tea Port area were hand excavated. The area measured *c.*3.08-3.30m in length × 2.10m in width, and was excavated to a depth of *c.*0.40m BGL. The church floor tiles were removed, to be re-laid once the groundworks were completed. Beneath the floor a small void was noted, possibly a vaulted burial, though that was difficult to determine at such a shallow depth.

Plate 1: New WC and Tea Port Area (scale 1m)

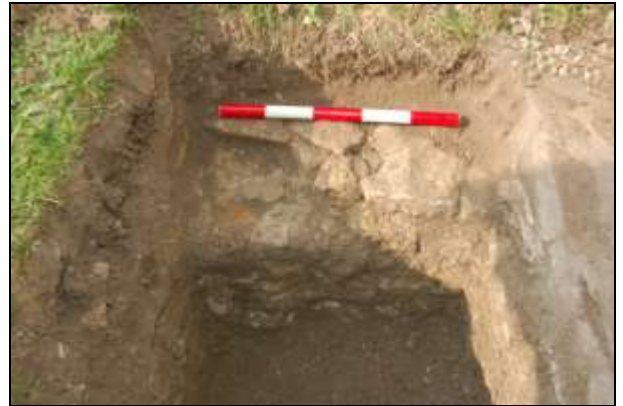
Along the south outer wall of the church a drainage inspection chamber was hand excavated. The chamber measured *c.*1.03m in length × 0.70m in width, and was excavated to a maximum depth of 0.70m BGL. Towards the west end of the inspection chamber the remains of wall were found with a possible floor layer on top. The floor was 0.25m BGL, while the wall measured 0.34m in width, and continued beyond the limit of excavation at the west end. The wall was constructed of flint and stone with sandy mortar below probable floor slabs. A brick and cement rendered drain, 0.35m wide, was also exposed up against the church wall. No human remains or finds were encountered.

Plate 2: Inspection Chamber: Wall and floor surface (scale 500mm)

- 5.4 Excavation of the inspection chamber uncovered the remains of a wall overlying a possible floor surface. The wall was constructed of flint and stone with sandy mortar below probable floor slabs. It is likely that this structure forms an earlier part of the church that may date back to the 12th century.

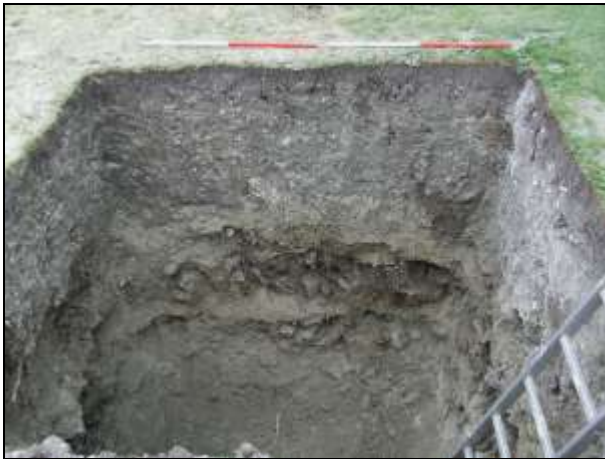
The klargester pit was both hand and machine excavated. It measured *c.*2.35m sq, and was excavated to a maximum depth of 2.60m BGL. The stratigraphy comprised *c.*0.15m of turf, beneath which was *c.*0.85m of cemetery soil (07), and *c.*1.60m of natural strata chalk. A modern drainage pipe was found orientated north-west to south-east, *c.*0.60m BGL.

Within the klargester pit were found significant quantities of disarticulated human remains, twenty articulated human burials, at a depth between *c.*0.35-1.50m BGL (Section 4.8 and Appendix 4), and Roman pottery (Section 4.9 and Appendix 2).

Plate 3: NE facing section of klargester pit (scale 2m)

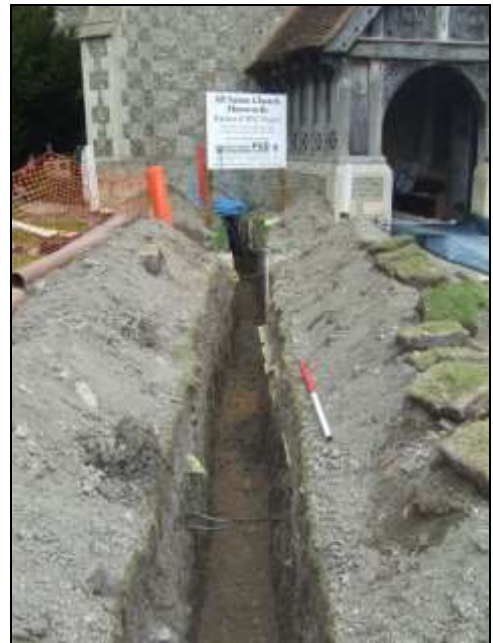
Drainage trench 1 ran from the north-west side of the klargester pit to the inspection chamber at the south wall of the church. It was hand excavated and measured *c.*1.2m in length, *c.*0.50m in width, and varied between *c.*0.74-1.06m in depth. The stratigraphy comprised *c.*0.15m in depth of turf above cemetery soil (07): modern services ran down part of the length of the trench, causing ground disturbance.

Plate 4: Drainage trench 1, looking N (scale 1m)

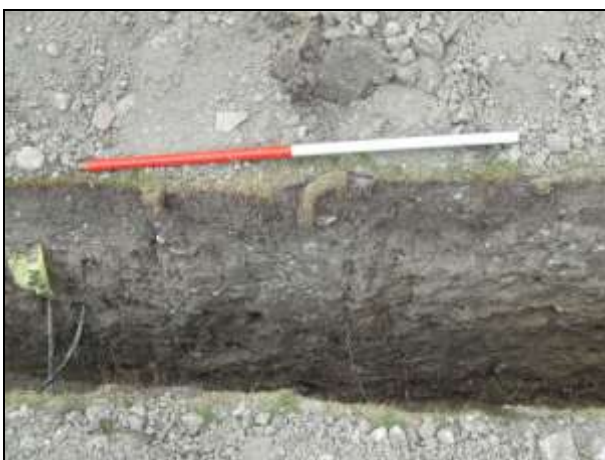
Plate 5: Drainage trench 1, west facing section (scale 1m)

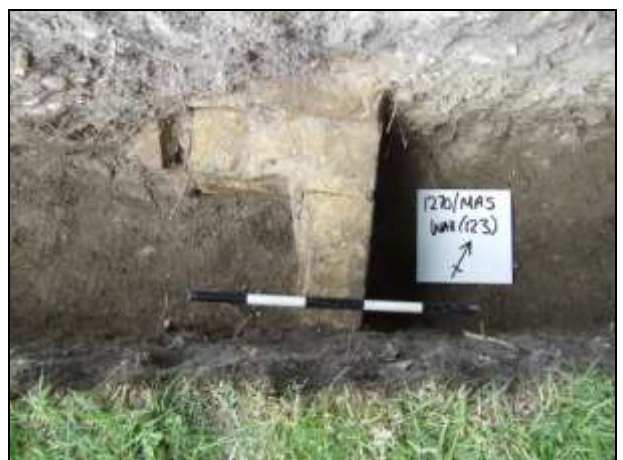
Towards the south-west end of the trench an L-shaped wall (123) was revealed at a depth of 0.46m BGL at the north-west side of the trench, and 0.48m BGL at the south-east side of the trench. It was exposed to 4-5 brick courses (0.31-0.34m) high. The bricks (23 × 10 × 6cm) were hand-made and light orange in colour, set in light cream lime mortar. The north-east side of the wall had a more smooth/finished appearance and was probably the outer face, whilst the south-west side of the wall had a more rough finish.

Plate 6: Drainage Trench 2, wall (123) (scale 500mm)

- 5.5 Another wall was uncovered towards the south-west end of Drainage Trench 2. This L-shaped wall was constructed of hand-made bricks, and survived to at least 4-5 brick courses. Its north-east face was better finished than its south-west side. Related to the wall on its north-east side were deposits of modern building debris, one containing a metal fitting. The wall could belong to a structure, though its size, date and function remain uncertain. From cartographic evidence it is apparent that the churchyard boundary has changed since the late 19th / early 20th century, so it is possible that the wall is associated with the earlier boundary.

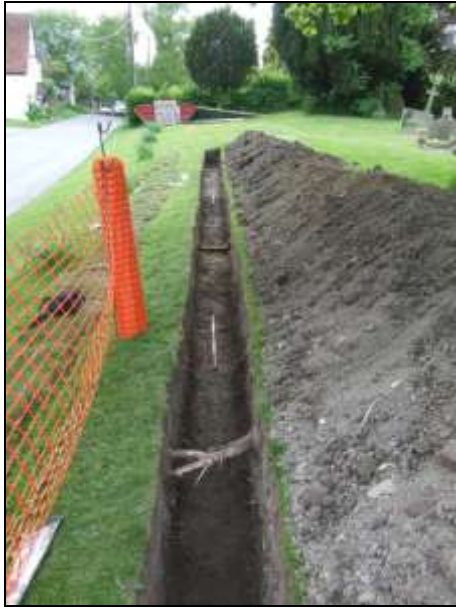
Drainage trench 2 ran from the south-east side of the klargester pit in a north-east south-west direction, parallel to Church Lane. The trench was hand excavated and measured *c.*0.25m in length, *c.*0.50m in width, and between *c.*0.73-1.01m in depth. The stratigraphy comprised *c.*0.10m in depth of turf, above cemetery soil (07).

Plate 7: Drainage trench 2, looking SW
(scale 2x1m)

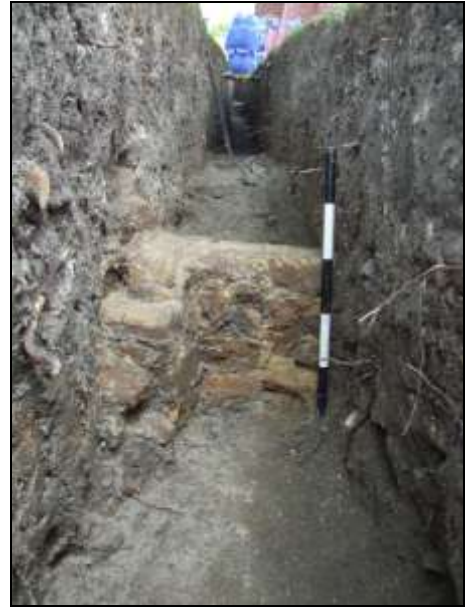
Plate 8: Drainage trench 2, inner face of wall
(123), looking NE (scale 500mm)

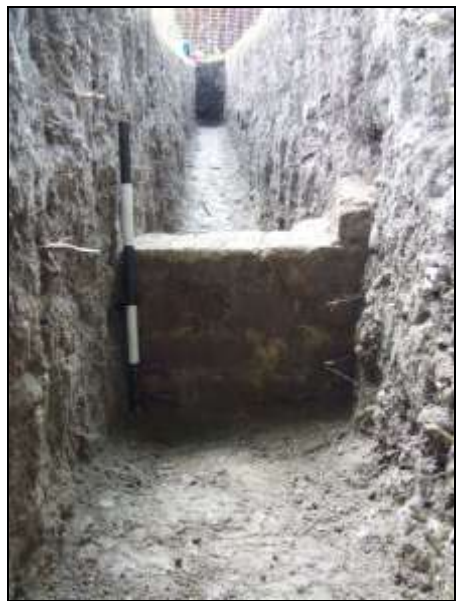
Plate 9: Drainage trench 2, outer face of wall
(123), looking SW (scale 500mm)

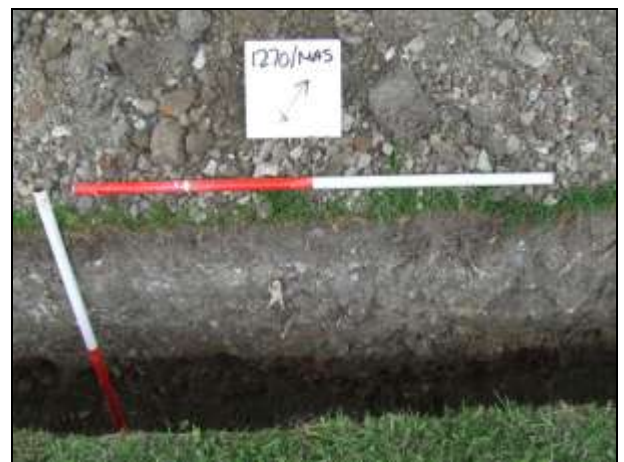
Immediately north-east of the wall were deposits (124) and (128). Deposit (124) was *c.*0.50m BGL. It extended for 3m along the trench, and was *c.*0.08m in depth. It consisted of light yellow gravel containing quantities of modern broken brick, roof tile, and a metal fitting, possibly for a gateway. The underlying deposit (128) was *c.*0.58m BGL. It extended for *c.*2.50m in length, and was >0.24m in depth. It consisted of cemetery soil containing modern broken brick and roof tile.

Plate 10: Drainage trench 2, SE facing section,
deposits (124) and (128) (scale 2x1m)

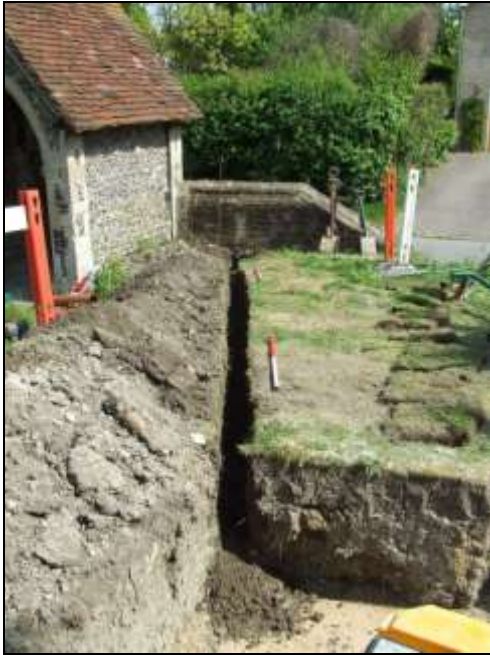
Drainage trench 3 ran from the south-east side of the klargester pit down to the water mains and bib tap on the southern boundary of the site. The trench was hand excavated and measured *c.*6.41m in length, *c.*0.17m in width, and *c.*0.50m in depth. The stratigraphy revealed comprised *c.*0.10m depth of turf, *c.*0.07-0.40m depth of cemetery soil (07), above natural chalk. Because of the slope of the site at its south-east boundary, the natural chalk appeared to rise up towards the south-east site boundary. The trench was also much disturbed by modern services.

Occasional disarticulated human remains were recovered and one partially articulated burial, at a depth of 0.39m BGL, was identified. It was present in the south side of the trench and was disturbed by modern services.

Plate 11: Drainage trench 3, looking SE
(scale 2x1m)
