**ARCHAEOLOGICAL EVALUATION:  
LAND TO THE REAR OF  
THE BUNGALOW  
HIGH STREET, LUDGERSHALL  
BUCKINGHAMSHIRE**

NGR: SP 6599 1755

July 2010

ASC: /1312/LHS/2r

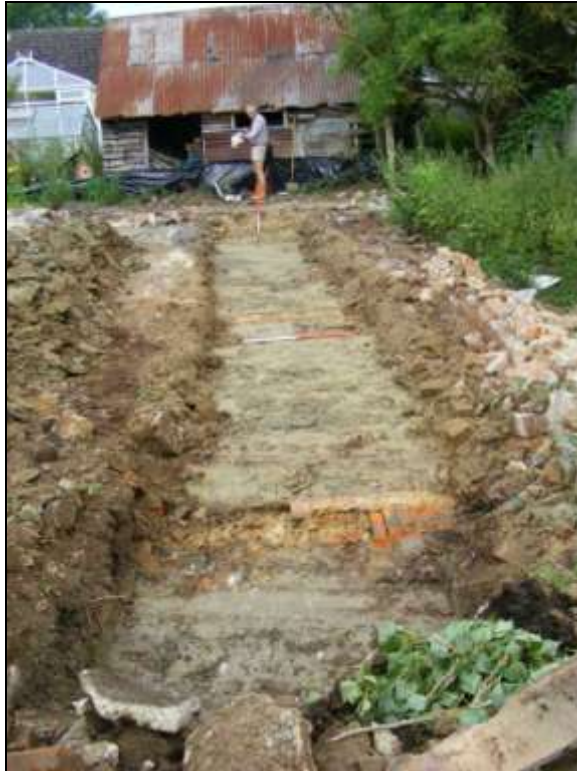
**Plate 1:** View of the evaluation trench looking west

4.2.4 No significant archaeological features or artefacts were present in the trench.

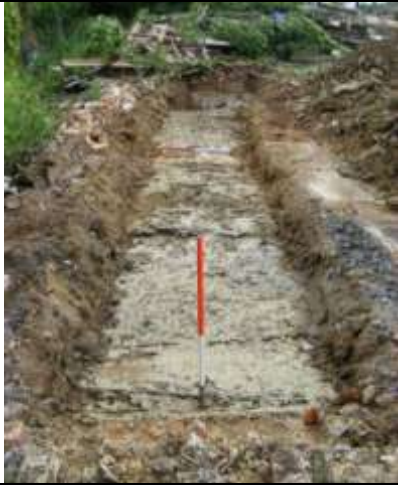
<b>Trench 1</b>

<b>Max Dimensions (m)</b>					
	<b>Length</b>	11.5m	<b>Width</b>	1.6m	<b>Depth</b>	c.300mm
	<b>Levels</b>					
	<b>Trench top W</b>			70.72m OD		
	<b>Trench base W</b>			70.45m OD		
	<b>Trench top E</b>			71.15m OD		
	<b>Trench base E</b>			70.49m OD		
	<b>NGR Co-ordinates</b>					
	<b>E</b>	SP 65975 17572		<b>W</b>	SP 65966 17574	
	<b>Orientation</b>			E-W		
<b>Reason for Trench</b>			Evaluation of footprint of new building			
<b>Context</b>	<b>Type</b>	<b>Description and Interpretation</b>		<b>Width (max: mm)</b>	<b>Thickness (max: mm)</b>	<b>Depth (BGL: mm)</b>
101	Layer	Unconsolidated rubble. Modern building debris. Cut by two modern brick wall footings		1.6	c.300	-
100	Layer	Homogenous bluish grey clay. Natural strata		1.6	-	c.300
