**ARCHAEOLOGICAL EVALUATION:  
LAND SOUTH OF BAYSWATER BROOK  
BAYSWATER ROAD, BARTON  
OXFORD**

NGR: SP 5570 0803

August 2010

ASC: 1337/OBB/2

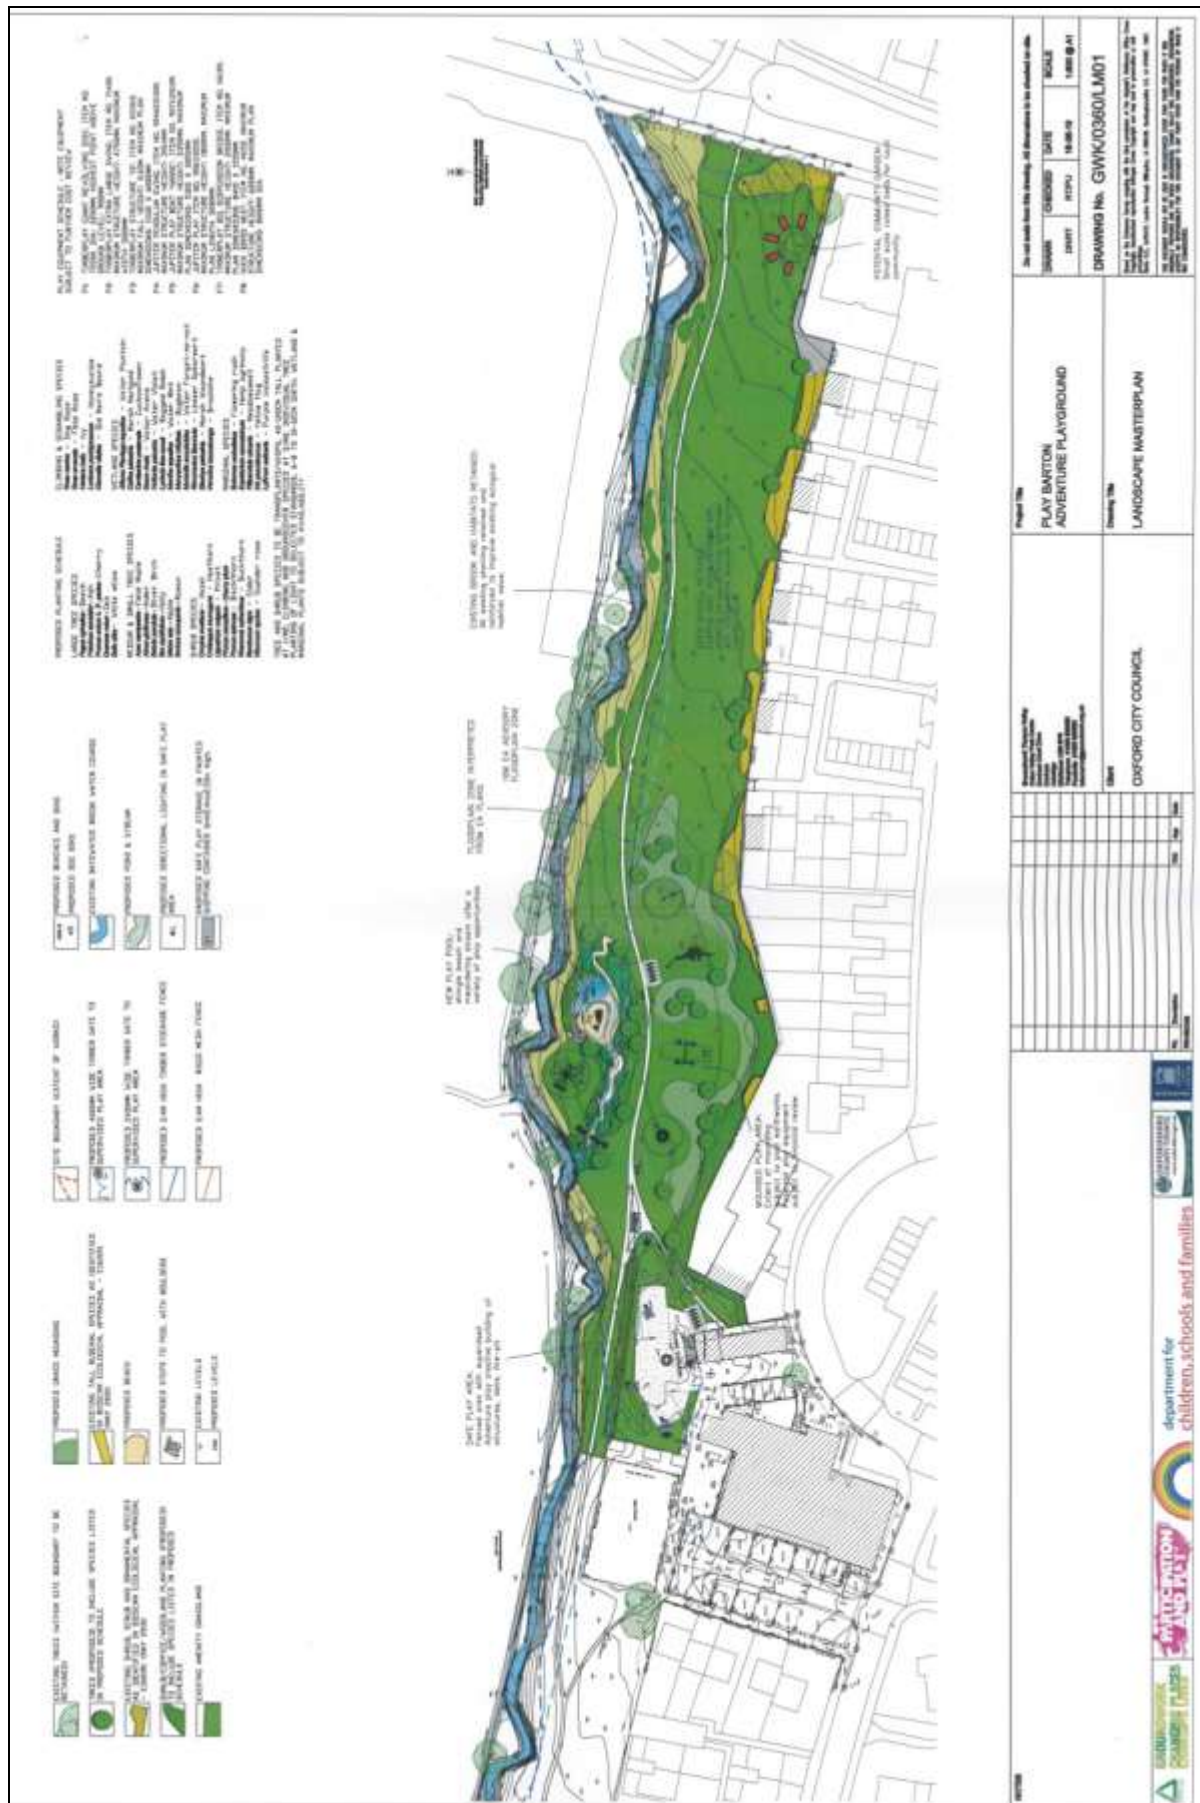
**Figure 3: Proposed development (*not to scale*)**

The development proposal is for the landscaping works and improvements to the recreation ground, notably with the excavation of a new play pool, beach area and watercourse (Fig. 3).

- The excavation of 15 linear metres of trial trenches of c.1.6m width targeting the new play pool, beach area and watercourse (Fig. 3)
- Particular attention was to be paid to the environmental potential of the site, specifically the possible presence of 'dark earth' masked by alluvium

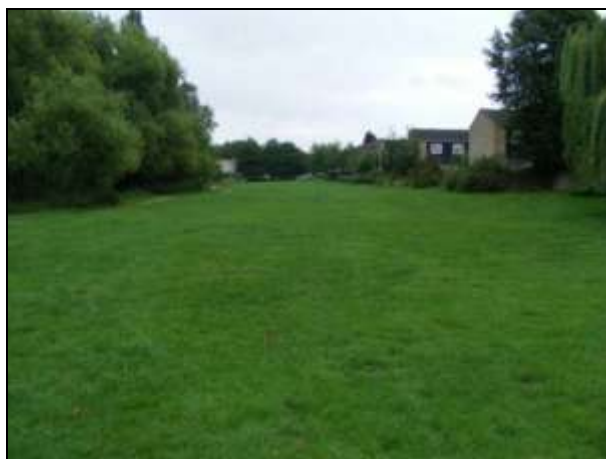
**Plate 1:** General view looking east across the site

4.2.1 The trench was situated in the north central part of the site and aimed to test the footprint of the proposed new play pool and beach area (Plates 1 and 2). It was 16.6m long and was excavated to an average depth of c.400mm. Sondages were excavated at each end in order to test the underlying natural strata (Plate 3).

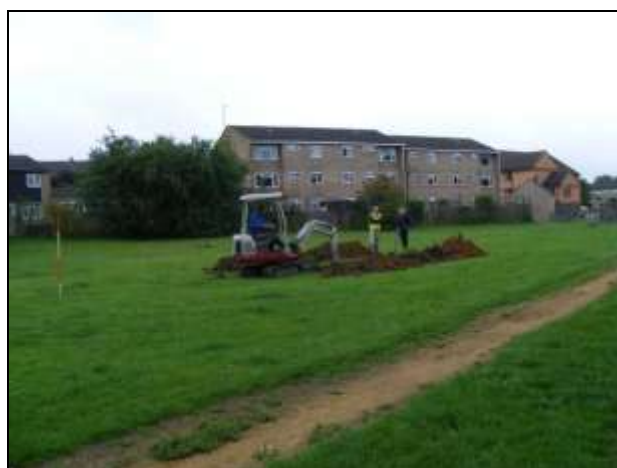
**Plate 2:** General view of the excavation

4.2.2 The modern surface comprised turf and topsoil (100) which was c.0.1m thick. This overlay a deposit of grey clay mixed with fragments of gravel and occasional modern building debris (101). It was c.0.15m thick at the west end of the trench but was discontinuous and was largely absent from the central part of the trench. This material is interpreted as modern debris deposited during the construction of the Stowford Road development during the 1960s. It is not of archaeological significance.

4.2.3 The modern material (101) overlay a 0.2m thick layer of light orangy brown clayey subsoil (102). It was present across the entire area of the trench but was sealed by the modern clay (102) at the west end of the trench. This in turn sealed a deposit of dark orangy brown clayey silt (103), which is interpreted as alluvium. The latter was c.0.2m thick and sealed the natural strata which comprised homogenous grey clay (104) at a depth of c.0.7m

4.2.4 No significant archaeological features or artefacts were present in the trench.

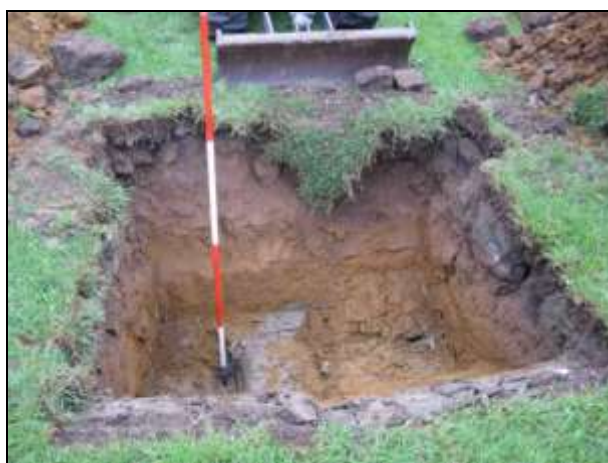
**Plate 3:** View of the natural profile at the west end of the trench

- 5.2 The sequence of deposits comprised topsoil (100) and subsoil (102) with an intervening layer of modern clay (101). The subsoil developed over a deposit of alluvial material (103) which overlay the natural Oxford Clay (104).

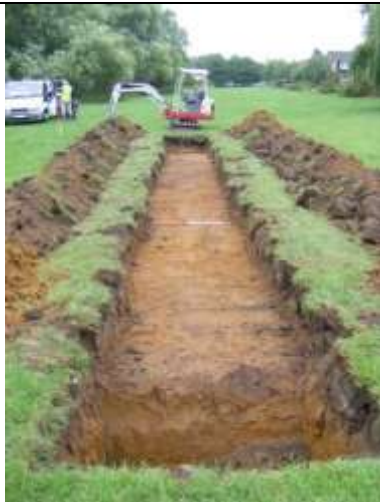
Trench 1

Max Dimensions (m)						
	Length	16.6m		Width	1.5m	Depth	0.4m
	Levels						
	Trench top east			72.69m OD			
	Trench base east			72.32m OD			
	Trench top west			72.69m OD			
	Trench base west			72.32m OD			
	NGR Co-ordinates						
	W	SP 55658 08038			E	SP 55674 08038	
	Orientation			E - W			
Reason for Trench			Evaluation of new play pool				
Context	Type	Description and Interpretation			Width (max: mm)	Thickness (max: mm)	Depth (BGL: mm)
100	Layer	Mid greyish brown silty clay. Topsoil and turf			1.5m+	100	-
101	Layer	Lumps of homogenous grey clay mixed with gravel fragments. Modern redeposited material			1.5m+	c.200	100
102	Layer	Light orangy brown silt. Buried subsoil			1.5m+	c.200	c.300
103	Layer	Dark orangy brown clayey silt. Alluvium			1.5m+	c.200	c.500
103	Layer	Homogenous mid grey clay. Natural strata			1.5m+	-	c.700
