**EXCAVATION AND WATCHING BRIEF:
ST JOHN THE BAPTIST CHURCH
GRANBOROUGH
BUCKINGHAMSHIRE**

NGR: SP 7678 2500

November 2010

ASC: 1340/GSJ/3

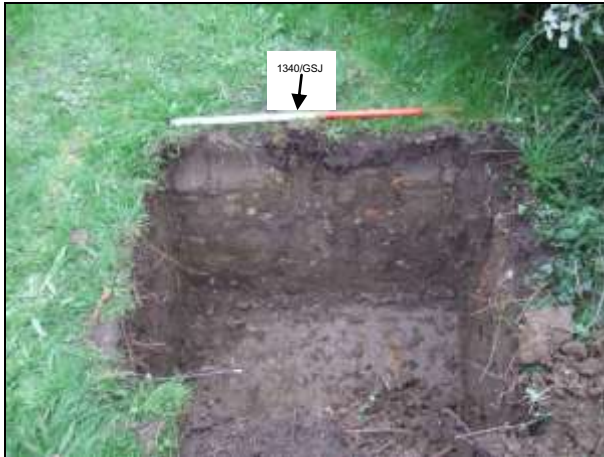
The soakaway and the initial 300mm ground reduction uncovered no significant archaeological features, deposits, finds or human burials from the excavation areas. Towards the southwest corner of the excavation area heavy root disturbance and tree stumps were present.

Plate 1: North facing section of soakaway, looking S (*scale 1m*)

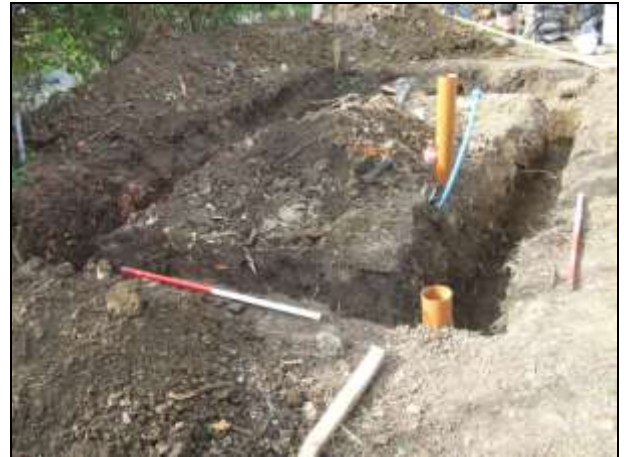
An area of c.12.70 sq m encompassing the new toilet and a 1×1m soakaway was mechanically excavated with a 1m toothless bucket. The new toilet area was initially excavated to a level of c.300mm, after which a watching brief was carried out on the footing trench within the stripped area (see section 4.2.1). The soakaway was excavated to a depth of c.0.80m max.

Plate 2: Excavation area of new build and footing trench, looking NW (*scale 2×1m*)

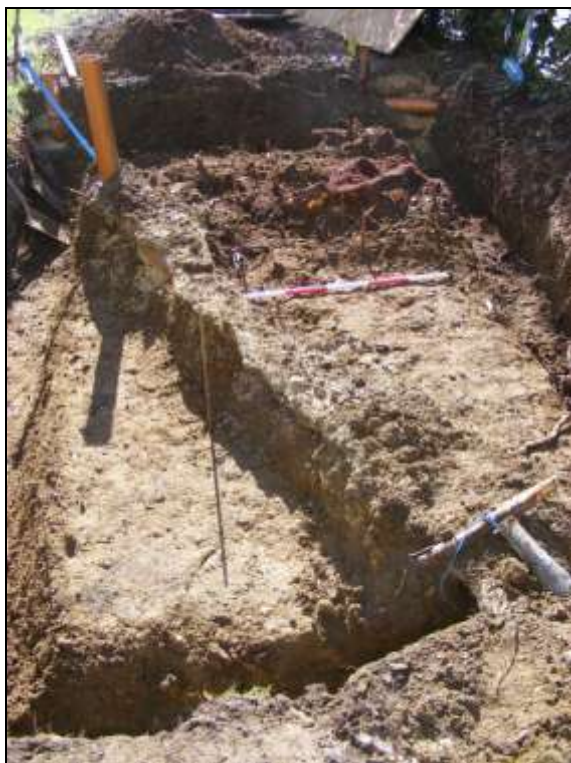
A further 300mm was hand excavated in the new toilet area. The ground reduction uncovered remains of a limestone surface (see below for further details), c.0.50m BGL (below ground level). Two fragments of animal bone, one fragment of human bone and small tile fragments were also found within the made-ground.

Plate 3: New toilet area excavated a further 300mm exposing limestone surface towards the east, looking S (*scale 1m*)

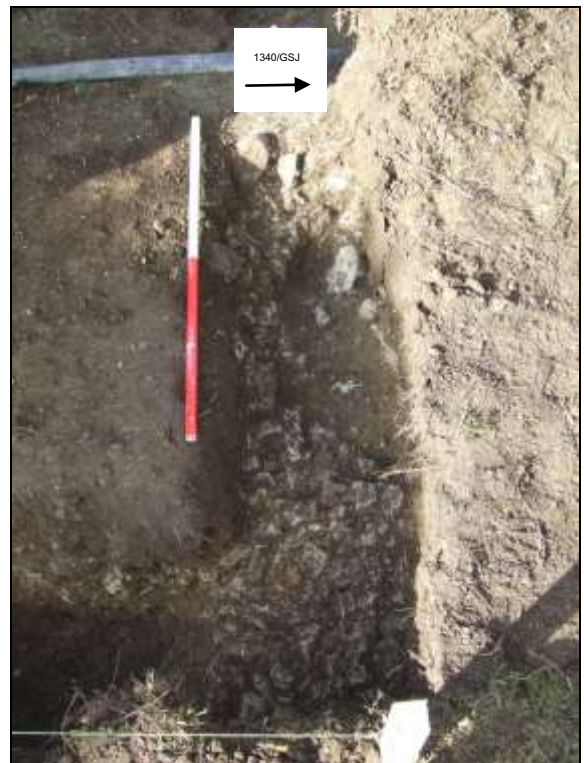
A compact sub-angular limestone surface, with no bonding, was uncovered at the northern and southern ends of the footing trench during excavation. The surface also extended into the eastern end of the footing trench, which was not noticed during excavation due to the surface being less compact in this area and less noticeable. Therefore, the surface at the eastern end of the footing trench was only identified in section and measured *c.*3.60m in width.

At the northern end of the trench the maximum stone size of the surface measured *c.*170 × 110 × 80mm. At the southern end the surface had a number of stones that were flatter, measuring a maximum size of *c.*180 × 190 × 20mm. The surface at the northern end of the trench included traces of light yellowy orange loose sand underlying the stone.

Plate 4: Limestone surface at northern end of footing trench, looking W (*scale 1m*)

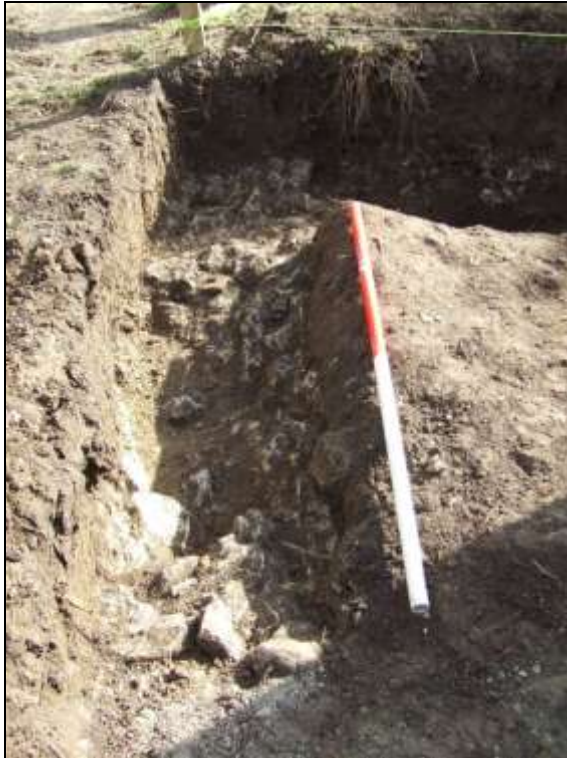
The surface was visible at *c.*0.24m BGL at the northern end, *c.*0.50m BGL at the southern end, and *c.*0.28m BGL at the eastern end of the footing trench. The total surface area excavated measured at *c.*3.01 sq m, to a maximum depth of *c.*0.20m, and extended beyond the limit of excavation towards the north, east and south. No remains of the surface were uncovered in the soakaway trench.

Plate 5: Limestone surface at northern end of footing trench, looking E (*scale 1m*)

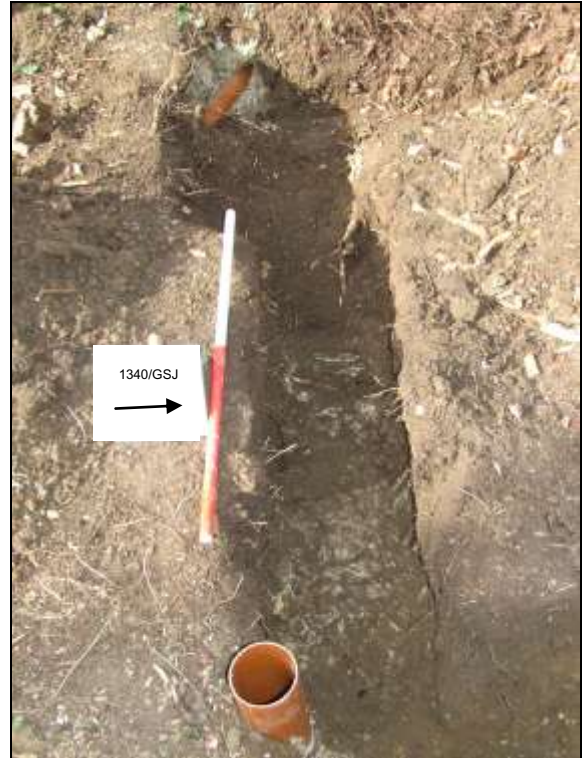
Plate 6: Limestone surface at southern end of footing trench, looking W (*scale 1m*)

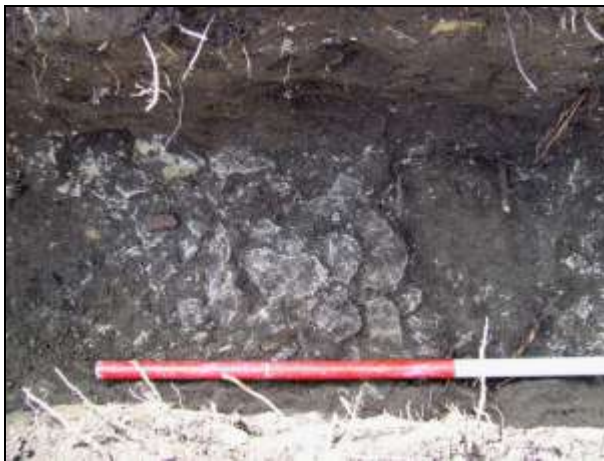
Plate 7: Limestone surface detail at southern end of footing trench, looking S (*Scale 500mm*)

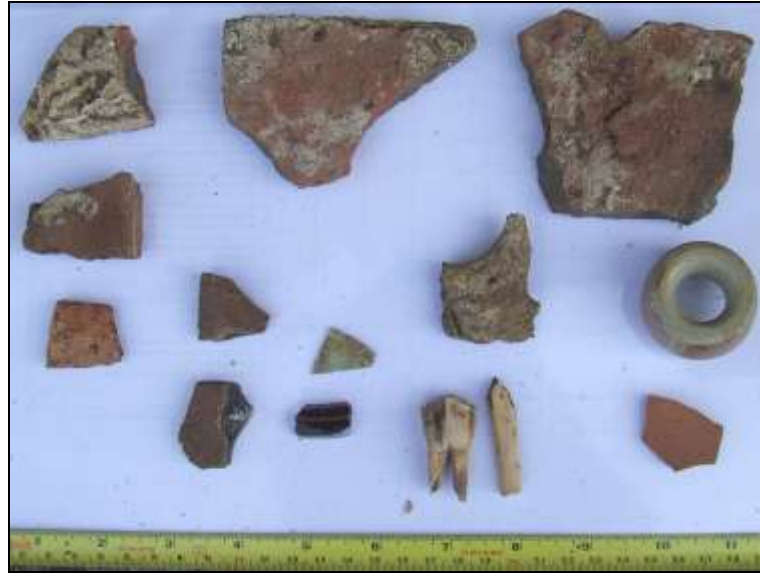
During the excavation of the surface area a number of finds deriving from immediately above and within the surface comprised one disarticulated human bone, animal bone and tooth, glass, tile with traces of a light brown/orange mortar, post-medieval pottery and pottery with the date undetermined.

Plate 9: Finds deriving from limestone surface area (*scale 270mm*)

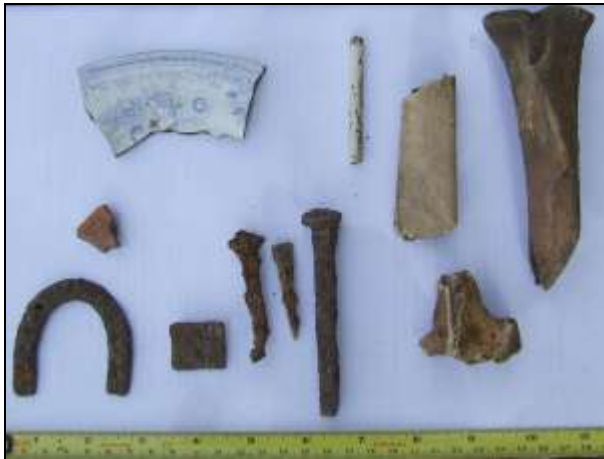
Further finds from the footing trench was a fragment of white and blue 'willow pattern' pottery dating to *c.*19th century, animal bone, clay pipe stem, iron nails, iron square fitting, iron shoe fitting, and pottery (date undetermined).

Plate 10: Finds deriving from footing trench
(*scale 280mm*)

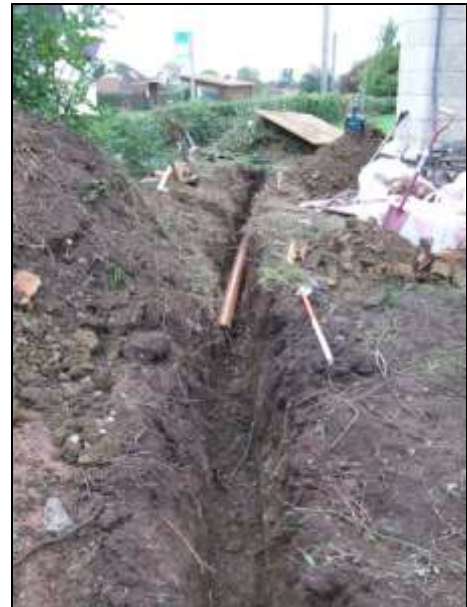
Service trench 1 was orientated NW-SE and measured *c.*8.50m in length, to a depth of *c.*0.50-0.90m BGL. Towards the NW end of the trench, evidence of 20th century pottery, plastic, and metal was uncovered indicating modern disturbance near to a recent man-hole.

Plate 11: General view of service trench 1,
looking NW (*scale 2x1m*)

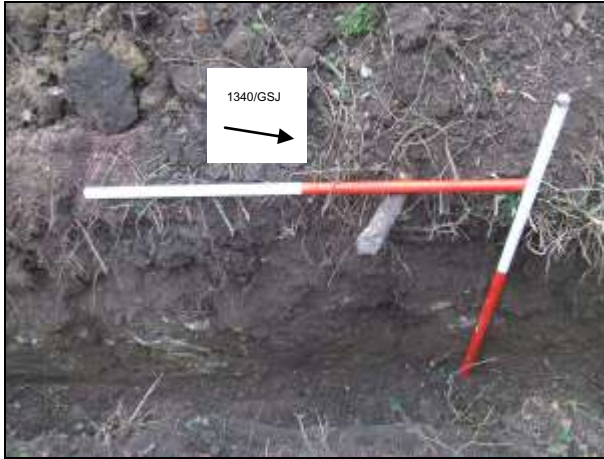
Plate 12: NE facing section of service trench 1,
looking NW (scale 2×1m)

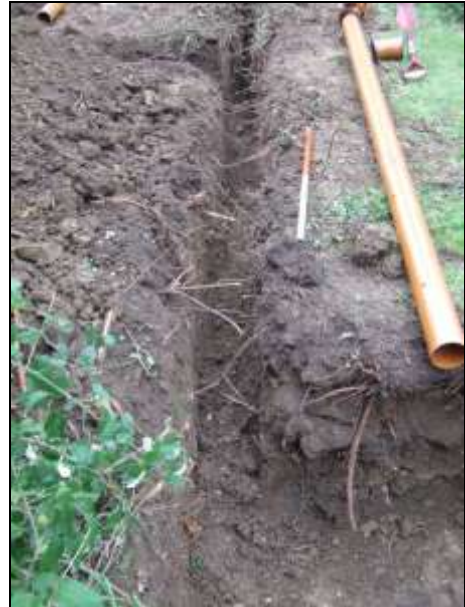
Service trench 2 was oriented N-S and measured *c.*4m in length, to a depth of *c.*0.57-0.68m BGL. Two elongated pieces of iron were uncovered, deemed to be of little archaeological significance.

Service trench 3 was orientated NW-SE and measured *c.*2.90m in length, to a depth of *c.*0.50-0.60m BGL. The made-ground contained a glass bottle, a clay pipe stem, and an iron rivet for a fence, of little archaeological significance.

Plate 13: General view of soakaway with service
trench 2 and 3, looking N (scale 1m)

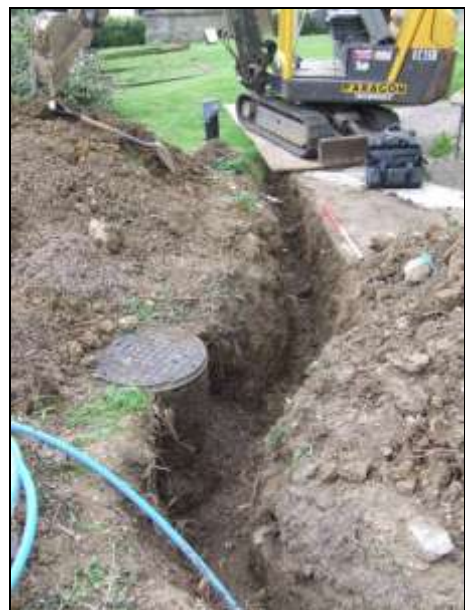
Service trench 4 was oriented SW-NE and measured *c.*4m in length, to a depth of *c.*0.70m max BGL. The made-ground contained recent disturbance of buried plastic near to the man-hole.

Plate 15: General view of service trench 4,
looking NE (scale 1m)

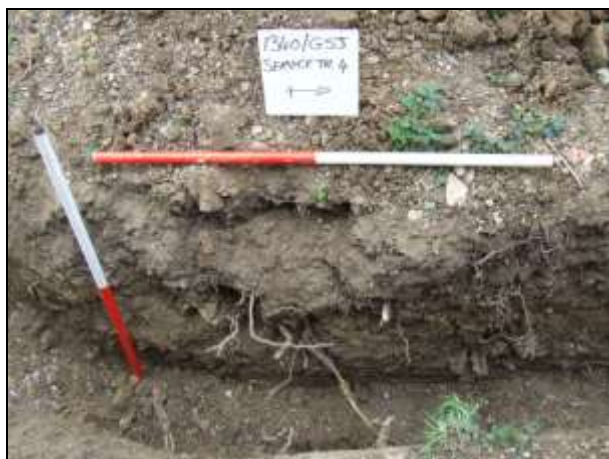
Plate 16: E facing section of service trench 4,
looking W (scale 2×1m)

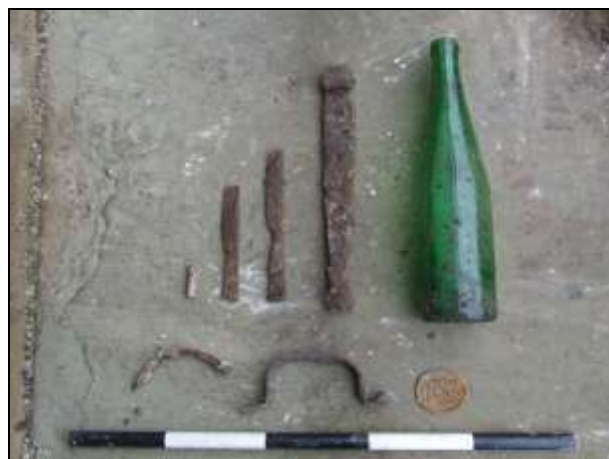
No significant archaeological features, deposits, finds or human burials were uncovered from the service trenches.

Plate 17: Finds deriving from service trenches
(scale 250mm)
