**WATCHING BRIEF:
CHURCH FARM
CHURCH END
SHERINGTON
MILTON KEYNES**

NGR: SP 8903 4692

ASC: 1307/SCF/2

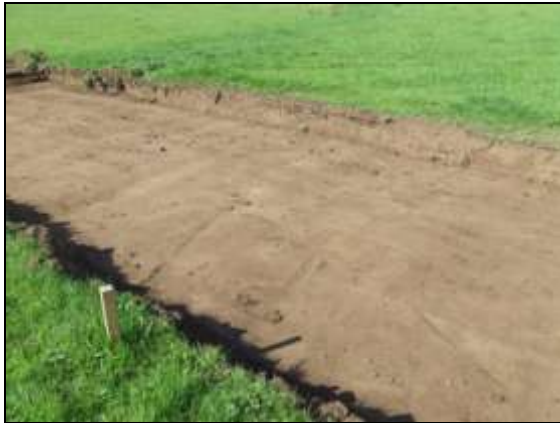
- 4.1 Both watching briefs were carried out in three days, and the ground reduction for both developments was carried out as one continuous process. The ground was reduced across both development sites by 0.3m, through 0.1-0.3m of topsoil and up to 0.2m of mid-brown loamy subsoil. The interface between subsoil and natural was only exposed in patches, and the natural comprised a mid-brown silty clay.
- 4.2 An area of burning was partially exposed along the southeastern edge of the driveway (Fig. 3, Plates 2 & 4). This area contained pieces of animal bone, modern brick and tile. Close to this was a large spread of rubble (Fig. 3, Plates 3 & 4). This was observed continuing into the area of the field shelter (Plate 5).
- 4.3 No finds or features were observed within the area of the earthworks (Plate 1).

Plate 1: Driveway in the area of linear earthworks, looking southwest

- 5.1 The new driveway passed directly through the area of undated linear earthworks mentioned in section 3.8, above. Although the earthworks were visible on the surface of the field due to a good growth of vegetation, no evidence for them was observed below ground level. This may be the result of ploughing over time, as the field containing the development area was part of a working farm until the mid-1980s (*pers.comm.* B. Cawley).

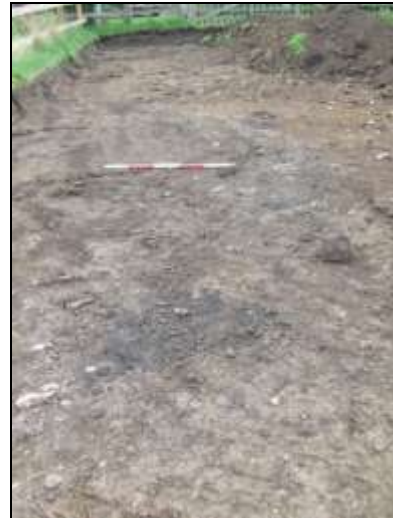
Plate 2: Area of burning along southeastern edge of driveway, looking south, 1m scale

- 5.2 The area of burning and the spread of rubble observed at the southern end of the driveway and within area of the field barn contained post medieval and modern debris, as well as pieces of animal bone. The area of burning may be attributed to agricultural activity within the area, due to its close proximity to Church Farm, and the area's inclusion within a working farm until recent times.

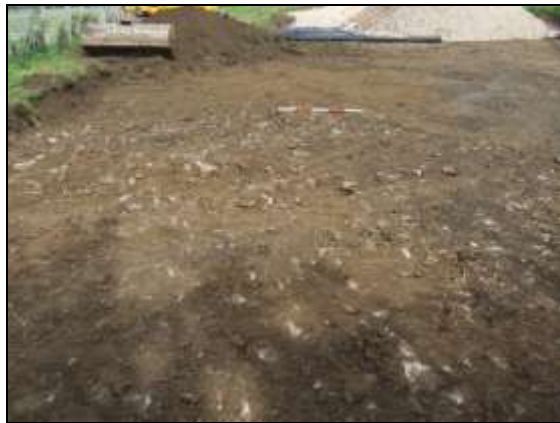
Plate 3: Spread of rubble at southern end of driveway, looking north, 1m scale

- 5.3 A study of the readily available mapping of the area, dating back to the end of the 19th century, has not revealed any buildings within the vicinity of the rubble spread. This may be because the rubble was brought in from elsewhere, or that it was part of a building that was not recorded cartographically.

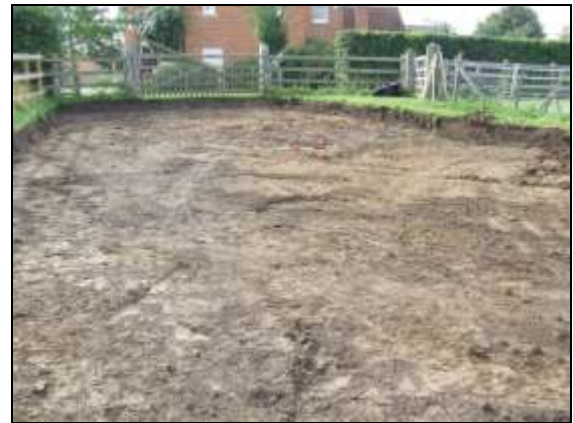
Plate 4: Areas of burning and rubble at southern end of driveway, looking south, 1m scale

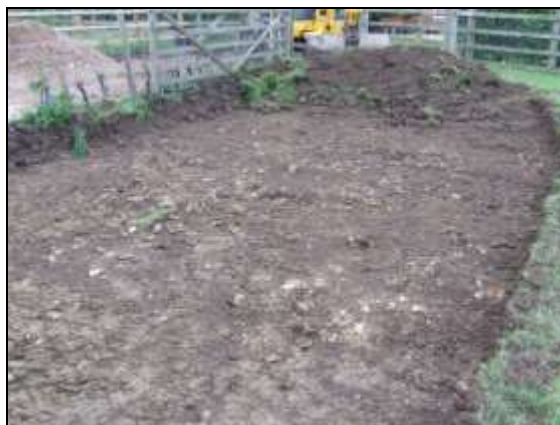
Plate 5: Rubble observed within area of field barn, looking southeast
