**ARCHAEOLOGICAL EVALUATION:  
GEORGE'S FIELD  
HATFIELD PARK  
OLD HATFIELD  
HERTFORDSHIRE**

NGR: TL 2346 0833

*on behalf of Gascoyne Cecil Estates*

ASC: 1367/HHC/2r

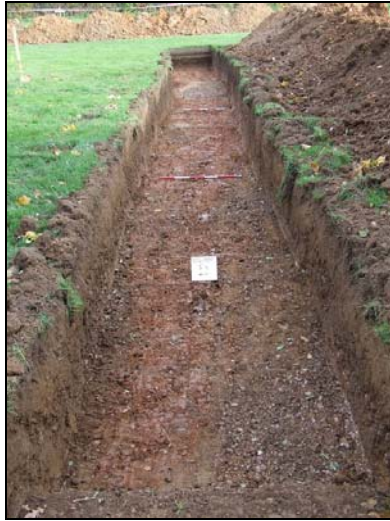
**Plate 1:** Trench 4, looking east, 2x 1m scale

Trenches 1 to 4 were located at the southern end of the site, and were between 19.5m and 21.5m in length. All four trenches contained between 0.27m and 0.36m of soft, mid brown topsoil, below which was a *c.*0.3m thick layer of soft silty mid brown clay, with frequent pebble inclusions. This layer overlay the natural subsoil, which consisted of a mid orange brown soft, silty clayey sand, with flint and pebble inclusions. No pre-modern features were observed in these trenches.

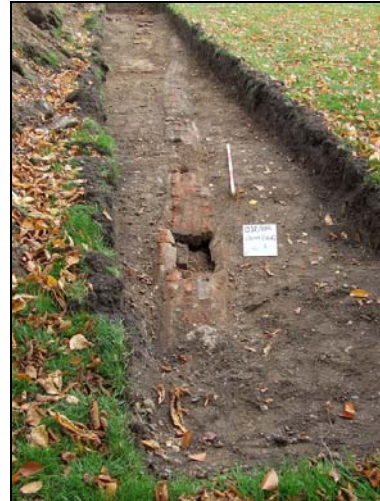
**Plate 2:** Trench 5, Brick culvert, looking east, 1m scale

Trench 5 was located at the northern end of the development site, and was 18.8m in length. The stratigraphy comprised 0.17m of topsoil (500), as observed in Trenches 1-4. Below this was a 0.4m thick layer of made ground (501), which consisted of mid brown silty clay, with frequent inclusions of brick, tile and mortar fragments. Within this layer was a brick culvert (502), *c.*10m of which was exposed within the trench. The culvert had a domed roof, and was constructed of black and orange bricks, bonded by a white/cream lime mortar. The bricks measured 22x6x10cm, and are likely to date to the 18<sup>th</sup> century. To the east of this was a wall footing (503), with one surviving course of orange bricks, 24x10x5.5cm, bonded with white/cream lime mortar. These bricks are likely to date to the 16<sup>th</sup> century. The footing measured *c.*5.5m in length, and was *c.*0.35m wide, with evidence of a return at the western end. Immediately to the east of this footing is an area of bricks, probably associated with the demolition of the footing.

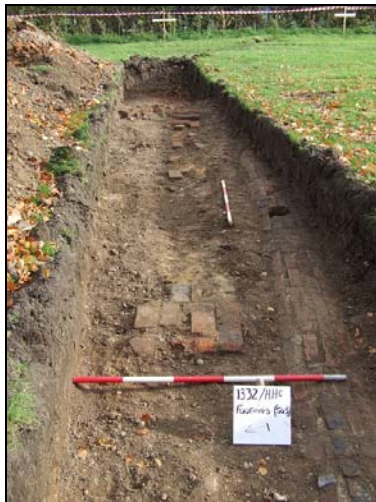
**Plate 3:** Trench 5, showing culvert and footing, looking east, 2x 1m scale

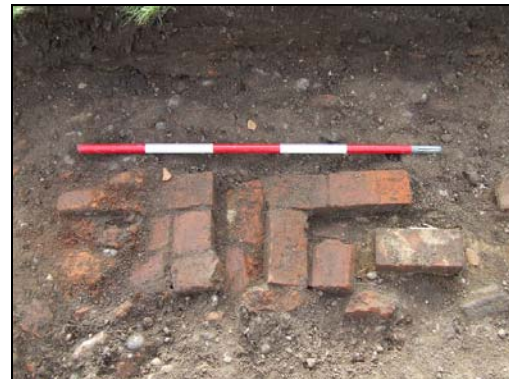
**Plate 4:** Trench 5, detail of footing, looking north, 1m scale

The eastern end of the trench was initially machined to the level of (501). At this end of the trench a large amount of building demolition was observed. It was subsequently decided to machine through this layer. At a depth of 0.8m, further brick footings were encountered (504). An area measuring 1.7x1.1m was exposed, filled by further demolition material. To the east of this was an angled section of brickwork, five courses high. The section was *c.*0.5m wide, and was constructed of orange bricks, measuring 24x10x5.5cm, bonded by a white lime mortar. As with the footing (503), these bricks are likely to date to the 16<sup>th</sup> century.

- 5.3 Both footings uncovered in Trench 5 are made from bricks that probably date to the 16<sup>th</sup> century. This makes them a similar date to the buildings shown on Figure 4, which dates to 1610. The footings at the eastern end of the trench, (504), are likely to have been for a cellar, with the angled footing having been for the steps. The function of the building was not established during the evaluation, but at this date, the presence of a cellar suggests that the building above was of some status, such as a merchant's house, or a pub. Although the HER locates the George Inn to the north east of the development site, the presence of these remains suggest it may have been located in the top corner of the development site.

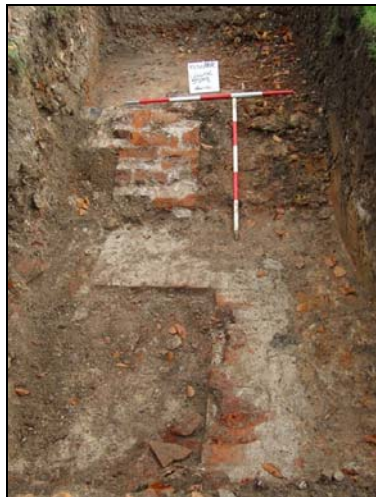
**Plate 5:** Trench 5, footings for cellar and steps, looking east, 2x 1m scale

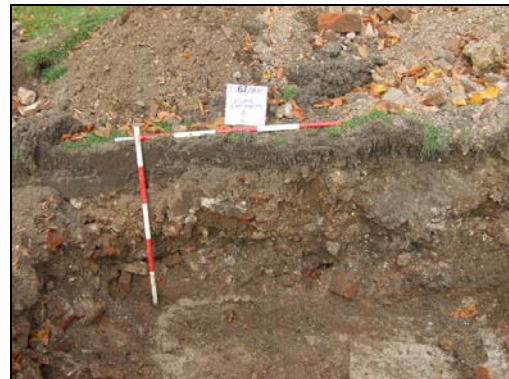
**Plate 6:** Trench 5, demolition at east end, looking north, 2x 1m scale

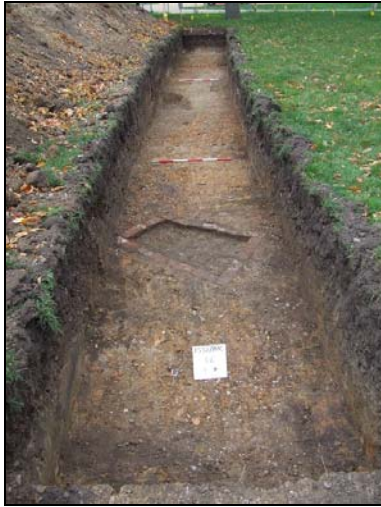
**Plate 7:** Trench 6, looking west, 2x 1m scale

Trench 6 was the northernmost trench excavated during the evaluation. The stratigraphy of this trench comprised *c.*0.1m of topsoil, as seen in the previous five trenches (600), overlying a layer of made ground (601), similar in composition to (501). Below this, in the central part of the trench, a 0.18m thick layer of light orange sand (602) was observed. This overlay a further layer of made ground (603), which

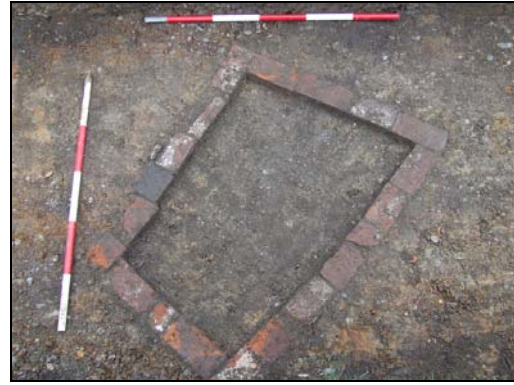
**Plate 8:** Trench 6, filled in soakaway, looking north, 2x 1m scale

comprised mid brown soft silt, with inclusions of flint, pebbles, tile and plastic. Two features were observed within this trench. At the eastern end was a roughly square red brick feature, made from similar bricks to the brick culvert in Trench 5, (502), and was probably a disused soakaway (607). Closer to the middle of the trench, against the southern edge, was a flat bottomed sub-circular feature [606], filled with light orange grey silty sand, from which occasional pieces of tile, post medieval pottery and animal bone (605) were recovered.

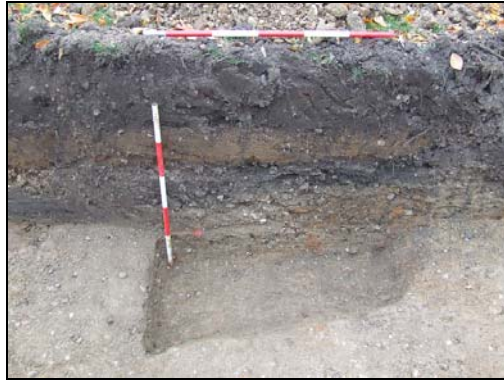
**Plate 9:** Trench 6, [606], looking south, 2x 1m scale

- 5.4 Pit [606] dates to the post medieval period. Although not exposed in its entirety, it probably functioned as some kind of refuse pit associated with the buildings in the area during this period. Soakaway (607) probably dates to the 18<sup>th</sup> century, and was probably part of the Hatfield Park drainage system mentioned above.

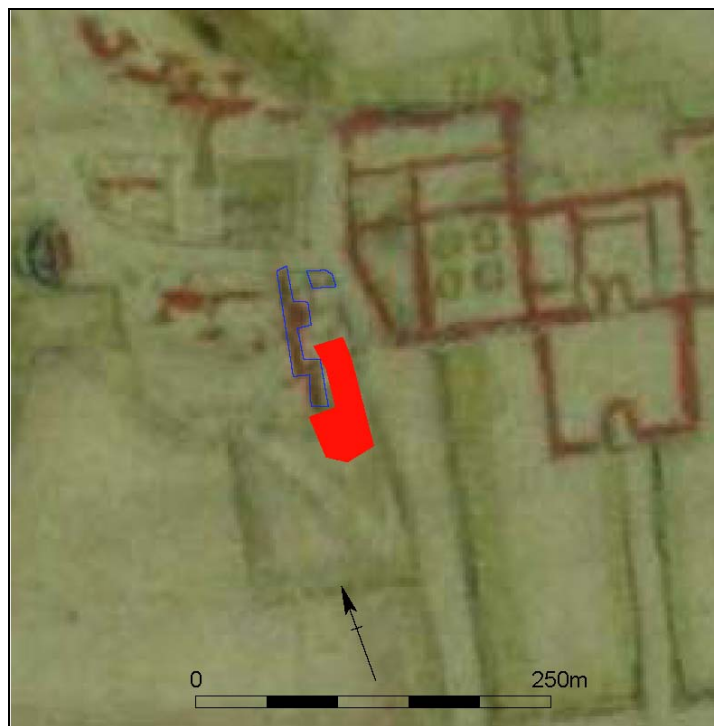
**Figure 4:** Extract from 1610 plan of Hatfield Park, with the trenched area shown in red, and buildings outlined in blue (*scale as shown*)

- 5.2 The HER evidence for the George Inn within the vicinity of the development site, and the cartographic evidence showing buildings close to the area of trenching, suggests that the features uncovered in Trenches 5 and 6 may be related to these buildings. The brick culvert (502) in Trench 5 is made from bricks that are likely to date to the 18<sup>th</sup> century. Local knowledge says that there are many such culverts known throughout Hatfield Park, and within the area of Old Hatfield.

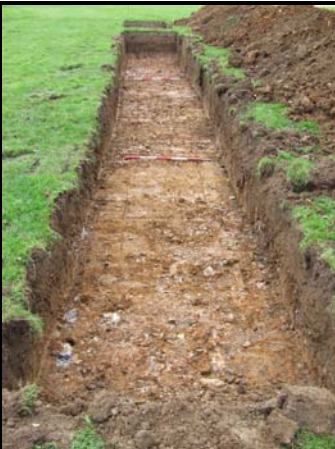
Trench 1

Max Dimensions (m)								
	Length	19.3m		Width	1.6m		Depth	0.75m	
	Levels								
	Trench top S				84.5495m OD				
	Trench base S				83.8695m OD				
	Trench top N				84.7495m OD				
	Trench base N				84.6995m OD				
	NGR Co-ordinates								
	N	TL 23451 08313			S	TL 23451 08295			
	Orientation				N-S				
Reason for Trench				Within development footprint					
Context	Type	Description and Interpretation			Width (max: mm)	Thickness (max: mm)	Depth (BGL: mm)		
100	Layer	Mid brown silty loam – Topsoil			1600	270	-		
101	Layer	Mid-brown silty clay - Subsoil			1600	170	270		
102	Layer	Mid brown silty clay with frequent pebble inclusions – Subsoil			1600	140	440		
103	Layer	Orangey mid-brown soft clay with chunks of flint and small pebbles – Natural			1600	180	710

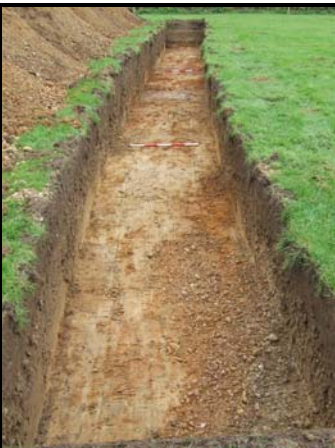
Trench 2

Max Dimensions (m)					
	Length	21.5m	Width	1.6m	Depth	0.82m
	Levels					
	Trench top E			84.5395m OD		
	Trench base E			83.4795m OD		
	Trench top W			83.0595m OD		
	Trench base W			82.3795m OD		
	NGR Co-ordinates					
	E	TL 23483 08292		W	TL 23463 08288	
	Orientation			E-W		
Reason for Trench			Within development footprint			
Context	Type	Description and Interpretation	Width (max: mm)	Thickness (max: mm)	Depth (BGL: mm)	
200	Layer	Mid brown silty loam – Topsoil	1600	340	-	
201	Layer	Mid brown silty clay with frequent inclusions of pebbles – Subsoil	1600	320	340	
202	Layer	Light coloured sand with patches of light brown and orange sand and areas of flint – Natural	1600	160	660

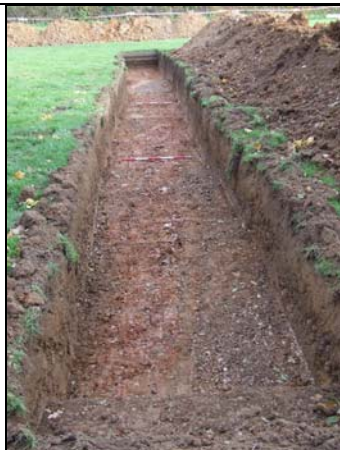
Trench 4

Max Dimensions (m)					
	Length	19.8m	Width	1.6m	Depth	0.91m
	Levels					
	Trench top E			82.9395m OD		
	Trench base E			82.1095m OD		
	Trench top W			83.8495m OD		
	Trench base W			81.8895m OD		
	NGR Co-ordinates					
	E	TL 23468 08324		W	TL 23448 08324	
	Orientation			E-W		
Reason for Trench			Within development footprint			
Context	Type	Description and Interpretation	Width (max: mm)	Thickness (max: mm)	Depth (BGL: mm)	
400	Layer	Mid brown silty loam – Topsoil	1600	340	-	
401	Layer	Mid brown silty clay with frequent inclusions of pebbles – Subsoil	1600	320	340	
402	Layer	Orange-brown silty sand with areas of flint and pebbles – Natural	1600	240	660

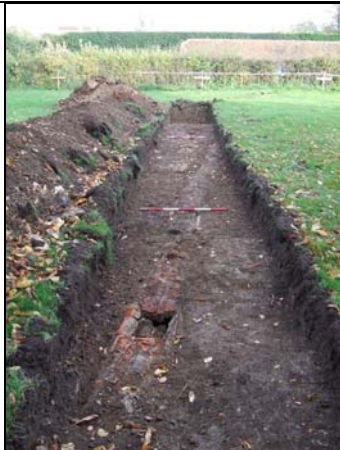
Trench 5

Max Dimensions (m)						
	Length	18.8m		Width	1.6m	Depth	0.88m
	Levels						
	Trench top W			82.7395m OD			
	Trench base W			82.445m OD			
	Trench top E			84.0395m OD			
	Trench base E			83.2595m OD			
	NGR Co-ordinates						
	E	TL 23490 08353		W	TL 23471 08353		
	Orientation			E-W			
Reason for Trench			Within development footprint				
Context	Type	Description and Interpretation	Width (max: mm)	Thickness (max: mm)	Depth (BGL: mm)		
500	Layer	Mid brown silty loam – Topsoil	1600	170	-		
501	Layer	Mid brown friable silty clay with frequent brick, tile and mortar fragments – Made ground	1600	400	170		
502	Structure	Brick culvert constructed with black and orange bricks 22x6x10cm, bonded with lime mortar	300	-	170		
503	Structure	Footing constructed of orange bricks 10x24x5.5, bonded with lime mortar, with area of demolition	500	-	170		
504	Structure	Cellar footing with footing for steps, constructed of orange bricks 10x24x5.5, bonded with lime mortar	800	-	880

505	Layer	Light salmon/orange firm clay – Natural	1600	230	880

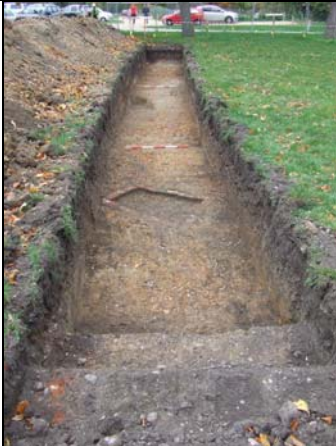
Trench 6

Max Dimensions (m)					
Length	21m	Width	1.6m	Depth	1.09m
Levels					
Trench top E			83.7895m OD		
Trench base E			82.8295m OD		
Trench top W			82.5995m OD		
Trench base W			81.8195m OD		
NGR Co-ordinates					
E	TL 23489 08368		W	TL 23469 08369	
Orientation			E-W		
Reason for Trench			Within development footprint

Context	Type	Description and Interpretation	Width (max: mm)	Thickness (max: mm)	Depth (BGL: mm)
600	Layer	Mid brown silty loam – Topsoil	1600	100	-
601	Layer	Mid brown friable silty clay with frequent brick, tile and mortar fragments – Made ground	1600	240	100
602	Layer	Light orange sand – Made Ground	1600	180	340
603	Layer	Mid brown silt with inclusions of tile, plastic and flint – Made Ground	1600	190	520
605 606	Fill Cut	Light coloured sand with occasional inclusions of tile and post-medieval pottery and animal bone – fill of pit Flat bottomed pit with moderately sloping sides	770	470	520
607	Structure	Sub-square brick feature – disused soakaway	900	-	520
604	Layer	Light coloured sand – Natural	1600	120	520

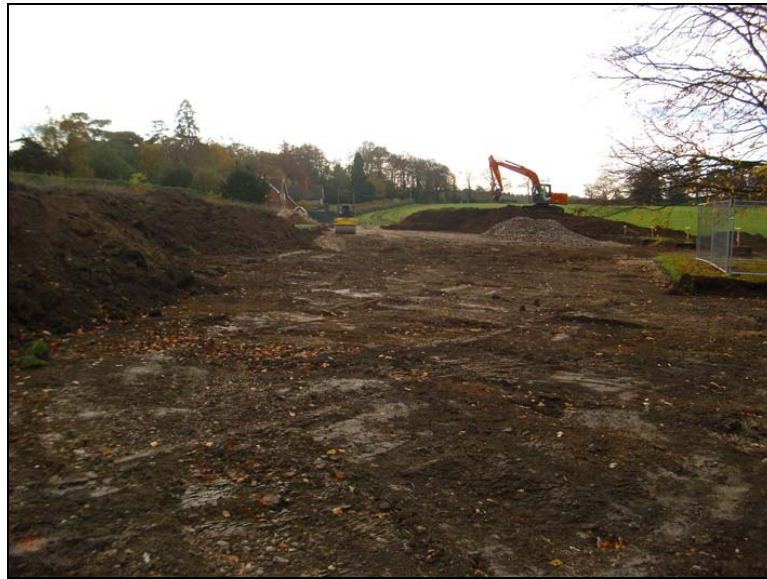
**Plate 1:** Ground reduction, looking south

During the construction of the car park, the ground was reduced by c0.4-0.45m at the northern end of the site, and by slightly more than this at the southern end, where the ground was less stable. Following this, a layer of Terram was laid across the car park, and layers of aggregate were laid on top to form the surface of the car park. It is not likely that the development has impacted on any archaeological remains in the area.

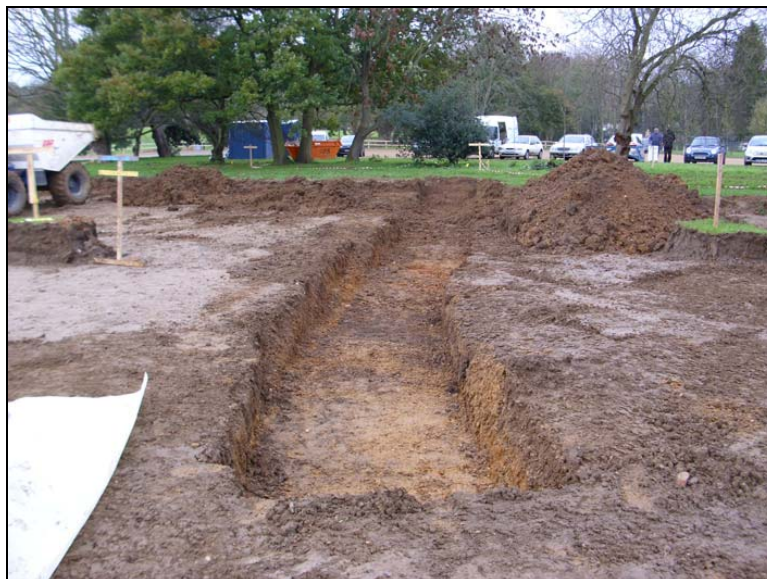
**Plate 2:** Trench 4 during ground reduction, looking west

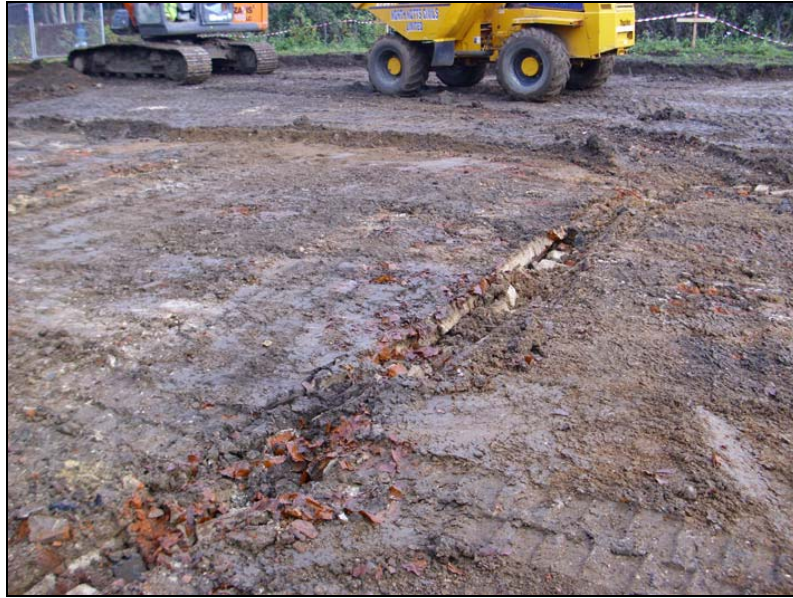
**Plate 3:** Brick culvert in Trench 5, looking north east

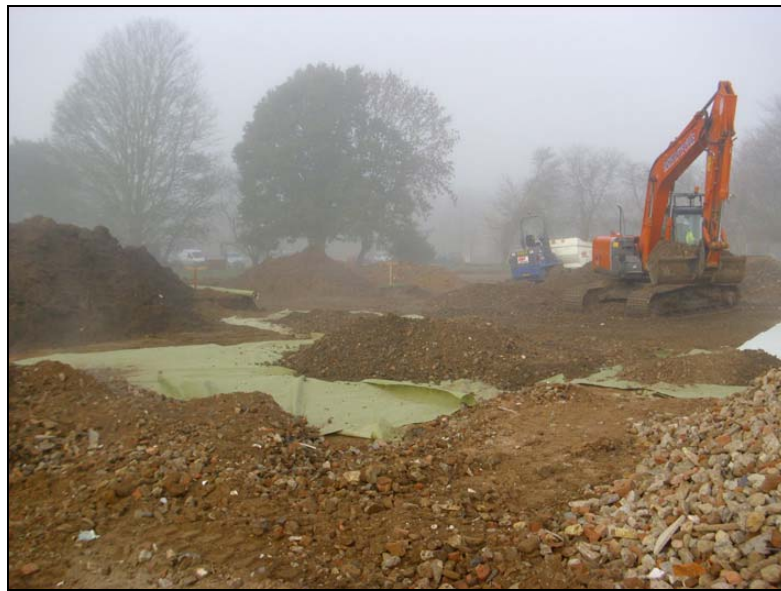
**Plate 4:** General construction shot, looking north west
