DESK-BASED & HISTORIC BUILDING ASSESSMENT: THE OLD SCHOOL HOUSE, LEICESTER ROAD, SAPCOTE, LEICESTERSHIRE

Nicholas A Crank BSc AIFA

February 2005

ASC: 637/SOS/02

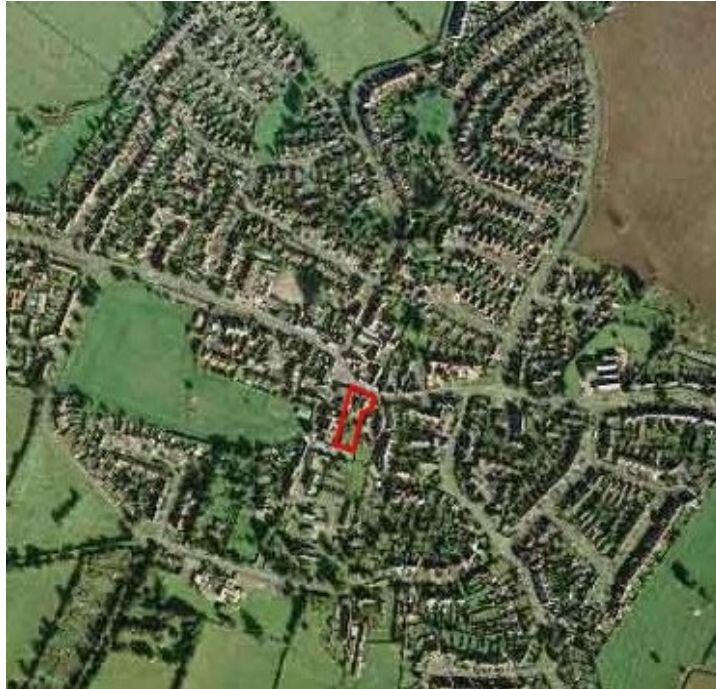
Plate 1: Aerial Photograph of the Site Location (Outlined in red)

The site is located in the village of Sapcote in the rural parish of Sapcote, c.6km east of Hinckley town centre at NGR SP 48917 93377 (Fig. 1), and comprises a roughly L-shaped parcel of land c.0.18ha in area.

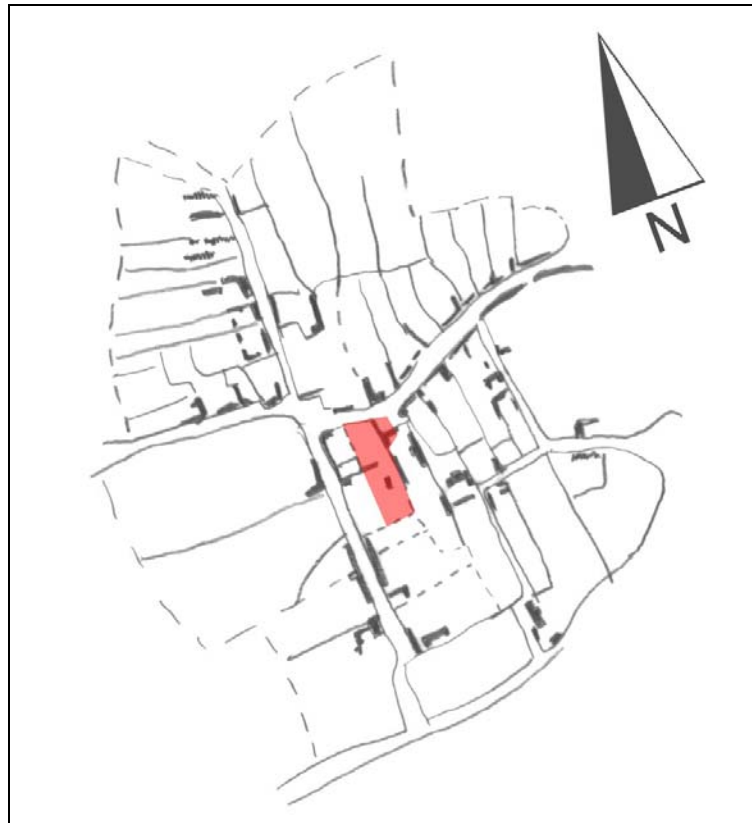
Figure 4: Inclosure Map 1778 (not to scale)

The earliest map showing the site is the 1778 enclosure map (fig. 4) which shows the site to be largely unoccupied although a few small structures or possible cottages are present in the central and north east areas. The adjacent grade II listed cottage at No. 1 New Walk is clearly marked. The available sources all state that the Old School was constructed in 1819, and indeed the roundel plaque on its Leicester Road frontage reinforces this fact. Its benefactor John Frewen Turner was both the main landowner in the village and the rector of the parish and seems to have taken some interest in the wellbeing of his parishioners having in 1806 built a public bath house over a well on Stanton Road (MLE9837) (Nichols 1811, 897)

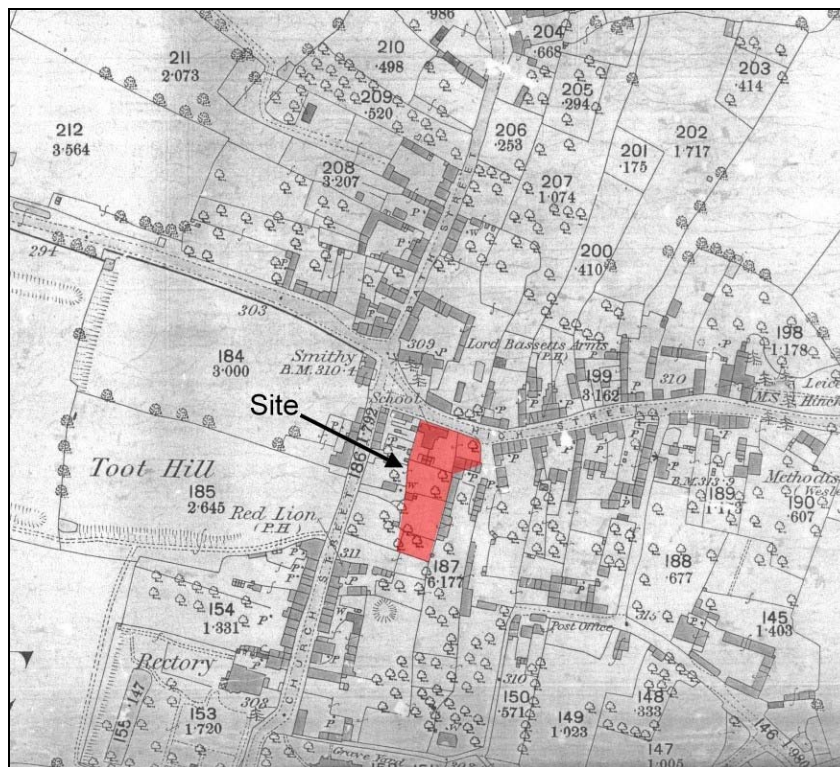
Figure 5: Ordnance Survey 1887 (Scale 25in)

The next available map is the Ordnance Survey (OS) 1st edition of 1887 (fig. 5). This depicts the school building in its finished layout minus the small extensions constructed in the 1960s and 1980s. However, it had only recently taken this form, a substantial extension comprising the hall and classroom to the rear of the school and the eastern third of the frontage being constructed around 1881 (pers. comm. R. Haslett). In addition a wall divides the playground and a small probable toilet block is attached to this. The remainder of the site appears to be gardens and is at least partly wooded. A small structure is present on the sites western boundary.

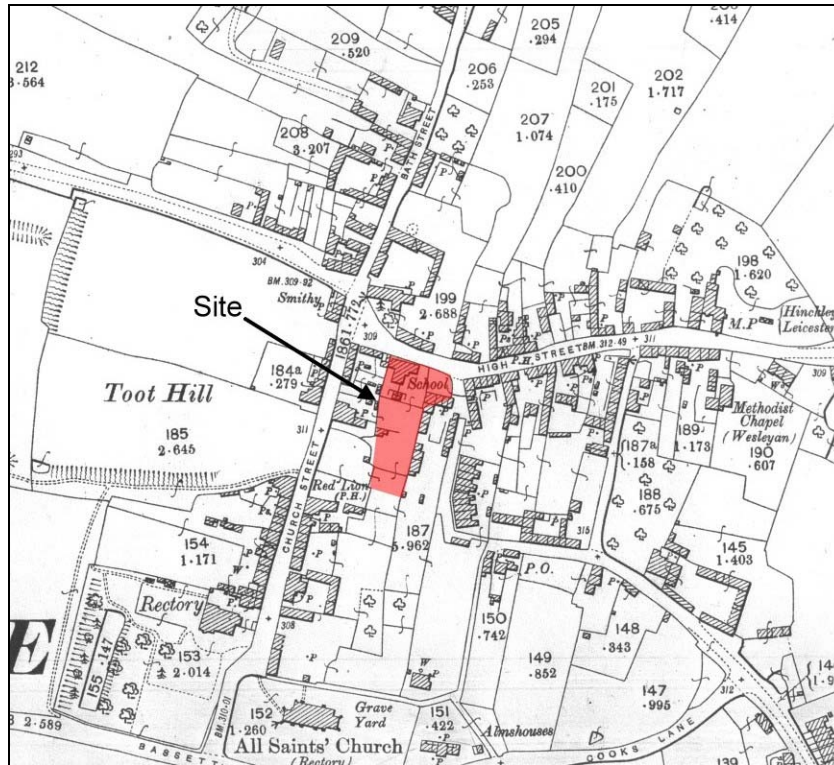
Figure 6: Ordnance Survey 1903 (Scale 25in)

By the time of the 1903 2nd edition OS map the layout of the site is unchanged (fig. 6). The next available map is the 1963 OS 1:2500 sheet (fig. 7) when the site boundaries assume their present form. Between this and the 1971 edition (fig. 8) the construction of the small flat roofed extension on the east of the school is apparent, as is the demolition of the toilet block in the playground. The 1971 map also shows a temporary classroom, briefly used and then removed prior to the re-siting of the school later in the 1970s. A comparison of the school plan between 1971 and today (fig. 3) shows little change except the addition of the two small side extensions to the south east and south west

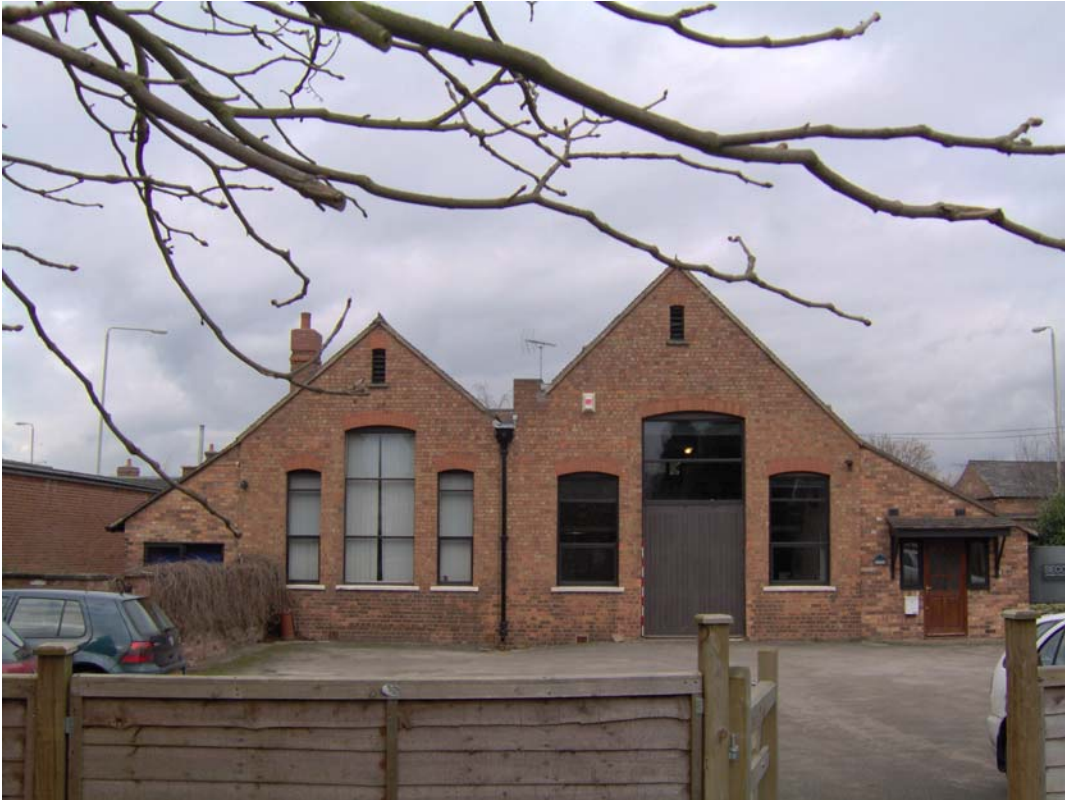
Plate 2: South Elevation

The south elevation comprises two bays with gables of uneven height. The western bay is pierced by three tall windows with arched red brick lintels and stone sills. A small louvred vent in the same style is located above. The larger eastern bay features a similar arrangement offset to the east to accommodate a small square chimney stack. The larger central opening in this case featuring a double door with glazing above. Two 1980's constructed lean-to extensions in matching brick abut each side of the wing.

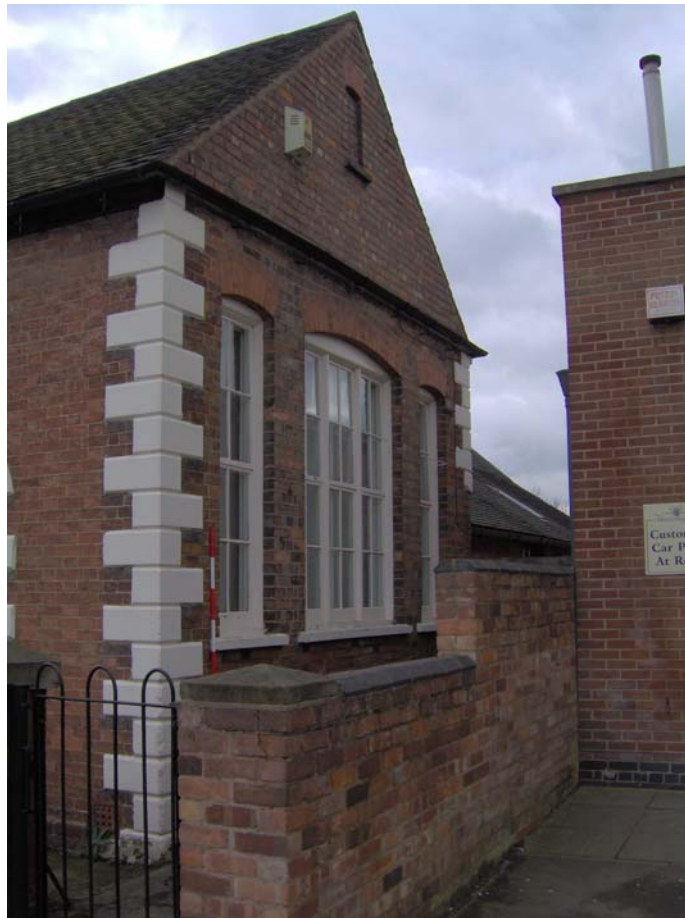
Plate 3: West Elevation

To the north this comprises the gable end of the Leicester Road frontage (Plate 3). It features a central '3 over 3' wood mullioned casement window flanked by smaller single transomed casements. The windows all have red brick segmental arched lintels and stone sills. A small niche detail is positioned centrally above. To the south, recessed porch with stone lintel inscribed 'Girls and Infants' and brown glazed brick surround (Plate 4). Continuing southwards brick built south wing with matched brick 1980's addition.

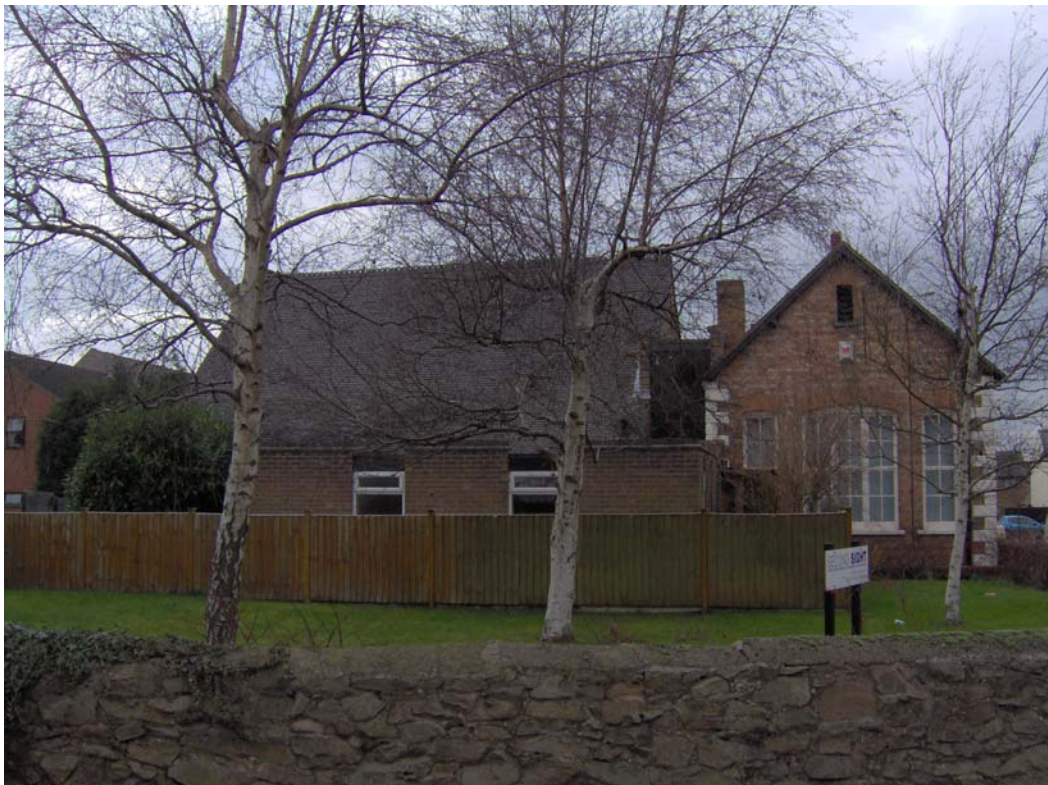
Plate 5: East Elevation

Northern part identical to west elevation with minor differences including projecting eaves and louvred central vent. The southern of the three windows is partially boarded. To the south, a flat roofed single storey 1960's header bond brick extension with matched brick 1980's extension attached.

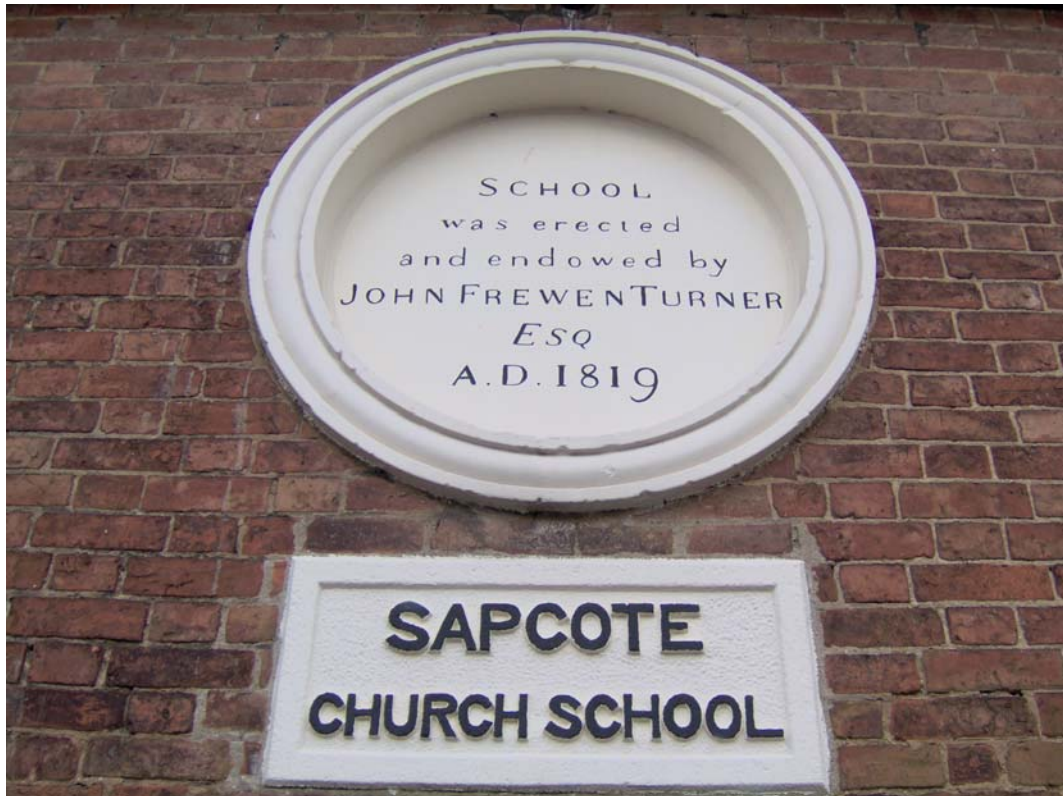
Plate 6: North Elevation (detail)

As listing description (above). Four iron strengthening wall plates are present at the east end of the building, three iron ventilation grilles are also noted. A vertical join in the brickwork is partly concealed by the cast iron rainwater drainpipe at the east end.

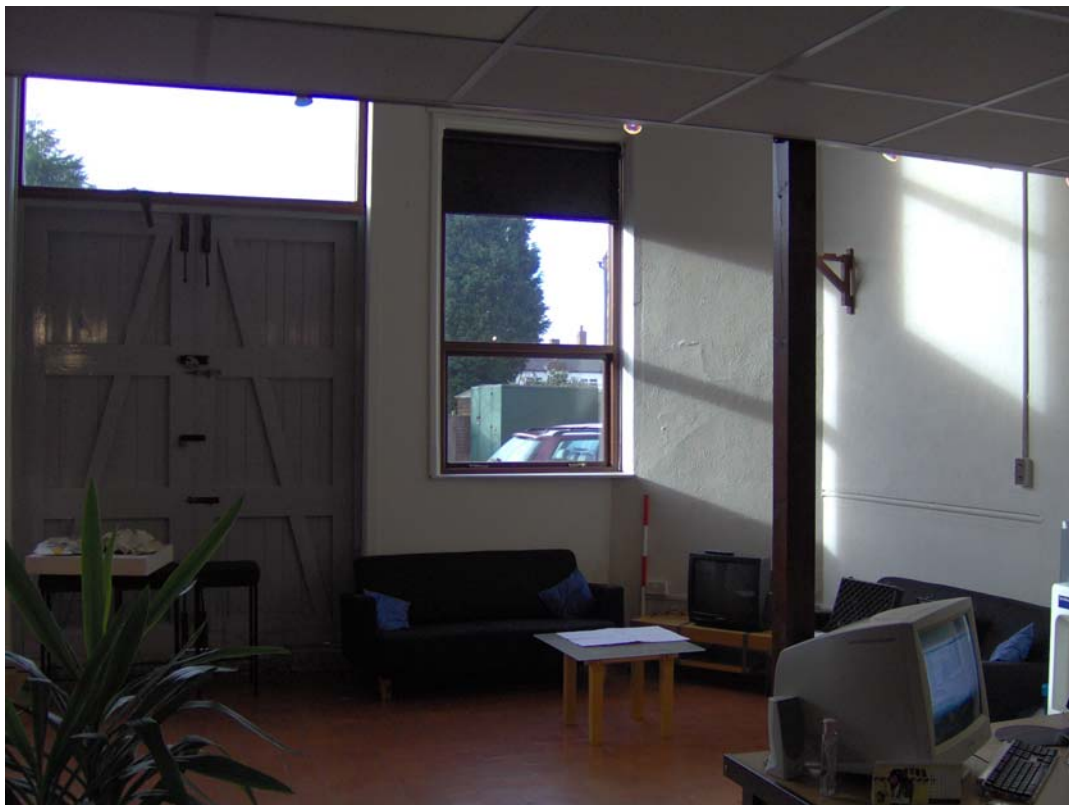
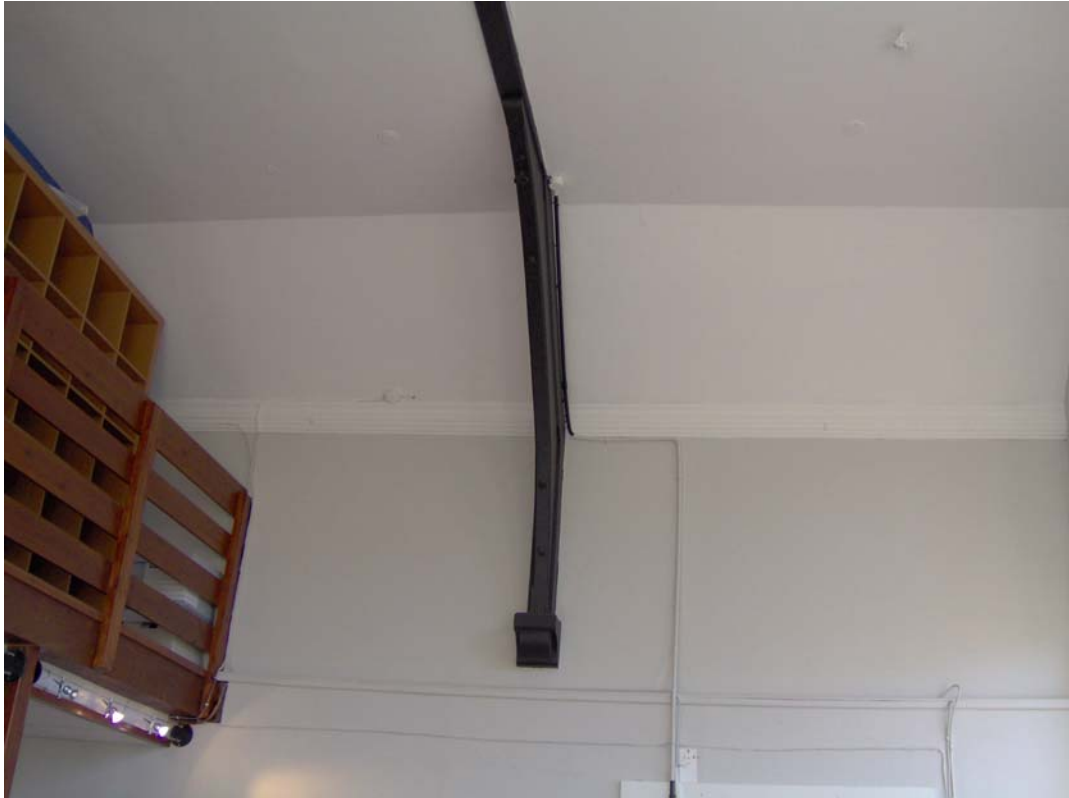
Description: Large lofty rectangular hall, with 1980's mezzanine balcony (Room 18) over northern part. Walls plastered and painted. Large double door with original fittings in south wall, window over. Modern flush panel door in south east corner. Four panelled half glazed door in north wall linking to corridor. Modern dogleg stairway to mezzanine in north east corner. Modern partition forms store in north west corner. Two narrow high windows each side of door in south wall, with modern glazing units. Two blocked and blind fireplaces in north west and south west corners. Hipped plastered ceiling with visible roof beams, and moulded stone plinths (Plate 8). Southern part of floor ceramic tiled, remainder boarded and carpeted.

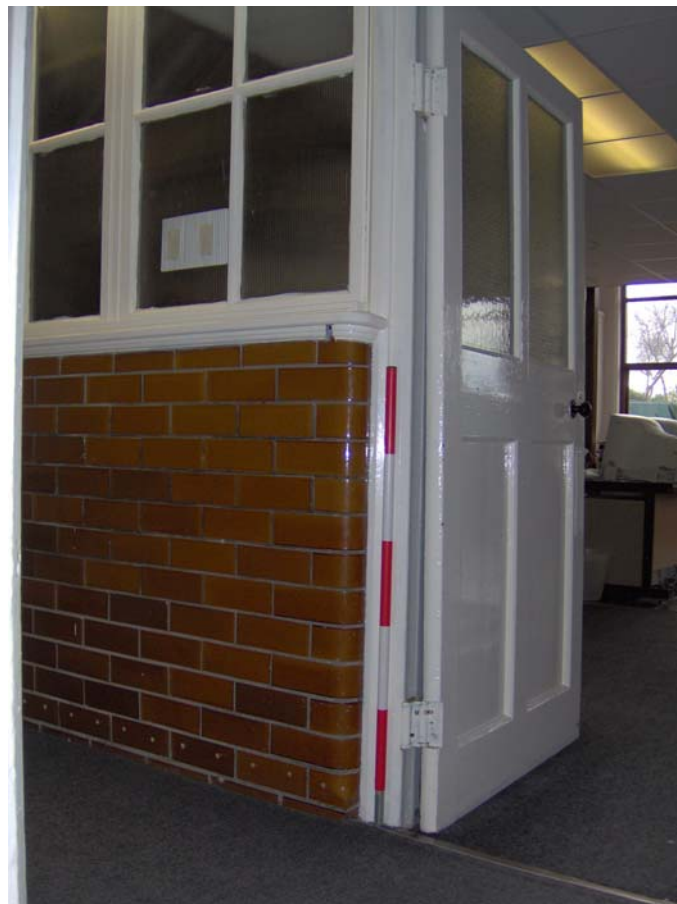
Plate 9: Corridor, doorway to Room 2

Description: Linking corridor. South wall in brown glazed brick with upper half glazed, no skirting. North wall plastered and painted with dado rail and modern skirting. Door in south wall four panelled half glazed with window over. Doors in north wall and west wall modern flush panel. Ceiling plastered. Floor carpeted.

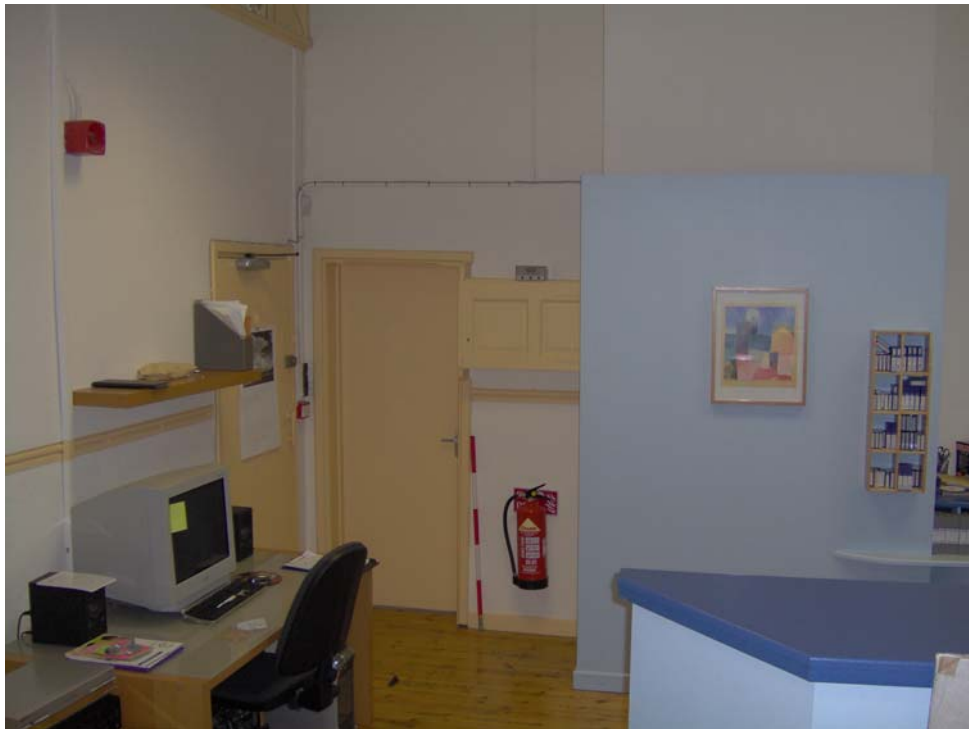
Plate 10: Room 3, looking south west

Description: Rectangular room, walls plastered and painted, modern skirting and dado rail. Modern flush panelled door with window over in south wall. Modern flush panelled door in west wall. Double lancet window in north wall. Central three light mullioned casement with flanking single transomed casements in east wall. Ceiling is false and polystyrene tiled. Floor split level: lower part boarded, upper part carpeted. A small partitioned store occupies the south east corner.

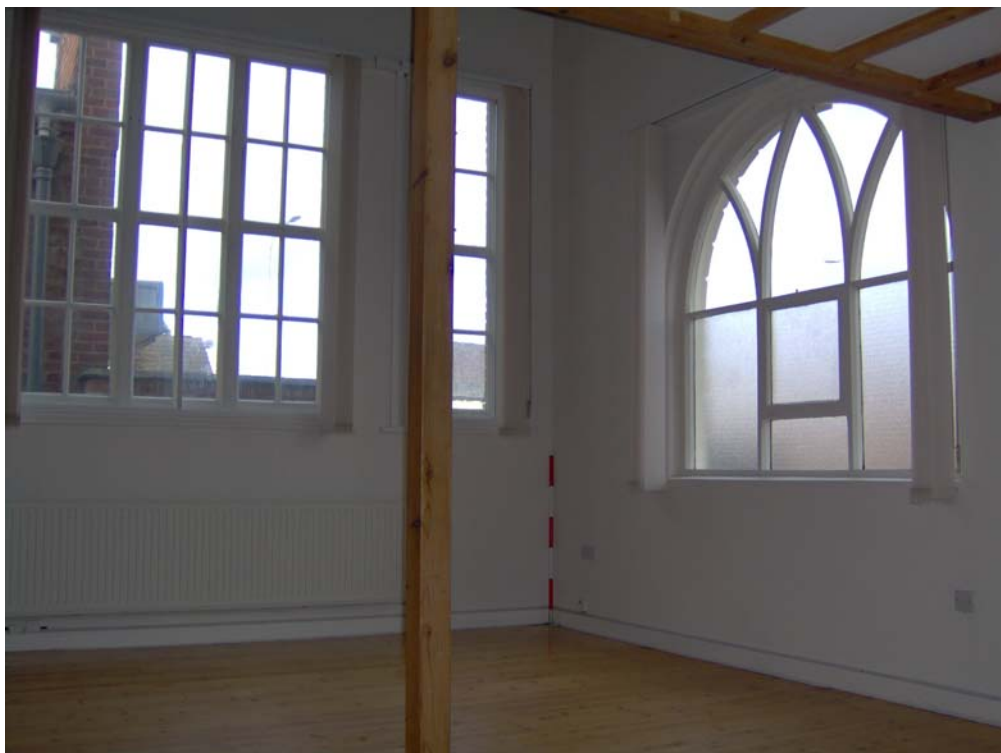
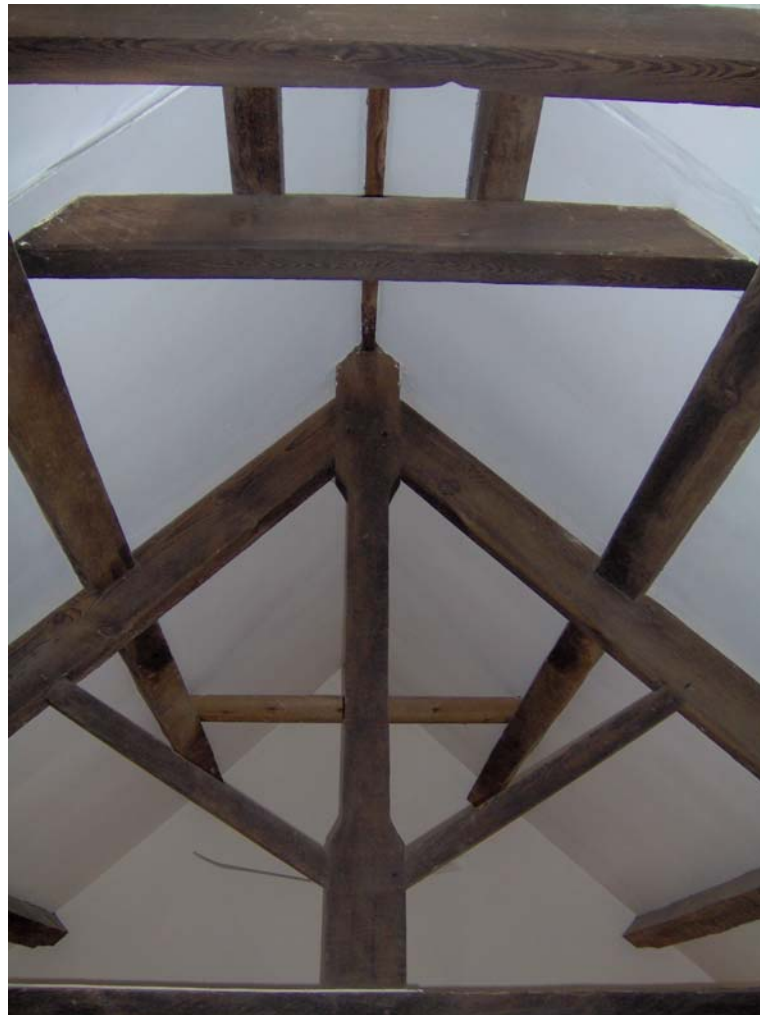
Description: Rectangular room, walls plastered and painted, modern skirting. Single four panelled half-glazed modern pine door in south wall. Part blocked fireplace and chimney breast with modern pine surround and mantel in south east corner. Balcony forming mezzanine floor (Room 14) over east half of room with staircase up. Floor is modern wood laminate boarded. The ceiling is plastered and painted and the King post roof truss with paired diagonal braces and a double row of purlins is visible (Plate 12).

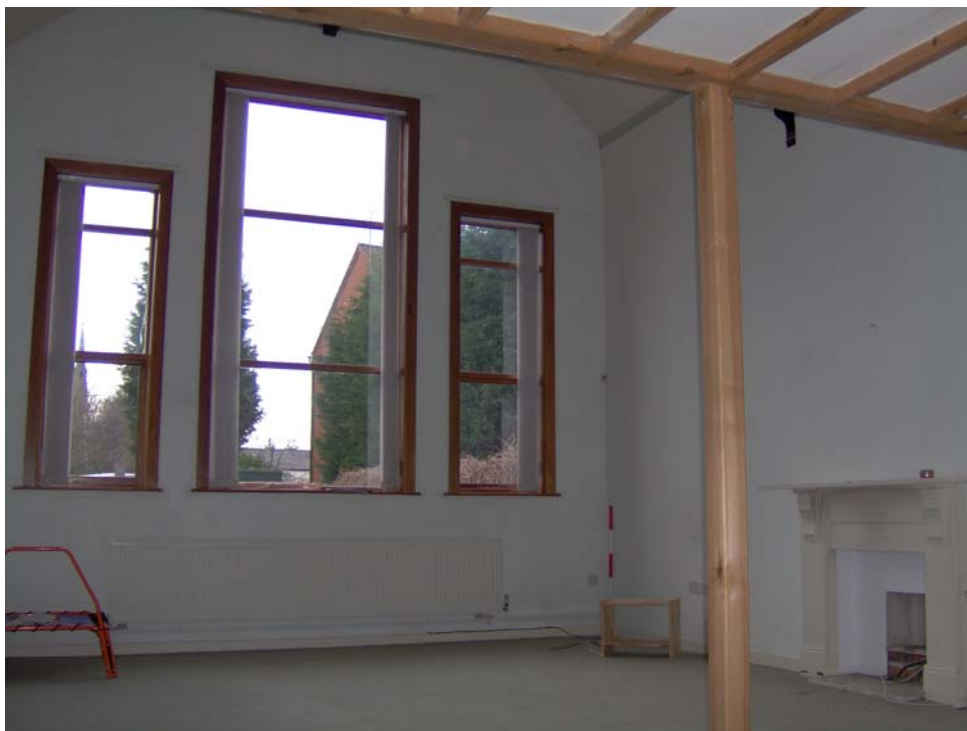
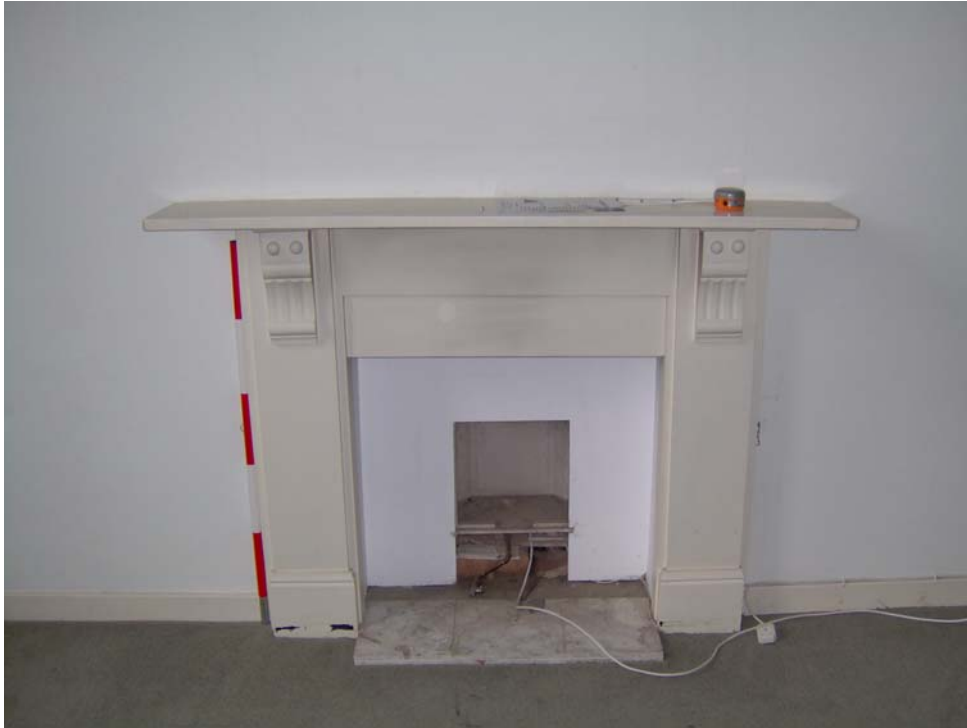
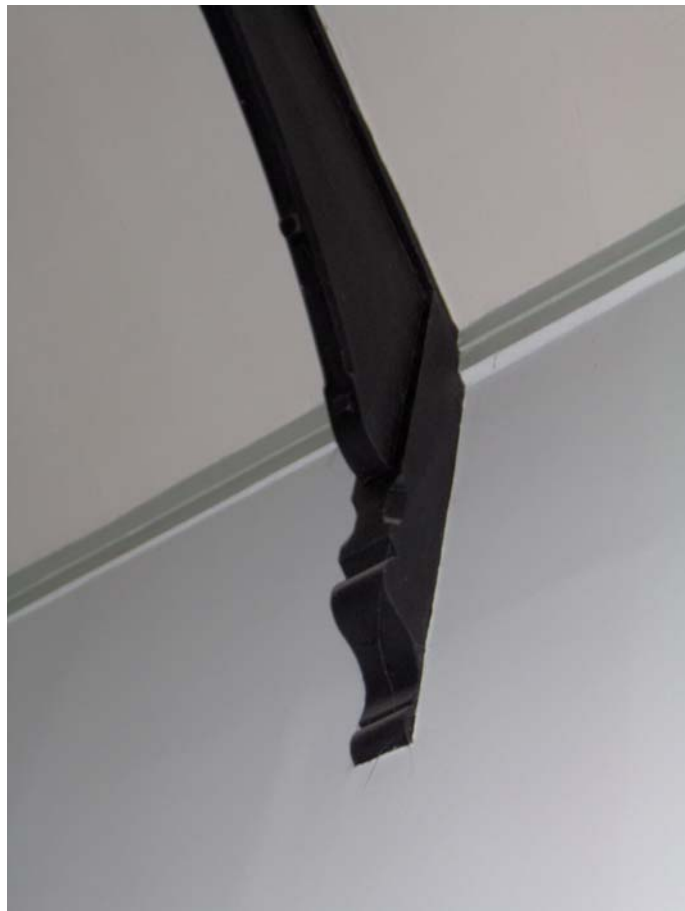
Description: Large rectangular plastered and painted room with modern skirting. Modern balcony forming mezzanine over northern part. Two flush panel modern doors in north west corner. Three tall rectangular windows with modern glazing units in south wall matching those in Room 2. Non-original 19th century painted stone fireplace and chimney breast on west wall (Plate 14). Hipped plastered ceiling with visible roof truss featuring scroll moulded bases (Plate 15). Floor carpeted.

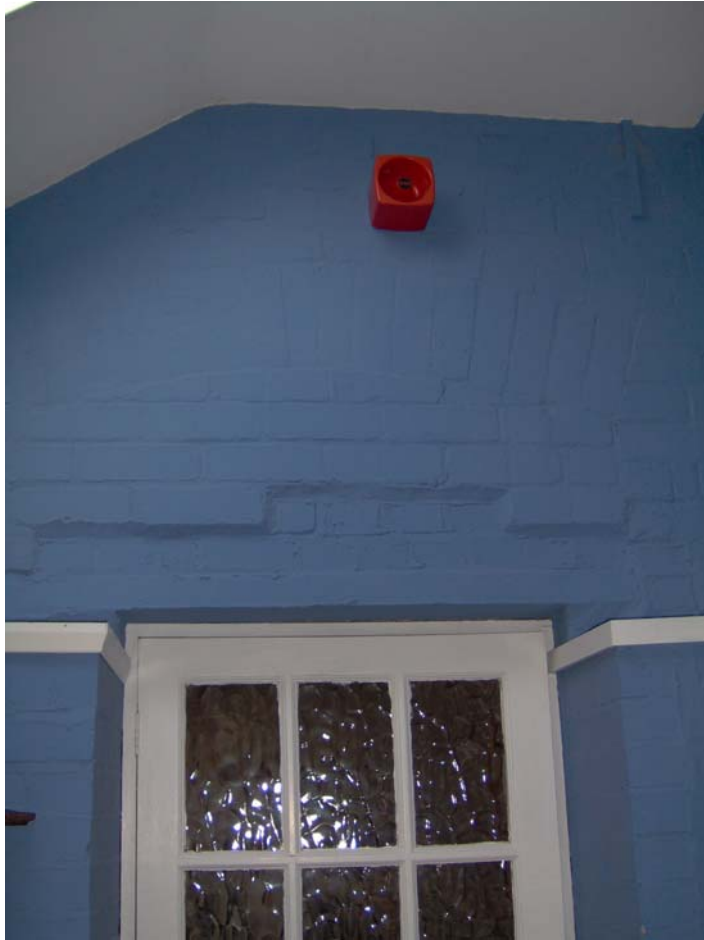
Plate 16: Room 9, detail of bricked up entrance on north wall

Description: Small rectangular room of 1980's construction with painted brick walls, partial high single brick thickness plinth on north and east walls. Modern glazed door set within larger bricked up doorway with segmental arched lintel (Plate 16). Modern double glazed external door in west wall. Single modern casement window in south wall. South part of floor raised with low partition, remainder as in Room 8. Ceiling as in Room 8, with skylight.

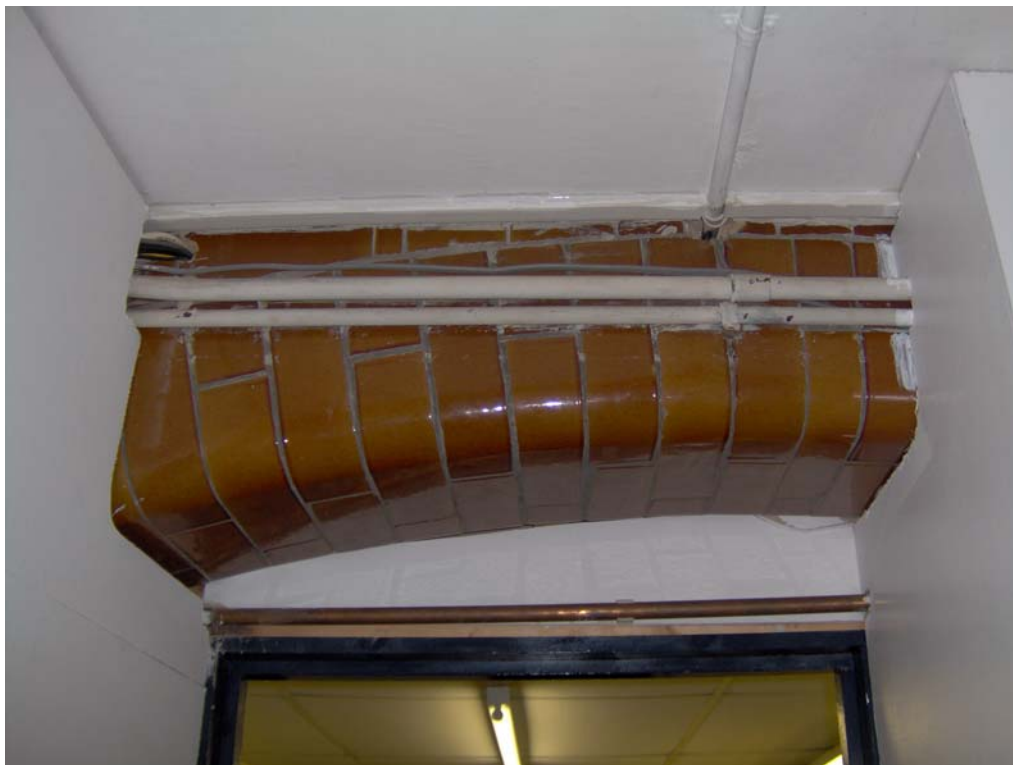
Plate 17: Glazed brick over entrance to Room 10, looking south

Description: Small rectangular room, walls plastered and painted, modern skirtings. Two modern flush panel doors in east wall, one in south wall. No windows. Modern polystyrene tiled false ceiling. Floor carpeted. Modern worktop and cupboards on west wall. Entrance in north wall notable for arch of brown glazed brick over (Plate 17).

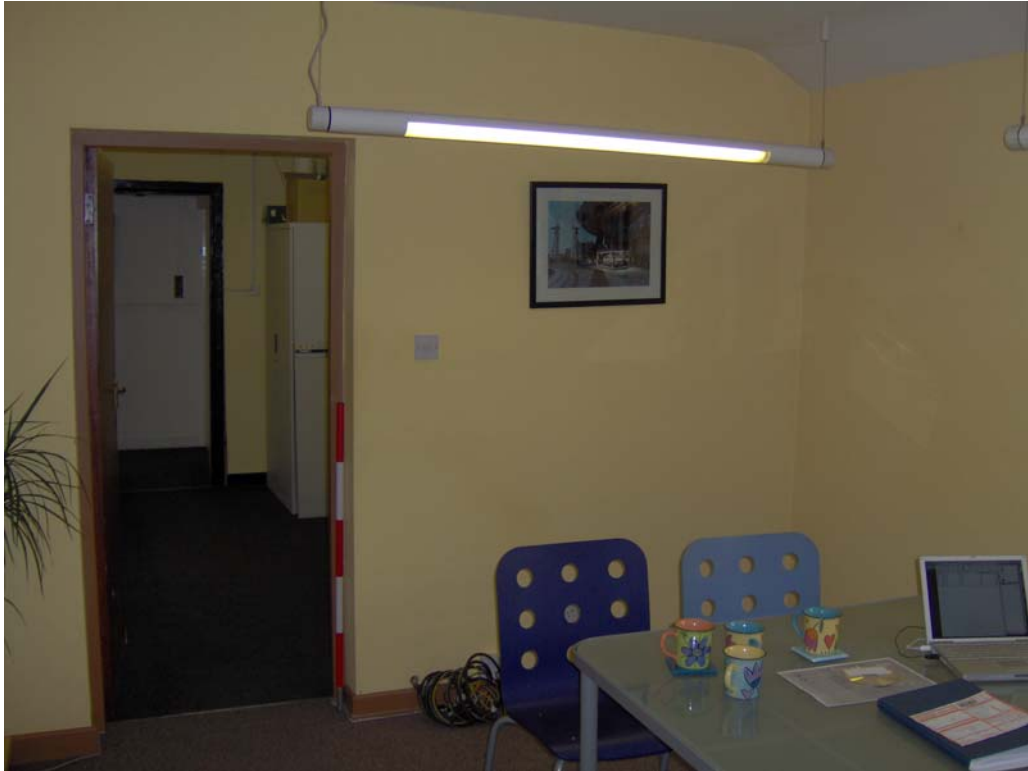
Plate 18: Room 13, looking north

Description: Rectangular room, 1980s construction, walls plastered and painted, modern skirtings. South wall is a studwork partition. Single modern flush panel door in south and north walls. Double glazed casement window in east walls. Ceiling plastered and painted. Floor carpeted.

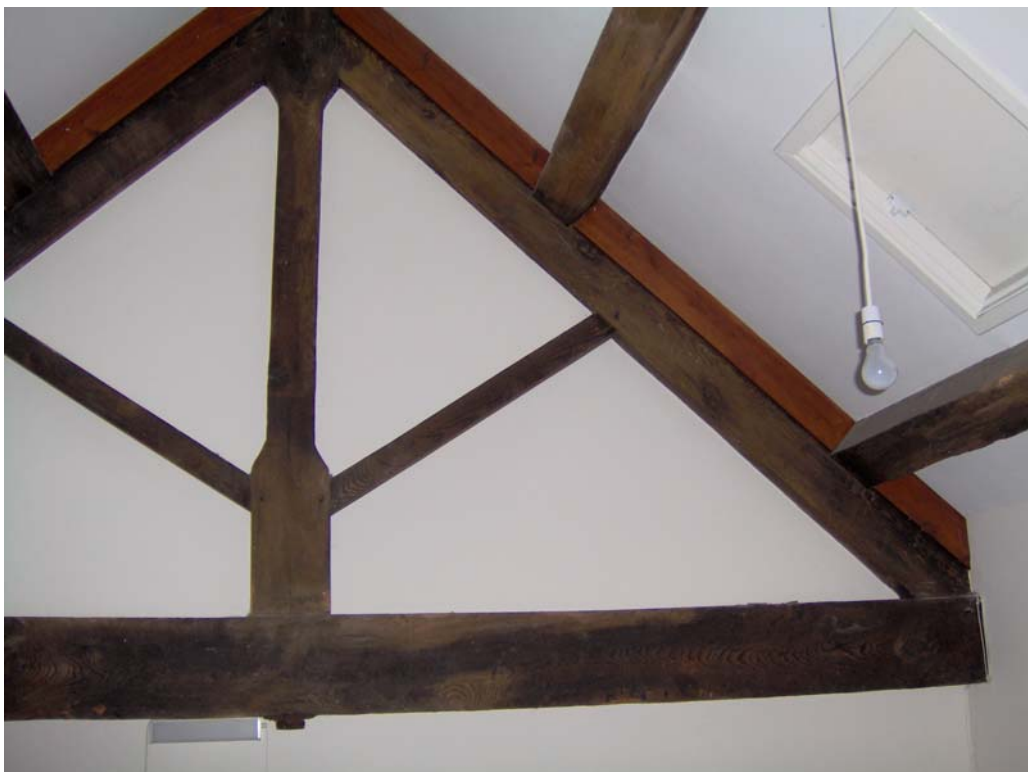
Plate 19: Room 14, detail of roof truss

Description: Small rectangular mezzanine bedroom with balcony, formed from roof space over east end of Room 5. King post roof truss and braces visible, as in Room 5 (Plate 19).

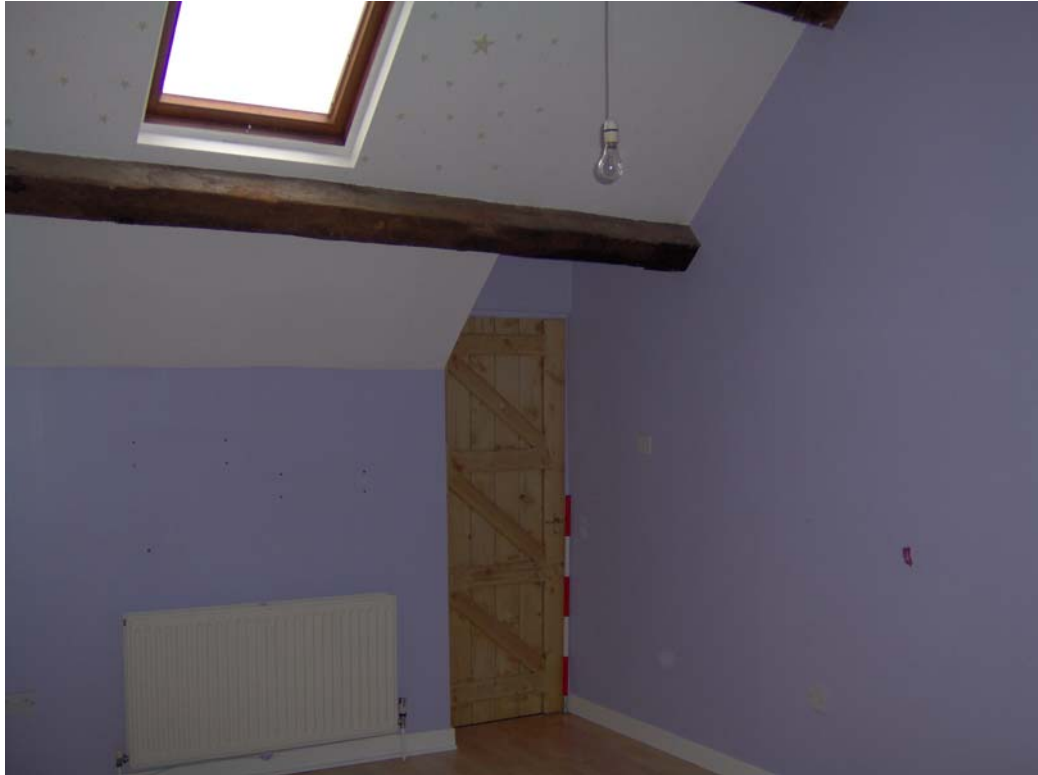
Plate 20: Room 15, looking south west

Description: Small rectangular mezzanine bedroom, formed from roof space over Room 4. Double row of purlins present in hipped ceiling.

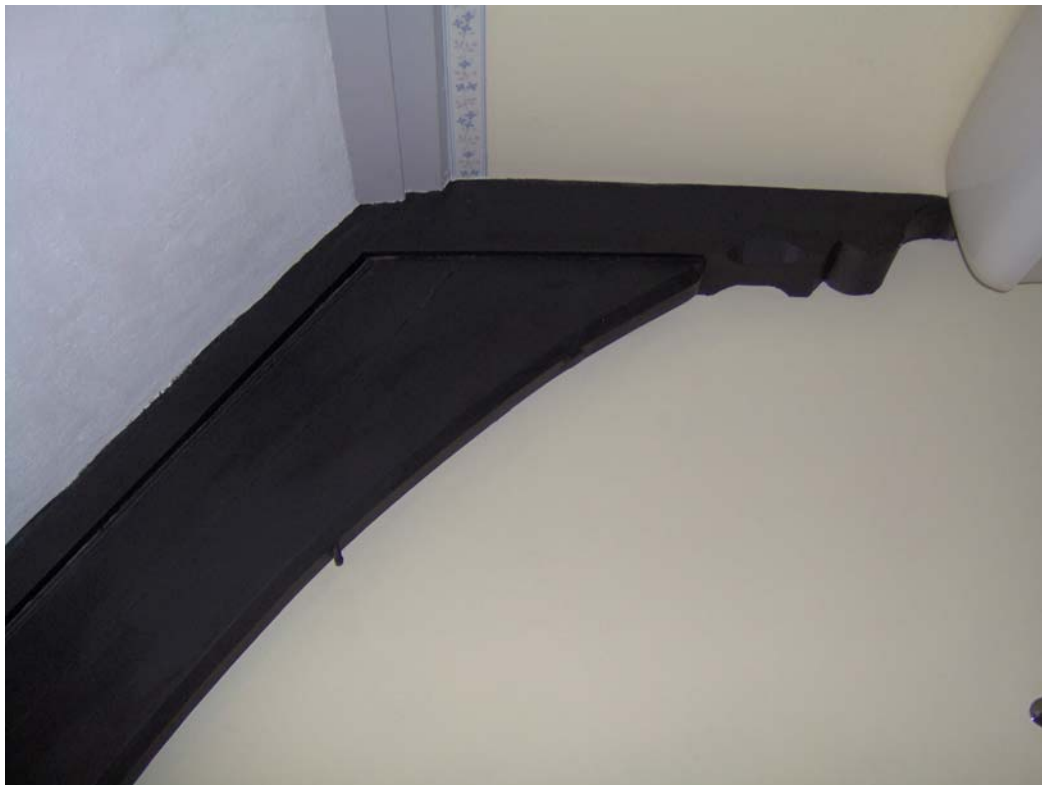
Plate 21: Room 16, detail of roof truss, south wall

Description: Rectangular landing linking to mezzanine rooms in western part of building, inserted over hall Room 6. Separate toilet and airing cupboard on west wall. Carved roof truss visible on south wall (Plate 21).

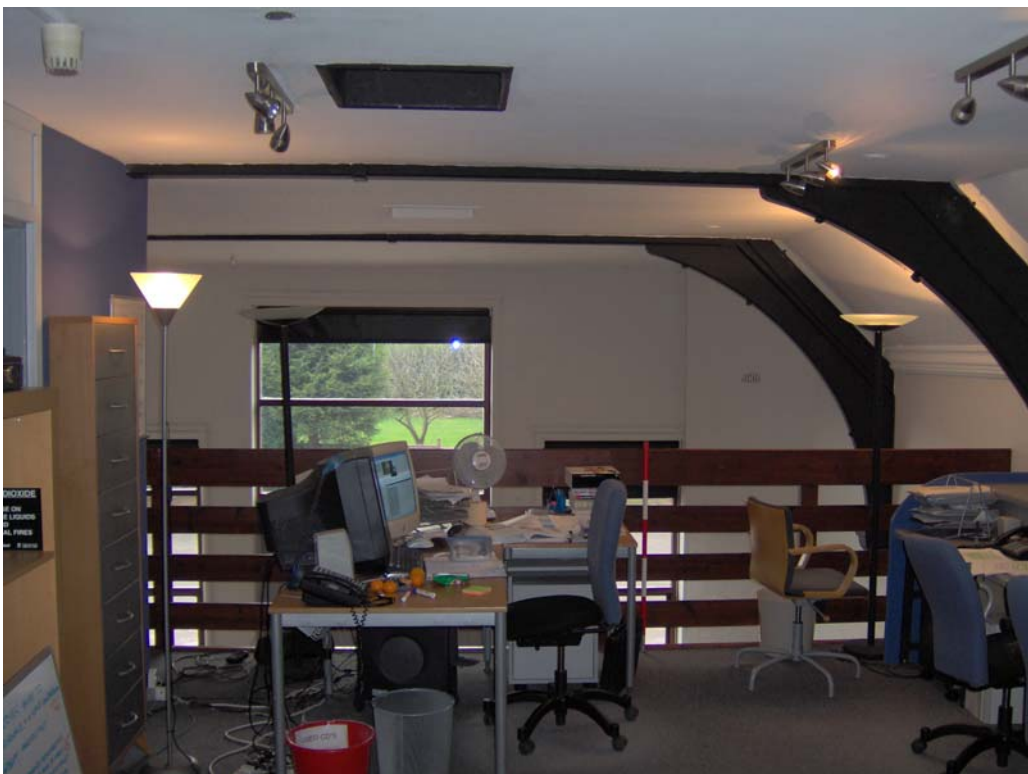
Plate 23: Room 18, looking south

Description: Rectangular mezzanine floor in roof space over Room 2. Roof trusses visible in hipped ceiling. Small partition store on east wall.
