ARCHAEOLOGICAL WATCHING BRIEF SITES 3A, 3B AND 3C MIDDLEMORE DAVENTRY NORTHAMPTONSHIRE

*on behalf of
Bovis Homes Ltd.*

March 2005

ASC: 642/DMM/02

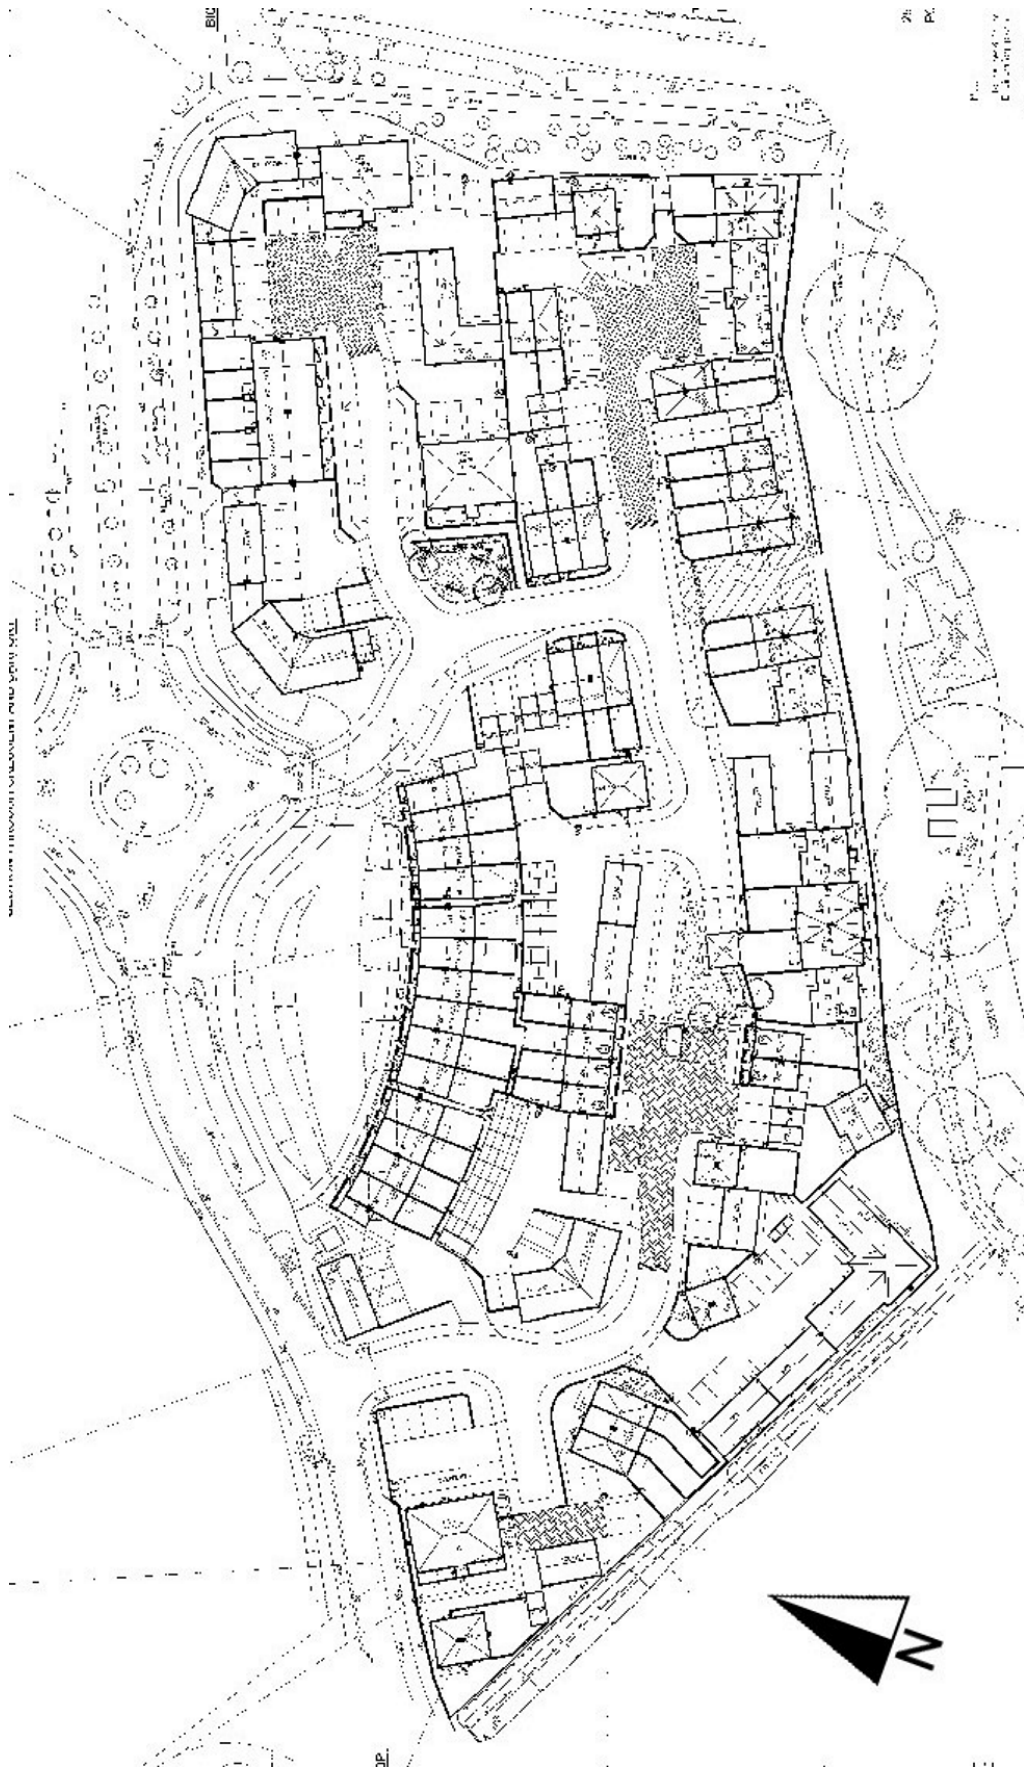
Figure 3. Site plan showing proposed development (not to scale)

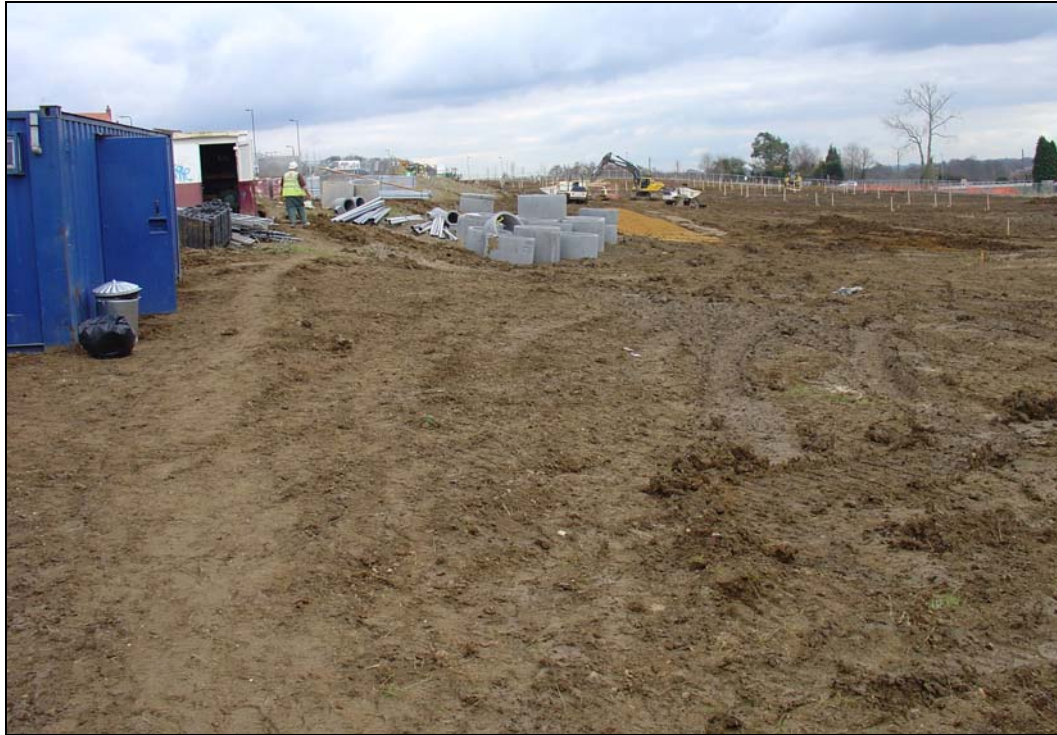
Plate 1. General site shot during topsoil strip, looking east

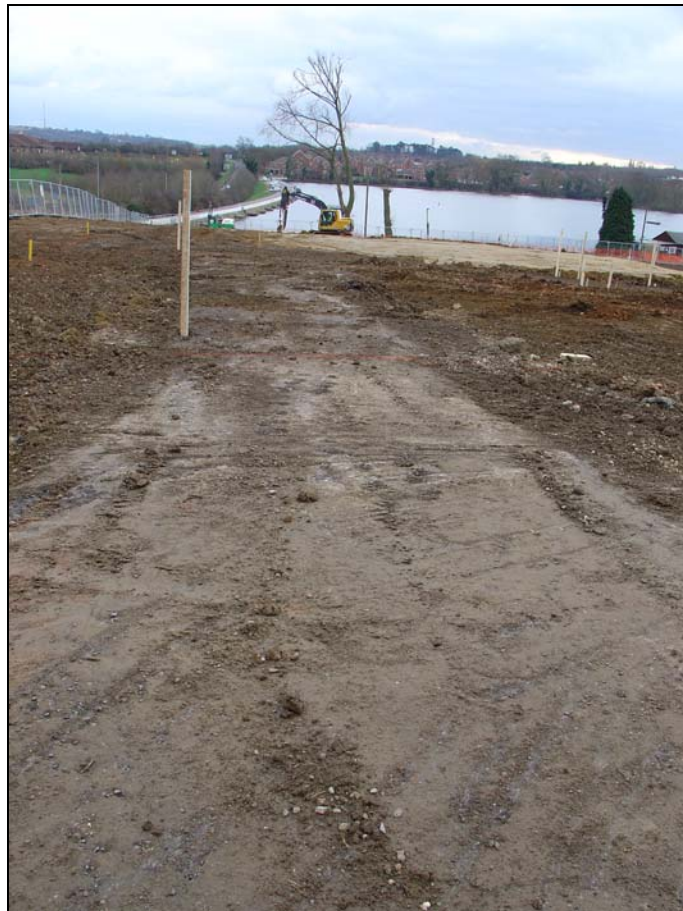
Regular monitoring visits commenced the week beginning 10/01/05 and terminated the week beginning 28/02/05. Although a modern metalled surface and short length of modern masonry foundation (Plate 2), were revealed in the northern part of Site 3A no other finds or features were noted during the topsoil strip of Sites 3A, 3B and 3C (Plate 1). The observations made during further monitoring visits are detailed by site subdivision in the following sections.

Plate 2. Site 3A; modern metallised surface, looking south

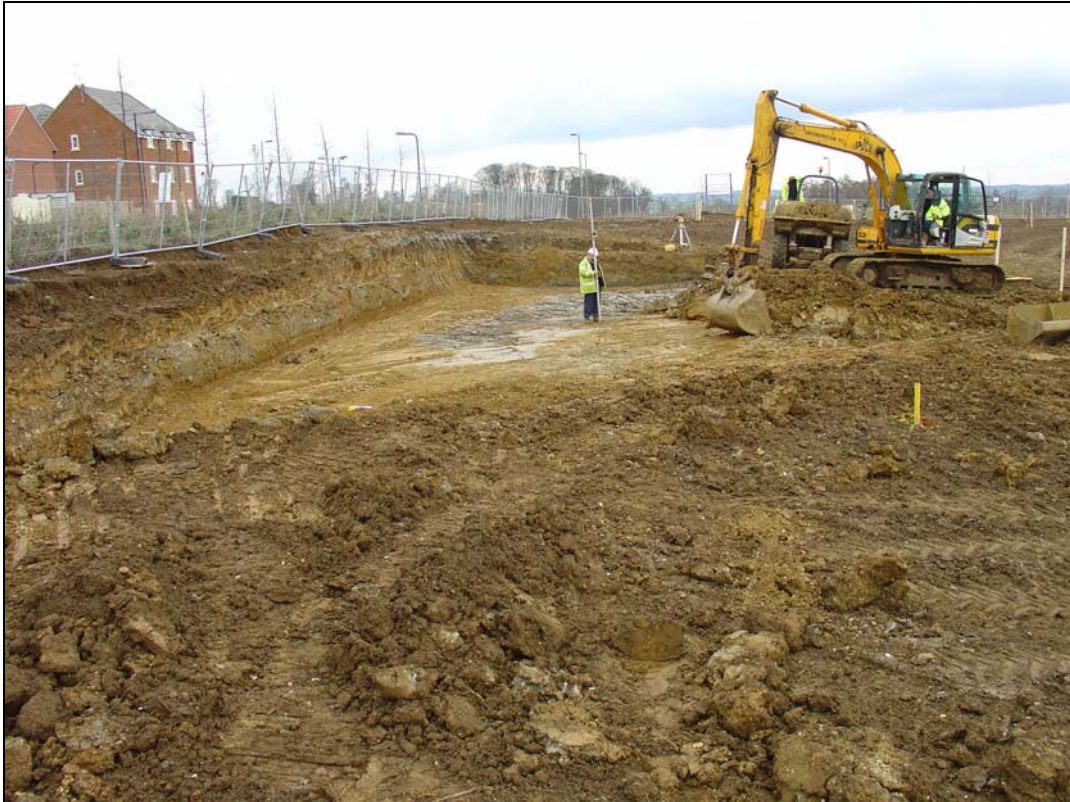
This part of the site had a moderate north-south slope. The developer created two east-west aligned terraces through excavation and deposition of material thus establishing flat surfaces in which to dig footings (Plate 4). The strata revealed in the northernmost terrace (Plate 3), were (depths from surface at highest point of slope):

| • Topsoil | mid brown organic silt | c. 0 - 0.2m |
| • Subsoil | orangeish brown sandy clay | c. 0.2 - 0.4m |
| • Natural | brownish yellow clayey sand | c. 0.4 – 2.4m |
| • Natural | light grey clay | c. 2.4m + |

Plate 3. Site 3A; northern terrace being excavated, looking east

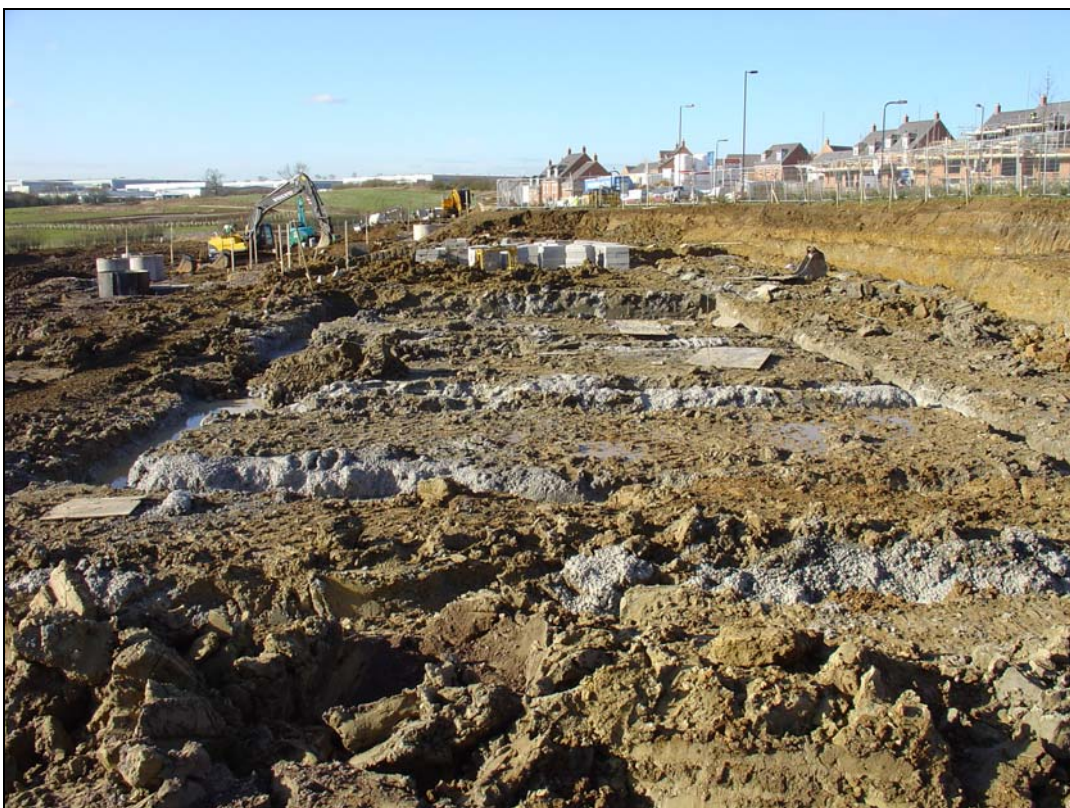
Plate 4. Site 3A; footings in northern terrace, looking west

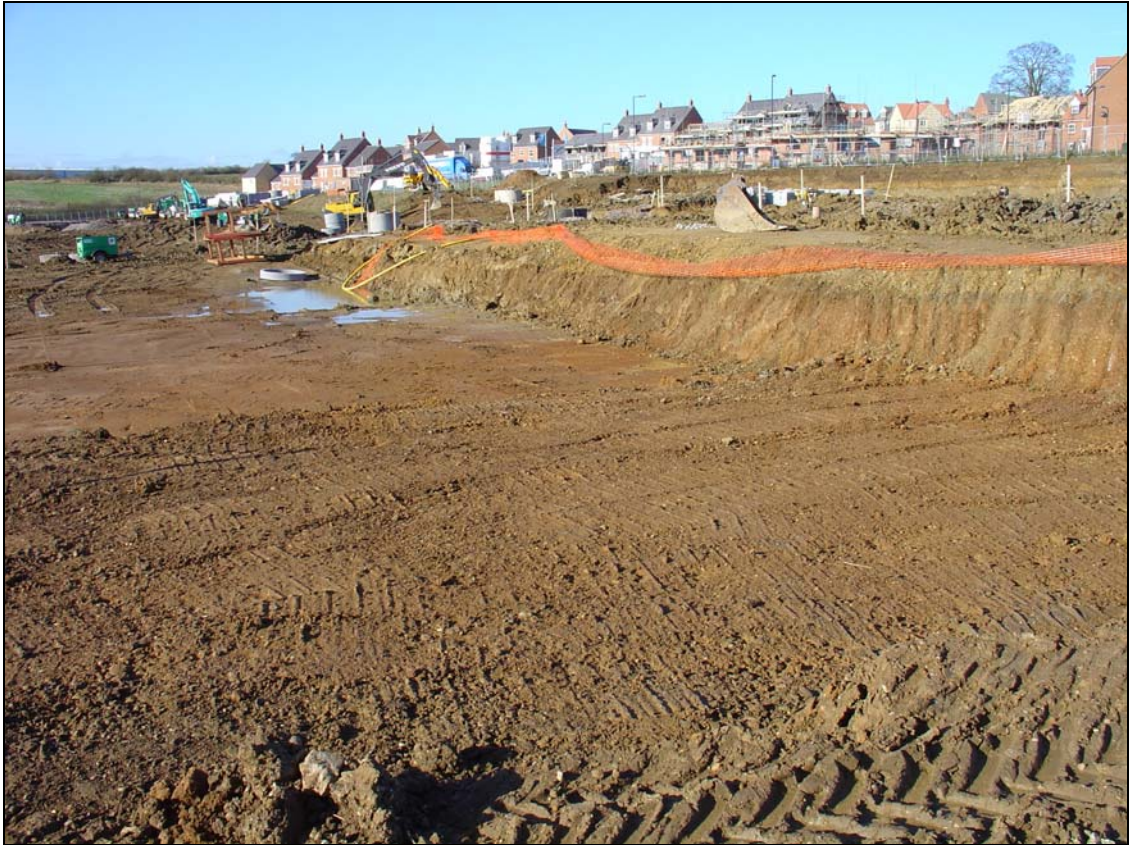
The profile revealed after excavation of the more southerly, downslope, terrace (Plate 5) was c. 1.2m deep and exhibited only the first three of the strata listed above.

Plate 5. Site 3A; southern terrace, looking west

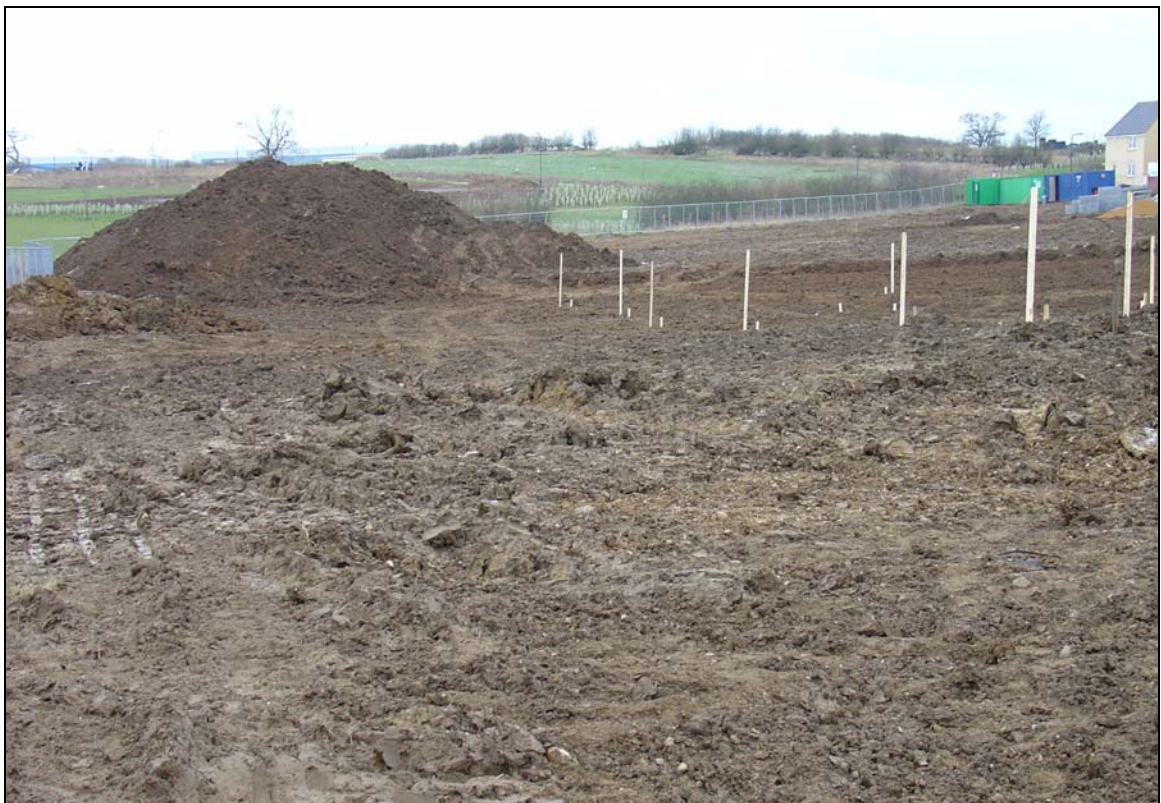
This part of the site was flatter, although still exhibiting a gradual north-south slope, than both 3A and 3C. Topsoil stripped during the initial groundwork was stored in a large spoil heap adjacent to the southern perimeter fencing, and the site office and stores were positioned along the northern boundary (Plate 6). Levelling material was deposited on the subsoil in the central part of the site (Plate 7), to reduce the slope gradient and make its height equivalent to that of the levelling material deposited at Site 3C.

Archaeological finds or features were not apparent in the top / subsoil and it was impossible to determine the presence or absence of archaeological finds or features in underlying strata due to the presence of the topsoil store and deposition of the levelling material.

Plate 6. Site 3B showing topsoil store and site cabins, looking west

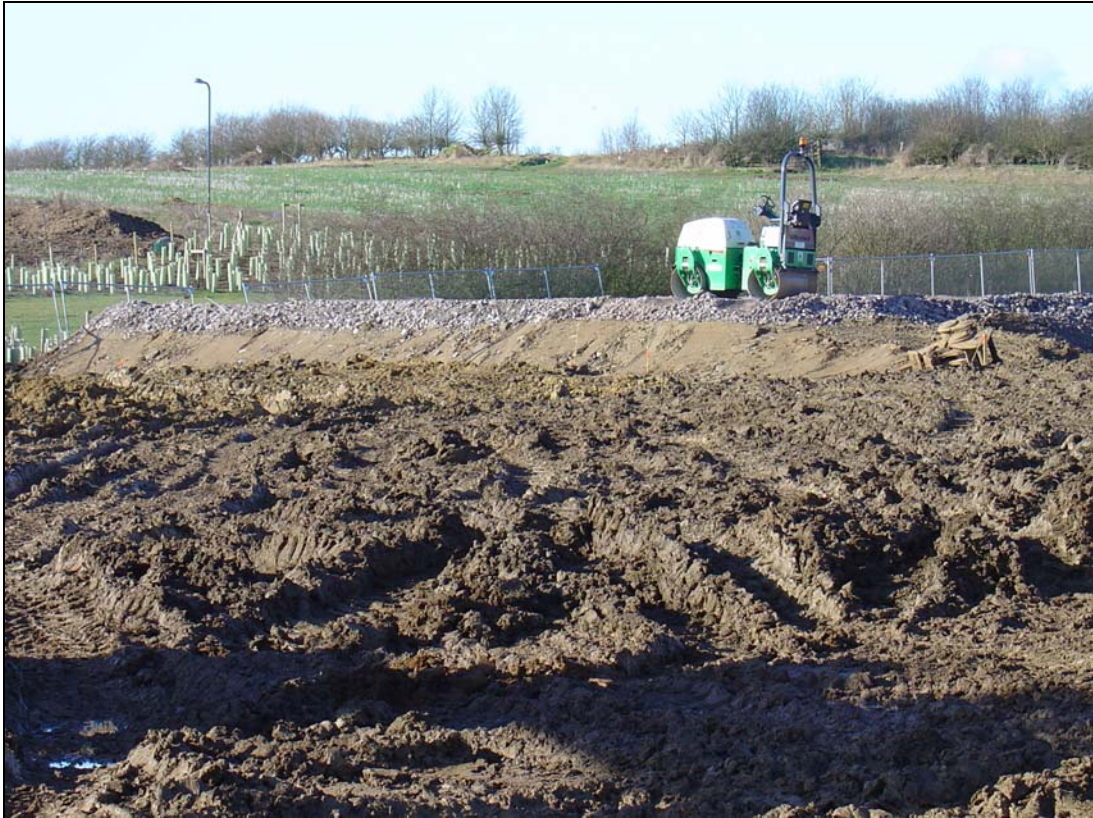
Plate 7. Site 3B; deposition of levelling material, looking southwest

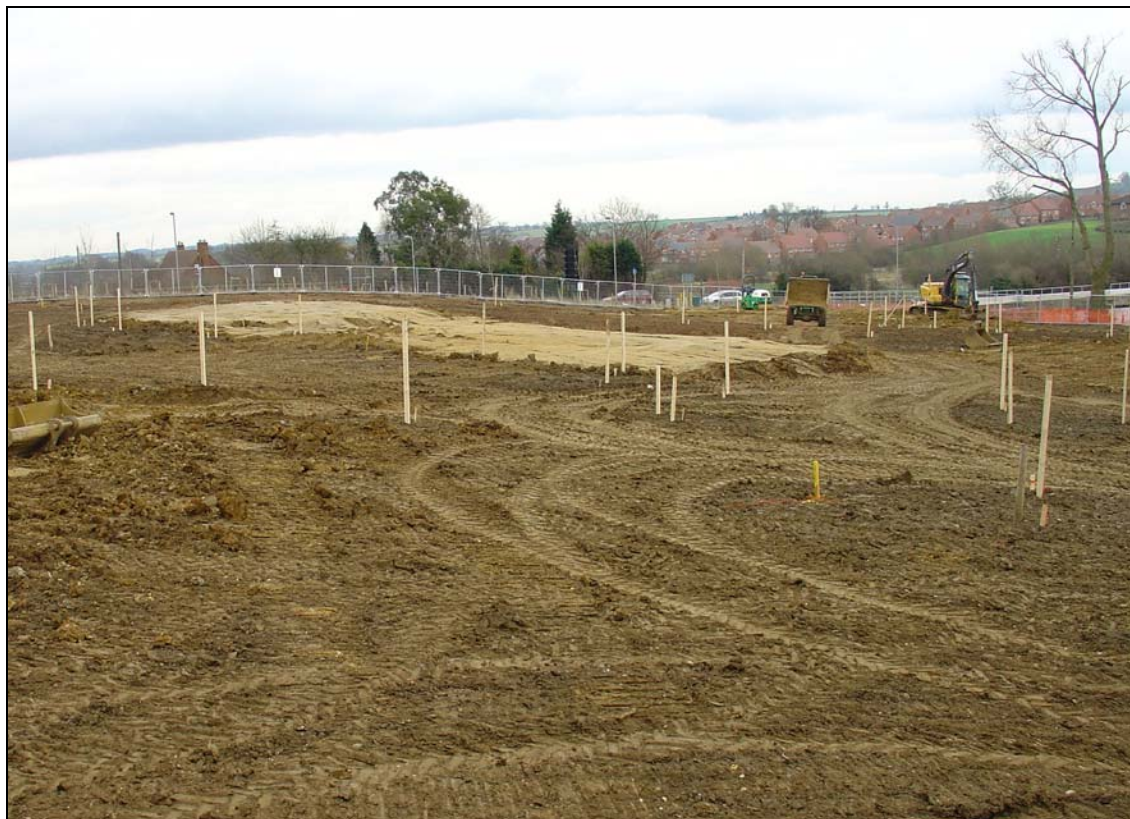
This part of the site was located at the base of the slope noted in Section 4.2. Brownish yellow clayey sand removed from the terraces excavated in Site 3A was deposited onto the exposed subsoil to level the slight north-south gradient (Plate 8).

Archaeological finds or features were not revealed in the top / subsoil and it was impossible to determine the presence or absence of archaeological finds or features in underlying strata due to the deposition of the levelling material.

Plate 8. Site 3C; deposition of levelling material, looking east
