**ARCHAEOLOGICAL DESK-BASED ASSESSMENT,
BUILDING APPRAISAL & EVALUATION:
HOME FARM, BRADGATE ROAD,
ANSTEY, LEICESTERSHIRE**

on behalf of Maplelink Ltd

April 2005

ASC: 659/ABR/02

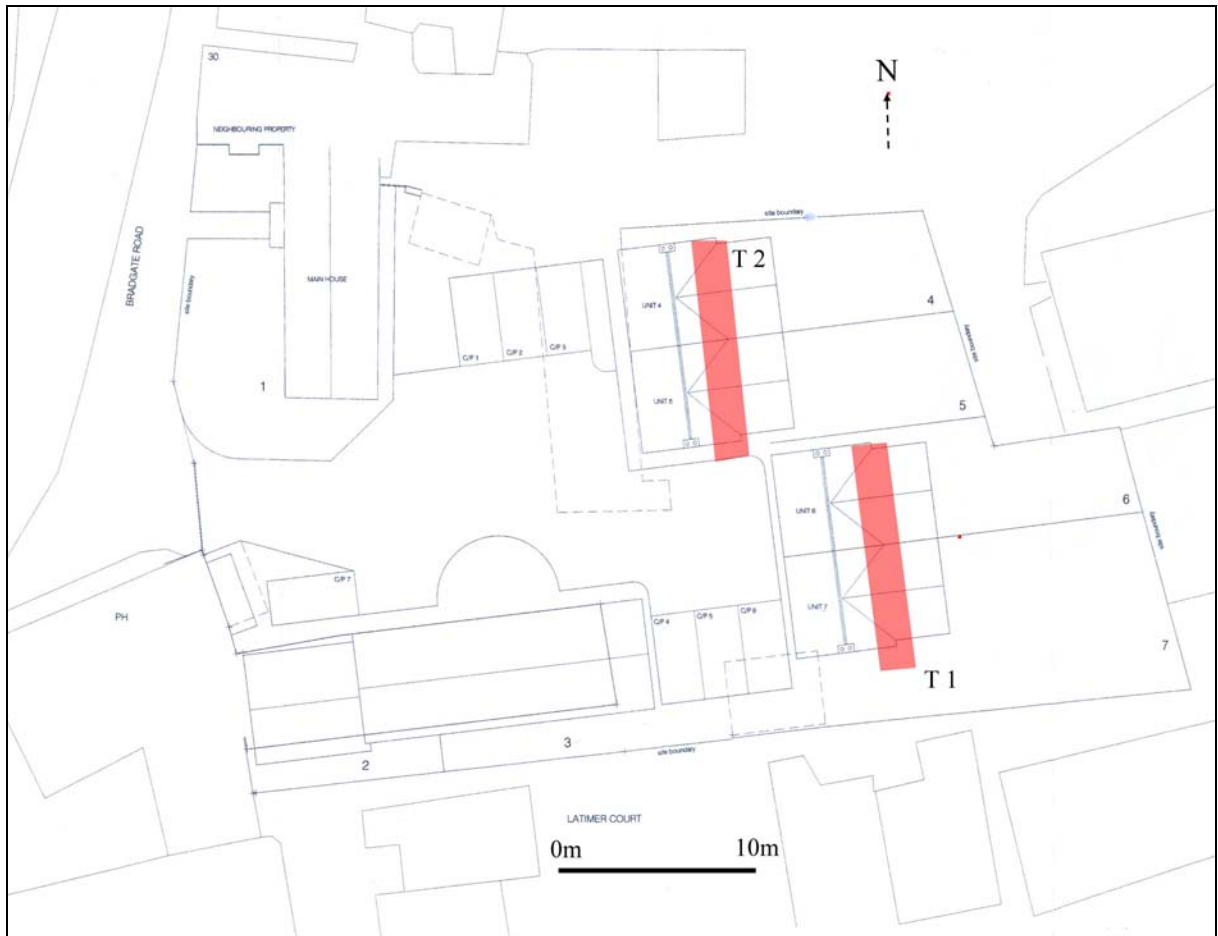
Figure 3: Trench location plan in relation to proposed development

Owing to access problems, it was not possible to excavate trenches at the locations shown in fig. 3 of the project design. Following agreement by LEHS, two north-south trenches, each 12 × 2m, were excavated across the proposed locations of the new buildings (Fig. 3).

Two trenches were excavated across the footprints of the proposed houses (Fig. 3). The results are summarised below. Details regarding location, depths, descriptions of fills etc. appear in Appendix 1.

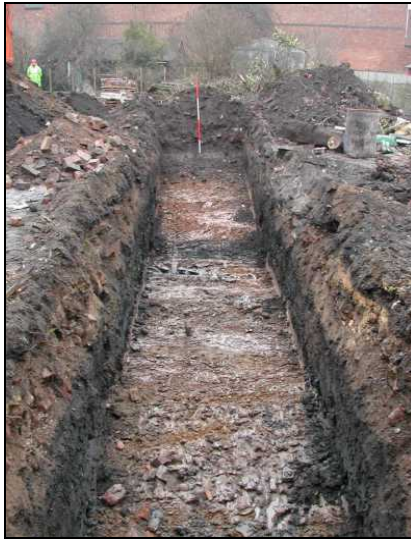
Plate 1: Trench 1 looking north

Trench 1 (12 x 2m) was orientated N-S and located 15m to the east of the western end of the barn (Plate 1). Its depth ranged from 1.3m at its northern end to 1.8m at its southern end (Plate 2). The upper 0.6m was made up of demolition material composed of mainly brick rubble. Beneath this lay a dark greyish silt 0.5m thick, containing considerable quantities of 20th-century domestic rubbish in the form of ceramics and complete bottles (Plate 3 & 4). The lowest horizon consisted of a dark grey, organic silt c.0.7m thick. The trench was excavated down to a reddish clay horizon containing areas of pebbles and gravel bands. This is almost certainly the natural glacial boulder clay of the area.

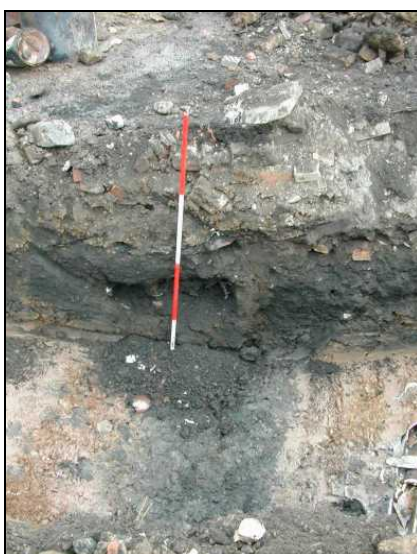
Plate 5: Modern pit in Trench 1

Two features were present, both cutting through the natural strata. A 20th-century drain, aligned WNW-ESE, was located c.8m from the south end of the trench. The second feature was a pit, 11.5m from the southern boundary of the site. It was c.1m and extended into the eastern section (Plate 5). It was filled with dark ashy soil containing late 19th and early 20th-century domestic rubbish. Neither feature was archaeologically significant.

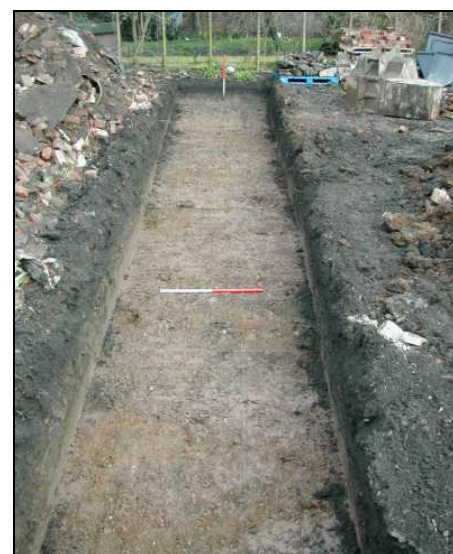
Plate 6: Trench 2 looking north

Trench 2 (12.2 x 2m) was located towards the northern side of the site, 11.5m from the east boundary of the site and 1.2m from the north boundary. It was orientated N-S and reached a maximum depth of 0.45m. The upper fill of the trench comprised dark organic topsoil. This sealed the natural reddish gravelly clay observed in Trench 1 (Fig. 6). No archaeological features were present in Trench 2.

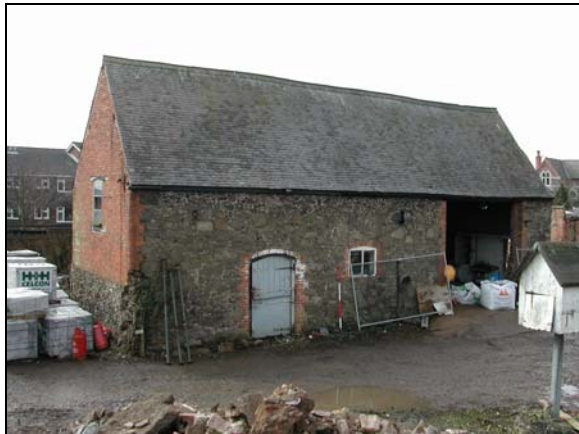
Plate 7: Building 1, north elevation.

Description: Stone-built barn with brick quoins, under a slate roof. Originally four bays, of which the three easternmost survive, each of slightly different lengths. The east bay was 4.75m in length internally, with its main trusses running E-W. Its east wall was composed of stone rubble up to 1.5m high, with brick above. Access was obtained through a stable door on its north side and there was an unglazed window opening to the east. In the south wall was a blocked arched door 1.5m wide x 1.65m high. The next bay to the east was 4.65m in length, with trusses aligned N-S. Access was obtained through a doorway in the north end of the west wall. There was a small window in the north wall. On the south side was a brick-built bench with two square recesses. The top of the west wall of this bay seems to have been a later addition, since it has an access point through the centre 2.5m wide and the roof truss has been severed. The third bay was 4.8m in length, and was dominated by a cart entrance 3.5m wide and 3.7m high, facing north. In the south wall was a similar blocked entrance in which was a smaller blocked door. There were two doorways in the west wall, one of which was blocked. The steeply pitched roof with its curved upper principals, substantial ridge beam, staggered purlins and queen struts, suggests a mid 17th-century date. Outside the western end of the barn the area was devoid of structures.

Comments: The building has undergone several phases of development, commencing as a four-bay barn with opposing double door entrances. The stone walls of the building, and the surviving roof structure, suggest a 17th-century foundation date. The steepness of the roof pitch suggests that the roof was originally clad with clay tiles, or possibly thatch. Considering the predominance of pastoral farming in the area and evidence for animal husbandry, the structure was probably used more as a hay barn than one for threshing corn. Subsequently the building has been much altered. The upper part of the east gable end has been rebuilt in brick, the west bay of the building has been demolished, and various external openings have been made and/or blocked.

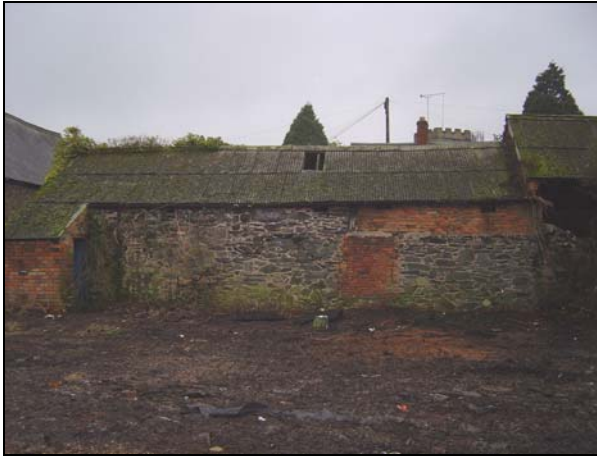
Plate 19: Building 2, east elevation

Description: A rectangular stone and brick-built structure of five bays, orientated north-south, beneath a pitched asbestos roof. It had two single door entrances on its west side and one at its south end, and four small window openings to the east. Internally, it was subdivided into five stalls, with a passage on the west side. Stalls 2-5 were separated by modern concrete block walls. There were two attached brick structures to this building. On the west side was a privy, 1.8 x

Comments: The structural evidence suggests that the building had at least three phases, the internal subdivisions representing the latest phase of activity. The roof is of 19th-century date, though according to the map evidence (Fig. 8) the building itself is at least of 18th-century date.

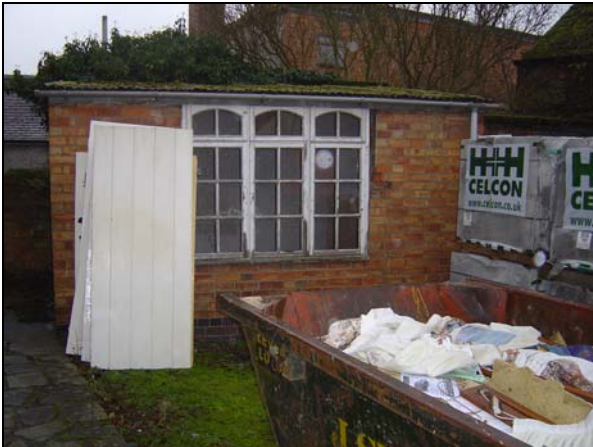
Plate 27: Building 3, south elevation

Description: A small, single roomed, rectangular brick-built structure with a flat asbestos roof. Its window opening and 20th century date suggests it was originally a site office.

Comments: Appears to be of mid 20th-century date. First appears on the 1968 Ordnance Survey map (Fig. 14).

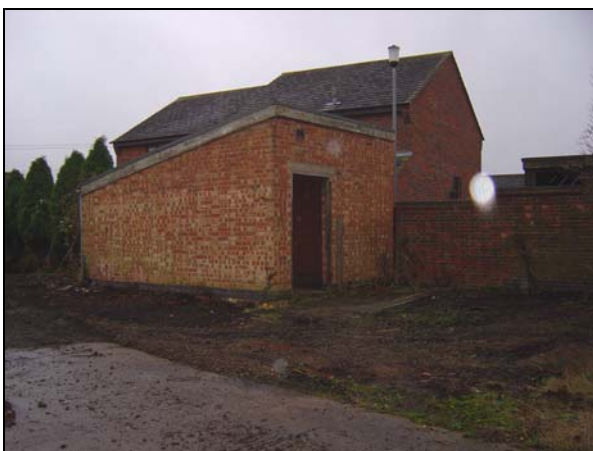
Plate 29: Building 4, from north-west

Description: A small rectangular brick-built structure with a sloping roof covered with felt and pierced by a single skylight. It had concrete floor and a single entrance.

Comments: Appears to be of mid 20th-century date. First appears on the 1968 Ordnance Survey map (Fig. 14), as part of a structure extending southwards into the adjoining property.
