**WATCHING BRIEF:
CUBITT GARAGE, COUNTY MUSEUM
CHURCH STREET,
AYLESBURY**

on behalf of Buckinghamshire County Museum

March 2005

ASC: 655/ACM/02

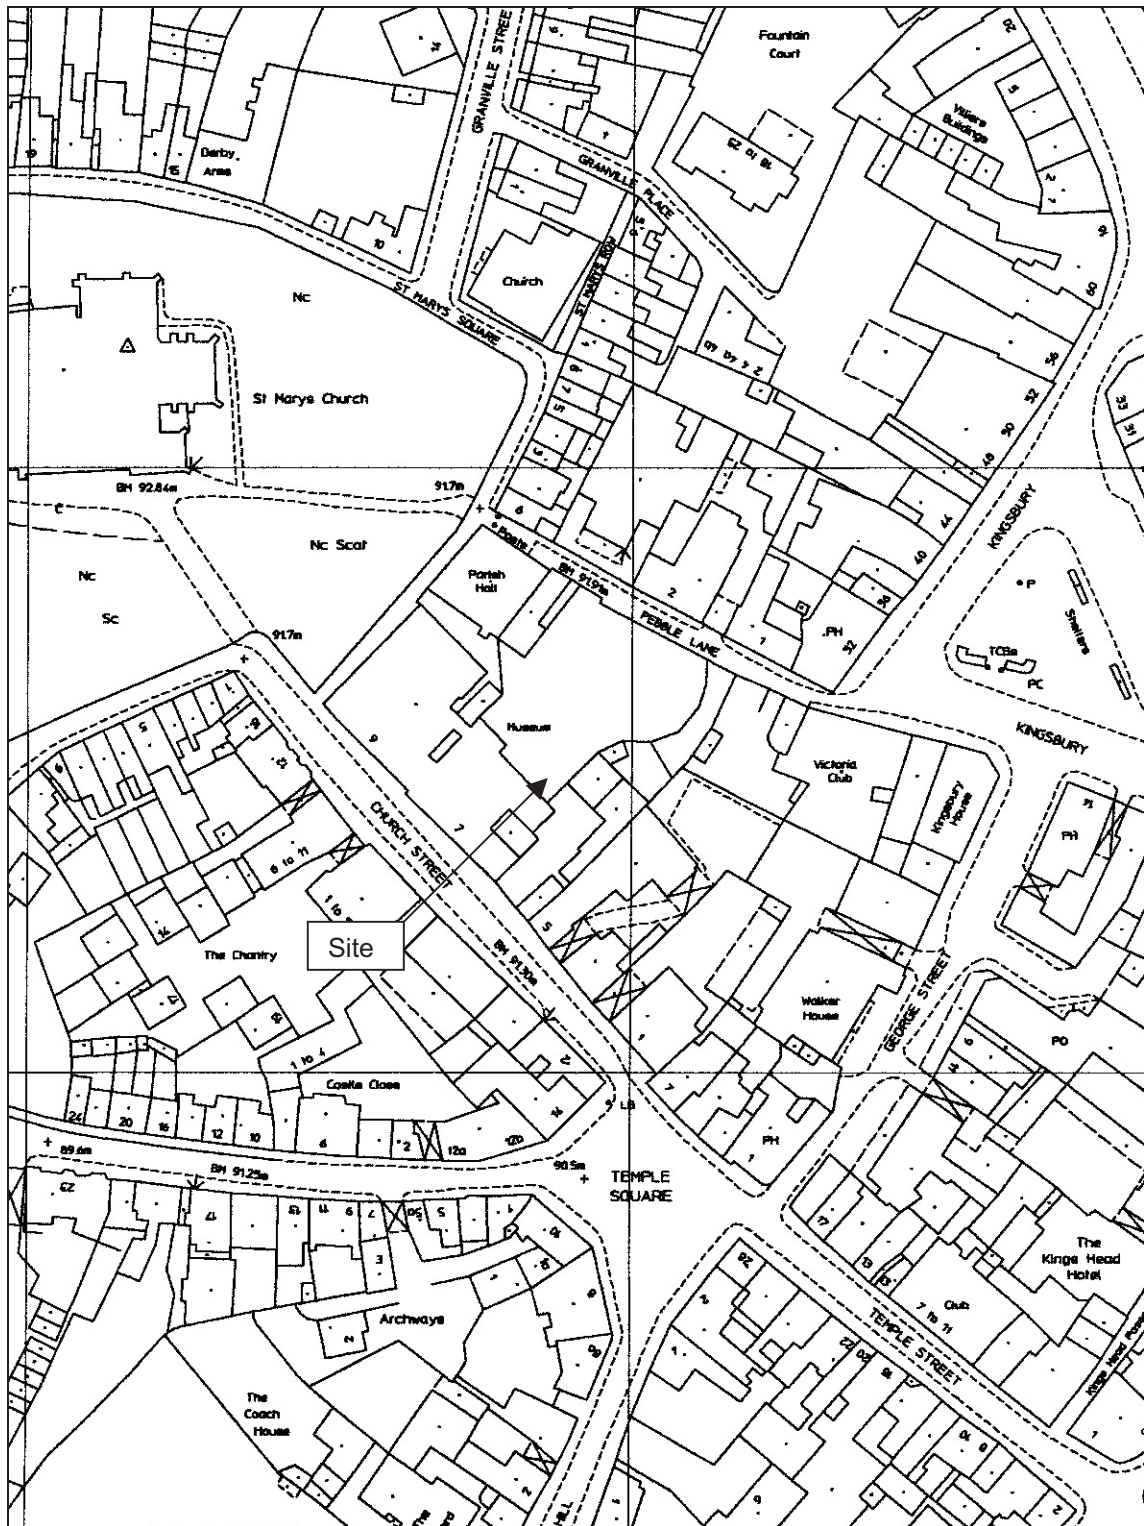
Figure 2: Site plan (scale 1:1250)

The site is situated in the Museum courtyard, and was partly covered by block paving and a planted border. A well is situated on the western side of the development area, and a manhole on the east. The main access to the site is from the east via the entrance off Church Street.

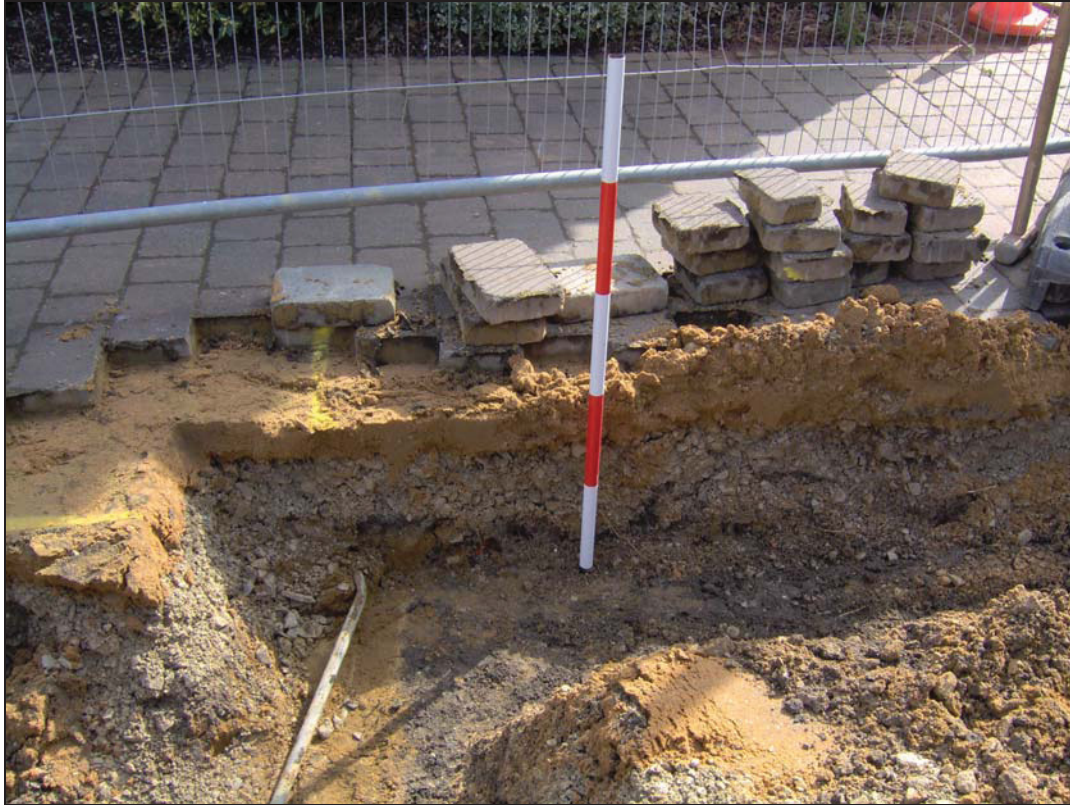
Plate 1: Eastern Corner of Trench Section

2.3 Observation of the foundation trench revealed a general stratigraphy, summarised below:

0.00 – 0.10m	L100	Base for paving – Builders sand
0.10 – 0.30m	L101	Base for paving – Hardcore
0.30-0.40m+	L102	Modern levelling(?) – Topsoil and mixed demolition rubble
