**ARCHAEOLOGICAL EVALUATION:  
ISLAND SITE REINFORCEMENT MAIN  
LITTLE PAXTON  
CAMBRIDGESHIRE**

**NGR TL 1890 6195 (CENTRE)**

*on behalf of Anglian Water Services Ltd.*

**ASC: 685/LPI/02**

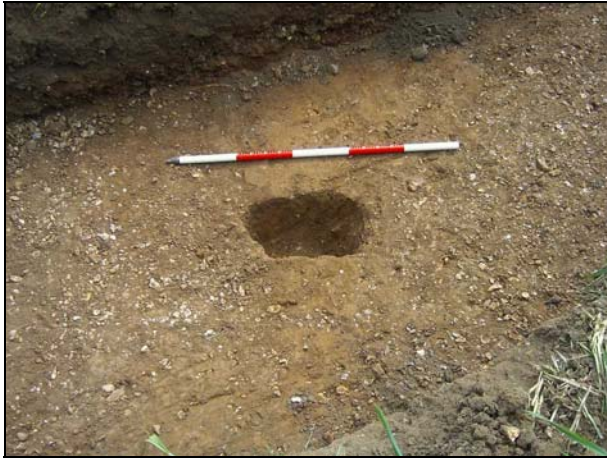
**Plate 1:** Land drain [1101]

Seven features were excavated in the trenches to the south of the island, of which two ([1003] in Trench 10 and [1103] in Trench 11) were found to have been a naturally cut gully and a tree bole respectively. Two linear features were revealed in Trench 11. Feature [1101] was straight-sided, orientated east to west and was approximately 0.40m wide x 0.19m deep (Plate 3). It contained a mid brown sand fill [1102]. No finds were recovered from this feature, which appeared to have been a land drain. Feature [1105], which was approximately 0.30m wide x 0.04m deep, was orientated north-east to south-west and lay adjacent to a layer of re-deposited gravel with patches of orange-brown clay and light yellow sand [1107] (Plate 4). The stratigraphic relationship between the two features was unclear, but it appeared that feature [1105] could have served as a drainage gully.

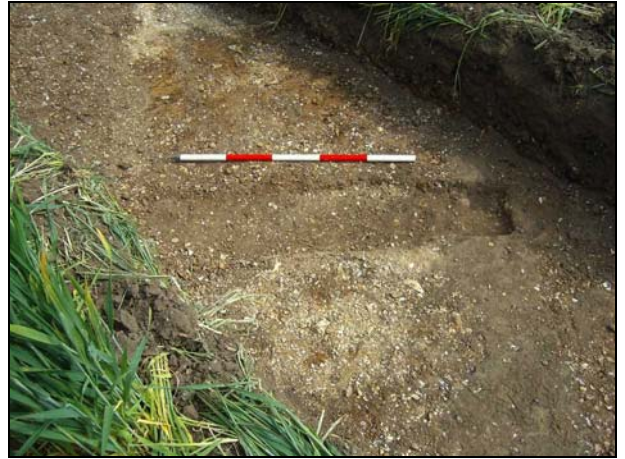
**Plate 2:** Drainage gully [1105] & deposit [1107]

1106	Fill	Greyish brown sandy clay. Fill of 1105.	0.30m	0.04m	0.28m	
1107	Deposit	Gravel with patches of orange-brown reseeded clay and light yellow sand, probably a levelling deposit.	3.0m	0.04m	0.28m	
1109	Layer	Yellowish brown sandy clay subsoil.	1.50m	0.25m	0.28m	
A second levelling deposit that lay at the eastern end of the trench was not investigated.

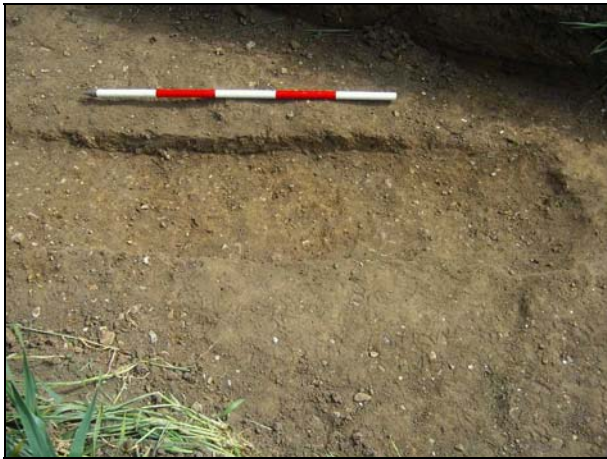
**Plate 3:** Medieval furrow [1303]

A linear feature [1303], approximately 1.90m wide x 0.08m deep and orientated north-west to south-east, was excavated in Trench 13. It contained a mid brown, slightly clayey sand that was devoid of artefacts [1304]. This feature was probably a medieval furrow and may have been part of the medieval agricultural system identified in the aerial photos.

- 5.3 The archaeological remains encountered in Trenches 11, 13, 15 and 16, to the south of the island consisted primarily of drainage features, a posthole and a probable furrow. The presence of the furrow indicates that during the medieval period this was part of one of the three areas of open field system identified on the southern side of the river in Little Paxton.

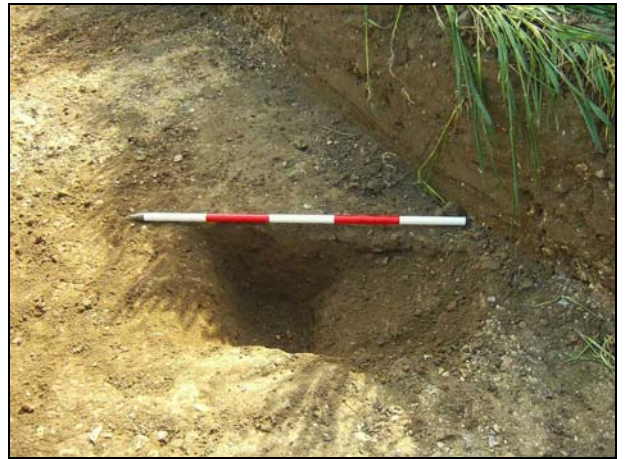
**Plate 4:** Ditch [1603]

Two modern sewer pipe trenches, two undated ditches [1603 & 1605] and a posthole [1607] were revealed in Trench 16. Ditch [1603] was orientated south-west to north-east and was approximately 0.80m wide x 0.30m deep. It contained a mid brown silty clay that was devoid of artefacts. Ditch [1605] was orientated north-west to south-east and was approximately 1.28m wide x 0.40m deep. No datable artefacts were recovered from the pale reddish brown sandy silt fill. Posthole [1607] was approximately 0.72m in diameter x 0.22m deep and contained a yellow brown sandy silt fill with occasional stones but no artefacts. It was cut by ditch [1603], which in turn was cut by the modern sewer trenches and ditch [1605].

- 5.4 The other features produced no dating evidence although a sequential narrative was discernible in Trench 16 where the posthole [1607] was cut by ditch [1603], which in turn was truncated by the sewer trench and ditch [1605]. The area has probably been in agricultural use since at least the Romano-British period, which is not altogether surprising given the quality of the soil and the obvious disadvantages of settling in such close proximity to a major, flood prone watercourse. However, despite the archaeological evidence for farming activity in the area since the Neolithic period, there was nothing to suggest that these features were other than post-medieval in date.

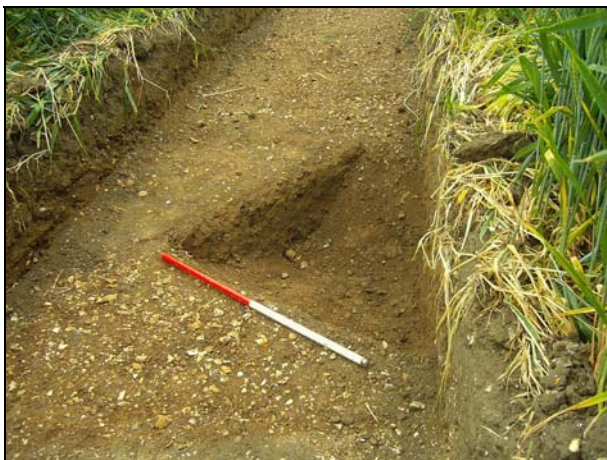
**Plate 5:** Ditch [1605]

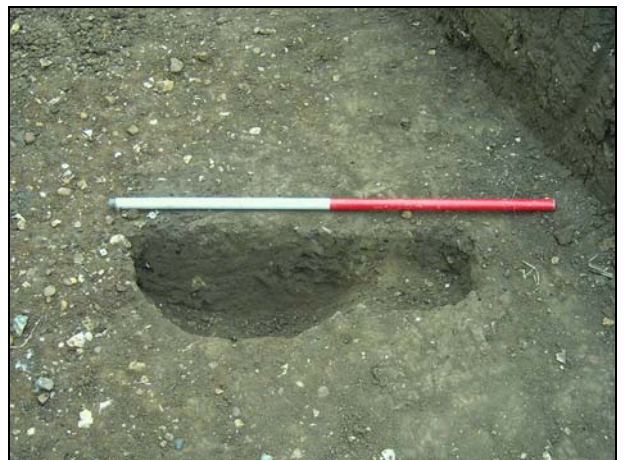
**Plate 6:** Posthole [1607]

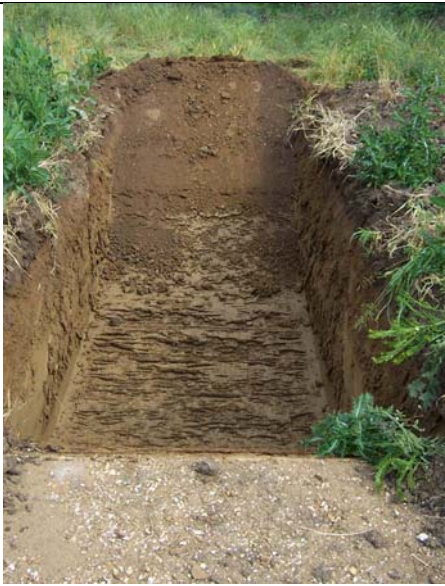
<b>Trench 1</b>

<b>Max Dimensions</b>					
	<b>Length</b>	31.69	<b>Width</b>	1.90	<b>Depth</b>	1.50
	<b>Levels</b>					
	<b>Trench base north-west</b>			12.87m OD		
	<b>Trench top north-west</b>			13.11m OD		
	<b>Trench base south-east</b>			13.23m OD		
	<b>Trench top south-east</b>			13.56m OD		
	<b>NGR Co-ordinates</b>					
	<b>E</b>	18709	<b>N</b>	61865		
	<b>E</b>	16861	<b>N</b>	61879		
<b>Orientation</b>			NW-SE			
<b>Reason for Trench</b>			Test western end of pipeline route			
<b>Context</b>	<b>Type</b>	<b>Description and Interpretation</b>	<b>Max Width (mm)</b>	<b>Max Thckn (mm)</b>	<b>Depth BGL (mm)</b>	
1001	Layer	Dark yellowish brown silty loam (Topsoil)	1.90m	0.30m	0m	
1002	Layer	Yellowish brown sandy clay with gravel (Subsoil)	1.90m	1.20m	0.30m

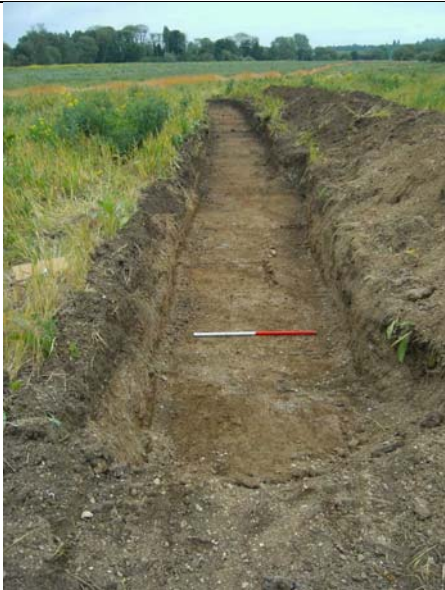
<b>Trench 2</b>

<b>Max Dimensions</b>					
	<b>Length</b>	23.54	<b>Width</b>	1.45	<b>Depth</b>	0.55
	<b>Levels</b>					
	<b>Trench base south-west</b>		12.74mOD			
	<b>Trench top south-west</b>		13.37mOD			
	<b>Trench base north-east</b>		7.80OD			
	<b>Trench top north-east</b>		12.75OD			
	<b>NGR Co-ordinates</b>					
	<b>E</b>	18751	<b>N</b>	61869		
	<b>E</b>	18772	<b>N</b>	61887		
<b>Orientation</b>			SW-NE			
<b>Reason for Trench</b>			Test western end of pipeline route			
Context	Type	Description and Interpretation	Max Width (mm)	Max Thckn (mm)	Depth BGL (mm)	
2001	Layer	Dark yellowish brown silty loam (Topsoil)	1.45m	0.30m	0m	
2002	Layer	Yellowish brown sandy clay subsoil. Small random patches of blue-grey clay, timber remains and two car tyres were revealed at the south-western end of the trench.	1.45m	0.25m	0.30m

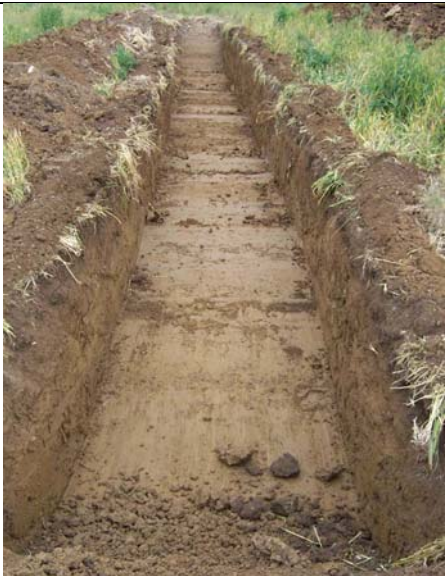
<b>Trench 3</b>

<b>Max Dimensions</b>					
	<b>Length</b>	29.45	<b>Width</b>	1.60	<b>Depth</b>	1.60
	<b>Levels</b>					
	<b>Trench base west</b>			12.71mOD		
	<b>Trench top-west</b>			13.10mOD		
	<b>Trench base-east</b>			12.76mOD		
	<b>Trench top-east</b>			13.36mOD		
	<b>NGR Co-ordinates</b>					
	<b>E</b>	18810	<b>N</b>	61899		
	<b>E</b>	1884	<b>N</b>	61899		
<b>Orientation</b>			E-W			
<b>Reason for Trench</b>			Test western end of pipeline route			
<b>Context</b>	<b>Type</b>	<b>Description and Interpretation</b>	<b>Max Width (mm)</b>	<b>Max Thckn (mm)</b>	<b>Depth BGL (mm)</b>	
3001	Layer	Dark yellowish brown silty loam (Topsoil)	1.55m	0.20m	0	
3003	Deposit	Blue-grey clay interspersed with flint and gravel. This deposit was approximately 2.70m long and lay at the eastern end of the trench. It appears to have been the result of dredging activities.	1.55m	0.25m	0.20m	
3004	Agricultural	Modern ploughmarks, orientated SW-NE, were observed approximately 14.0m from the eastern trench edge.	0.20m	-	0.20m

3002	Layer	Yellowish brown sandy clay subsoil.	1.55m	1.40m	0.20m

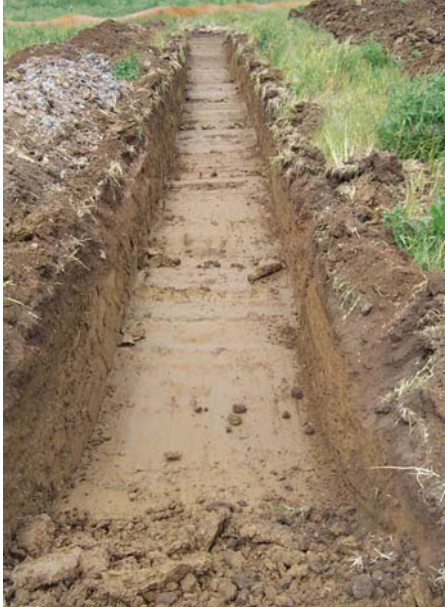
<b>Trench 4</b>

<b>Max Dimensions</b>					
	<b>Length</b>	30.88	<b>Width</b>	1.60	<b>Depth</b>	1.60
	<b>Levels</b>					
	<b>Trench base north-east</b>		12.53mOD			
	<b>Trench top north-east</b>		12.78mOD			
	<b>Trench base south-west</b>		12.85mOD			
	<b>Trench top south-west</b>		13.22mOD			
	<b>NGR Co-ordinates</b>					
	<b>E</b>	18870	<b>N</b>	61913		
	<b>E</b>	18886	<b>N</b>	61940		
<b>Orientation</b>		NE-SW				
<b>Reason for Trench</b>		Test western end of pipeline route				
<b>Context</b>	<b>Type</b>	<b>Description and Interpretation</b>	<b>Max Width (mm)</b>	<b>Max Thckn (mm)</b>	<b>Depth BGL (mm)</b>	
4001	Layer	Dark yellowish brown silty loam (Topsoil)	1.40m	0.45m	0	
4003	Deposit	Blue-grey clay deposit interspersed with flint, gravel and mussel shells was observed approximately 4.75m from the south-western trench edge. It was approximately 8.85m long and appeared to have been a dump deposit, possibly as a result of dredging.	1.40m	0.33m	0.43m

4002	Layer	Yellowish brown sandy clay subsoil.. It was approximately 8.85m (l) x 1400m (w) x 0.33m (d).	1.40m	1.15m	0.43m

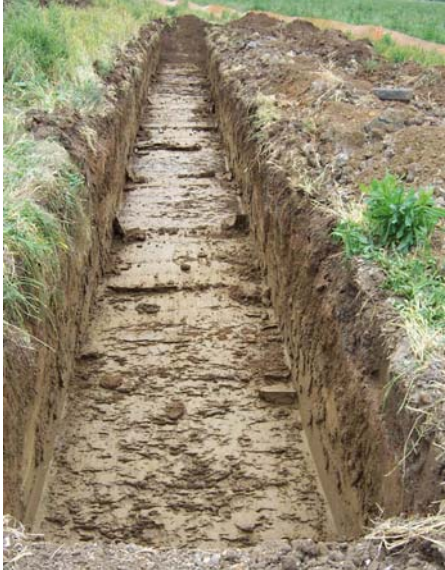
<b>Trench 5</b>

<b>Max Dimensions</b>					
	<b>Length</b>	28.75	<b>Width</b>	1.60	<b>Depth</b>	1.60
	<b>Levels</b>					
	<b>Trench base east</b>			12.42mOD		
	<b>Trench top east</b>			12.79mOD		
	<b>Trench base west</b>			12.56mOD		
	<b>Trench top west</b>			13.02mOD		
	<b>NGR Co-ordinates</b>					
	<b>E</b>	18915	<b>N</b>	61954		
	<b>E</b>	18944	<b>N</b>	61958		
<b>Orientation</b>			E-W			
<b>Reason for Trench</b>			Test western end of pipeline route			
<b>Context</b>	<b>Type</b>	<b>Description and Interpretation</b>	<b>Max Width (mm)</b>	<b>Max Thckn (mm)</b>	<b>Depth BGL (mm)</b>	
5001	Layer	Dark yellowish brown silty loam (Topsoil)	1.50m	0.30m	0	
5003	Deposit	Grey-blue clay with flint, gravel and mussel shells. This deposit contained occasional fragments of modern brick.	1.50m	0.40m	0.30m	
5004	Deposit	Grey-blue clay with flint, gravel and mussel shells. A car tyre was found within this deposit.	1.50m	0.30m	0.30m

5002	Layer	Yellowish brown sandy clay subsoil. Two areas of re-deposited observed at either end of the trench. These were c.0.20-0.40m deep and contained modern brick and car tyres.	1.50m	1.30m	0.30m

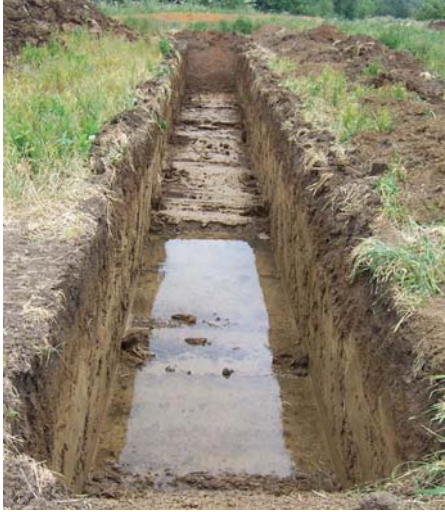
<b>Trench 6</b>

<b>Max Dimensions</b>					
	<b>Length</b>	27.69	<b>Width</b>	1.60	<b>Depth</b>	1.70
	<b>Levels</b>					
	<b>Trench base north-east</b>			12.22mOD		
	<b>Trench top north-east</b>			12.69mOD		
	<b>Trench base south-west</b>			12.65mOD		
	<b>Trench top south-west</b>			13.18mOD		
	<b>NGR Co-ordinates</b>					
	<b>E</b>	18967	<b>N</b>	61964		
	<b>E</b>	18983	<b>N</b>	61987		
<b>Orientation</b>			SW-NE			
<b>Reason for Trench</b>			Test western end of pipeline route			
<b>Context</b>	<b>Type</b>	<b>Description and Interpretation</b>	<b>Max Width (mm)</b>	<b>Max Thckn (mm)</b>	<b>Depth BGL (mm)</b>	
6001	Layer	Dark yellowish brown silty loam (Topsoil)	1.50m	0.30m	0	
6003	Deposit	A 2.60m long deposit of grey-blue clay interspersed with gravel, flint and mussel shells in a sandy matrix was revealed at the south-western end of the trench. This is liable to have been the result of dredging activities.	1.50m	0.25m	0.30m

6002	Layer	Yellowish brown sandy clay subsoil.	1.50m	1.40m	0.30m

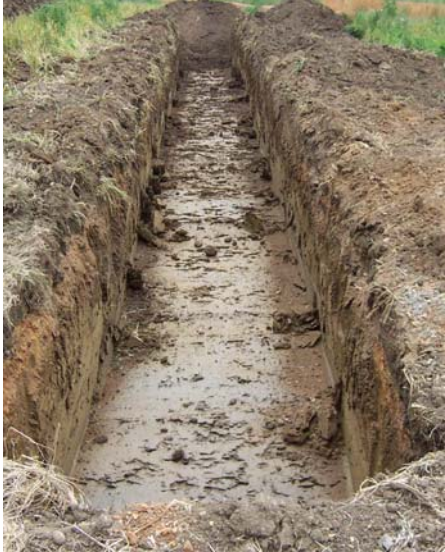
<b>Trench 7</b>

<b>Max Dimensions</b>					
	<b>Length</b>	27.98	<b>Width</b>	1.60	<b>Depth</b>	1.60
	<b>Levels</b>					
	<b>Trench base east</b>			12.49mOD		
	<b>Trench top east</b>			12.80mOD		
	<b>Trench base west</b>			12.41mOD		
	<b>Trench top west</b>			12.92mOD		
	<b>NGR Co-ordinates</b>					
	<b>E</b>	19005	<b>N</b>	61998		
	<b>E</b>	19033	<b>N</b>	61999		
<b>Orientation</b>			E-W			
<b>Reason for Trench</b>			Test central area of pipeline route			
<b>Context</b>	<b>Type</b>	<b>Description and Interpretation</b>	<b>Max Width (mm)</b>	<b>Max Thckn (mm)</b>	<b>Depth BGL (mm)</b>	
7001	Layer	Dark yellowish brown silty loam (Topsoil)	1.50m	0.32m	0	
7003	Agricultural	Two modern ploughmarks were revealed at the eastern end of the trench.	0.20m	-	0.32m	
7004	Deposit	Flint and gravel in a sandy matrix was observed in the easternmost 7.30m of the trench.	1.50m	0.25m	0.32m	
7002	Layer	Yellowish brown sandy clay subsoil.	1.50m	1.28m	0.32m

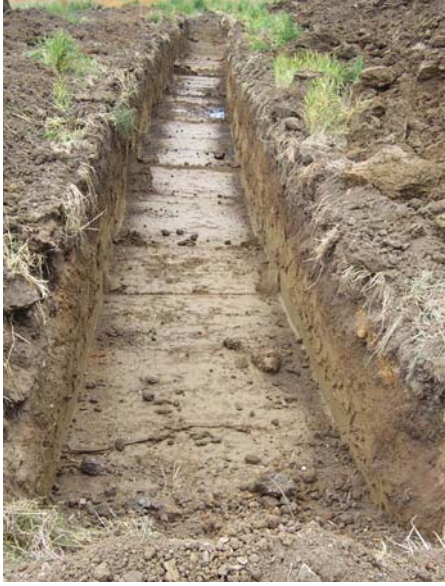
<b>Trench 8</b>

<b>Max Dimensions</b>					
	<b>Length</b>	29.63	<b>Width</b>	1.60	<b>Depth</b>	1.60
	<b>Levels</b>					
	<b>Trench base north-east</b>		12.31mOD			
	<b>Trench top north-east</b>		12.83mOD			
	<b>Trench base south-west</b>		12.22mOD			
	<b>Trench top south-west</b>		12.82mOD			
	<b>NGR Co-ordinates</b>					
	<b>E</b>	19056	<b>N</b>	62009		
	<b>E</b>	19078	<b>N</b>	62029		
<b>Orientation</b>			SW-NE			
<b>Reason for Trench</b>			Test central area of pipeline route			
Context	Type	Description and Interpretation	Max Width (mm)	Max Thckn (mm)	Depth BGL (mm)	
8001	Layer	Dark yellowish brown silty loam (Topsoil)	1.50m	0.40m	0m	
8003	Deposit	A gravel deposit was present in the first 3.50m from the south-western trench edge, predominantly in the south-east facing section. It contained a few small pockets of blue-grey clay and frequent mussel shells. This deposit appears to have been the result of dredging.	1.50m	0.30m	0.20m

8002	Layer	Yellowish brown sandy clay subsoil.	1.50m	1.20m	0.40m

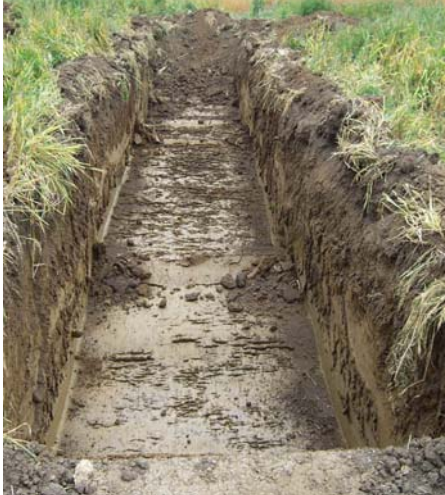
<b>Trench 9</b>

<b>Max Dimensions</b>					
	<b>Length</b>	26.57	<b>Width</b>	1.60	<b>Depth</b>	1.60
	<b>Levels</b>					
	<b>Trench base north-west</b>		12.37mOD			
	<b>Trench top north-west</b>		12.74mOD			
	<b>Trench base south-east</b>		12.43mOD			
	<b>Trench top south-east</b>		-OD			
	<b>NGR Co-ordinates</b>					
	<b>E</b>	19095		<b>N</b>	62035	
	<b>E</b>			<b>N</b>		
<b>Orientation</b>			NW-SE			
<b>Reason for Trench</b>			Test central area of pipeline route			
<b>Context</b>	<b>Type</b>	<b>Description and Interpretation</b>		<b>Max Width (mm)</b>	<b>Max Thckn (mm)</b>	<b>Depth BGL (mm)</b>
9001	Layer	Dark yellowish brown silty loam (Topsoil)		1.50m	0.30m	0
9002	Layer	Yellowish brown sandy clay subsoil.		1.50m	1.30m	0.30m

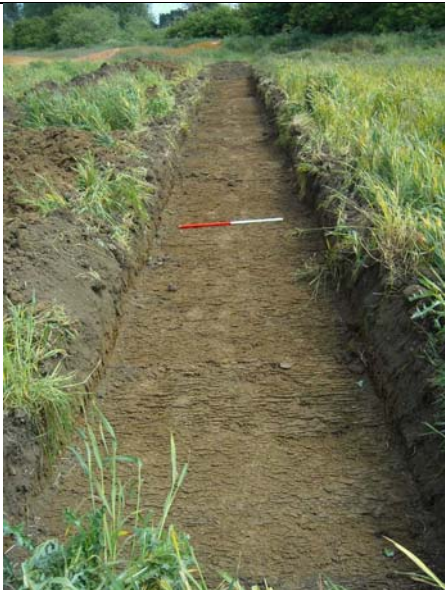
<b>Trench 10</b>

<b>Max Dimensions</b>					
	<b>Length</b>	28.77	<b>Width</b>	1.50	<b>Depth</b>	0.50
	<b>Levels</b>					
	<b>Trench base NNW</b>			13.26mOD		
	<b>Trench top NNW</b>			13.72mOD		
	<b>Trench base SSE</b>			13.71mOD		
	<b>Trench top SSE</b>			14.0mOD		
	<b>NGR Co-ordinates</b>					
	<b>E</b>	19137	<b>N</b>	61991		
	<b>E</b>	19151	<b>N</b>	61966		
<b>Orientation</b>			NNW-SSE			
<b>Reason for Trench</b>			Test central area of pipeline route, S of river			
Context	Type	Description and Interpretation	Max Width (mm)	Max Thckn (mm)	Depth BGL (mm)	
1001	Layer	Dark yellowish brown silty loam (Topsoil)	1.50m	0.30m	0	
1003	Cut	Linear feature orientated E-W. The indistinct southern edge and the depth of the feature suggest that this is a natural deposit following the undulations in the gravel rich subsoil.	0.55m	0.04m	0.30m	
1004	Fill	Mid brown sandy silt.	0.55m	0.04m	0.30m	
1002	Layer	Yellowish brown sandy clay subsoil, becoming progressively ore gravelly towards the south-western end of the trench.	1.50m	0.20m	0.30m

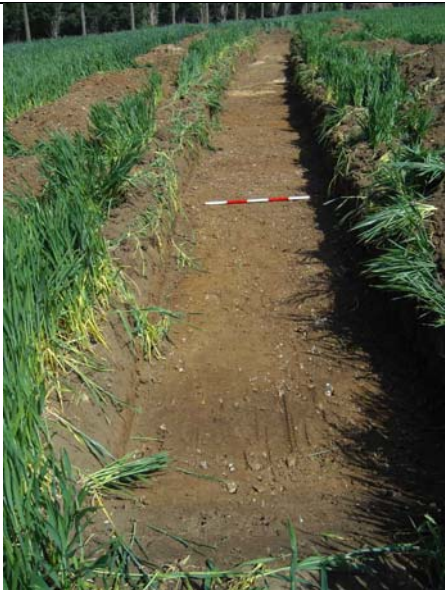
<b>Trench 11</b>

<b>Max Dimensions</b>					
	<b>Length</b>	28.42	<b>Width</b>	1.50	<b>Depth</b>	0.53
	<b>Levels</b>					
	<b>Trench base east</b>		14.16mOD			
	<b>Trench top east</b>		14.44mOD			
	<b>Trench base west</b>		13.78mOD			
	<b>Trench top west</b>		14.53mOD			
	<b>NGR Co-ordinates</b>					
	<b>E</b>	19173	<b>N</b>	61950		
	<b>E</b>	19201	<b>N</b>	61946		
<b>Orientation</b>		E-W				
<b>Reason for Trench</b>		Test central area of pipeline route				
Context	Type	Description and Interpretation	Max Width (mm)	Max Thckn (mm)	Depth BGL (mm)	
1108	Layer	Dark yellowish brown silty loam (Topsoil)	1.50m	0.28m	0	
1101	Cut	E-W orientated linear, probably a land drain.	0.40m	0.19m	0.28m	
1102	Fill	Mid brown sand. Fill of 1101.	0.40m	0.19m	0.28m	
1103	Cut	Tree bole, 0.74m long.	0.64m	0.09m	0.28m	
1104	Fill	Mid-dark brown sandy clay. Fill of 1103	0.64m	0.09m	0.28m	
1105	Cut	N-S orientated linear, probably a drainage gully. No artefacts were present.	0.30m	0.04m	0.28m

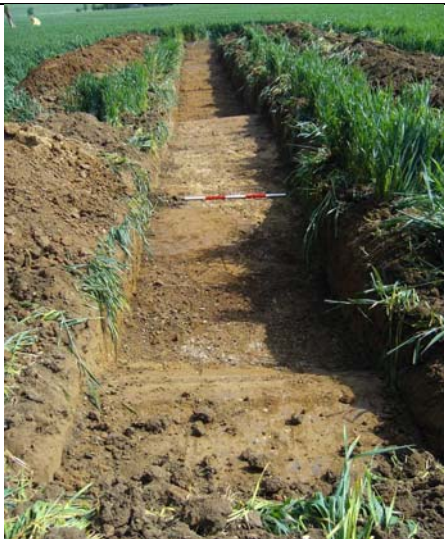
<b>Trench 12</b>

<b>Max Dimensions</b>					
	<b>Length</b>	26.73	<b>Width</b>	1.50	<b>Depth</b>	0.80
	<b>Levels</b>					
	<b>Trench base NNW</b>			14.17mOD		
	<b>Trench top NNW</b>			14.46mOD		
	<b>Trench base SSE</b>			13.87mOD		
	<b>Trench top SSE</b>			14.36mOD		
	<b>NGR Co-ordinates</b>					
	<b>E</b>	19227	<b>N</b>	61927		
	<b>E</b>	19240	<b>N</b>	61904		
<b>Orientation</b>			NNW-SSE			
<b>Reason for Trench</b>			Test eastern end of pipeline route			
<b>Context</b>	<b>Type</b>	<b>Description and Interpretation</b>		<b>Max Width (mm)</b>	<b>Max Thckn (mm)</b>	<b>Depth BGL (mm)</b>
1201	Layer	Dark yellowish brown silty loam (Topsoil)		1.50m	0.30m	0
1202	Layer	Mid brown gravelly sand subsoil.		1.50m	0.50m	0.30m

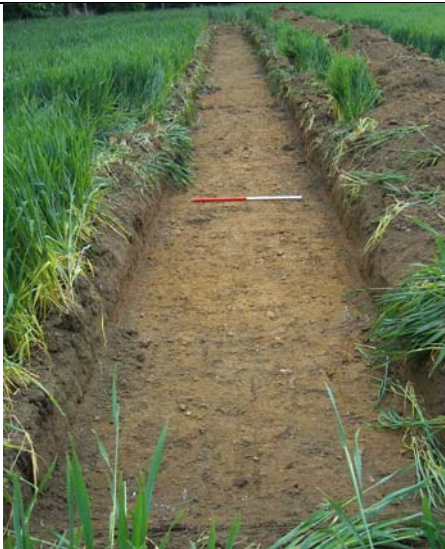
<b>Trench 13</b>

<b>Max Dimensions</b>					
	<b>Length</b>	27.38	<b>Width</b>	1.50	<b>Depth</b>	0.80
	<b>Levels</b>					
	<b>Trench base west</b>		13.91mOD			
	<b>Trench top west</b>		14.19mOD			
	<b>Trench base east</b>		14.00mOD			
	<b>Trench top east</b>		14.29mOD			
	<b>NGR Co-ordinates</b>					
	<b>E</b>	19265	<b>N</b>	61887		
	<b>E</b>	19292	<b>N</b>	61883		
<b>Orientation</b>		E-W				
<b>Reason for Trench</b>		Test eastern end of pipeline route				
<b>Context</b>	<b>Type</b>	<b>Description and Interpretation</b>	<b>Max Width (mm)</b>	<b>Max Thckn (mm)</b>	<b>Depth BGL (mm)</b>	
1301	Layer	Dark yellowish brown silty loam (Topsoil)	1.50m	0.30m	0	
1303	Cut	NW-SE orientated linear feature, probably a furrow.	1.90m	0.08m	0.30m	
1304	Fill	Fill of 1303. Mid brown slightly clayey sand.	1.90m	0.08m	0.30m	
1302	Layer	Mid brown gravelly sand subsoil.	1.50m	0.50m	0.30m

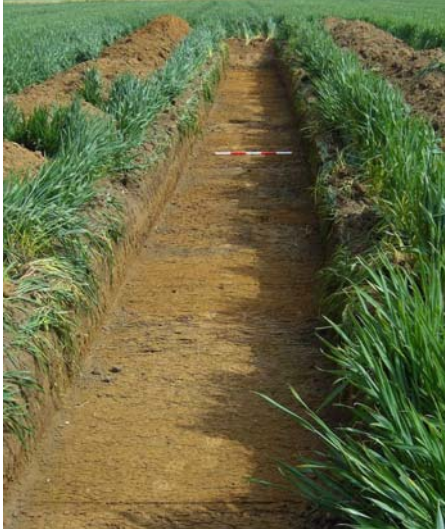
<b>Trench 14</b>

<b>Max Dimensions</b>					
	<b>Length</b>	25.47	<b>Width</b>	1.50	<b>Depth</b>	0.70
	<b>Levels</b>					
	<b>Trench base north-west</b>		13.93mOD			
	<b>Trench top north-west</b>		14.37mOD			
	<b>Trench base south-east</b>		13.63mOD			
	<b>Trench top south-east</b>		14.25mOD			
	<b>NGR Co-ordinates</b>					
	<b>E</b>	19319	<b>N</b>	61859		
	<b>E</b>	19340	<b>N</b>	61844		
	<b>Orientation</b>			NW-SE		
<b>Reason for Trench</b>			Test eastern end of pipeline route			
<b>Context</b>	<b>Type</b>	<b>Description and Interpretation</b>		<b>Max Width (mm)</b>	<b>Max Thckn (mm)</b>	<b>Depth BGL (mm)</b>
1401	Layer	Dark yellowish brown silty loam (Topsoil)		1.50m	0.30m	0
1402	Layer	Yellowish brown sandy clay subsoil.		1.50m	0.40m	0.30m

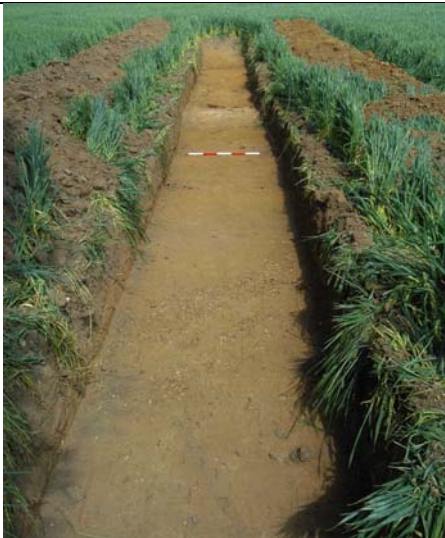
<b>Trench 15</b>

<b>Max Dimensions</b>					
	<b>Length</b>	23.04	<b>Width</b>	1.50	<b>Depth</b>	0.65
	<b>Levels</b>					
	<b>Trench base west</b>			13.89mOD		
	<b>Trench top west</b>			14.50mOD		
	<b>Trench base east</b>			13.67mOD		
	<b>Trench top east</b>			14.28mOD		
	<b>NGR Co-ordinates</b>					
	<b>E</b>	19340	<b>N</b>	61860		
	<b>E</b>	19361	<b>N</b>	61867		
<b>Orientation</b>			E-W			
<b>Reason for Trench</b>			Test eastern end of pipeline route			
<b>Context</b>	<b>Type</b>	<b>Description and Interpretation</b>	<b>Max Width (mm)</b>	<b>Max Thckn (mm)</b>	<b>Depth BGL (mm)</b>	
1501	Layer	Dark yellowish brown silty loam (Topsoil)	1.50m	0.30m	0	
1503	Cut	NW-SE orientated linear, probably a drainage gully.	0.50m	0.25m	0.30m	
1504	Fill	Fill of 1503.	0.50m	0.25m	0.30m	
1502	Layer	Yellowish brown sandy clay subsoil.	1.50m	0.35m	0.30m

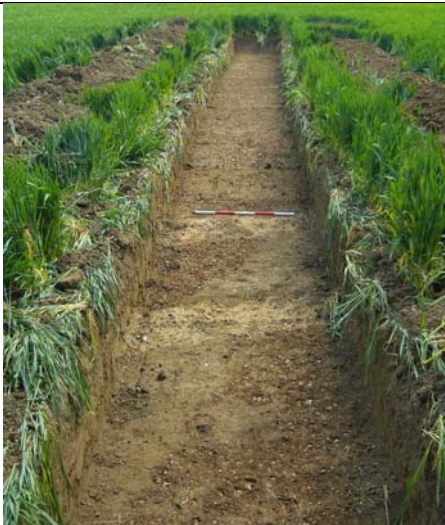
<b>Trench 16</b>

<b>Max Dimensions</b>					
	<b>Length</b>	26.17	<b>Width</b>	1.50	<b>Depth</b>	0.70m
	<b>Levels</b>					
	<b>Trench base north</b>			14.06mOD		
	<b>Trench top north</b>			14.69mOD		
	<b>Trench base south</b>			13.87mOD		
	<b>Trench top south</b>			14.38mOD		
	<b>NGR Co-ordinates</b>					
	<b>E</b>	19373	<b>N</b>	61886		
	<b>E</b>	19376	<b>N</b>	61912		
<b>Orientation</b>			N-S			
<b>Reason for Trench</b>			Test eastern end of pipeline route			
<b>Context</b>	<b>Type</b>	<b>Description and Interpretation</b>	<b>Max Width (mm)</b>	<b>Max Thckn (mm)</b>	<b>Depth BGL (mm)</b>	
1601	Layer	Dark yellowish brown silty loam (Topsoil)	1.50m	0.30m	0	
1603	Cut	Cut of NW-SE orientated, modern ditch.	0.80m	0.30m	0.30m	
1604	Fill	Mid brown silty clay. Fill of 1603	0.80m	0.30m	0.30m	
1602	Layer	Yellowish brown sandy clay subsoil.	1.50m	0.40m	0.30m

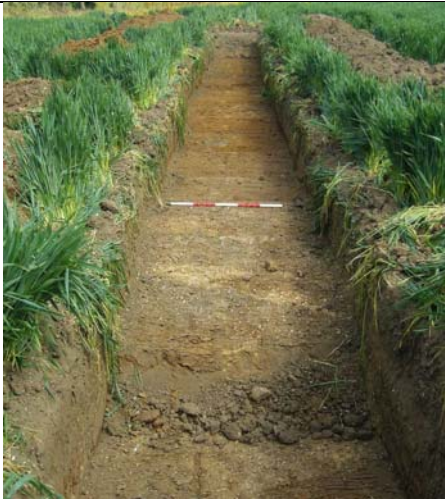
<b>Trench 17</b>

<b>Max Dimensions</b>					
	<b>Length</b>	26.80	<b>Width</b>	1.50	<b>Depth</b>	0.65
	<b>Levels</b>					
	<b>Trench base west</b>			13.86mOD		
	<b>Trench top west</b>			14.43mOD		
	<b>Trench base east</b>			13.38mOD		
	<b>Trench top east</b>			14.06mOD		
	<b>NGR Co-ordinates</b>					
	<b>E</b>	19393.66	<b>N</b>	61894.03		
	<b>E</b>	19419.70	<b>N</b>	61887.70		
<b>Orientation</b>			E-W			
<b>Reason for Trench</b>			Test eastern end of pipeline route			
<b>Context</b>	<b>Type</b>	<b>Description and Interpretation</b>		<b>Max Width (mm)</b>	<b>Max Thckn (mm)</b>	<b>Depth BGL (mm)</b>
1701	Layer	Dark yellowish brown silty loam (Topsoil)		1.50m	0.30m	0
1702	Layer	Yellowish brown sandy clay subsoil.		1.50m	0.35m	0.30m
