**WATCHING BRIEF:
ST MARY & ST GILES CHURCH
STONY STRATFORD
MILTON KEYNES**

NGR: SP 7869 4047

December 2010

ASC: 1295/SSC/2

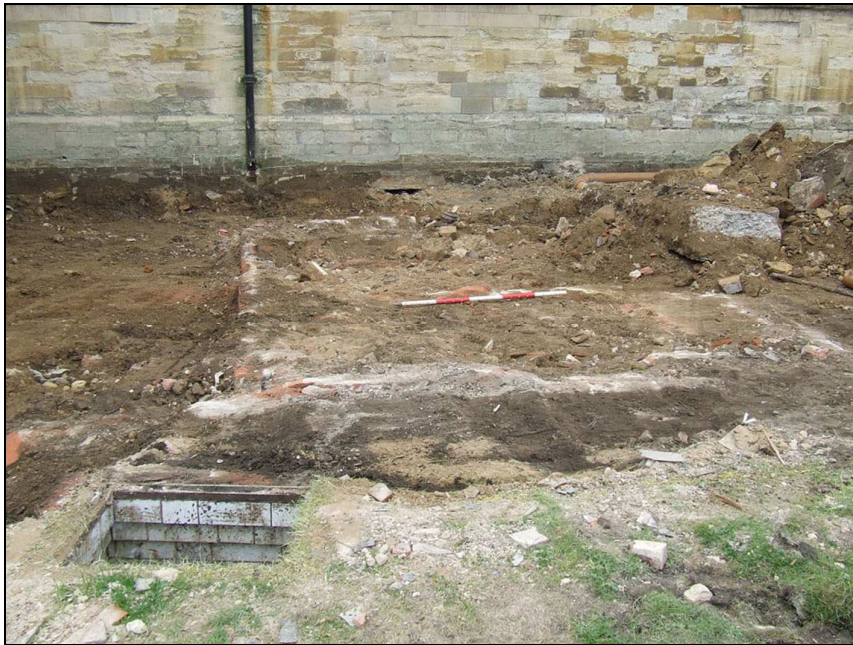
An area of *c.*91.50 sq. m was reduced to a depth of *c.*0.5m max within the footprint of the new development. Towards the centre of this the outline of the demolished 20th century boiler room was visible (Plate 1).

Plate 1: Ground reduction and outline of boiler room, looking southeast (*scale 1×1m*)

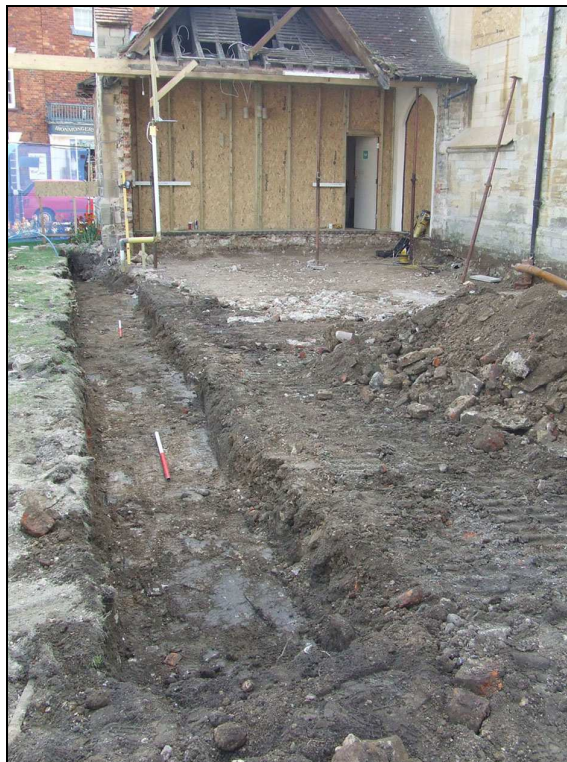
The footing trench (Fig. 4; Plate 2 & 3) measured between 0.6-0.8m wide, dug to a depth between 0.53-0.80m BGL (below ground level), within made-ground. A disarticulated human skull, adult male, was uncovered *c.*0.70m BGL within the northeast corner of the footing trench. Further disarticulated human remains were recovered within the northwest section of the footing trench.

Plate 2: Northwest side of footing trench, looking northeast (*scale 2×1m*)

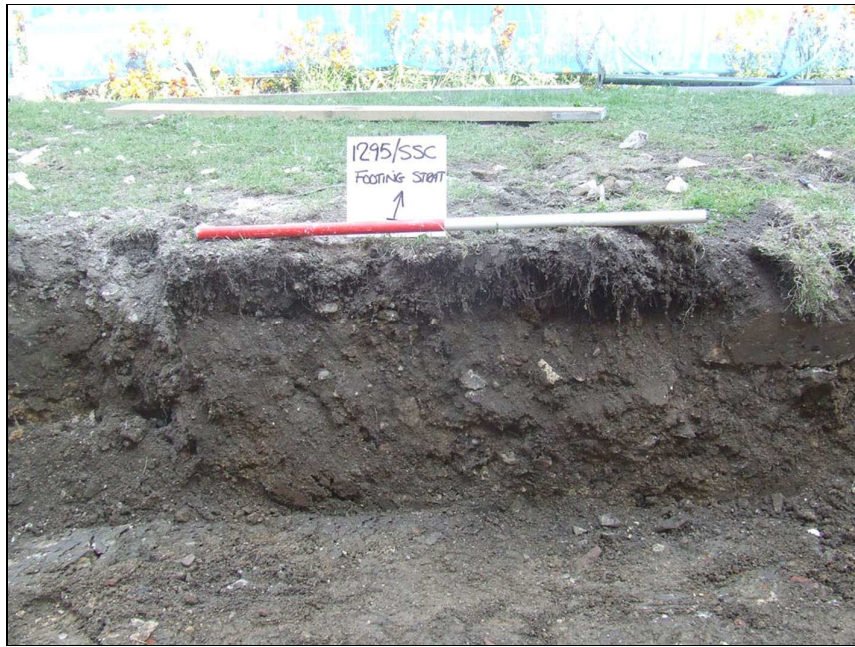
Plate 3: Southeast facing section of northwest side of footing trench (*scale 1×1m*)

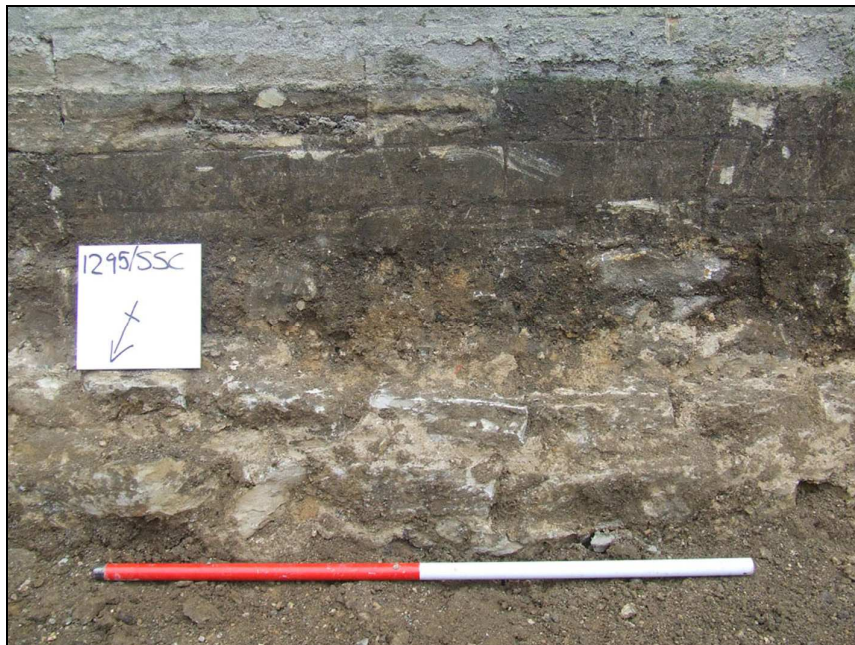
The southeast section of the footing trench exposed the church foundations (Plate 4). The footings comprised extended to a depth of *c.*0.23m BGL, underlying which was *c.*0.23m max of mottled light brown/yellow friable silty sand, beneath which were either two courses of unbonded sandstone *c.*0.26m in depth or made-ground of mid brown, friable silty clay.

Plate 4: Northwest facing section of church footings (*scale 1×1m*)

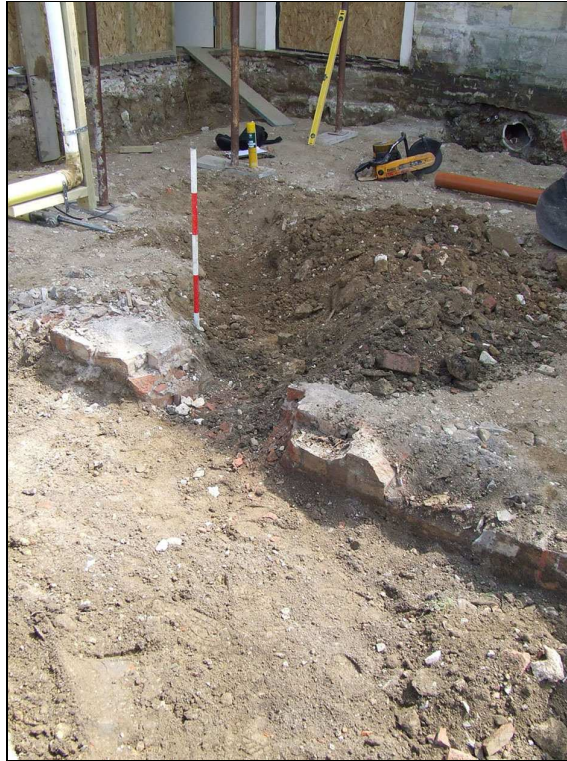
The majority of the associated services were excavated within the footing trench or tapped into known services within disturbed ground. One service trench was observed towards the northeast end of the new build area (Fig. 4; Plate 5). The trench was orientated southwest-northeast and measured *c.*2m in length cut to a depth of *c.*0.2m into made-ground, uncovering one disarticulated human bone.

Plate 5: Service trench, looking east (*scale 1×1m*)

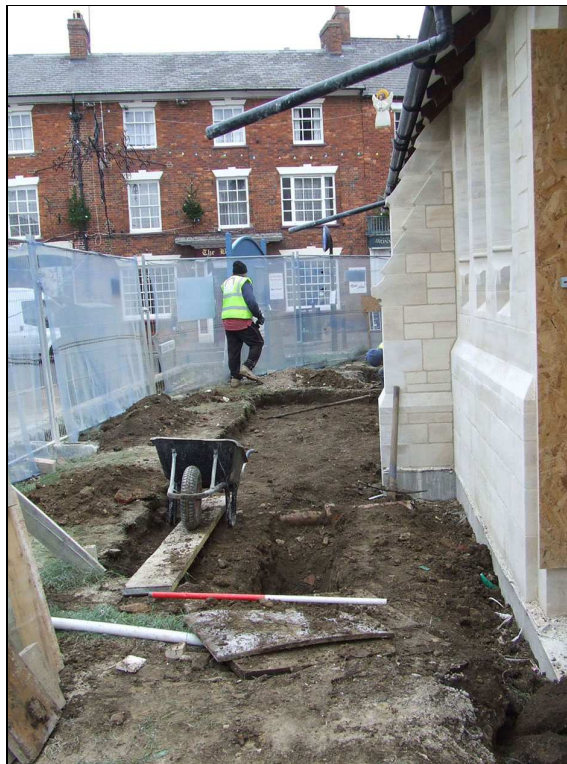
The hand excavation of a pathway to the northwest and south of the new extension was partly observed (Fig. 4; Plate 6). The observed area measured *c.*15.50 sq. m cut to a maximum depth of *c.*0.2m BGL within made-ground containing few disarticulated human remains, tile fragments, animal bone, clay pipe stems and a sherd of 19th century 'willow-pattern' pottery. All were retained by the church. A service trench was also hand excavated across the observed area to a depth of *c.*0.9m BGL, following

the line of a known service trench through made/disturbed ground. The pathway continued further to the south to a maximum depth of 150mm.

Plate 6: Pathway to the northwest of the new extension, looking northeast (*scale 1×1m*)
