**HISTORIC BUILDING RECORDING:  
96 SHENLEY ROAD  
BOREHAMWOOD  
HERTFORDSHIRE**

NGR: TQ 1946 9664

January 2011

ASC: 1369/BSR/1

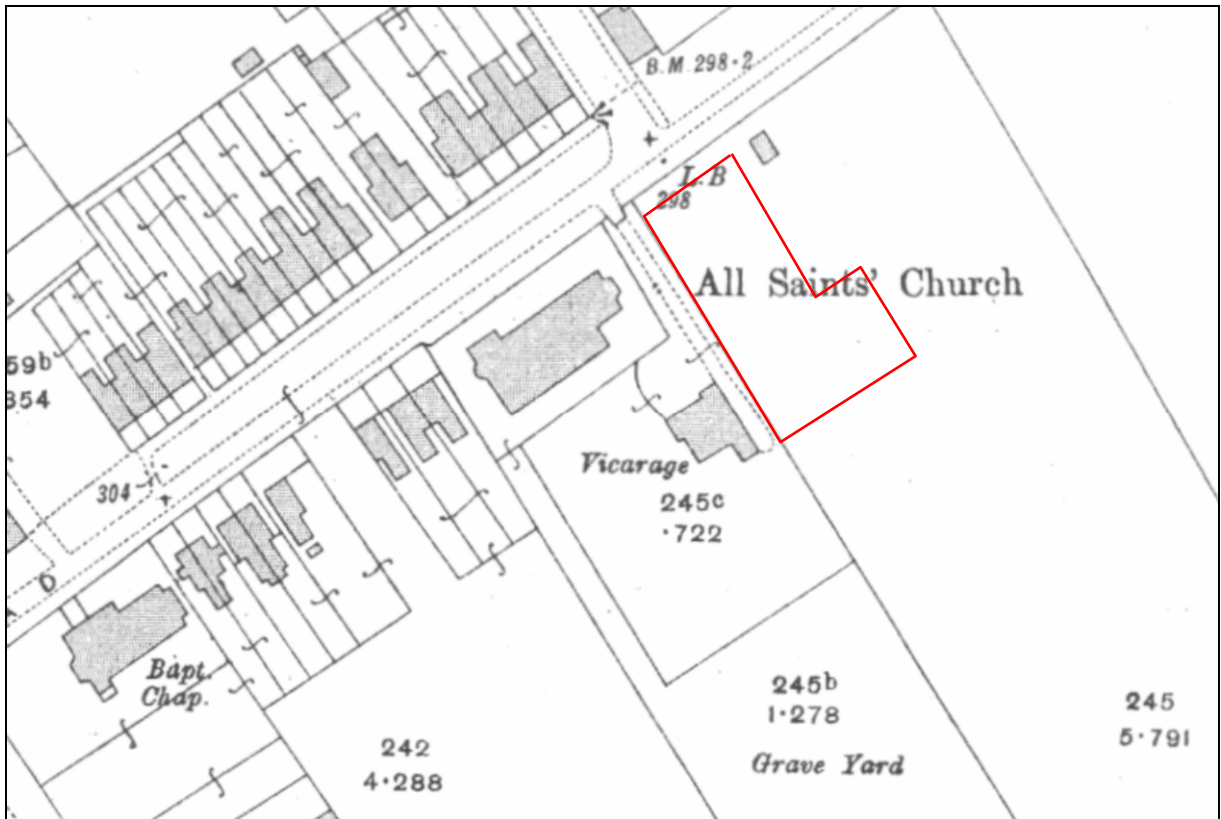
**Figure 3:** Extract of Ordnance Survey Third Edition 25" sheet XLV.I, 1914 (*not to scale*)

All Saints' Church first appears on the Ordnance Survey 25" sheet for 1914 (Fig. 3). At this time, Borehamwood was still at a relatively early stage of development: contemporary photographs of Shenley Road still present a relatively 'rural' environment. The church and adjoining vicarage (not the present house) are shown, but the site of the Church Hall and the Nursery forms part of a larger undeveloped plot of 5.79 acres. At this time, the land belonging to the church appears to have consisted of the environs of the church, the vicarage garden (0.72 acres) and, to the south, a graveyard (1.28 acres).

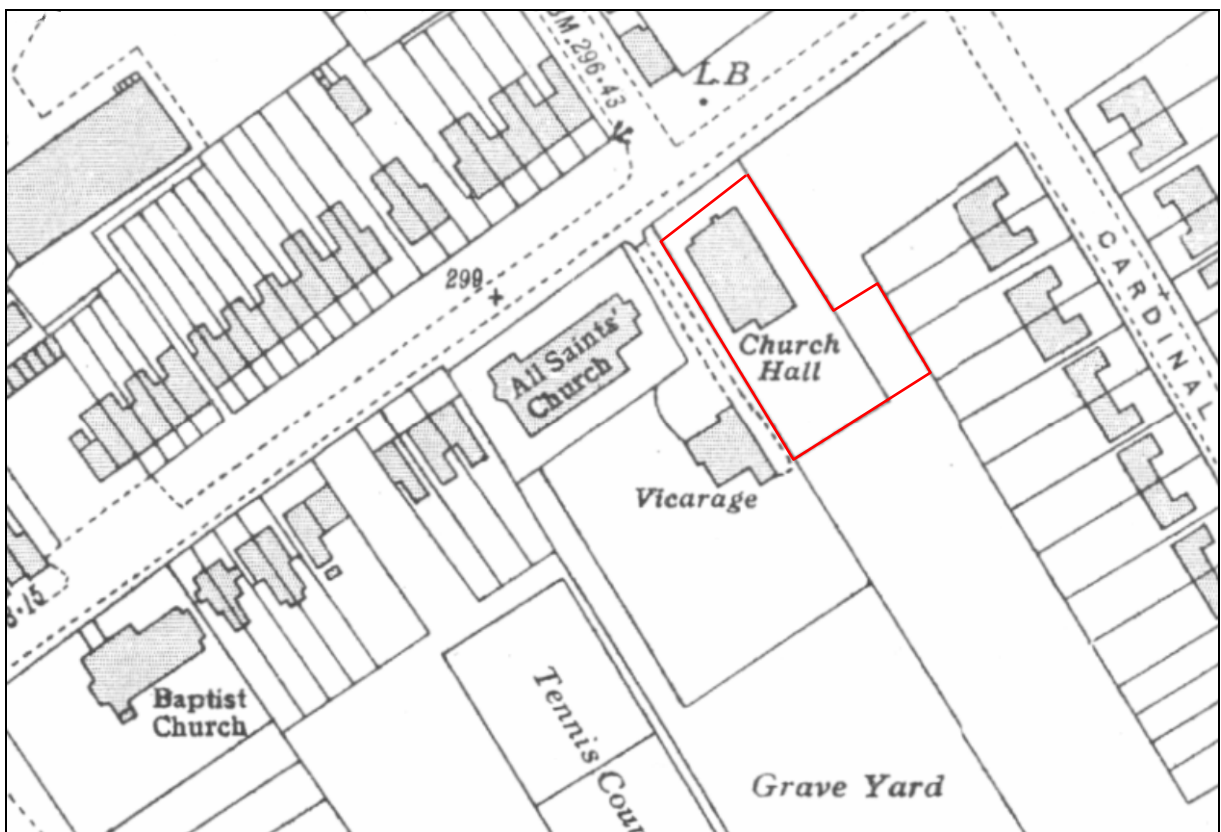
**Figure 4:** Extract of Ordnance Survey 25" sheet XLV.I, 1935 (*not to scale*)

By the next Ordnance Survey 25" edition in 1935 (Fig. 4), the development of Borehamwood had progressed significantly. Many previously open areas had been infilled with housing, light industry or commercial premises. Most of the film studios were by now established. On this map the Hall is shown for the first time, occupying a slightly smaller plot than it does today.

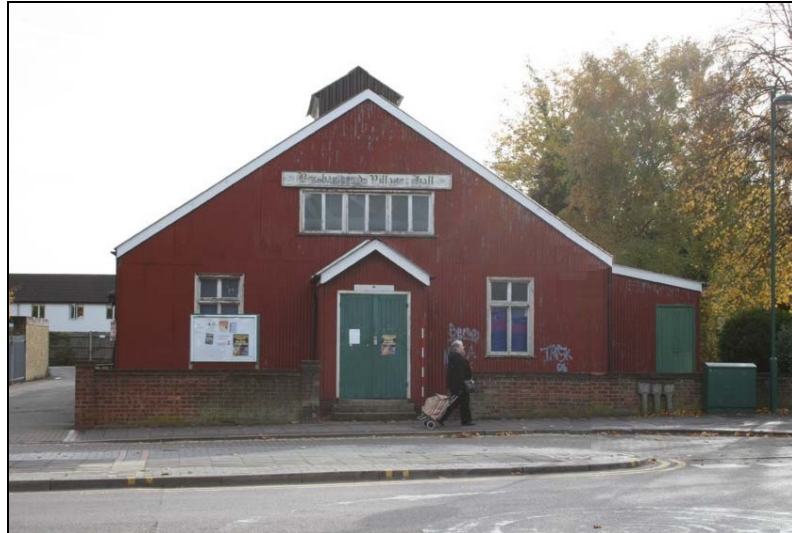
**Plate 1:** Church Hall: north-west elevation from north-west

This is the frontage of the building, facing onto Shenley Road. Gable end, with projecting central entrance porch beneath pitched roof. Double doors approached by flight of two concrete steps. Porch flanked by four-light windows with opening top hopper panels. Above porch is long six-light fixed window. Above this window is a long wooden signboard with the legend 'Borehamwood Village Hall' in Gothic script. Set back to the west of the main elevation, the north-west end of the kitchen extension is pierced by a door, now blocked internally.

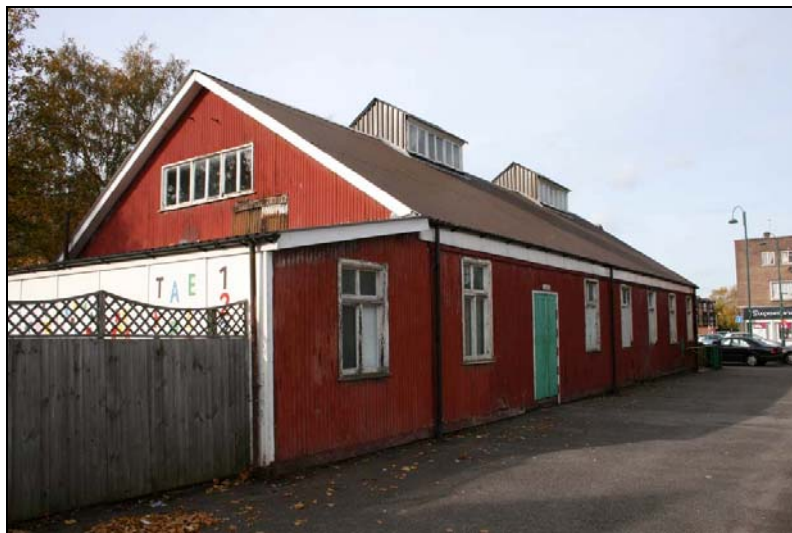
**Plate 2:** Church Hall: north-east elevation from east

The north-east elevation of the Church Hall faces onto the access road to the car park. It is pierced at regular intervals by six four-light windows with opening top hopper panels, identical to those in the north-west elevation, and a two-leaf fire escape door. At the south end of the elevation, the wall continues to form the east end of the backstage extension, pierced by a similar window to those already described.

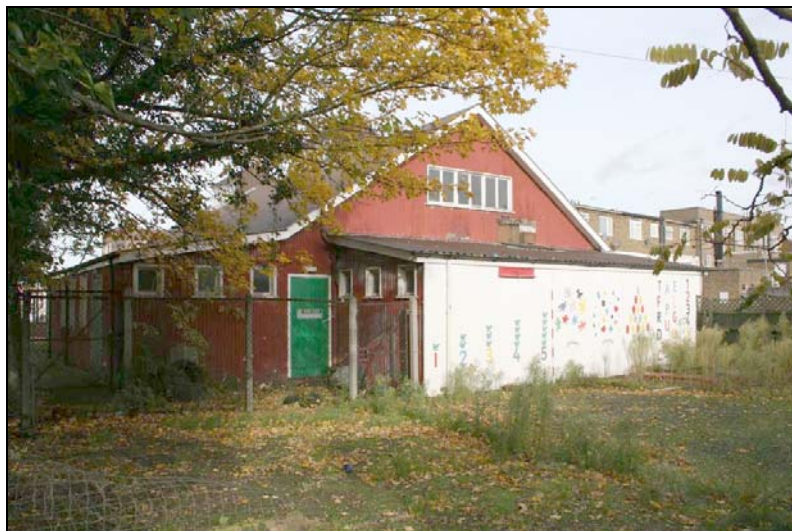
**Plate 3:** Church Hall: south-east elevation, from south

This elevation forms the rear of the building, facing the Nursery. The lower part consists of the south-east wall of the backstage extension. The three windows and door in this wall are now covered externally by boards, on which are painted a range of alphabetic and numeric teaching aids for the adjoining nursery. Above this extension, the gable end of the main building is pierced by a long fixed-light window, similar to that in the north-west elevation. To the west of this extension is a fire escape door leading from the stage area. West of that, the south-east end of the kitchen extension is pierced by two small four-light windows.

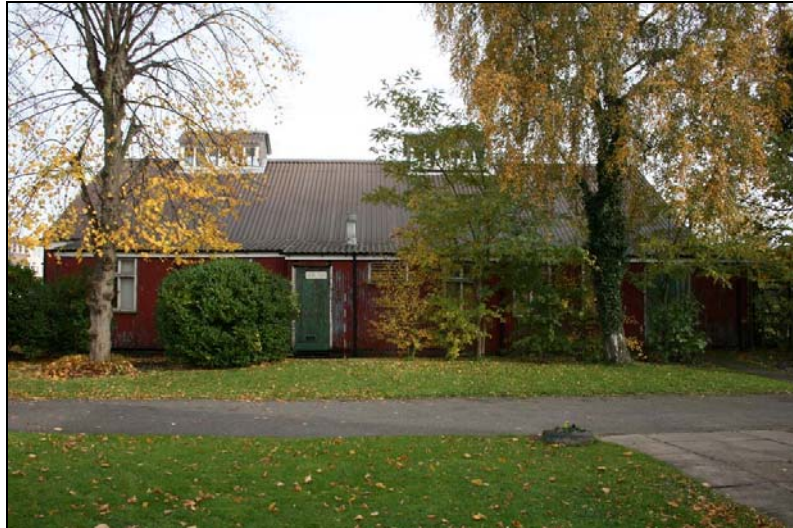
**Plate 4:** Church Hall: south-west elevation from south-west

This elevation faces the church: most of its lower part (*i.e.* below eaves height) consists of the south-west side of the kitchen extension. The south-west elevation of the main building is visible only at the north end, pierced by a fire escape door from the hall. At its north end, the extension is pierced by two fixed four-light windows.

At the south corner of the kitchen, the extension widens slightly. Adjacent to this is a door (locked at the time of the survey), followed by a vent with wooden louvres. South of this are three equidistant fixed four-light windows, followed by a two-leaf fire escape door. In the south-west end of the backstage extension are three small four-light windows.

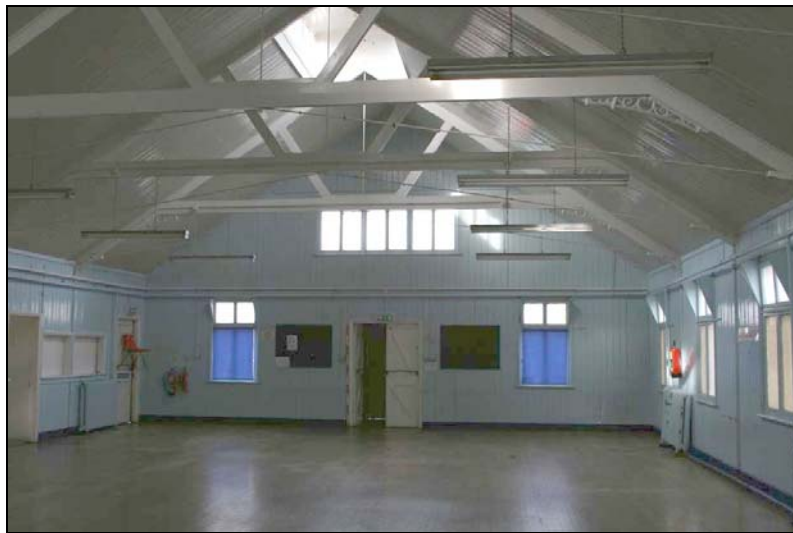
**Plate 5:** Church Hall: hall interior, looking north-west

*Description:* The main part of the building contains the hall and stage. The hall (16.4 × 10.4m) occupies 5½ bays, from the north-west end of the building (Plates 6-9). The stage (7.9 × 4.1m: Plate 12) is located at the south-east end, flanked to the north-east and south-west by passages (each 4.1 × 1.3m) leading respectively to the backstage store (Plates 13 & 14) and to the rear fire exits.

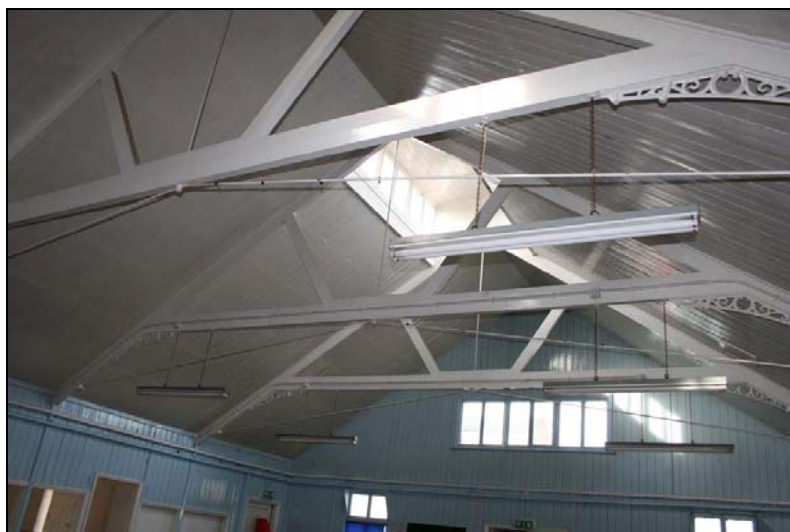
**Plate 9:** Church Hall: hall interior, detail of roof construction

The hall is open to the boarded roof, which is supported by five timber trusses incorporating iron tie rods and distinctive cast iron brackets (Plate 10). Additional natural lighting is provided by glazed 'pigeon boxes' set above the second and fifth bays (NB: these are not shown on the elevation drawings, as it was not possible to obtain accurate measurements). Artificial lighting is provided by fluorescent units. Heating is by cast iron radiators.

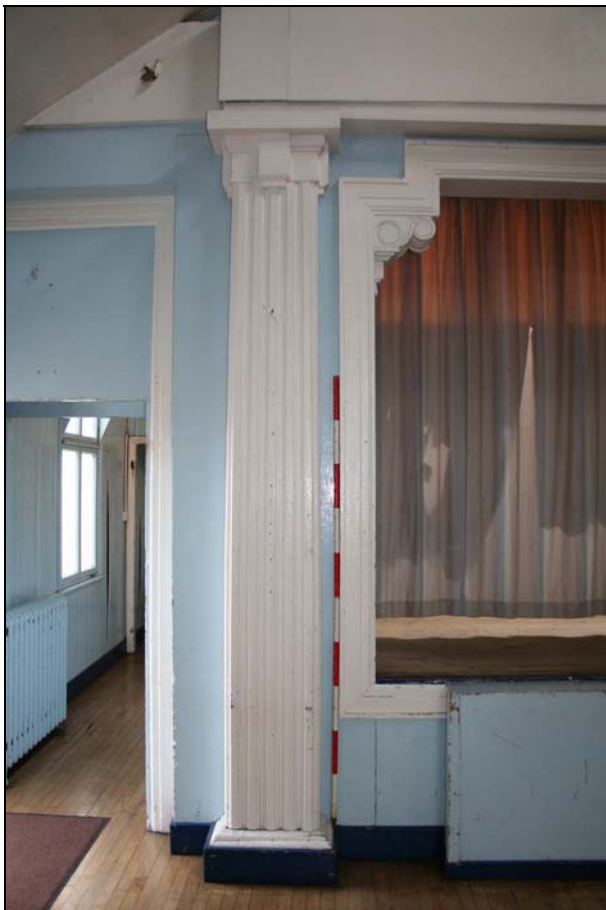
**Plate 11:** Church Hall: hall, detail of proscenium arch

The stage is raised c.0.8m above the hall floor. The proscenium arch, 6.25m wide, is flanked by fluted columns, executed in wood, with elaborate plaster brackets at the upper corners (Plate 11). The stage floor is laid with narrow planks running north-east to south-west. Two trapdoors to the under-stage space are present: both are sealed shut. On each side of the stage are plain wooden railings, and steps down to the two flanking passages. A door to the rear of the stage leads to the backstage store. Apart from the stage curtain, which is suspended from the southernmost roof truss, there appears to be little in the way of fixed stage equipment (e.g. backdrops, lighting).

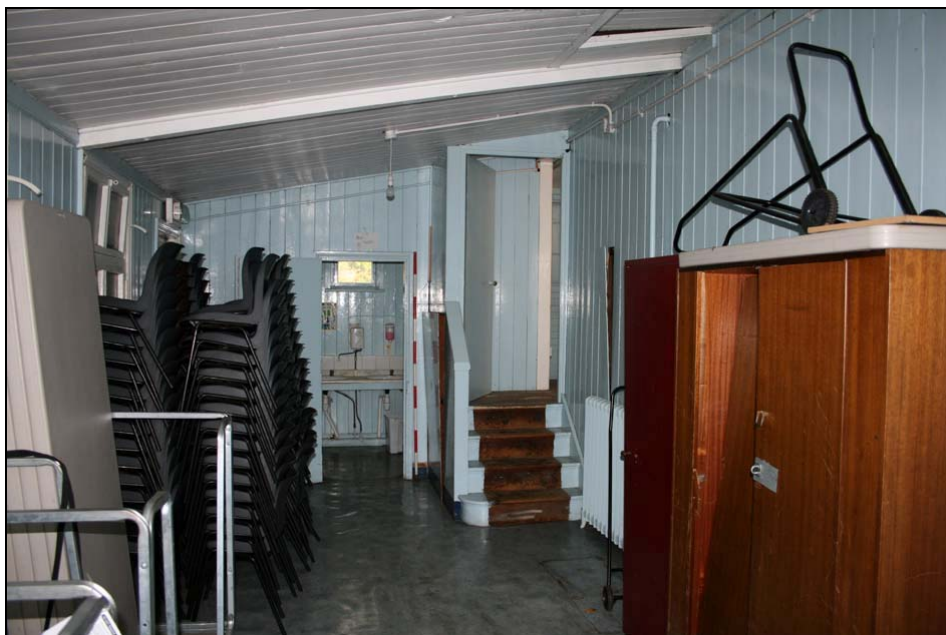
**Plate 15:** Church Hall: storeroom behind stage, looking south-west

*Description:* The extension at the south-east end of the building is largely occupied by a backstage room (3.15 × 7.60m), used for storage and presumably also for costumes and makeup. At the west end is a WC (3.15 × 1.30m). On the north-west side, a short flight of stairs leads to a door at the rear of the stage. The floor of this extension is planked, covered with vinyl flooring. The backstage room is lit by a single window to the north-east: windows and a door to the south-east have been boarded over externally. The WC has three south-west facing small four-light windows.

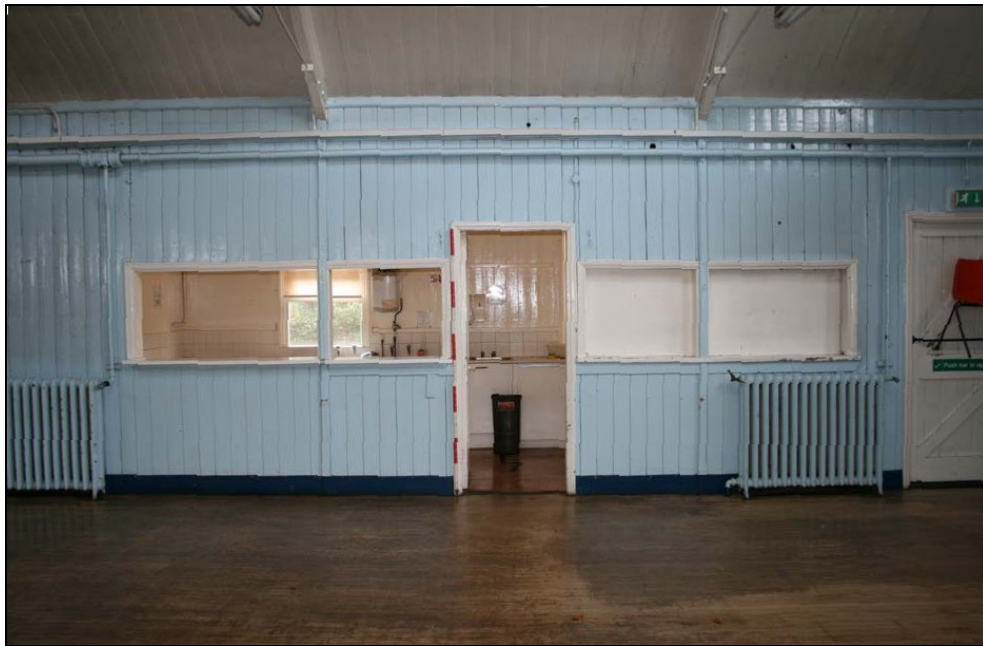
**Plate 16:** Church Hall: entrance to kitchen and serving hatches

The kitchen is accessed from the main hall, by a door flanked by serving hatches (Plate 16). The hatch south-east of the door remains open: the other is blocked. Internally, the kitchen is fitted out with modern units, and lit by windows to the south-west (Plate 17). At the north-west end, a doorway leads to the cleaning store, which also houses the electrical distribution board for the building. The partition separating these rooms has been inserted between one of the windows and the blocked serving hatch, and is evidently of recent origin. In the north-west wall of the cleaning store is a blocked external doorway.

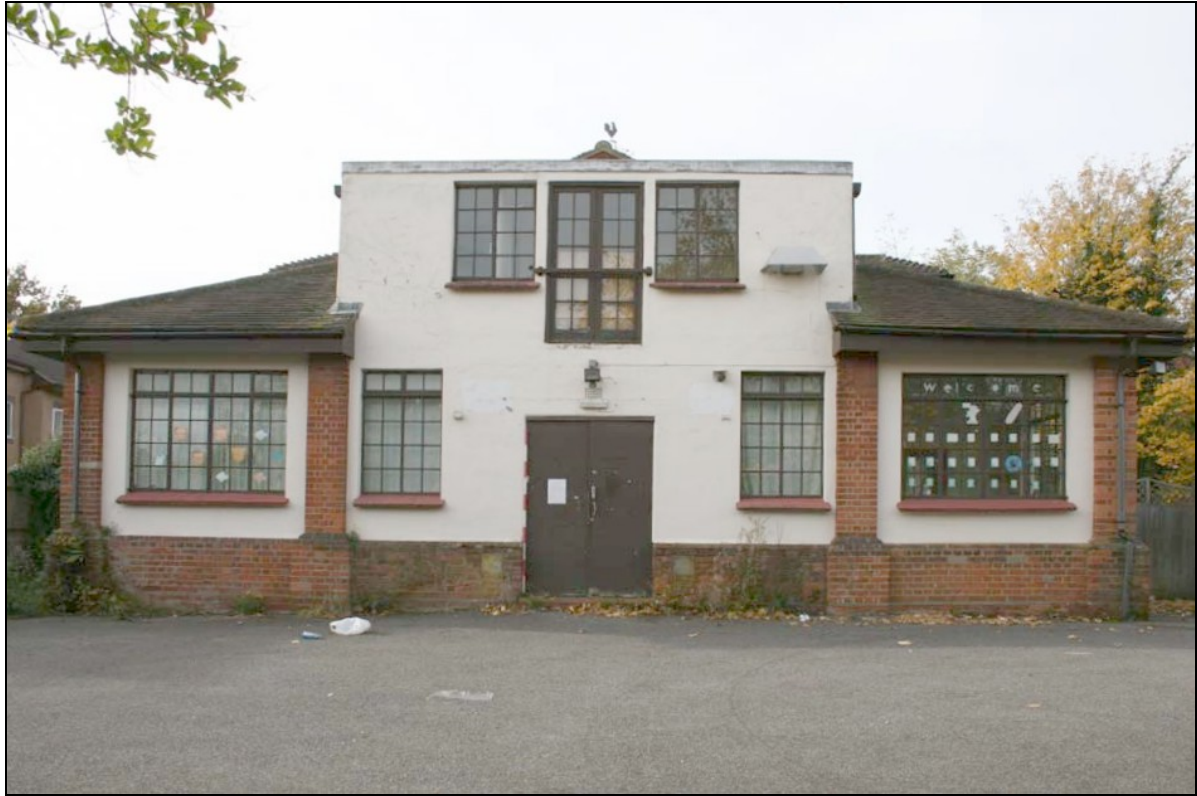
**Plate 18:** Nursery: north-east elevation, from north-east

This elevation (Plate 18) forms the front of the building, facing onto the car park. The central, two-storey section comprises a central entrance through double doors at ground-floor level, flanked by 20-light casements. At first-floor level is a central 2-leaf, 20-light French window, barred shut externally, flanked by 16-light casements. On each side of the two-storey section is a single-storey bay, with a central 40-light casement.

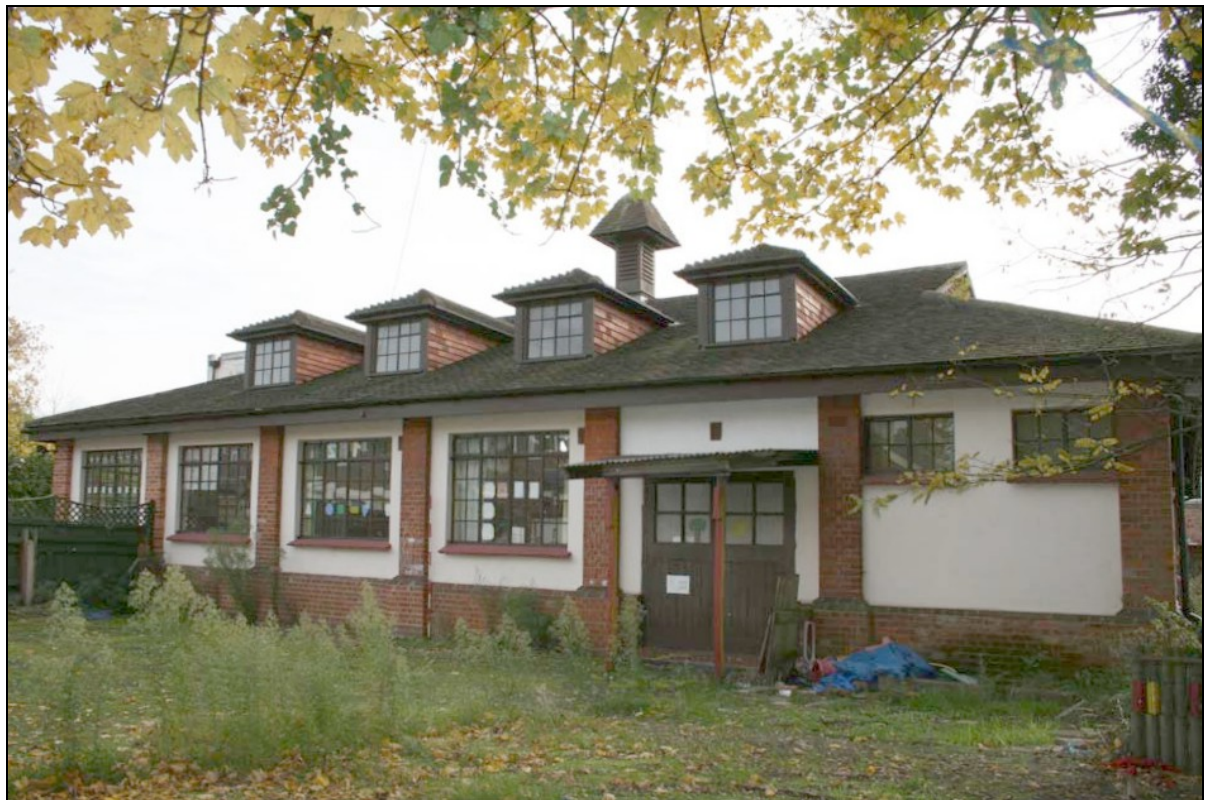
**Plate 19:** Nursery: north-west elevation, from north-west

The wall of the north-west elevation is divided into six bays, as described above. The four easternmost bays each have a central 40-light casement. The fifth bay is pierced by a part-glazed double door, fitted as a fire escape, covered by a modern flat-roofed porch of timber construction. The westernmost bay contains two 8-light windows, set high in the wall.

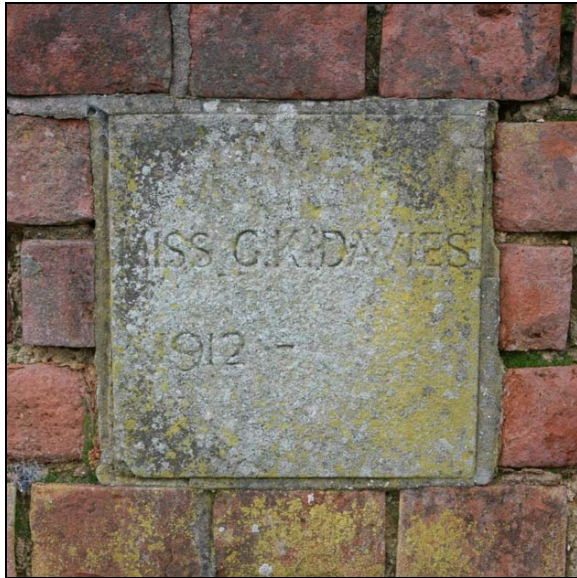
**Plate 20:** Nursery: foundation stone right of main entrance

Set into the plinth on each side of the entrance are foundation stones. That to the right of the entrance is inscribed "MISS G.K. DAVIES, 1912-" (Plate 20). That to the left, which is in a poor state of preservation, reads "MISS L. PH[ILLIPS], 1915-....". In the wall above the main entrance are traces of a possible projecting porch.

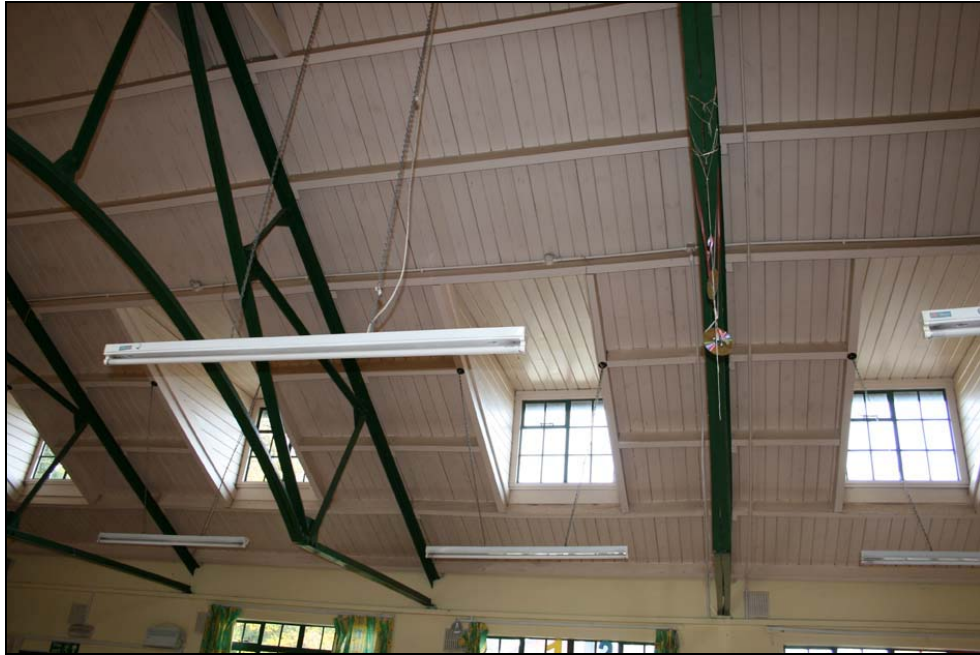
**Plate 30:** Nursery: Room G6, hall, detail of roof construction

The roof of the hall is boarded, carried on distinctive bolted angle-iron trusses, with curved lower sections (Plate 30). It has four dormer windows (1 per bay) facing to the north-west and south-east.

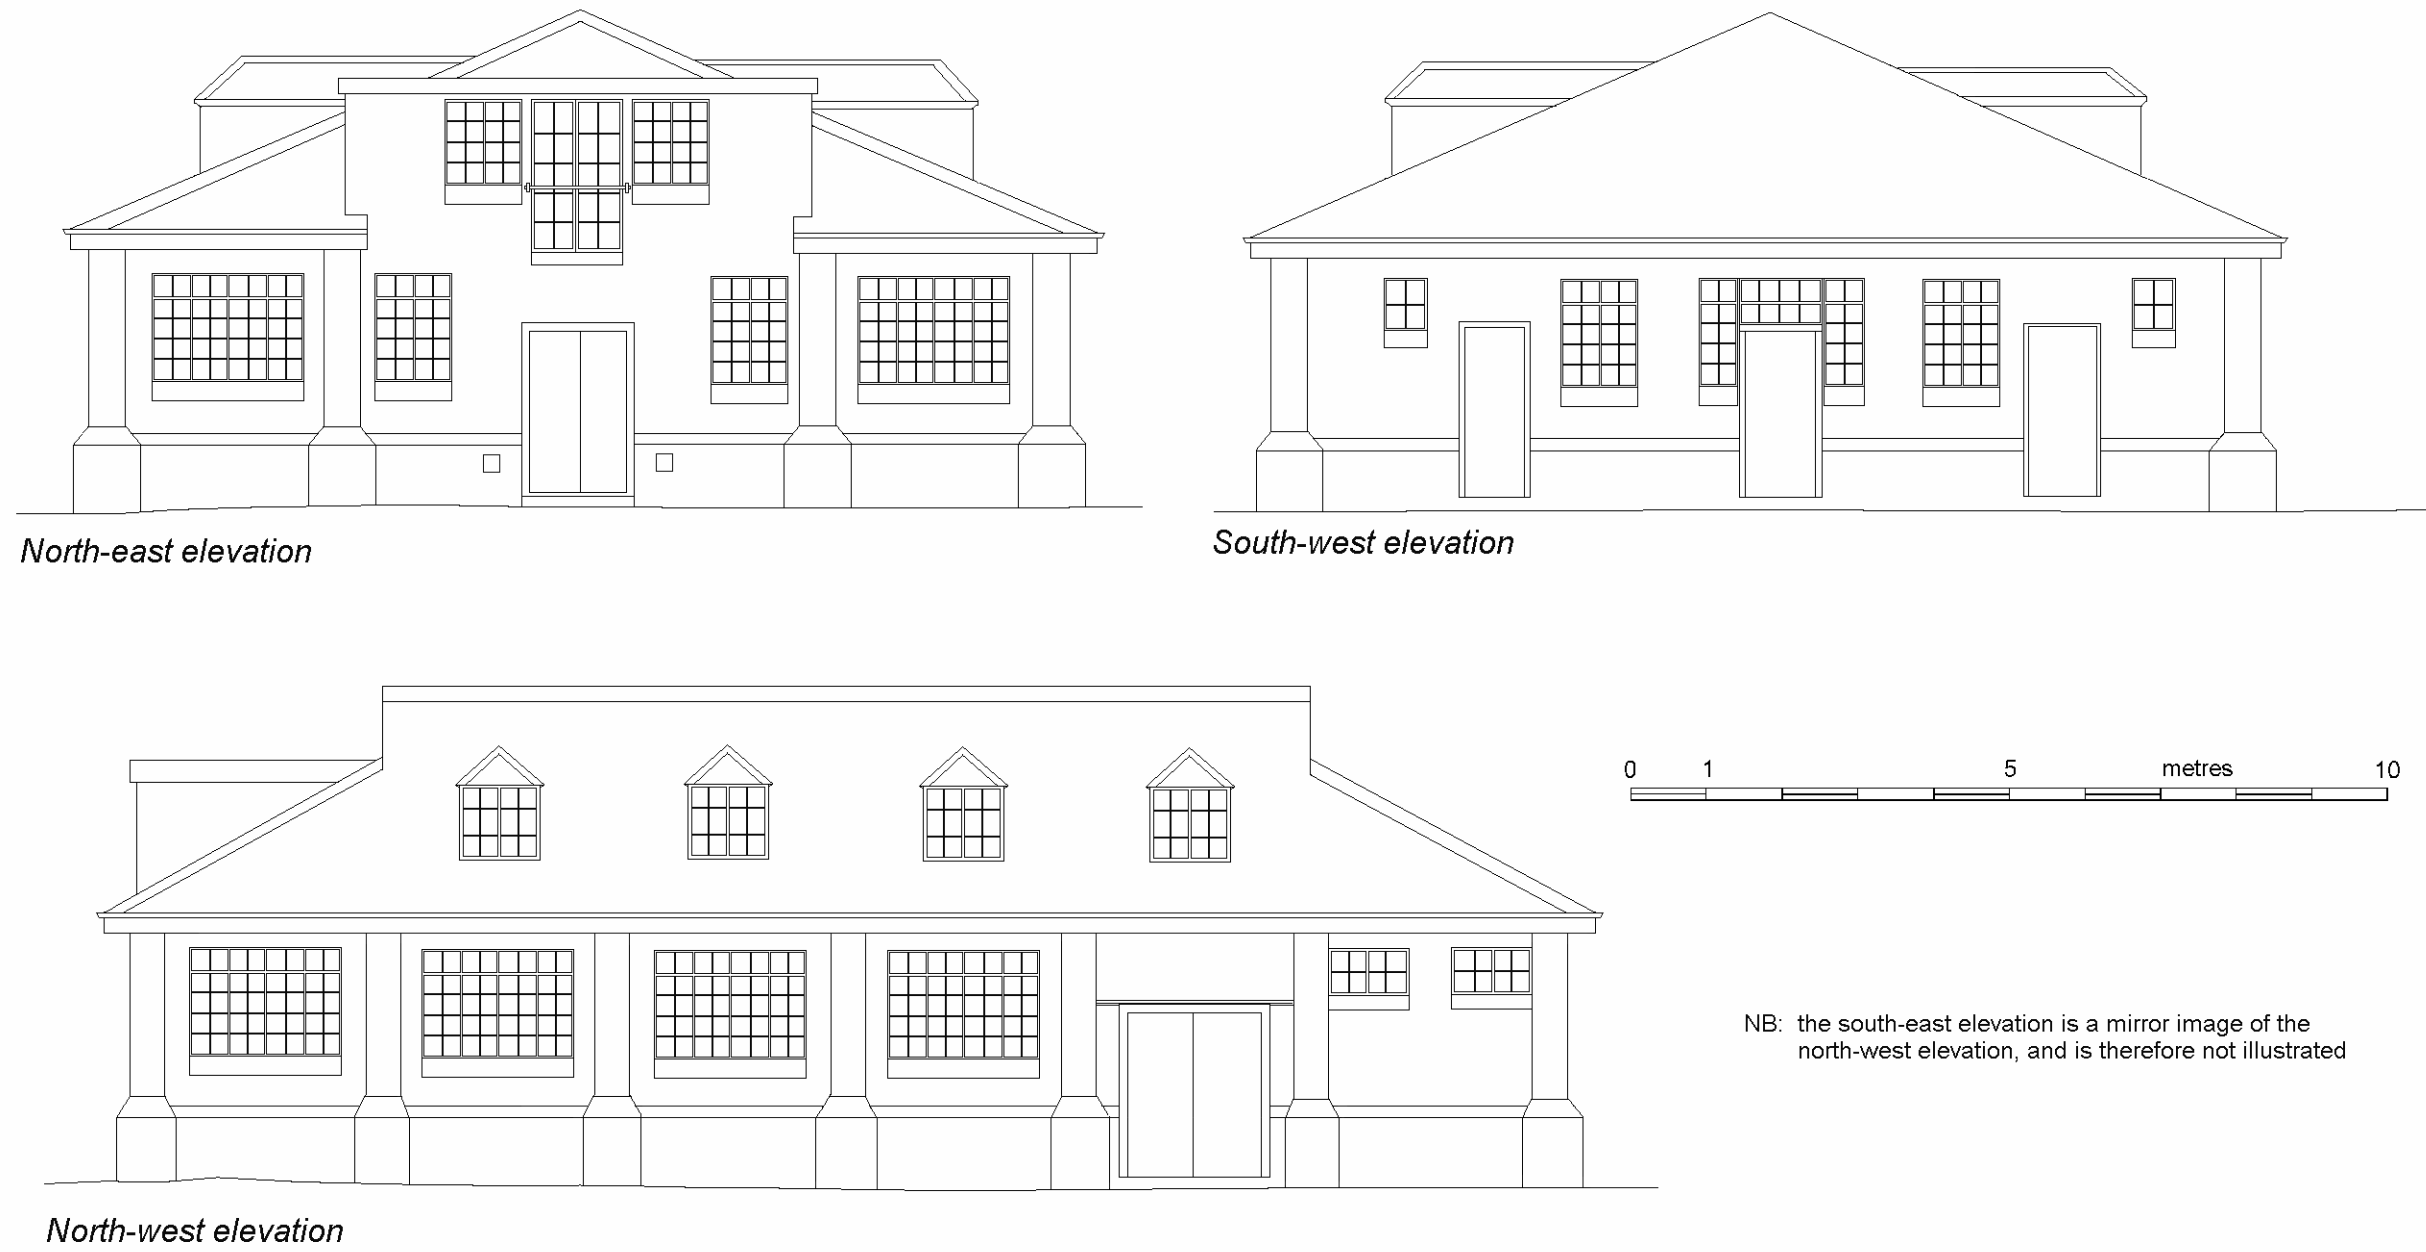
**Figure 9:** Nursery elevations (scale 1:100)

The external walls are constructed of red brick, laid in English bond. There is a substantial plinth c.0.8m high, topped with bevelled bricks. The walls are divided into panels corresponding to the bays along the length of the building by brick pilasters, the wall between them above the plinth being rendered and painted white. Windows are all metal-framed casements, of several standard sizes, all with sloping sills of plain red tile. Interior floors are all concrete, with a range of surfaces. Walls are mostly painted brick.

With the exception of the two-storey section, the building has a hipped gable roof, clad with purple-brown clay tiles. Above each of the central four bays, dormers face to the south-west and north-east. These also have hipped tiled roofs. Above the middle of the main roof rises a tall louvred structure, beneath a pyramid-shaped roof. This is not shown on the elevation drawings (Fig. 9), as it could not be measured accurately.
