**HISTORIC BUILDING RECORDING:
'THE CROSS' PUBLIC HOUSE
DENHAM WAY
MAPLE CROSS
HERTFORDSHIRE**

NGR: TQ 0328 9280

on behalf of Clearview Homes Ltd

February 2011

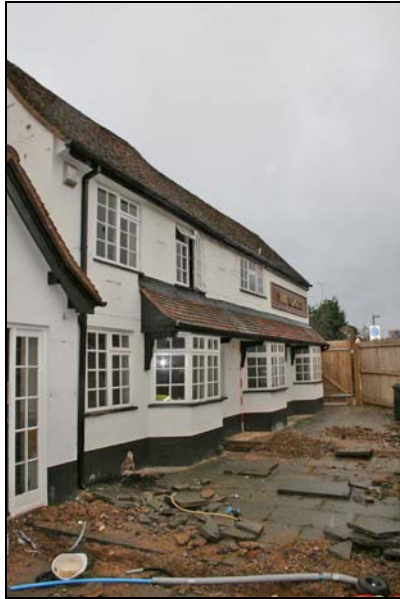
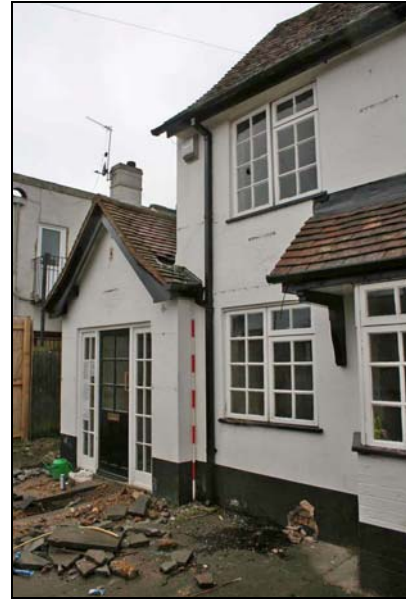
Plate 1: East elevation from the south

The main entrance into the building is by a porch at the southern end of the 2-storey core. There are three canted bay windows and a 2-light window (the original front entrance) beneath a continuous clay tiled roof. There are two 2-light and one shorter 3-light window on the first floor. The southern range also has a 2-light window.

Apart from the bay windows, the main building is rendered and painted in imitation of ashlar or blockwork. However, a small section of exposed walling revealed poorly puddled red and yellow bricks containing inclusions known as 'Spanish', appearing to be of 18th-century date. The bricks are set in a Flemish Bond using lime mortar. A clear building break is visible on both floors, between the northern and central bay windows.

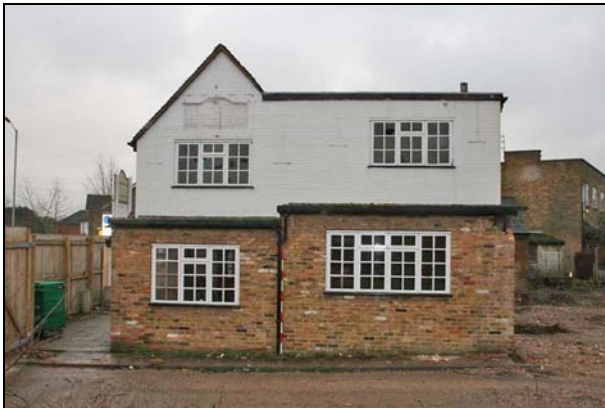
Plate 3: North elevation

The ground floor is of unpainted recycled bricks, laid in Stretcher bond using cement mortar, with a flat roof at two heights; the western part being the taller. The first floor wall is painted white and has a pitched roof to the east and a flat roof to the west. Two 3-light windows light the first floor. The ground floor has a 3-light window to the east and a 4-light window to the west. A pub sign has been removed from beneath the pitched roof.

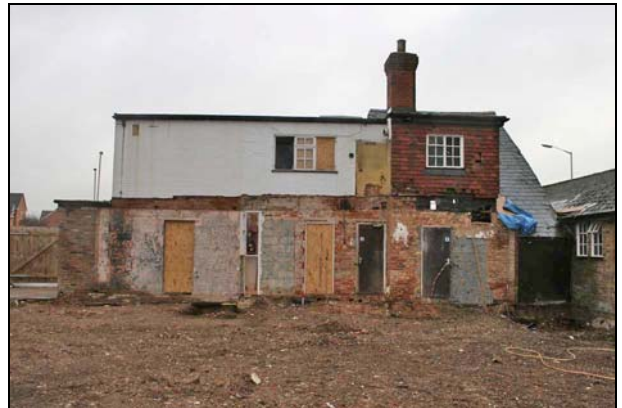
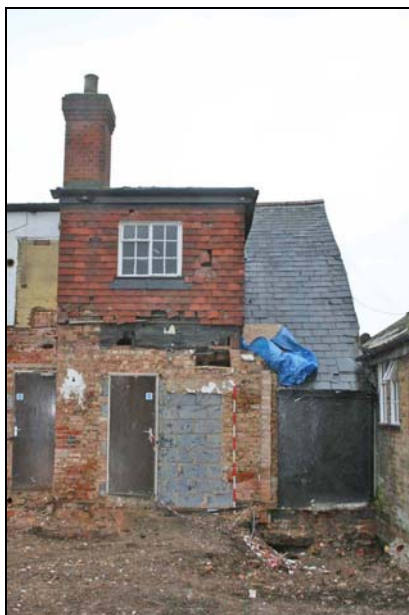
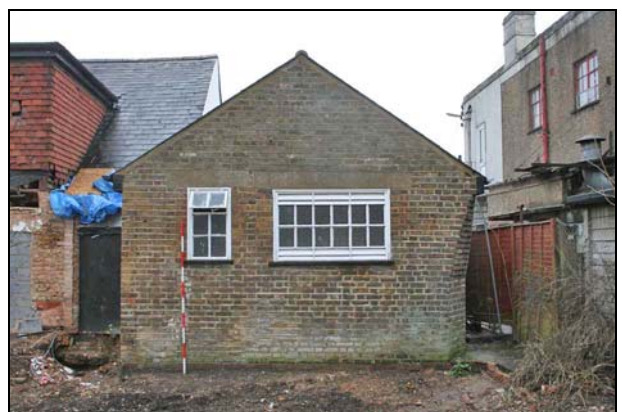
Plate 4: West elevation

Prior to the survey, the lower part of the west elevation had consisted of the modern single-storey western extension shown in Fig. 11, now demolished. Its removal revealed much of the west wall of the main building, albeit badly scarred and altered (Plates 4 & 5). The lower part is brick, pierced by several doorways, both extant and blocked. A clear building break is visible on both floors to the north of the 3-light window on the first floor. North of the break, the lower part of the wall is concrete blocks, with modern brickwork above. South of the break, the brickwork is of 19th-century or earlier date. South of the window at first-floor level is a flat-roofed projection with tile hung walls, lit by a 2-light window. The north-west corner of this

projection is formed by a brick chimney stack. South of the projection, the southern end of the main building has a slated catslide roof, above a rendered and painted wall.

The southern range is of 18th-century style bricks set in a Flemish Bond with cement mortar. There are some areas of repointing. The two windows have concrete lintels and frosted glass. The southwest corner is splayed with corbelled brickwork above.

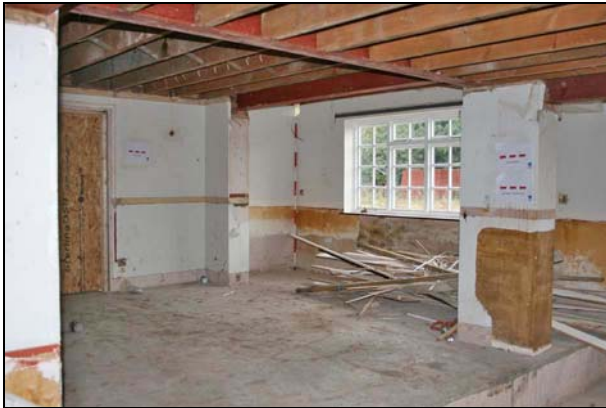
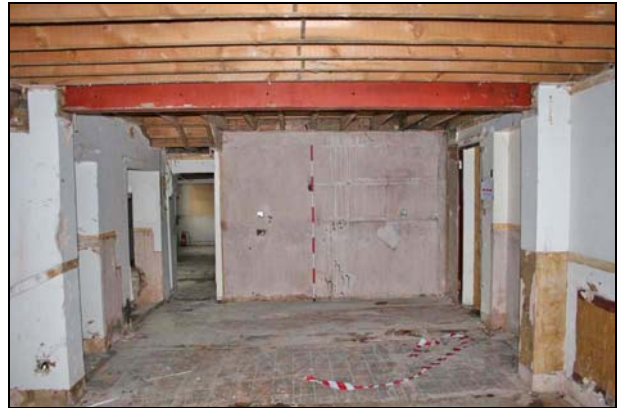
Plate 7: Room G1: northwest corner

Description: This is a modern extension built of Fletton bricks with a concrete and quarry tiled floor. There is a 4-light timber window in the north wall and a doorway in the west wall. Two steps at the eastern end lead down to Room G2. The bar at the southern end of the room had been removed prior to the survey.

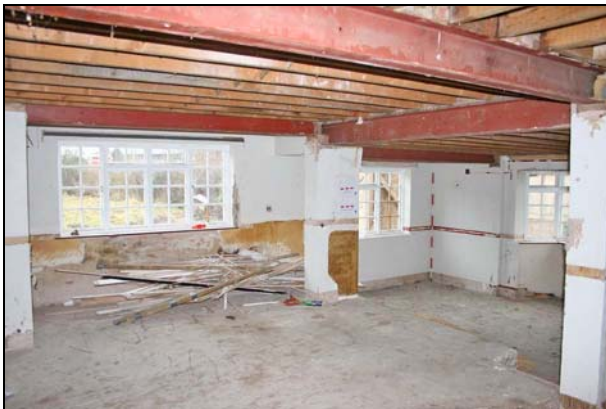
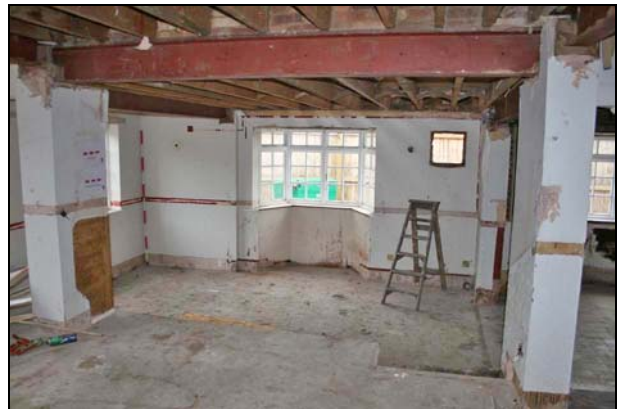
Plate 9: Rooms G1 & G2: north wall

Description: This is of a similar build to Room G1 and has a 3-light window in the north wall and a canted bay window in the east wall. The diamond braced joists in both rooms run east to west except at the northern end where they run north to south. The floor here is entirely concrete.

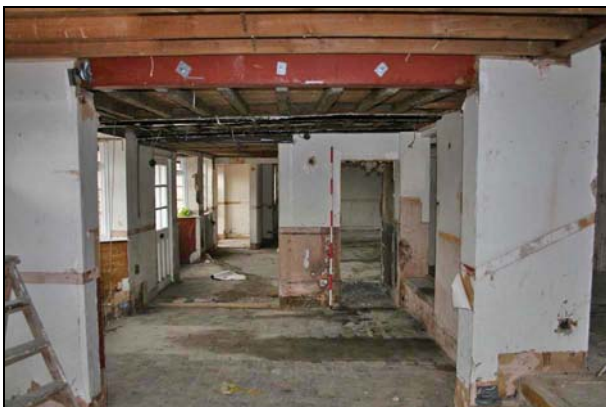
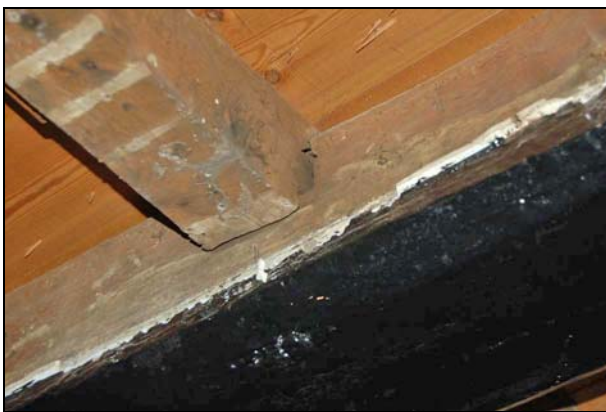
Plate 11: Rooms G2 & G3: looking south

Description: This has a canted bay window in the east wall and a concrete and quarry tiled floor. A transverse beam 14cm wide and 17cm high with a straight, narrow chamfer, extends into the bay (Plate 47). Another beam is located to the south of this, between Rooms G3 and G4. Remnants of old wallpaper adorn the wall.

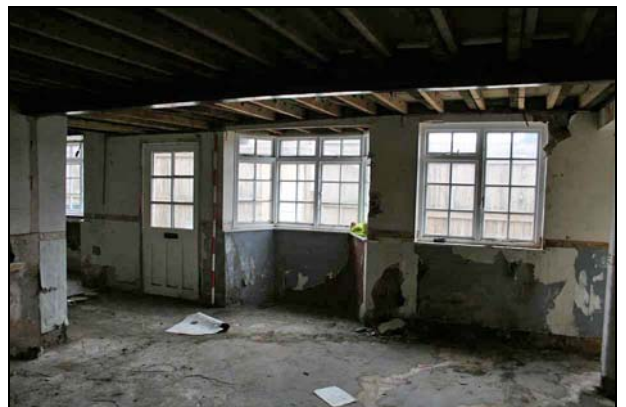
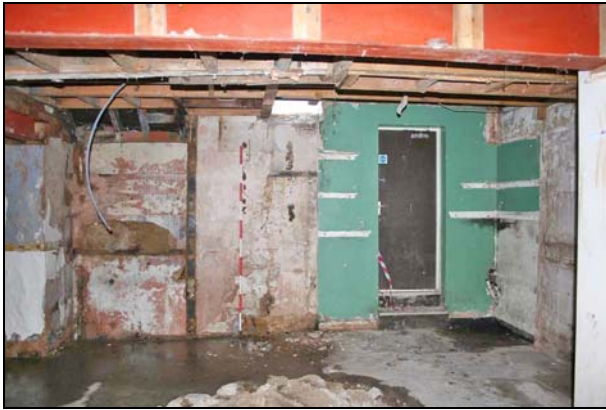
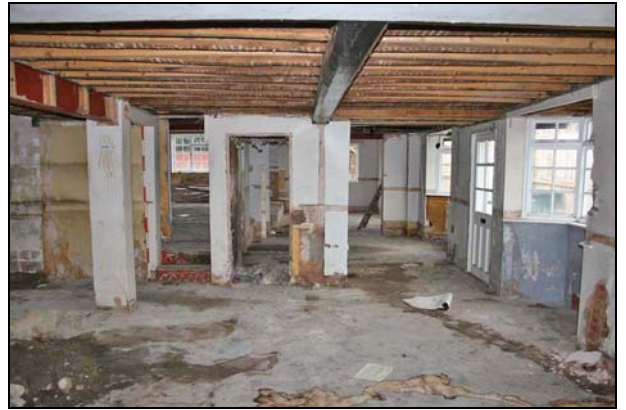
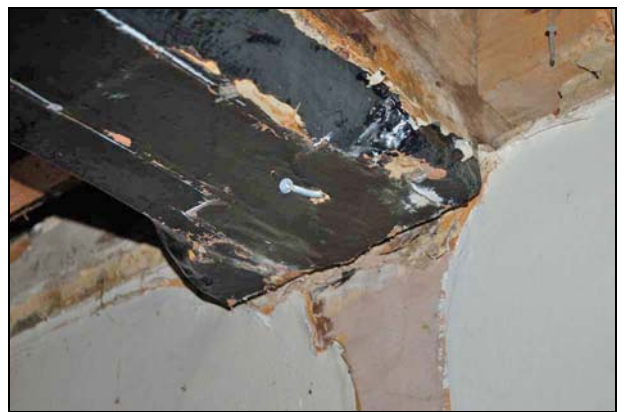
Plate 12: Room G4: east wall

Description: A canted bay window, a 2-light window and a half glazed door dominate the east wall. The west wall has a single door opening. The only architectural feature of merit in this room is the axial beam, 20cm wide and 25cm high, with short lamb's tongue chamfer stops at the northern end (Plate 48). The joists bear the scars of the lath and plaster ceiling. Two steps in the north wall lead up to the staircase.

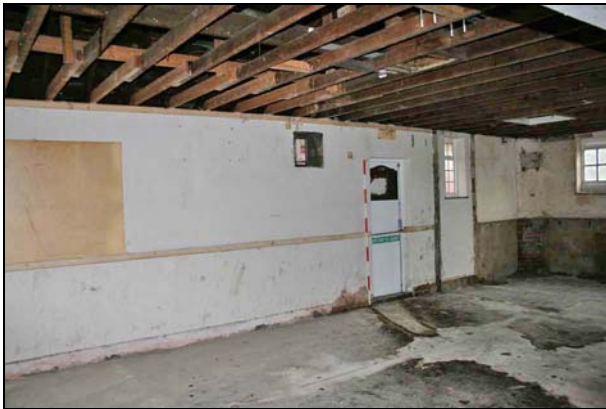
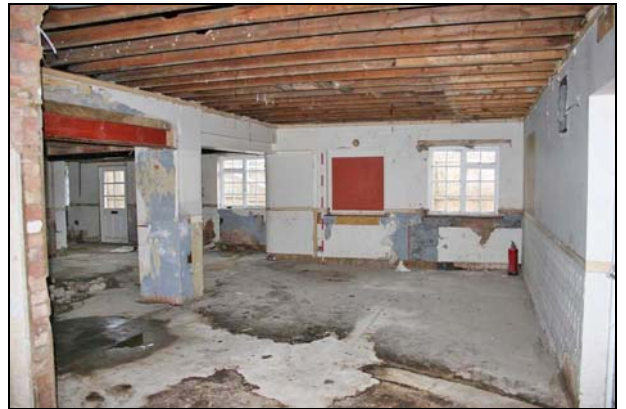
Plate 15: Room G5: south wall

Description: There is a 2-light window in the east wall with a window sized recess to the north of it. An emergency door and a 2-light window are located in the south wall. The A-frame roof is close boarded without roofing felt. The floor is concrete and the walls are papered and painted.

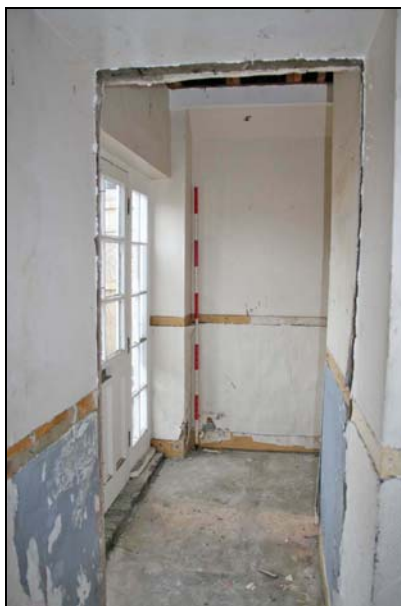
Plate 17: Entrance lobby

To the south of G5 is a modern entrance lobby (Plate 17).

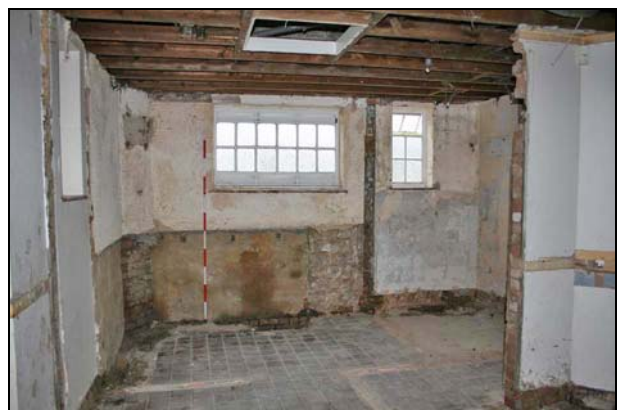
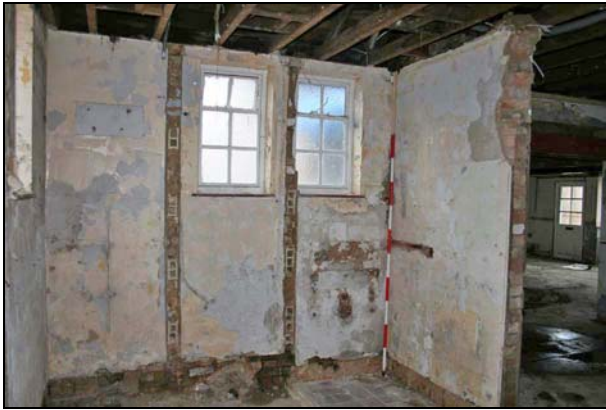
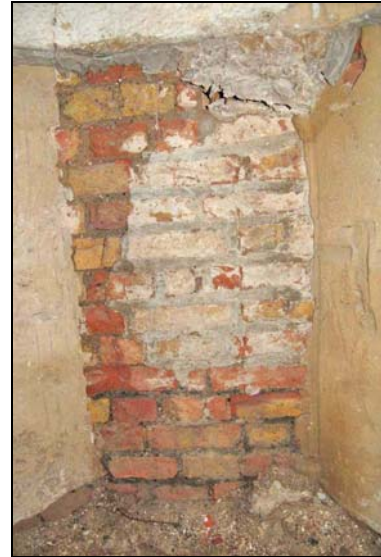
Plate 18: Room G6: west wall

Description: This was formerly divided off to provide WCs. The sanitary ware and internal partitioning had been removed prior to the survey. There is a 12-pane window with vents above in the west wall to the south of a 2-light Crittal-type window with frosted glass. The north wall has similar 2-light windows.

The brickwork in the southwest corner is of hand made, very poorly puddled bricks measuring 23 × 11 × 7cm (9 × 4⁵/₈ × 2³/₄ inches). The yellow bricks have stone inclusions, but the red ones do not. The floor is quarry tiled.

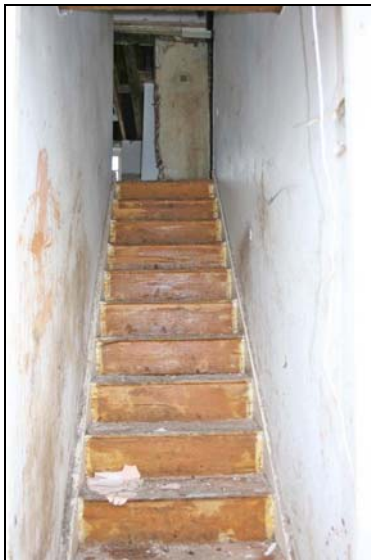
Plate 21: Room F1: Staircase

Description: The south wall is brick built and the north wall consists of concrete blocks. All are plastered and painted. There are 11 treads and the modern handrail on the south side had been removed. At the bottom of the stair is a modern flush door to the west and at the top of the stair are doorways to the south and east. The plasterboard ceiling slopes to follow the stairs.

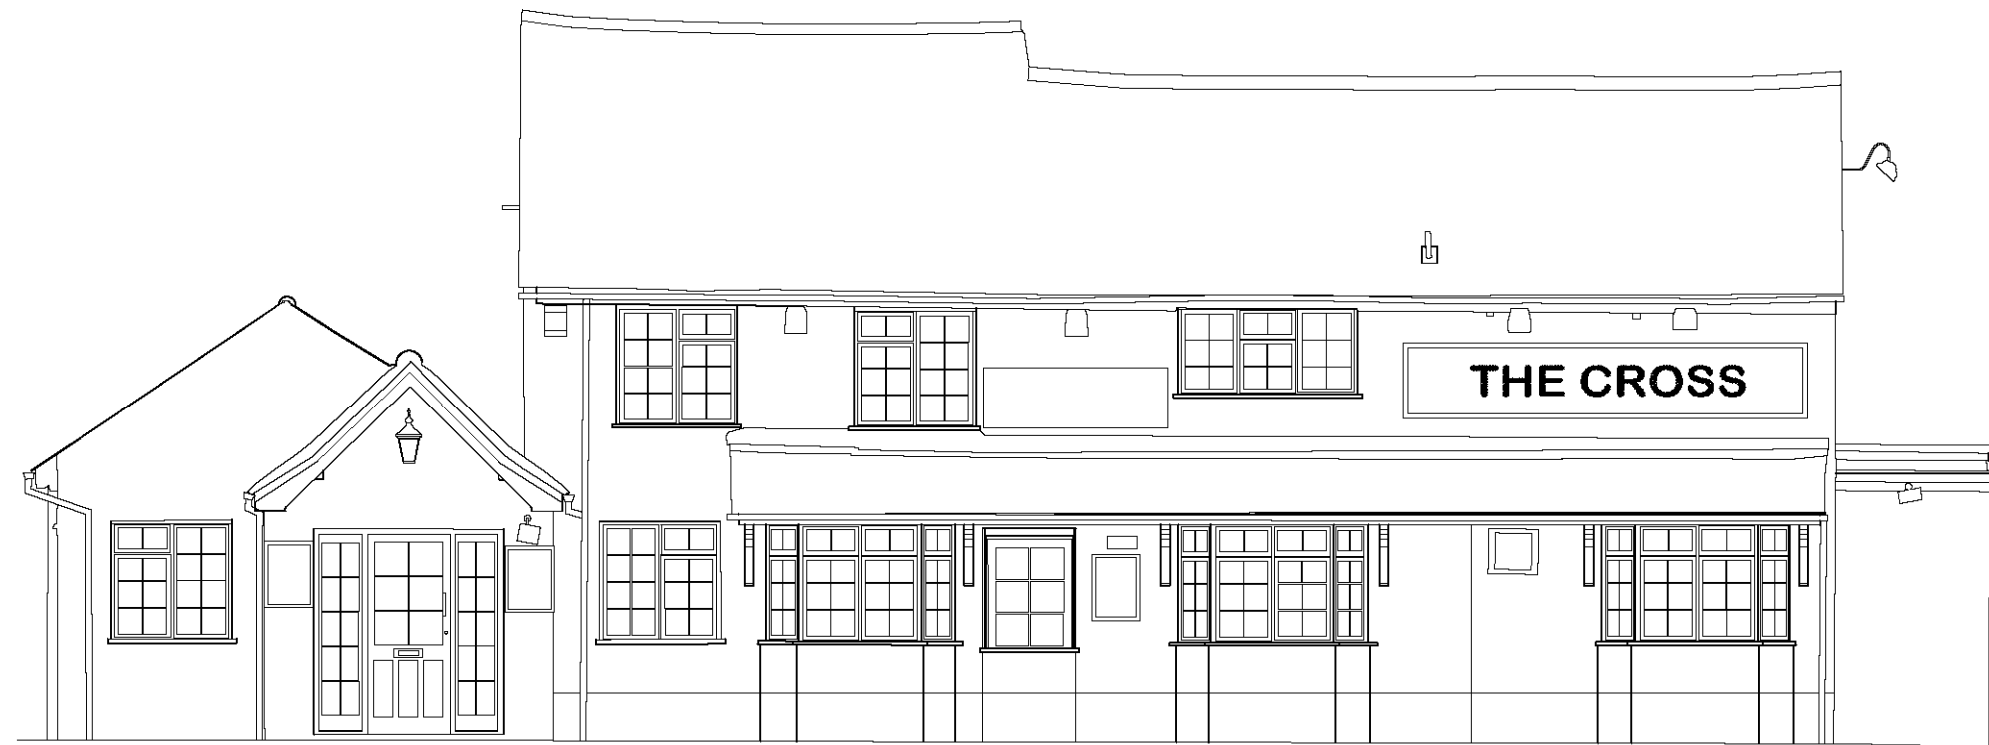
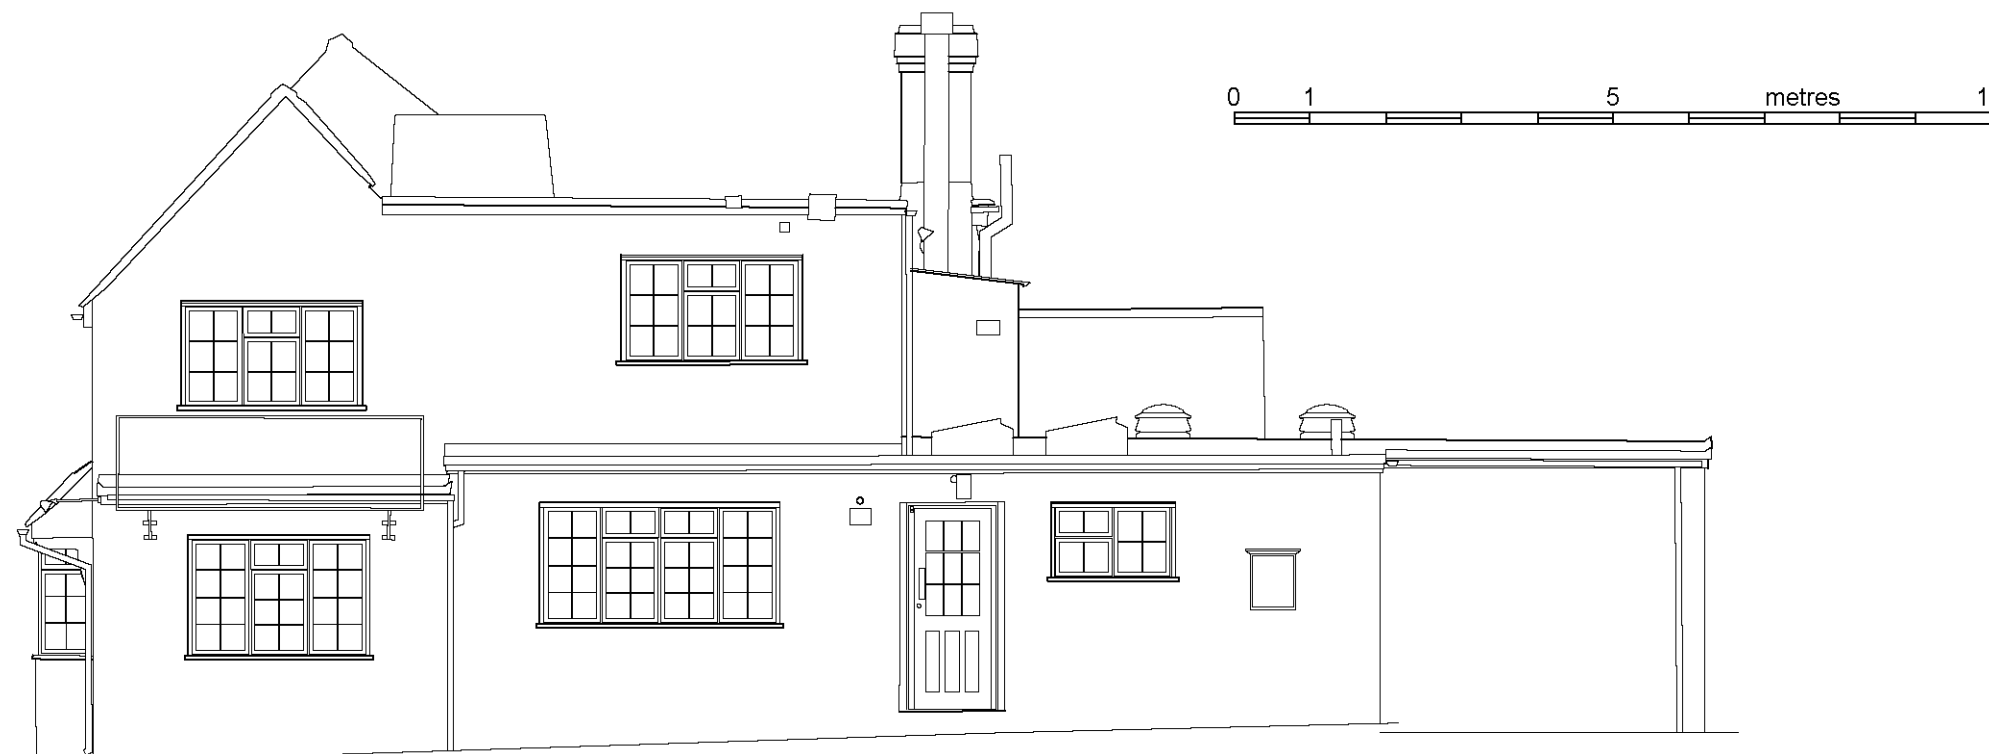
Figure 10: East and north elevations (scale 1:100)

4.2 *East Elevation* (Fig. 10, Plates 1, 2)

4.3 *North Elevation* (Fig. 10, Plate 3)

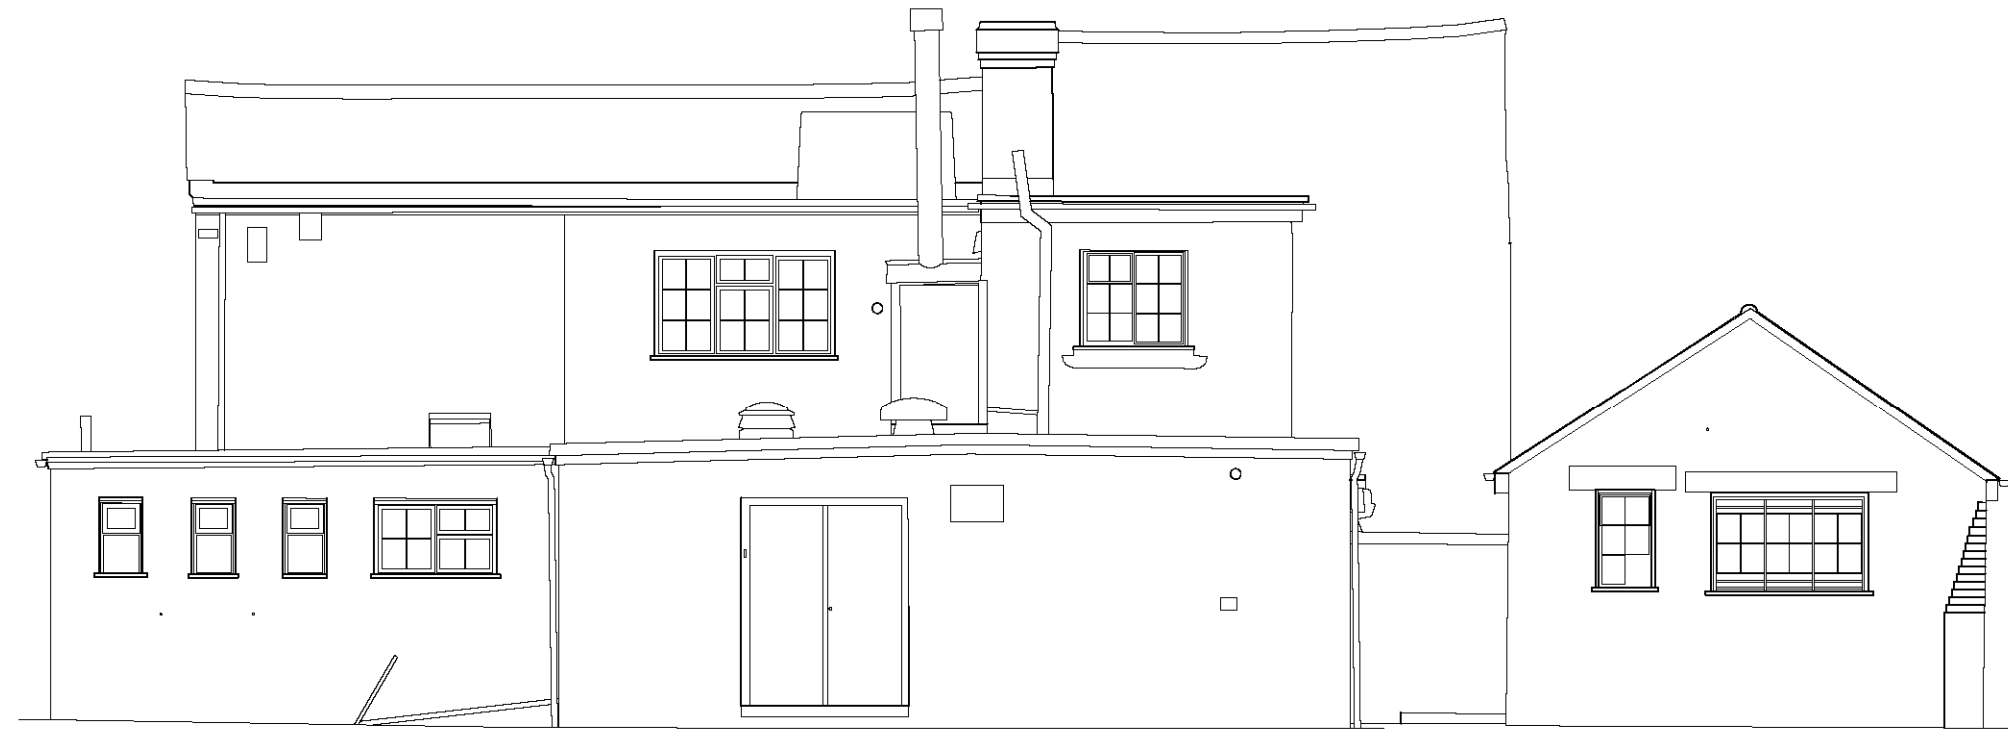
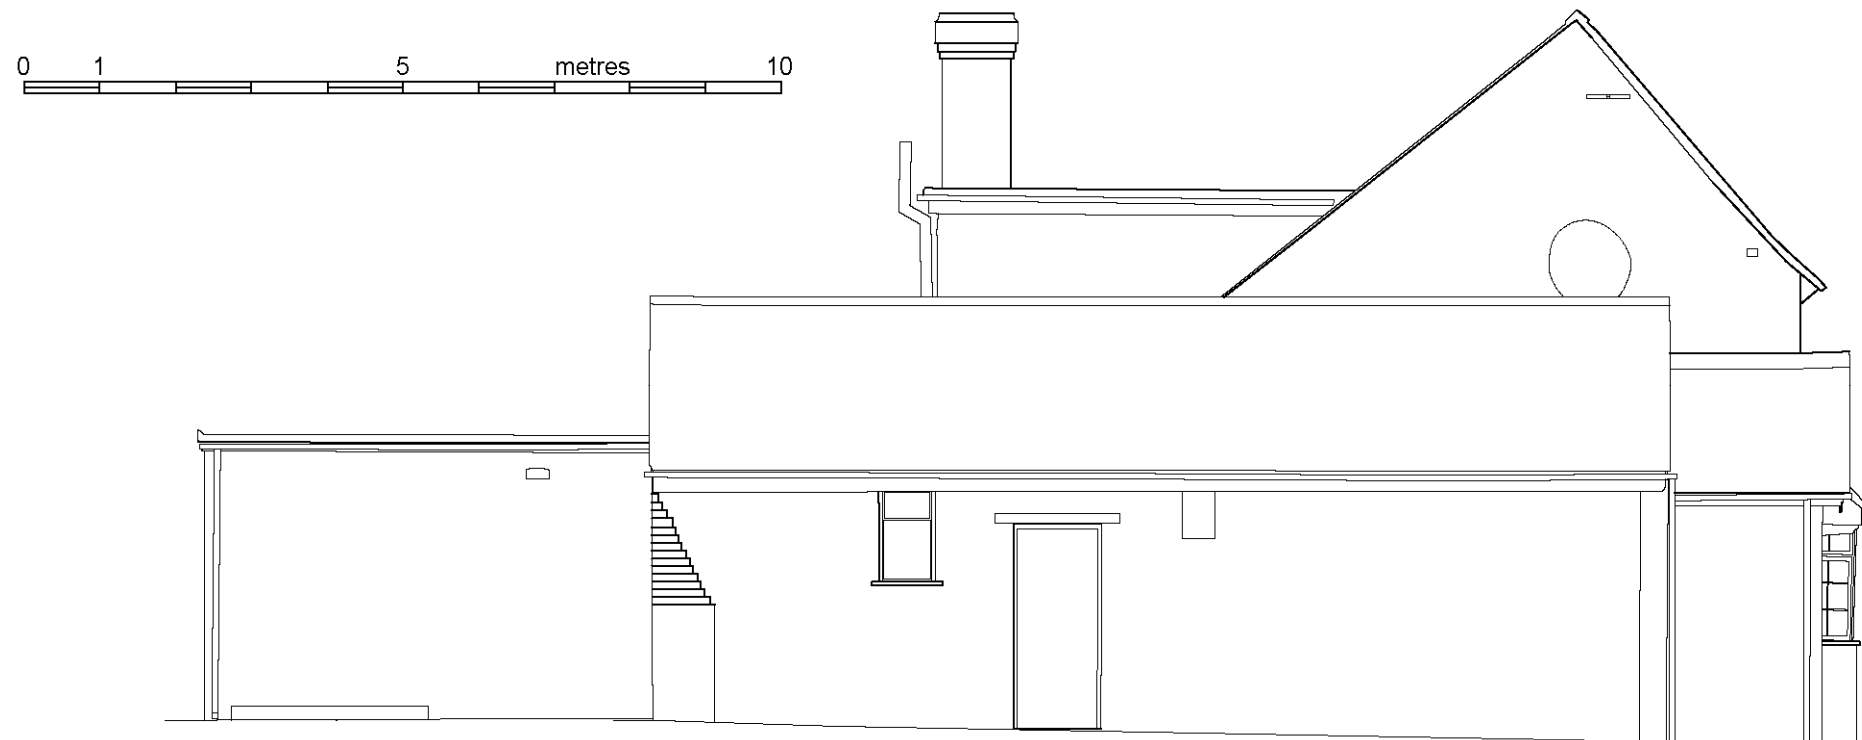
Figure 11: West and south elevations (scale 1:100)

4.4 *West Elevation* (Fig. 11, Plates 4-6)

4.5 *South Elevation* (Fig. 11)

The south elevation of the main building is blank, but the southern range has a door and a window at the western end.

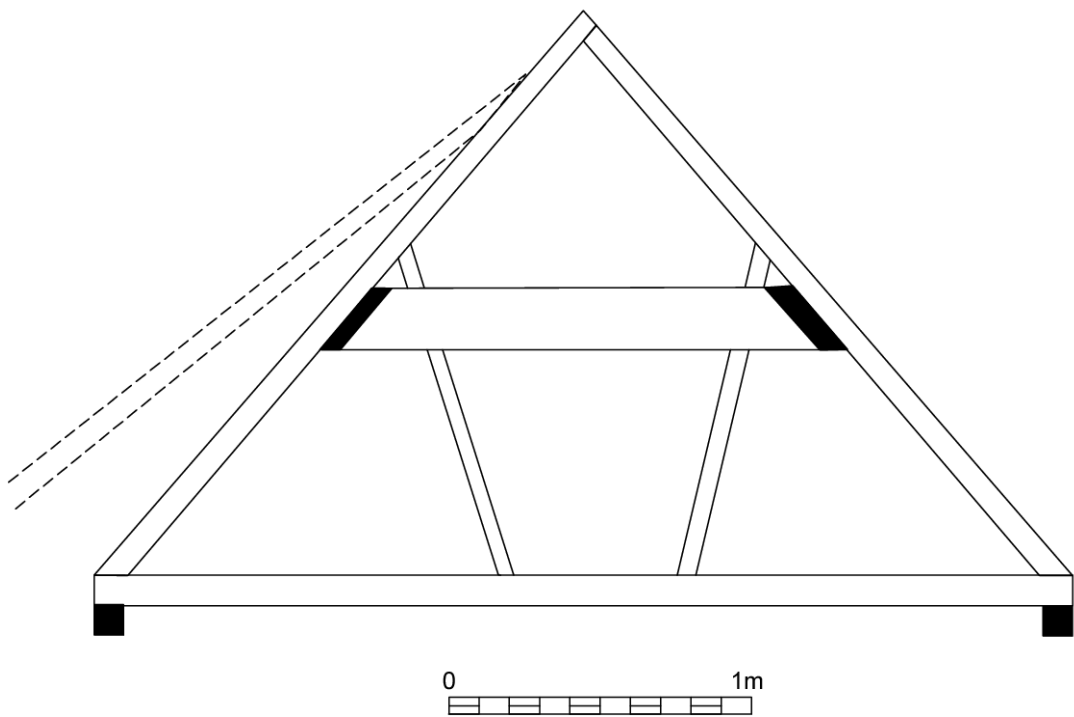
Figure 19: Schematic drawing of a roof truss looking north (*scale 1:25*)

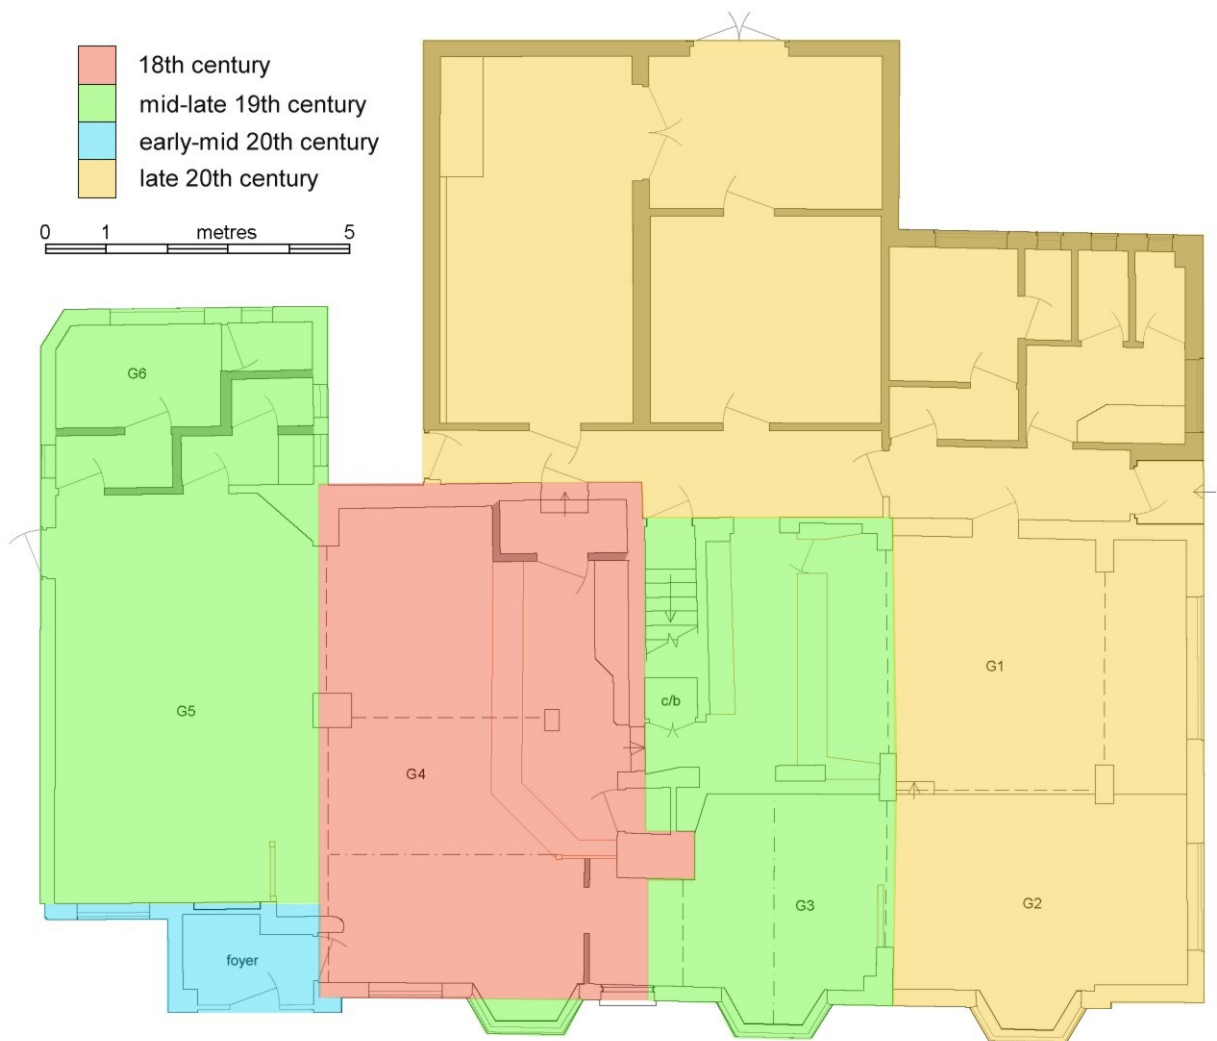
Figure 20: Suggested phasing (scale as shown)

- 5.6 Some time in the first half of the 20th century, the southern extension ceased its original use, and became a part of the public house. Its east end was rebuilt, removing

the double doors, and a small extension with a canted bay window was constructed. This was subsequently converted to an entrance porch and lobby, and the original entrance was converted to a window. At the rear of the building, the flat-roofed first-floor extensions containing Rooms F3 and F8 are probably of early-mid 20th-century date. Between 1960 and 1977 *The Cross* was subject to significant alterations and additions. A further two-storey bay in Fletton brick, with a canted bay window, was added at the north end of the existing structure, along with a narrow flat-roofed single-storey extension (possibly a slightly later event). A much larger flat-roofed single-storey extension was constructed to the rear of the building. During this period, it is likely that any surviving internal partitions at ground-floor level were removed to maximise the bar areas. Because of the extent of remodelling to the interior, no historic features or fittings relating to the original cottage or the public house remain.
