**TEST PITS:  
BELTON ROAD,  
BERKHAMSTED,  
HERTFORDSHIRE**

*on behalf of Hightown Praetorian Churches Housing Association Ltd*

**December 2004**

**ASC: 633/BBR/2**

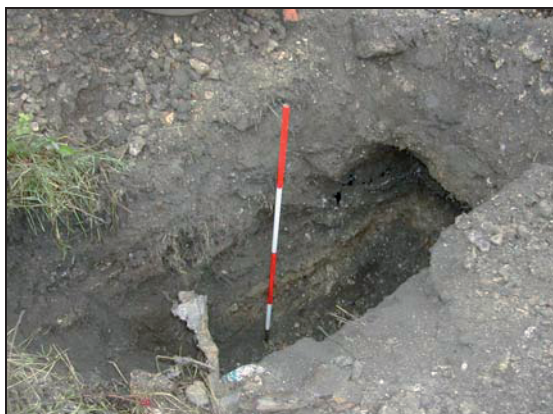
**Plate 1:** Test pit 1 looking north

*Description:* The upper 1.2m was made up of dark, loose gravely soil containing many small animal bones (Plate 1). Below this were the natural gravels of the valley bottom.

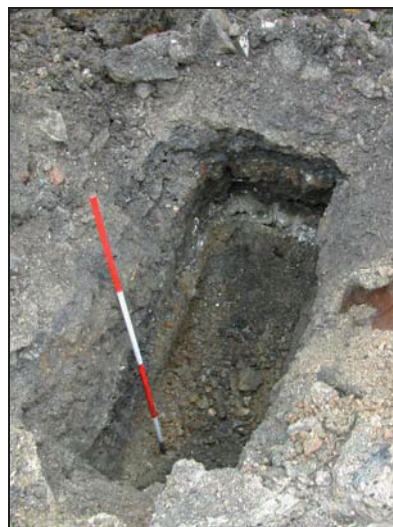
**Plate 2:** Test pit 2 looking north

*Description:* The upper 1.2m of ground consisted of a series of dumped layers (Plate 2). Below this the ground consisted of natural gravels.

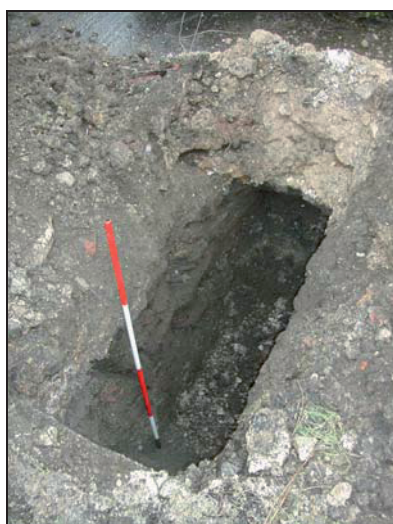
**Plate 3:** Test pit 3 looking north

*Description:* Down to a depth of 1.5m the ground consisted of land fill that contained much 20<sup>th</sup> century domestic rubbish (Plate 3). Below this the ground consisted of natural valley deposits (flinty gravels etc).

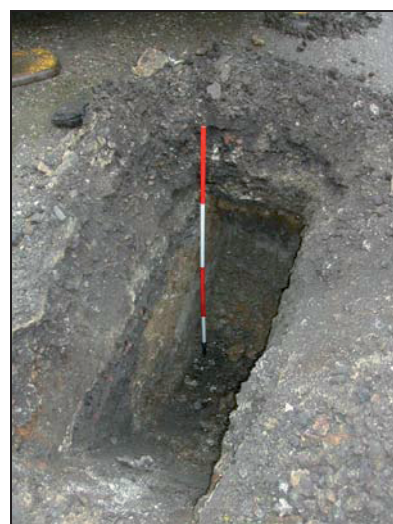
**Plate 4:** Test pit 4 looking north west

*Description:* There was about 1.5m of overburden consisting of several dumps of rubbish and re-deposited clay (Plate 4). Below this the ground was made up of grey alluvium overlying mixed natural gravels.
