**WATCHING BRIEF:
BEACHENDON FARM
EYTHORPE, NEAR STONE
BUCKINGHAMSHIRE**

on behalf of the Waddesdon Estate

June 2004

ASC: 569/SBF/02

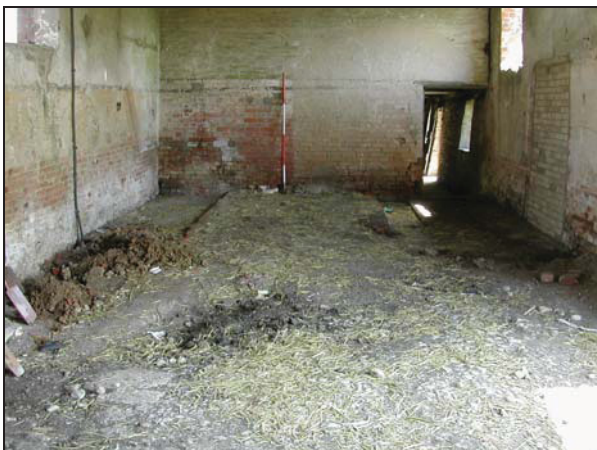
Plate 5: Detail of ground looking east

- 4.1 In order that the archaeology could be placed within the context of its setting a series of photographs were taken of the interior prior to the level being reduced (Plates 1-6). Much of the floor was recorded as found still partly obscured with straw and other detritus. The building had clearly been used for the stabling of cattle and the remains of concrete drainage channels could clearly be seen (Plates 3-5; see scaled sketch on reverse of sheet for June 7th in Appendix 1).

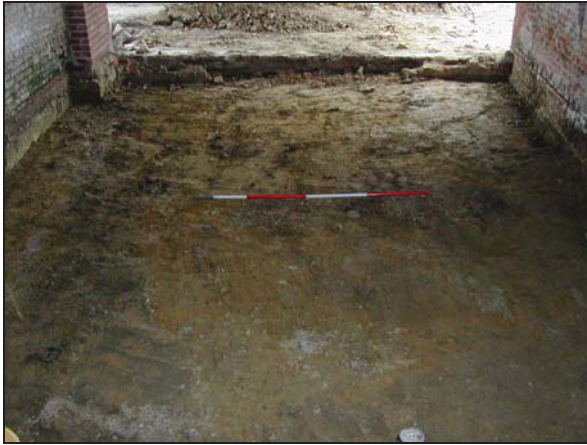
Plate 7: Reduced level of west end

- 4.3 The floor of the barn was reduced by approximately 0.5m in two stages. The eastern and western ends were excavated first and then the central portion. This revealed a series of drains on the northern and eastern ends of the barn (Appendix 1). The drains consisted of semi-circular tiles each 290mm wide (internal width of 230mm) and of unknown length. All ran into what appeared to be small brick built junctions (0.3m sq. approx). The drains all emptied on the down slope, i.e. south side. One of the drains cut an earlier N-S linear feature which was 0.86m wide and filled with a grey brown clay. A possibly even earlier feature lay on the north west side of the barn. It was filled by a darker clay. It was over 6m long and 0.4m wide. No dating was recovered,

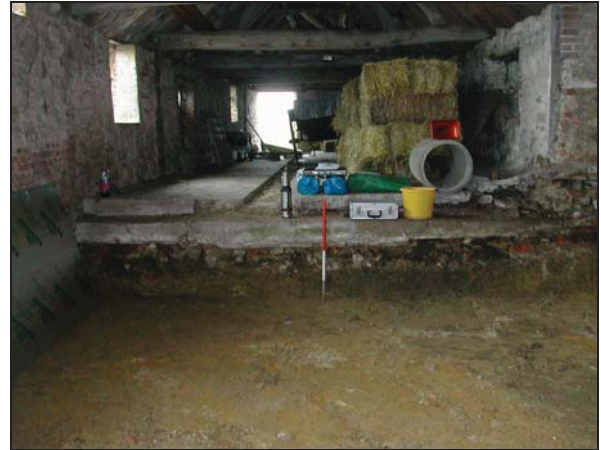
Plate 8: West section showing detail of excavated horizon

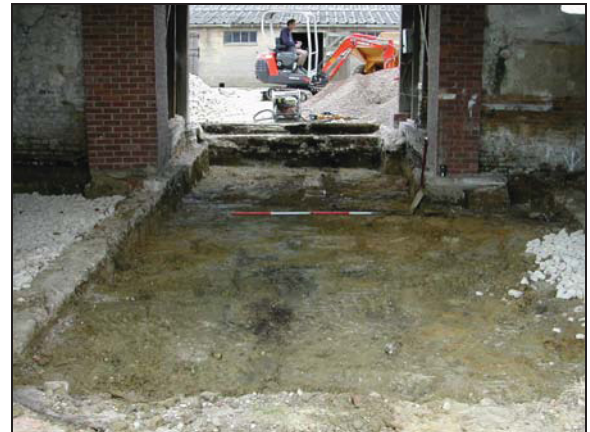
Plate 10 : Central reduced area

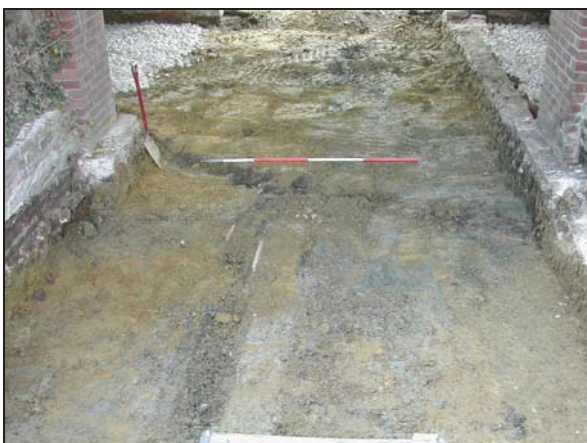
Plate 11: Detail of drains

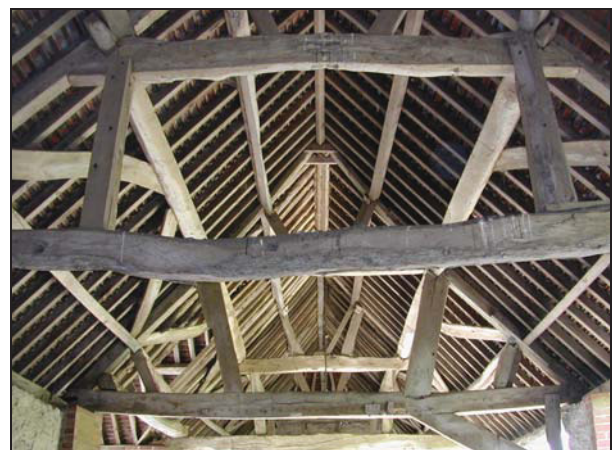
Plate 12: Detail of roof

- 4.2 The building was a five bay barn and had an internal measurement of 18.66m x 5.44m and 3.3m high to the eaves. There was a central N-S passage 4.2m wide, three blocked doorways and the whole structure rested on a brick base 1.14m high composed of reddish brown bricks (225mm x 114mm x 64mm). Above this were lain blocks of crudely cut limestone or cornbrash. There were four square windows (1.04m wide) and set 2.15m up from the floor. The walls were pierced by brick built air-vents on the south side of the barn.
