**WATCHING BRIEF:  
FENDLEY BARN  
COW ROAST  
HERTFORDSHIRE**

*on behalf of Guy Masters Esq*

**June 2004**

**ASC: 571/CRF/02**

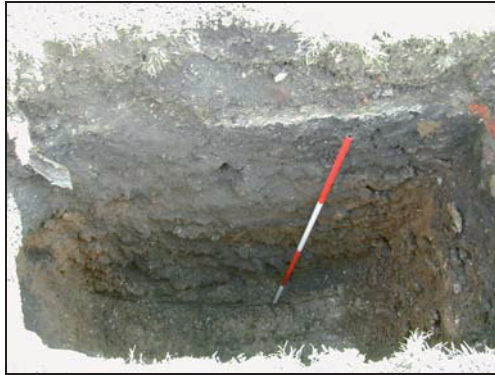
**Plate 1:** Section of the soakaway looking south west

- 4.3 The soakaway pit (Plate 1) was 1.8m x 1m x 2.4m deep and situated about 4m to the south east of the corner of the garage (see sketch on the reverse of the monitoring sheet). The upper 1 m was made up ground consisting of a combination of the original A-horizon and dumped material (dark ashy soil, brick fragments, polythene, flint, slate, iron nails and occasional glass frags. Beneath this was a very dark, yellowish brown clay (Mun: 10YR 4/6). At depth of 2m the ground turned to a light, yellowish brown chalky clay (Mun: 10YR 6/4).

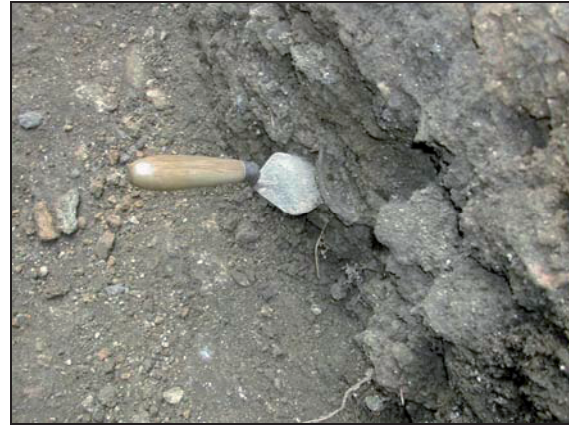
- 4.1 The foundations of the garage were about 0.5m wide and between 1.2m and 1.35m deep. Archaeological deposits were observed in the western, middle and southern foundations. The most extensive deposit was a layer of crushed chalk and flints [2] which lay 0.5m beneath a dark loam deposit [1]. It varied between 0.05m and 0.35m thick and was observed in the western section and extended about 3.6m across the middle foundation trench. A layer of pea-grit lay immediately on top of the chalky spread (*c.* 0.01m thick at maximum). It sealed a pit [7] which was 2.6m wide at the top and narrowed to about 1m at the base of the trench foundation. Three stratified horizons were observed: The upper fill [4] comprised a light brown gravelly clay, 0.08m thick This was followed by a dark grey silt [5] some 0.24m thick. The third horizon [6] was more chalk flecked but otherwise similar to [5] (see plates 3, 5, 6 & 8). The pit cut a light yellowish brown, chalky clay horizon (Mun: 10YR 6/4).

**Plate 8:** East facing section of N-S foundation with pot sherd in situ

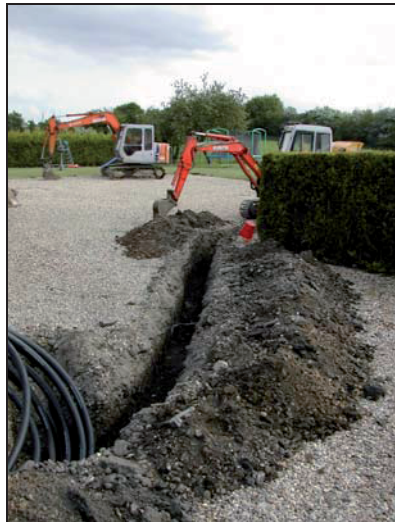
**Plate 9:** Service trench looking south

- 4.4 The service trench was 0.4m wide by about 0.6m deep. It was cut into dark soil but nowhere were any archaeological horizons identified (Plate 9).

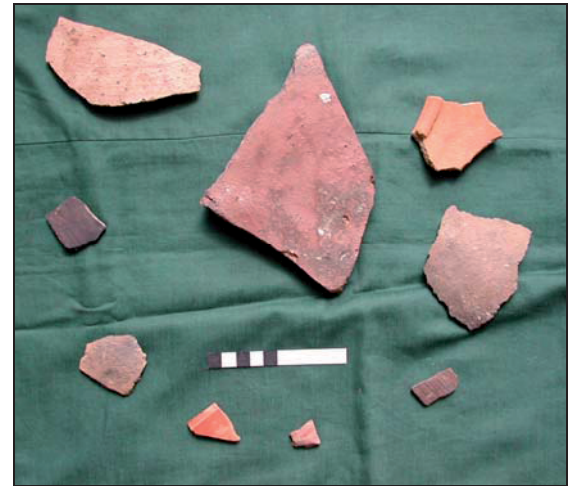
**Plate 10:** The finds

- 4.2 In the southern most foundation trench another possible pit was observed. This was *c.* 2.2m wide and had a darker fill than the surrounding natural soil. A piece of thin Roman brick/tile was observed together with a 2<sup>nd</sup> century coarse, reddish brown ware beaker (Plate 10).

- 4.5 Fragments of pottery, including Samian and amphora, bone, fragments of building material were recovered and a small piece of iron slag was noted but not retrieved. See appendix 1 for a more detailed description.
