### **ARCHAEOLOGICAL EVALUATION: THE RECTORY, STEEPLE ROW, LOUGHBOROUGH**

*on behalf of Andrew Granger & Co*

**September 2004**

**ASC: 574/LSR/03**

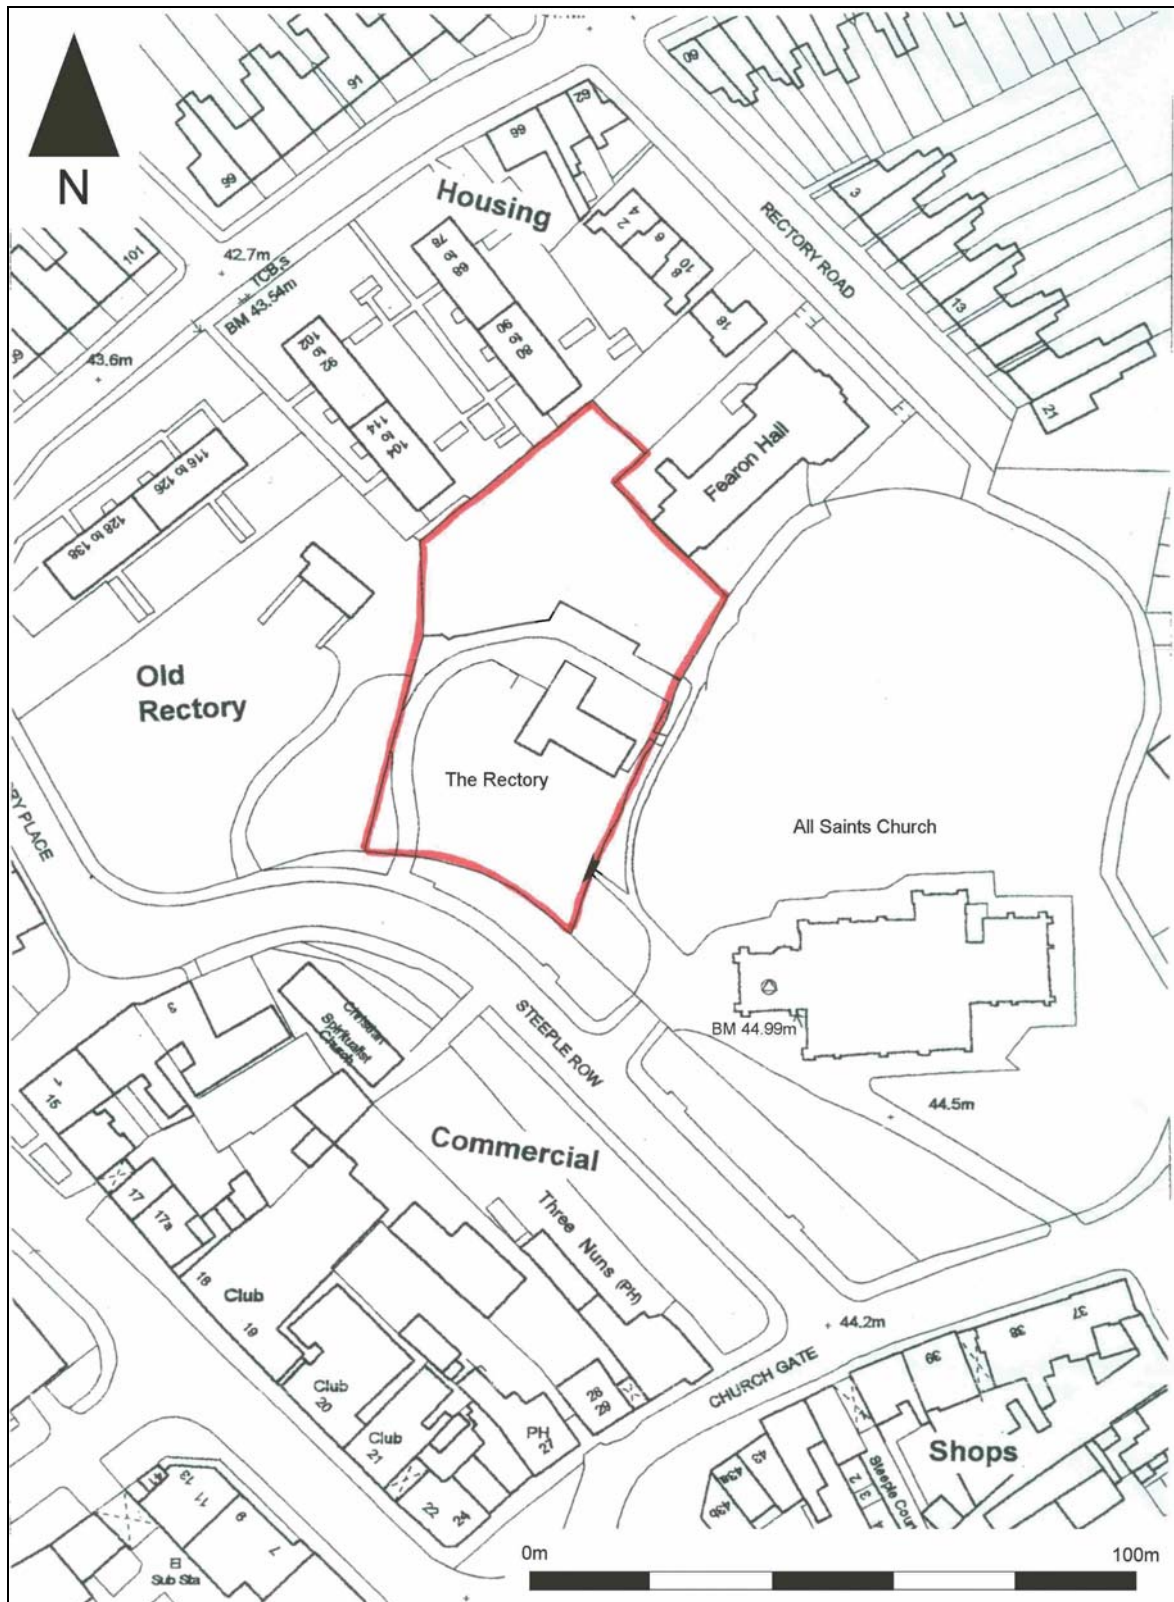
**Figure 2:** Site plan (scale 1:1,250)

The site covers an area of c.0.17 ha and comprises a building known as The Rectory and the surrounding grounds. It comprises an irregular area bounded by the churchyard to the southeast, Fearon Hall to the northeast, a housing estate to the northwest and Steeple Row to the southwest (Fig. 2).

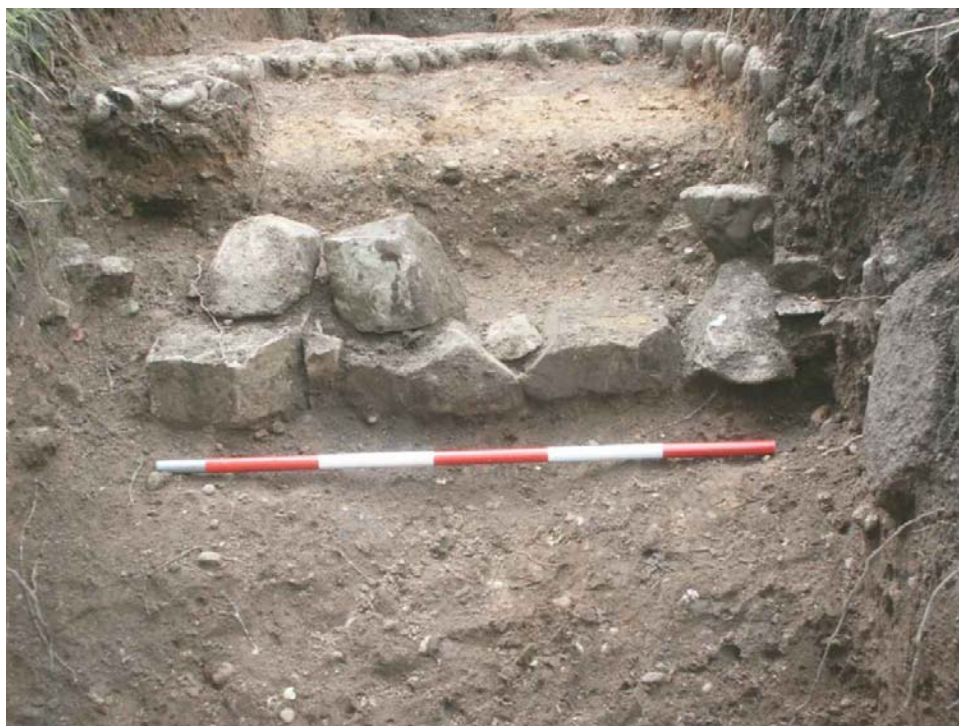
**Plate 1:** Wall foundation (105), Trench 1

A pathway aligned north west to south east traversed the south western part of the trench (103)(Plate 2). Measuring 1.3m in width, the pathway consisted of a 0.05m thick layer of rammed pebbles. On its north east side it was flanked by a wall foundation surviving as two courses of undressed limestone blocks (105)(Plate 1). The south west edge of (103) was bounded by (104) a line of four limestone blocks set in a mortar base. Sealing both the wall and pathway was a compacted sand and gravel levelling layer (102) that was in turn sealed by the topsoil (101). A hand-excavated slot to the south west of the pathway (Plate 3) revealed a probable modern machine cut service trench [107] that truncated another partial cobbled surface (108) possibly representing an earlier pathway. A mortar and brick rubble filled robber trench [118] and dumped deposits containing 19<sup>th</sup> / 20<sup>th</sup> century pottery were also revealed.

- 5.3 Trenches 1 and 2 also revealed a north west to south east aligned cobbled pathway (103) with a wall foundation (105) on its north east edge, in addition to an earlier possible cobbled surface in trench 1 (108) much truncated by later modern activity. The alignment and location of both the wall foundation and the pathway coincide well with the southern boundary to the Old Rectory marked on the 1837 plan (Fig. 4) and on all the subsequent maps up to the 1921 OS sheet (Fig. 5) (Fell 2004). This boundary is not apparent on the earlier 1735 plan (Fig. 3) or the 1962 OS sheet (Fig. 6) where the modern Steeple Row has been laid out. Clearly the wall and pathway are late 18<sup>th</sup> century to early 19<sup>th</sup> century in date and respectively formed and followed the boundary marked on the 19<sup>th</sup> and earlier 20<sup>th</sup> century plans.

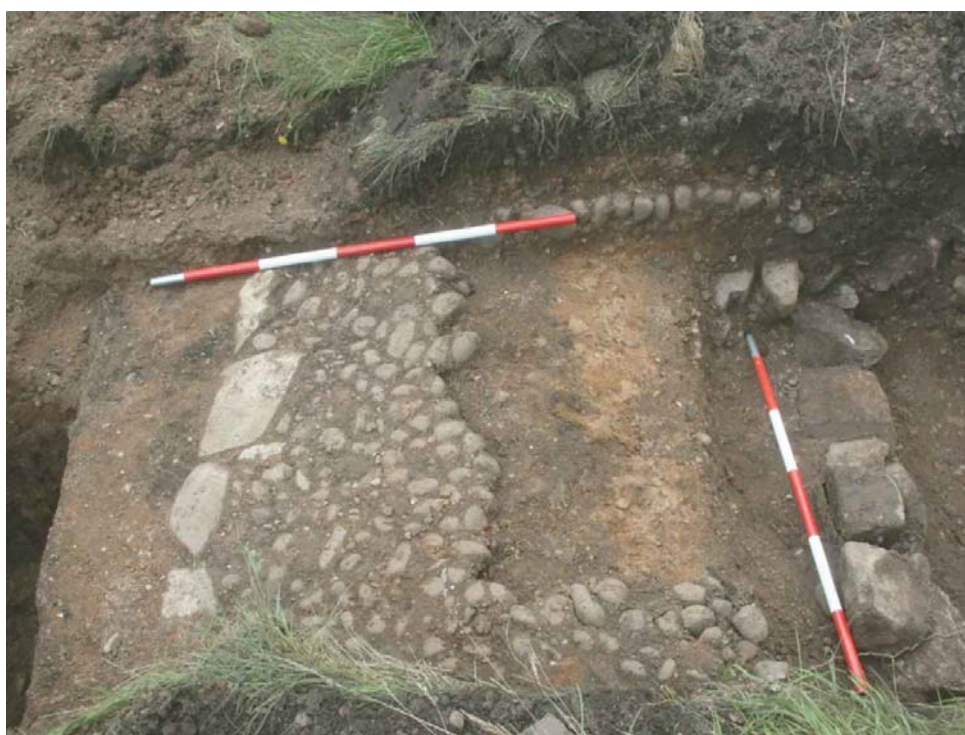
**Plate 2:** Pathway (103) and wall (105), Trench 1

The continuation of the north west to south east aligned pathway (103) observed in trench 1 was revealed at the southern end of the trench, but was much truncated by the presence of a modern quarry pit to the north and a modern soakaway to the south. In addition two modern service pipes ran through the centre of the heavily truncated cobbled surface.

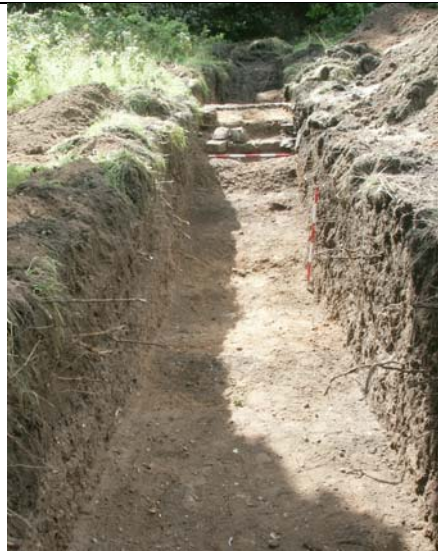
Trench 1

Max Dimensions						
	Length	19.0m	Width	1.6m	Depth	1.5m	
	Levels						
	Trench base north east			43.85m OD			
	Trench top north east			45.04m OD			
	Trench base south west			43.81m OD			
	Trench top south west			45.51m OD			
	NGR Co-ordinates						
	NE	SK 53761 19972		SW	SK 53752 19954		
	Orientation			North east to south west			
	Reason for Trench			General evaluation			
Context	Type	Description and Interpretation			Max Width (mm)	Max Thckn (mm)	Depth BGL (mm)
100	Layer	Natural – Mid brownish orange soft sand with moderate patches of flint gravel					>1500
101	Layer	Topsoil - Dark brown loose sandy loam				400	0-400
102	Layer	Levelling – Compacted sand and gravel			>1600	200	
103	Surface	C 19 <sup>th</sup> cobbled pathway			1300	50	
104	Curb	Line of stones on SW edge of (103)			200	200	
105	Wall	Roughly coursed foundation, NE of (103)			300	400	
106	Fill	Orangey brown silty clay/sand fill of [107]			1000	>1200

107	Trench?	Probable machine cut service trench			1000	>1200	
108	Surface?	Truncated possible earlier pebbled surface			400	100	
109	Layer	Modern dumped deposit			600	500	
110	Layer	Modern dumped deposit			400	500	
111	Fill	Mortar/brick rubble fill of [118]			1000	450	
112	Layer	Modern dumped deposit			4000	150	
113	Layer	Disturbed natural sand			4000	200	
114	Layer	Sand base for (103)			1300	50	
115	Layer	Modern dumped deposit			10000	600	
116	Layer	Disturbed natural sand			10000	150	
117	Surface?	Possible later clinker pathway above (103)			2000	50	
118	Robber trench	Cut of modern robber trench containing (111)			1000	450

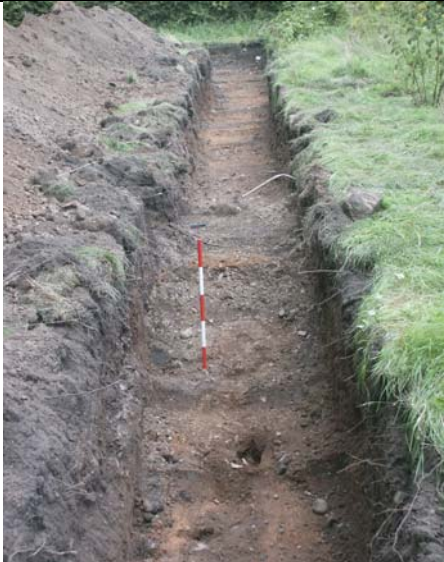
Trench 2

Max Dimensions					
	Length	25.0m	Width	1.6m	Depth	1.29m
	Levels					
	Trench base north north east			43.70m OD		
	Trench top north north east			44.86m OD		
	Trench base south south west			43.70m OD		
	Trench top south south west			44.99m OD		
	NGR Co-ordinates					
	NNE	SK 53744 19986		SSW	SK 53740 19962	
	Orientation			North north east to south south west		
Reason for Trench			General evaluation			
Context	Type	Description and Interpretation			Max Thckn (mm)	Depth BGL (mm)
200	Layer	Topsoil – Dark brown loose sandy loam			700	0-700
201	Layer	Modern dumped deposit – Mid to light brown loose silty sand with frequent modern brick and masonry rubble			800	700-1250
202	Layer	Natural – Mid brownish orange soft sand with moderate patches of flint gravel				>1250

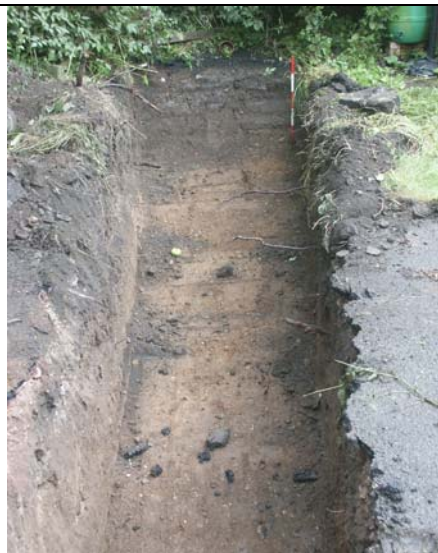
Trench 3a

Max Dimensions					
	Length	8.0m	Width	1.6m	Depth	1.18m
	Levels					
	Trench base north west			43.65m OD		
	Trench top north west			44.83m OD		
	Trench base south east			43.84m OD		
	Trench top south east			44.84m OD		
	NGR Co-ordinates					
	NW	SK 53762 19993		SE	SK 53768 19989	
	Orientation			North west to south east		
Reason for Trench			General evaluation			
Context	Type	Description and Interpretation			Max Thckn (mm)	Depth BGL (mm)
300	Layer	Topsoil - Dark brown loose sandy loam			330	0-330
301	Layer	Subsoil - Mid to light brown loose silty sand			620	330-950
302	Layer	Natural - Mid brownish orange soft sand with moderate patches of flint gravel				>950

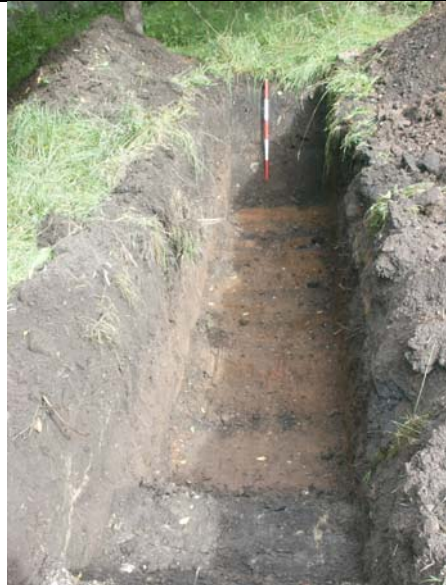
Trench 3b

Max Dimensions					
	Length	7.0m	Width	1.0m	Depth	1.09m
	Levels					
	Trench base east			43.60mOD		
	Trench top east			44.69m OD		
	Trench base west			43.69m OD		
	Trench top west			44.76m OD		
	NGR Co-ordinates					
	E	SK 53755 19997		W	SK 53747 19996	
	Orientation			East to west		
Reason for Trench			General evaluation			
Context	Type	Description and Interpretation			Max Thckn (mm)	Depth BGL (mm)
350	Layer	Topsoil - Dark brown loose sandy loam			430	0-430
351	Layer	Subsoil - Mid to light brown loose silty sand			540	430-970
352	Layer	Natural - Mid brownish orange soft sand with moderate patches of flint gravel				>970
