### **WATCHING BRIEF: MANOR FARM SOUTH STOKE, OXFORDSHIRE**

by  
**David Fell BA MA MIFA**

**July 2004**

**ASC: 579/SSM/2**

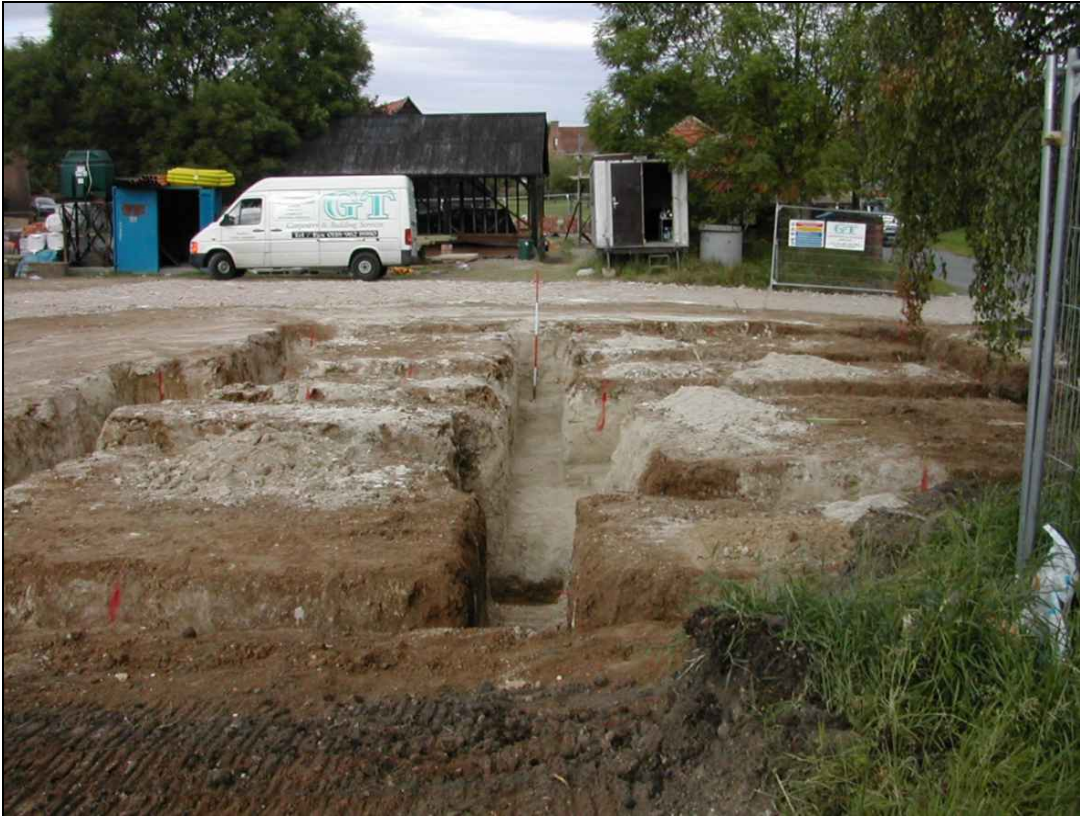
**Plate 3:** Foundation trenches of Plot 1 after excavation

- 4.3 The foundation trenches were generally c.0.9m wide and 1.2m deep and were generally cut into undisturbed natural strata. The natural strata had been disturbed in a number of localised areas, notably on the east side of Plot 1 where the trench was 2.2m deep. A larger area of disturbance was observed in the central part of Plot 3 and the trenches were up to 2.1m deep in this area. This disturbance was the result of a modern cut feature, probably a cellar or sunken floored area of the former agricultural buildings. It had been backfilled with obviously modern unconsolidated rubble, including wire cables. A tree bole was observed in Plot 3, but no significant archaeological remains were observed in any of the three plots.

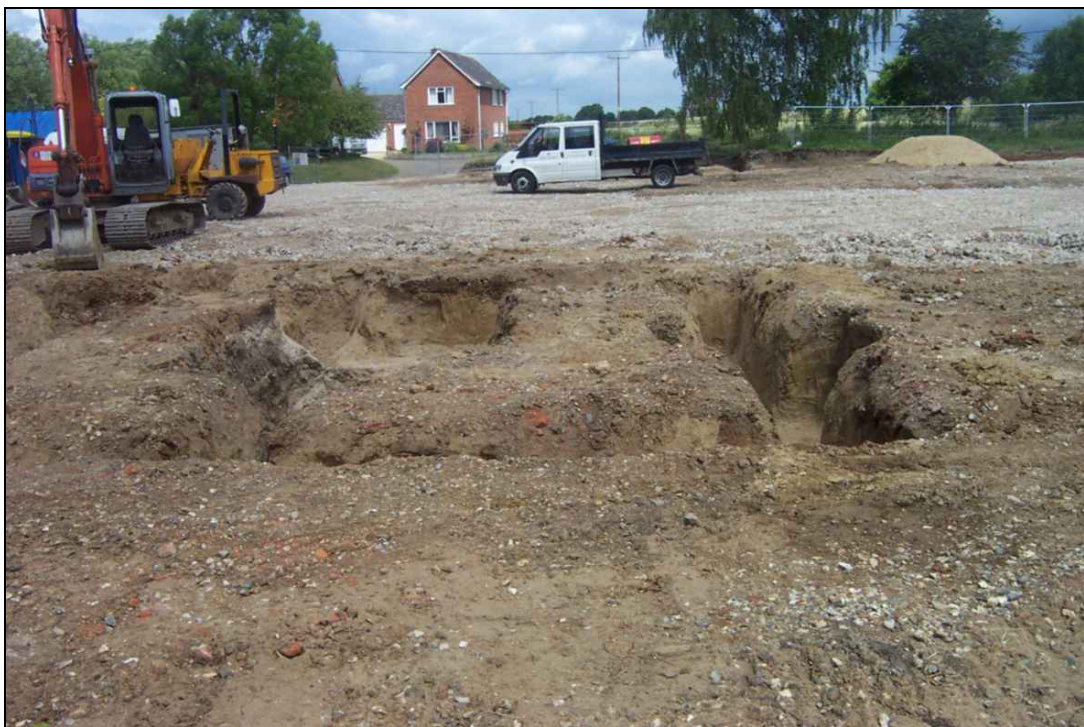
**Plate 4:** Foundation trenches of Plot 3 after excavation

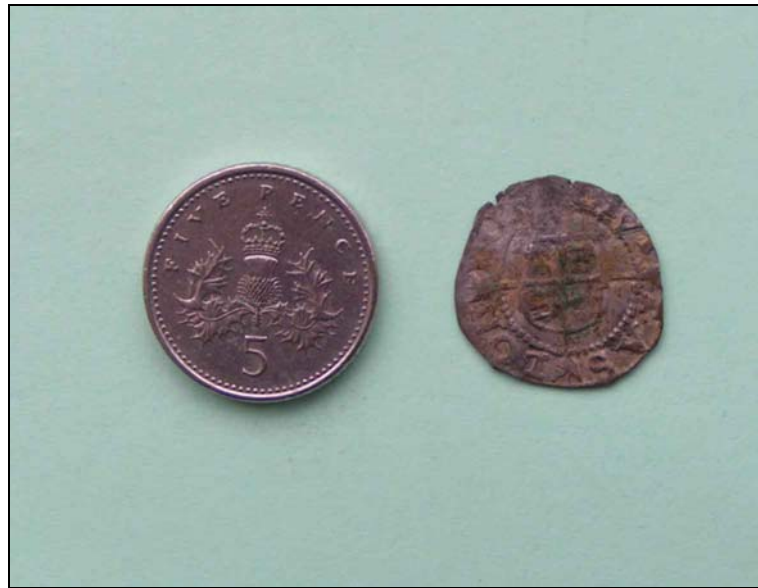
**Plate 5:** Base silver penny of Edward VI (reverse)

- 4.4 A hammered silver coin was found within the footprint of Plot 1 (Plates 5 and 6). It was a stray find, on the surface and not within an archaeological context and has been identified as a base silver penny of Edward VI (1547-1553).

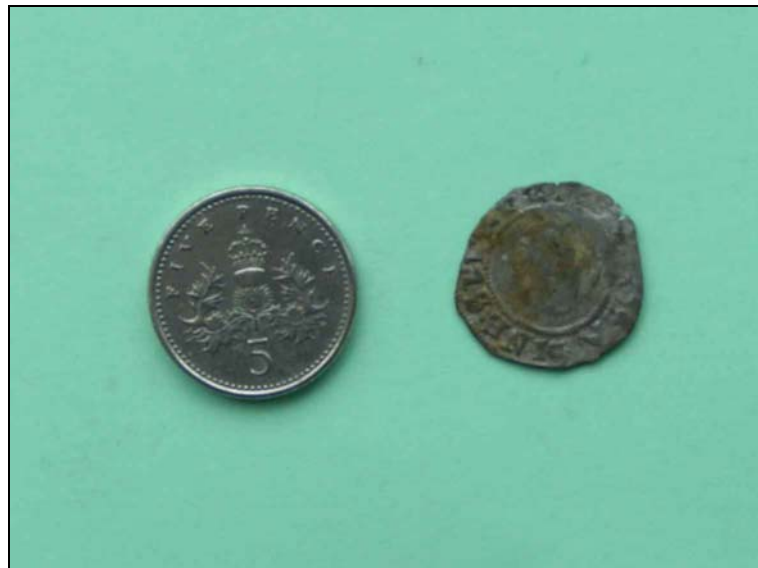
**Plate 6:** Base silver penny of Edward VI (obverse)
