**ARCHAEOLOGICAL EVALUATION:  
ACOUSTIC BUNDING,  
OLD LINSLADE MANOR  
OLD LINSLADE, BEDFORDSHIRE  
(SOUTH SIDE)**

*on behalf of  
Thomas Bros Excavations (Luton) Ltd*

**July 2004**

**ASC: OLM/02**

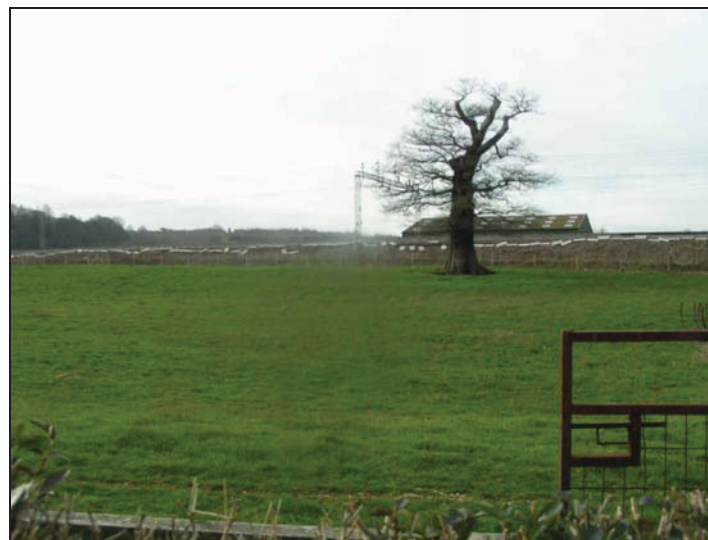
**Plate 2:** View looking west

1.5.1 The site lies on a west-facing slope at *c.*95m AOD above the floodplain of the river Ouzel, which flows in a northerly direction, *c.*0.5km to the east. A number of minor irregular undulations/earthworks are present, notably in the northern part of the site (Plates 2 and 3).

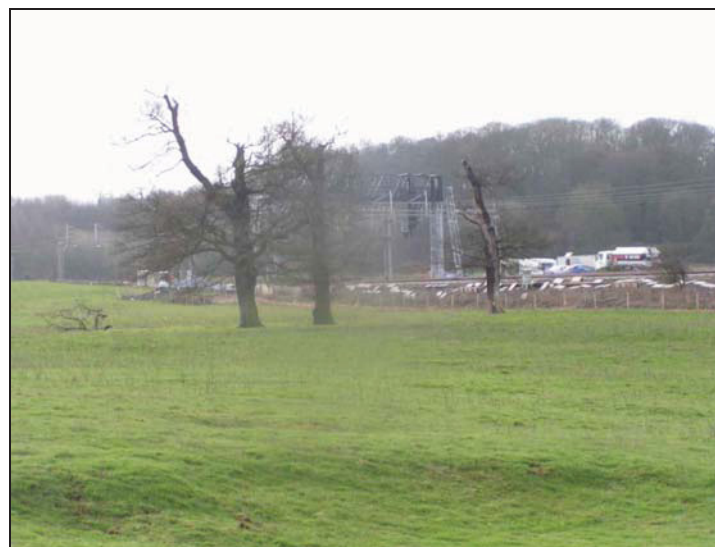
**Plate 3:** View looking southwest

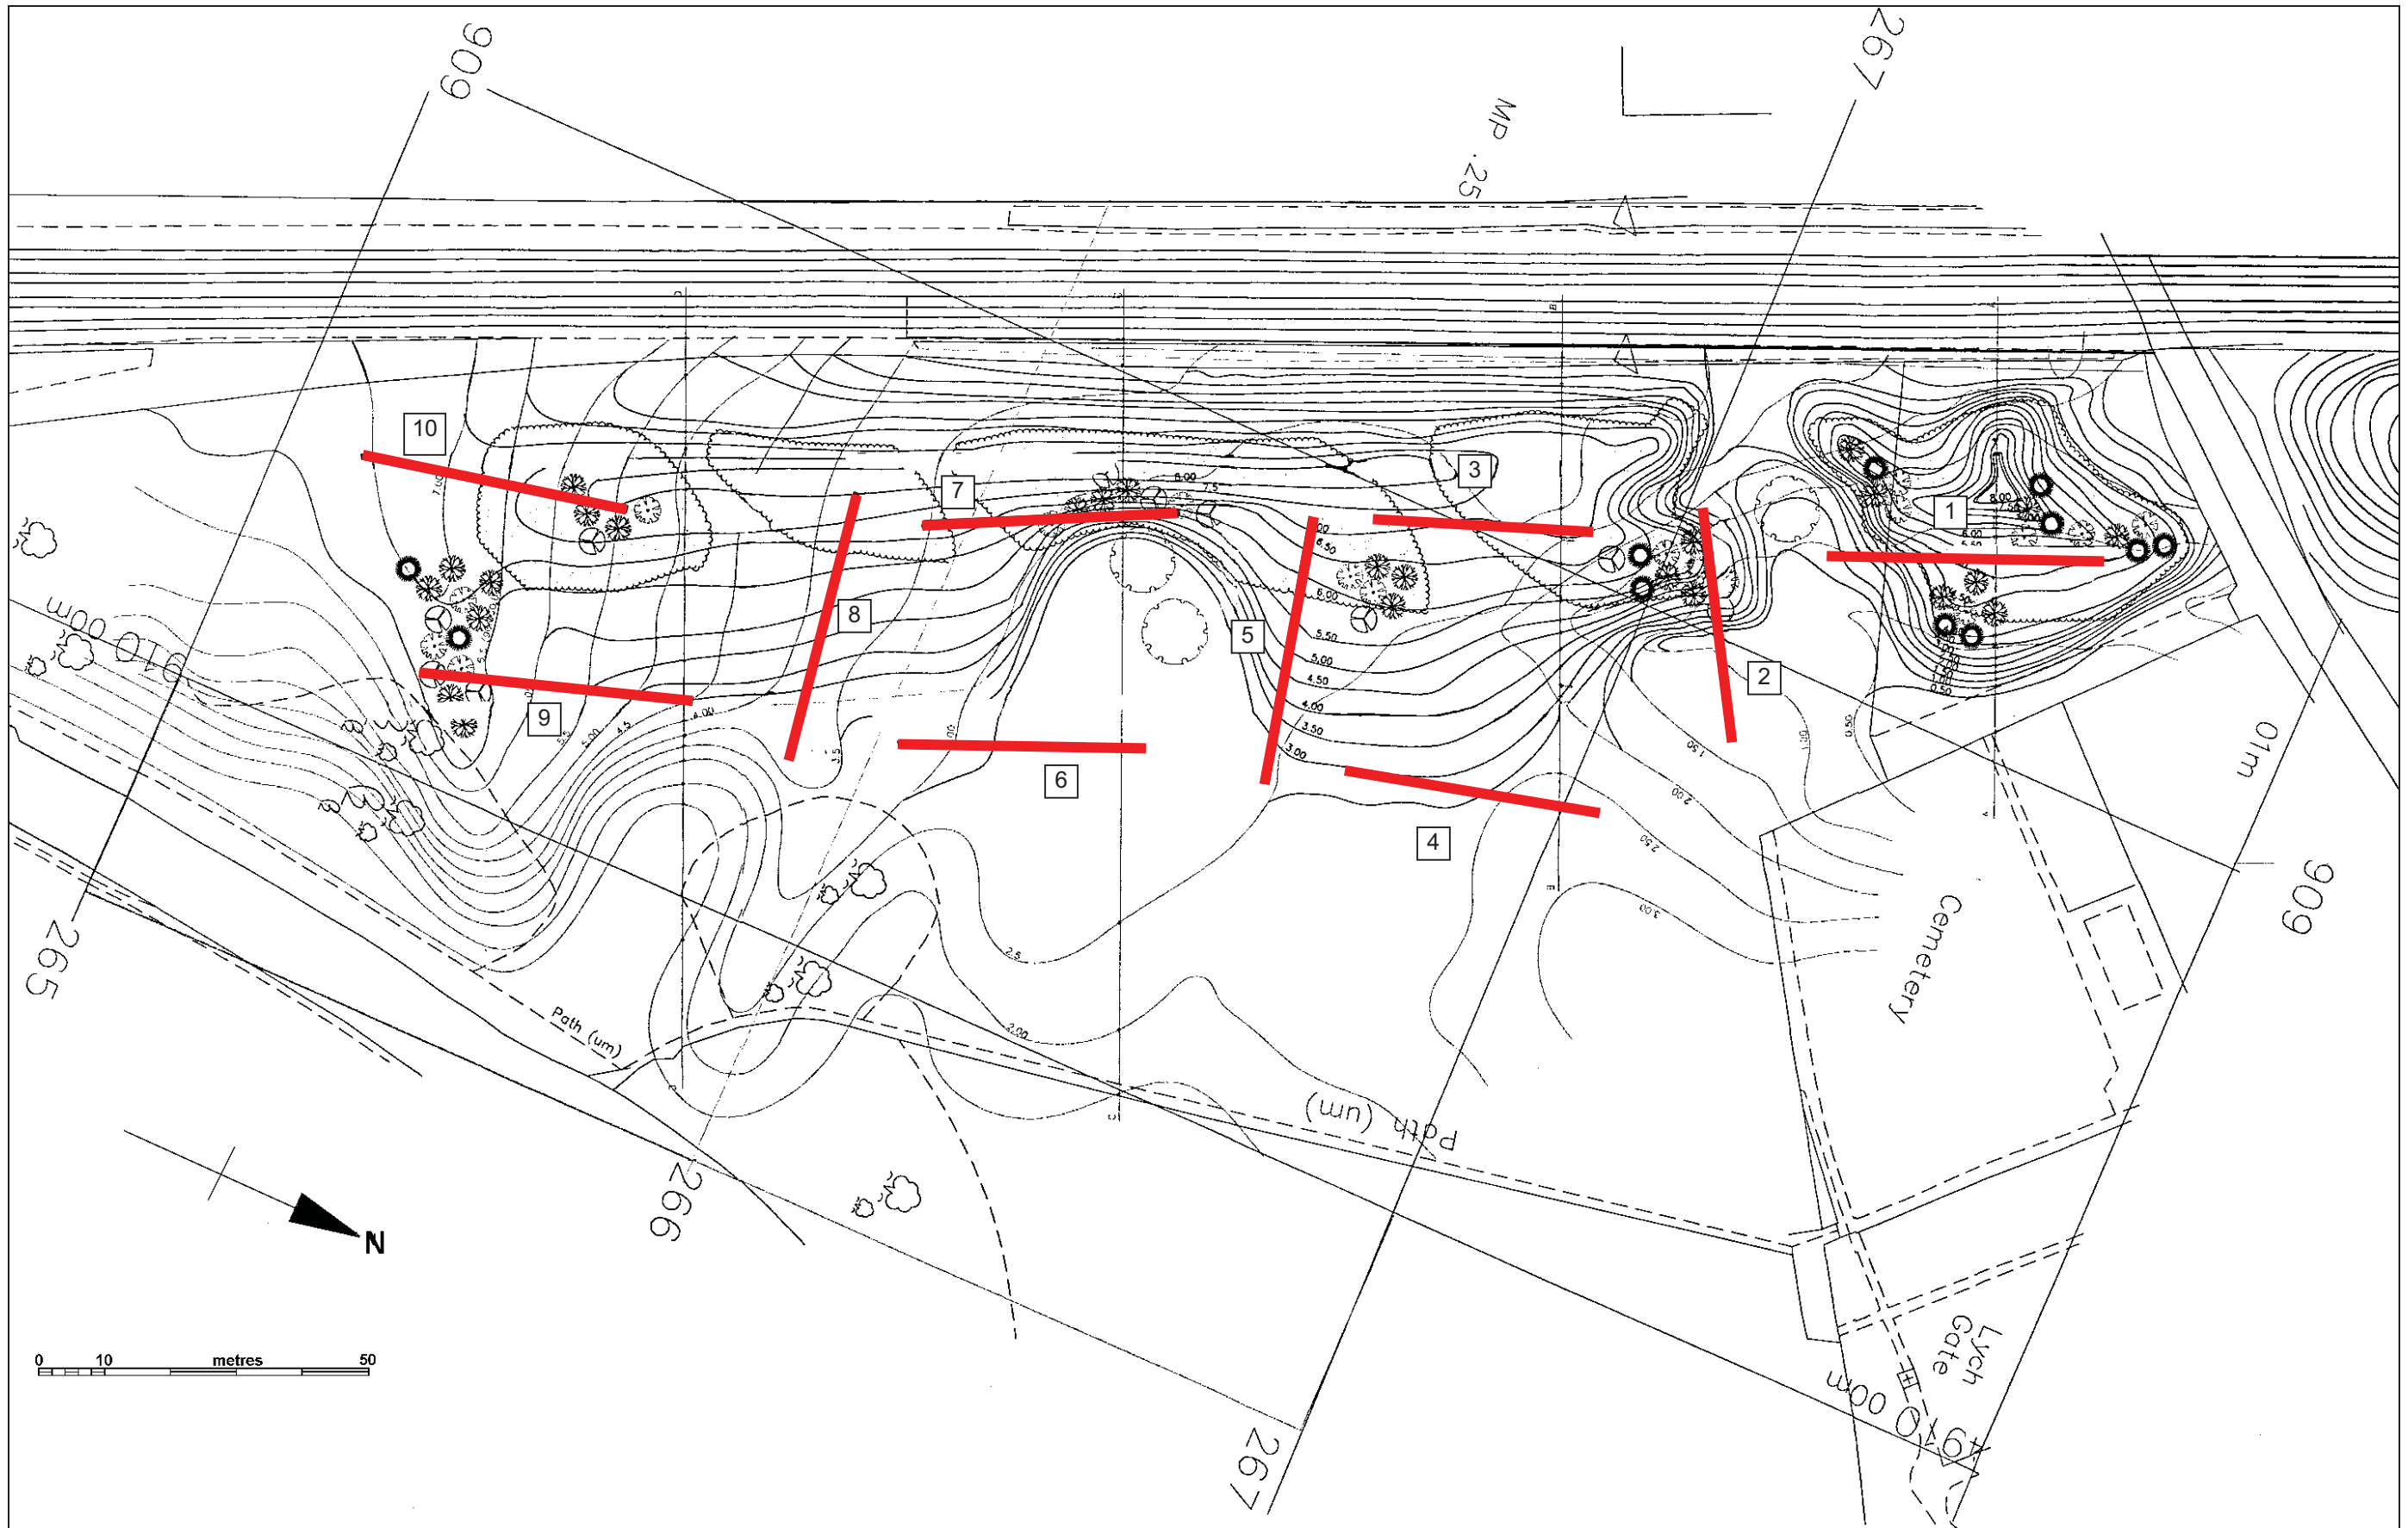
Figure 3: Trench locations (scale 1:1,000)

No archaeological features or finds were revealed during the fieldwork and the trenches revealed a consistent pattern of soil formation. The topsoil comprised loose grey silty clay, with a thick growth of roots. No separate subsoil layer was present and the soil was relatively shallow. The soil in the northern trenches was generally *c.*0.3m deep. It became marginally thinner towards the southern part of the area, and was 0.25m thick in Trenches 6, 9 and 10.

4.3 Greyish orange sand was revealed beneath the topsoil. It was relatively soft and contained occasional lenses of natural gravel and is interpreted as the natural strata.

- Archaeological trial trenching, up to a maximum of 5% of the area of development
- The trench locations are shown in Fig 3. The trench pattern was set out in order to achieve an even and adequate coverage of the site, as required in the *brief* (para. 5.6.3). A number of minor errors were noted on the official design drawings, principally in relation to trees and boundary fences, which are reflected in the final trench layout
- the trenches were excavated under archaeological supervision, with a mechanical excavator, fitted with a toothless bucket 2.2m wide.

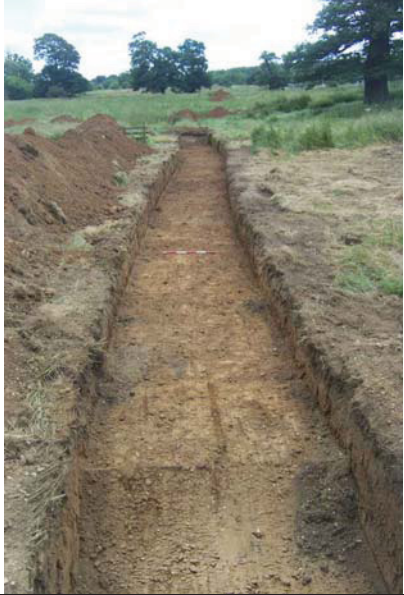
<b>Trench 1</b>

<b>Max Dimensions</b>					
	<b>Length</b>	38.94m	<b>Width</b>	2.2m	<b>Depth</b>	0.75m
	<b>Levels</b>					
	<b>Trench base north</b>		m OD			
	<b>Trench top north</b>		m OD			
	<b>Trench base south</b>		m OD			
	<b>Trench top south</b>		m OD			
	<b>NGR Co-ordinates</b>					
	<b>N</b>	SP 90864 26761	<b>S</b>	SP 90881 26723		
	<b>Orientation</b>		North to south			
<b>Reason for Trench</b>		General evaluation				
<b>Context</b>	<b>Type</b>	<b>Description and Interpretation</b>	<b>Max Width (mm)</b>	<b>Max Thckn (mm)</b>	<b>Depth BGL (mm)</b>	
100	Layer	Turf and loose grey silty clay. Topsoil	-	300	-	
101	Layer	Orange sand with pockets of gravel. Natural strata	-	450+	300

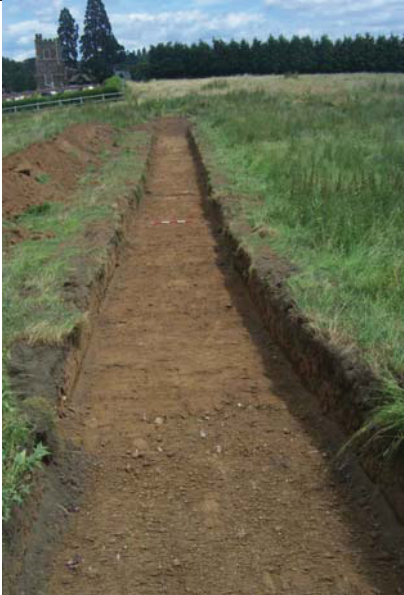
<b>Trench 2</b>

<b>Max Dimensions</b>					
	<b>Length</b>	36.80m	<b>Width</b>	2.2m	<b>Depth</b>	0.65m
	<b>Levels</b>					
	<b>Trench base north</b>		m OD			
	<b>Trench top north</b>		m OD			
	<b>Trench base south</b>		m OD			
	<b>Trench top south</b>		m OD			
	<b>NGR Co-ordinates</b>					
	<b>E</b>	SP 90914 26720	<b>W</b>	SP 90882 66702		
	<b>Orientation</b>		East to west			
<b>Reason for Trench</b>		General evaluation				
<b>Context</b>	<b>Type</b>	<b>Description and Interpretation</b>	<b>Max Width (mm)</b>	<b>Max Thckn (mm)</b>	<b>Depth BGL (mm)</b>	
200	Layer	Turf and loose grey silty clay. Topsoil	-	300	-	
201	Layer	Greyish orange sand. Natural strata	-	350+	300

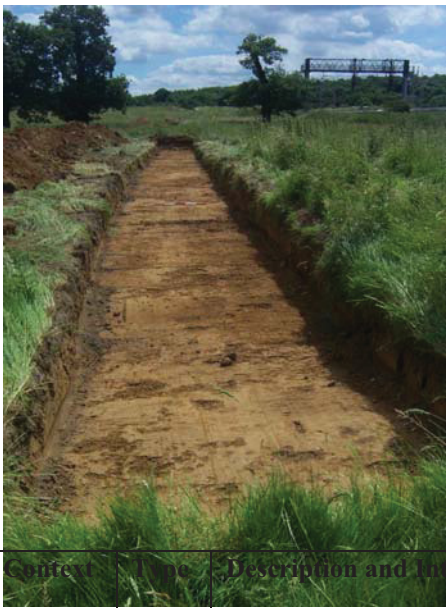
<b>Trench 3</b>					
<b>Max Dimensions</b>

<b>Max Dimensions</b>					
	<b>Length</b>	39.66m	<b>Width</b>	2.2m	<b>Depth</b>	0.5m
	<b>Trench base north</b>			m OD		
	<b>Trench top north</b>			m OD		
	<b>Trench base south</b>			m OD		
	<b>Trench top south</b>			m OD		
	<b>NGR Co-ordinates</b>					
	<b>N</b>	SP 90893 26688		<b>S</b>	SP 90904 26657	
	<b>Orientation</b>			North to south		
	<b>Reason for Trench</b>			General evaluation		
<b>Context</b>	<b>Type</b>	<b>Description and Interpretation</b>	<b>Max Width (mm)</b>	<b>Max Thckn (mm)</b>	<b>Depth BGL (mm)</b>	
300	Layer	Turf and loose grey silty clay. Topsoil	-	300	-	
301	Layer	Greyish orange sand. Natural strata	-	200+	300

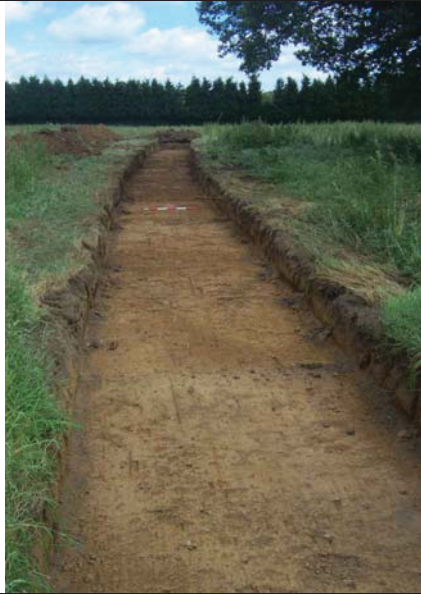
<b>Trench 5</b>

<b>Max Dimensions</b>					
	<b>Length</b>	39.16m	<b>Width</b>	2.2m	<b>Depth</b>	0.55m
	<b>Levels</b>					
	<b>Trench base north</b>		m OD			
	<b>Trench top north</b>		m OD			
	<b>Trench base south</b>		m OD			
	<b>Trench top south</b>		m OD			
	<b>NGR Co-ordinates</b>					
	<b>E</b>	SP 90949 26658		<b>W</b>	SP 90908 26649	
	<b>Orientation</b>			East to west		
	<b>Reason for Trench</b>			General evaluation		
<b>Context</b>	<b>Type</b>	<b>Description and Interpretation</b>	<b>Max Width (mm)</b>	<b>Max Thckn (mm)</b>	<b>Depth BGL (mm)</b>	
500	Layer	Turf and loose grey silty clay. Topsoil	-	300	-	
501	Layer	Greyish orange sand. Root disturbance at E end. Natural strata	-	250+	300

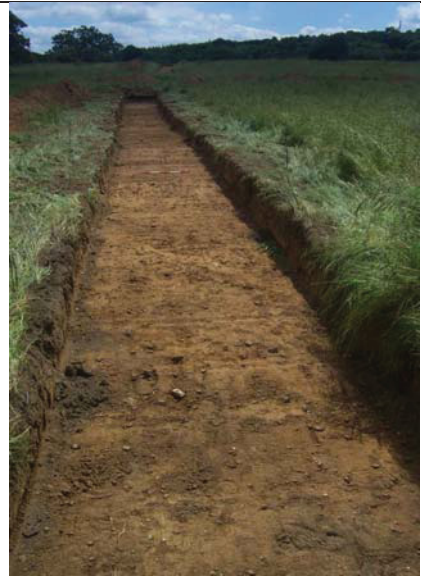
<b>Trench 6</b>

<b>Max Dimensions</b>					
	<b>Length</b>	39.99m	<b>Width</b>	2.2m	<b>Depth</b>	0.55m
	<b>Levels</b>					
	<b>Trench base north</b>		m OD			
	<b>Trench top north</b>		m OD			
	<b>Trench base south</b>		m OD			
	<b>Trench top south</b>		m OD			
	<b>NGR Co-ordinates</b>					
	<b>N</b>	90952 26640		<b>S</b>	90966 26604	
	<b>Orientation</b>			North to south		
	<b>Reason for Trench</b>			General evaluation		
<b>Context</b>	<b>Type</b>	<b>Description and Interpretation</b>	<b>Max Width (mm)</b>	<b>Max Thckn (mm)</b>	<b>Depth BGL (mm)</b>	
600	Layer	Turf and loose grey silty clay. Topsoil	-	250	-	
601	Layer	Greyish orange sand. Pocket of natural gravel in centre. Natural strata	-	300+	250

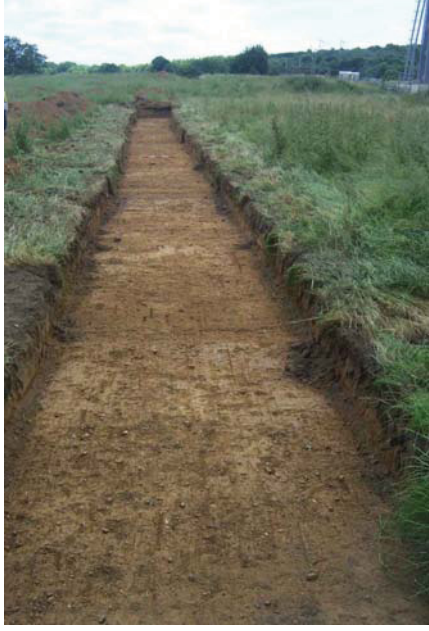
<b>Trench 7</b>

<b>Max Dimensions</b>					
	<b>Length</b>	40.04m	<b>Width</b>	0.6m	<b>Depth</b>	0.6m
	<b>Levels</b>					
	<b>Trench base north</b>		m OD			
	<b>Trench top north</b>		m OD			
	<b>Trench base south</b>		m OD			
	<b>Trench top south</b>		m OD			
	<b>NGR Co-ordinates</b>					
	<b>N</b>	SP 90916 26629	<b>S</b>	SP 90934 26597		
	<b>Orientation</b>		North to south			
	<b>Reason for Trench</b>		General evaluation			
	<b>Context</b>	<b>Type</b>	<b>Description and Interpretation</b>	<b>Max Width (mm)</b>	<b>Max Thckn (mm)</b>	<b>Depth BGL (mm)</b>
700	Layer	Turf and loose grey silty clay. Topsoil	-	300	-	
701	Layer	Greyish orange sand. Natural strata	-	300+	300

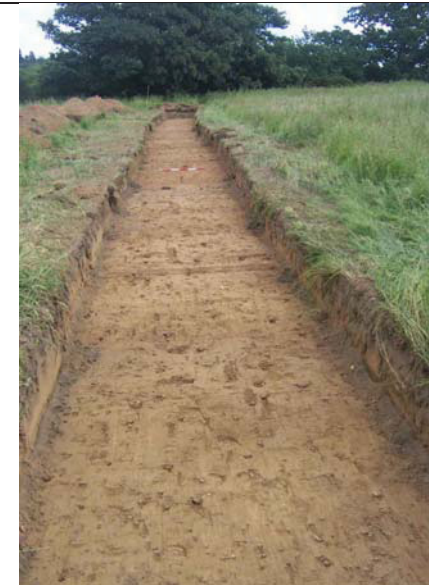
<b>Trench 8</b>

<b>Max Dimensions</b>					
	<b>Length</b>	40.83m	<b>Width</b>	2.2m	<b>Depth</b>	0.55m
	<b>Levels</b>					
	<b>Trench base north</b>		m OD			
	<b>Trench top north</b>		m OD			
	<b>Trench base south</b>		m OD			
	<b>Trench top south</b>		m OD			
	<b>NGR Co-ordinates</b>					
	<b>E</b>	SP 90975 26590	<b>W</b>	SP 90934 26585		
	<b>Orientation</b>		East to west			
	<b>Reason for Trench</b>		General evaluation			
	<b>Context</b>	<b>Type</b>	<b>Description and Interpretation</b>	<b>Max Width (mm)</b>	<b>Max Thckn (mm)</b>	<b>Depth BGL (mm)</b>
800	Layer	Turf and loose grey silty clay. Topsoil	-	300	-	
801	Layer	Greyish orange sand. Natural strata	-	250+	300

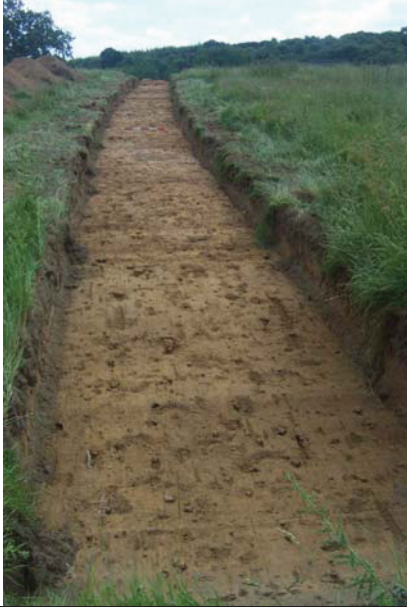
<b>Trench 9</b>

<b>Max Dimensions</b>					
	<b>Length</b>	41.77m	<b>Width</b>	2.2m	<b>Depth</b>	0.45m
	<b>Levels</b>					
	<b>Trench base north</b>		m OD			
	<b>Trench top north</b>		m OD			
	<b>Trench base south</b>		m OD			
	<b>Trench top south</b>		m OD			
	<b>NGR Co-ordinates</b>					
	<b>N</b>	SP 90972 26574	<b>S</b>	SP 90987 26534		
	<b>Orientation</b>		North to south			
	<b>Reason for Trench</b>		General evaluation			
<b>Context</b>	<b>Type</b>	<b>Description and Interpretation</b>	<b>Max Width (mm)</b>	<b>Max Thckn (mm)</b>	<b>Depth BGL (mm)</b>	
900	Layer	Turf and loose grey silty clay. Topsoil	-	250	-	
901	Layer	Greyish orange sand. Natural strata	-	200+	250

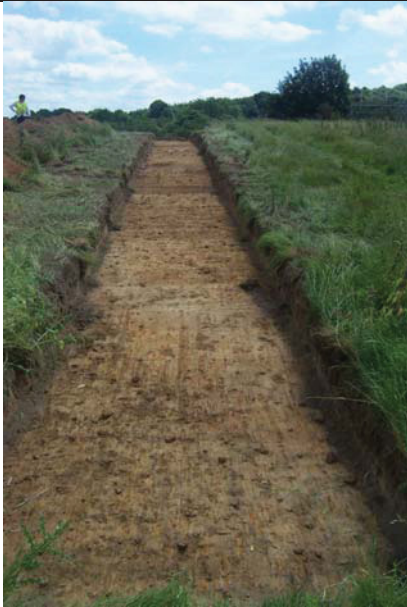
<b>Trench 10</b>

<b>Max Dimensions</b>					
	<b>Length</b>	41.20m	<b>Width</b>	2.2m	<b>Depth</b>	0.5m
	<b>Levels</b>					
	<b>Trench base north</b>		m OD			
	<b>Trench top north</b>		m OD			
	<b>Trench base south</b>		m OD			
	<b>Trench top south</b>		m OD			
	<b>NGR Co-ordinates</b>					
	<b>N</b>	SP 90951 26553	<b>S</b>	SP 90960 26563		
	<b>Orientation</b>		North to south			
	<b>Reason for Trench</b>		General evaluation			
<b>Context</b>	<b>Type</b>	<b>Description and Interpretation</b>	<b>Max Width (mm)</b>	<b>Max Thckn (mm)</b>	<b>Depth BGL (mm)</b>	
1000	Layer	Turf and loose grey silty clay. Topsoil	-	250	-	
1001	Layer	Greyish orange sand. Natural strata	-	250+	250
